# FNAL Crystal Collimator Modifications

Accelerator Division  
Division Head's Review  
7 August 2008

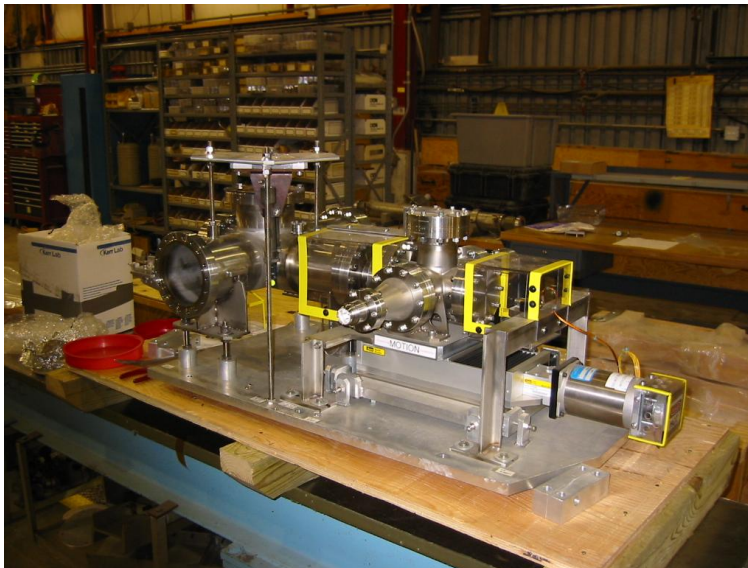
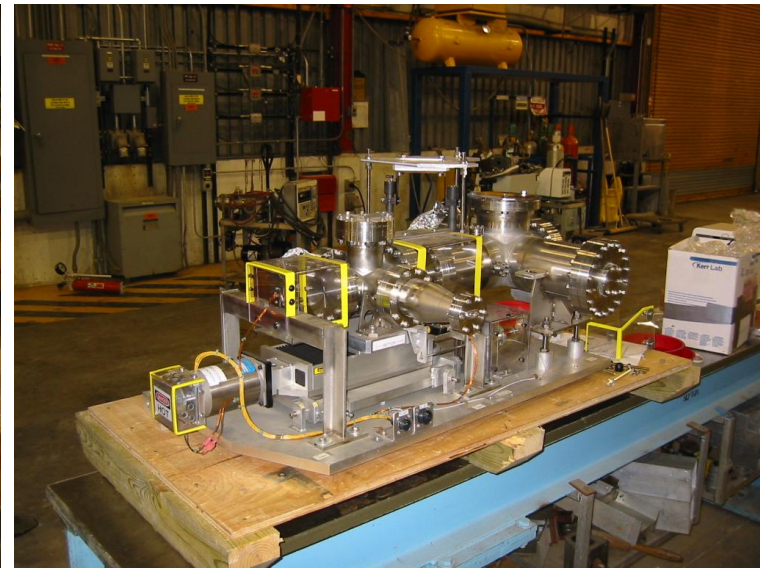
- Crystal Collimator or Goniometer as received from BNL, 2004
- Horizontal insertion drive stepper motor with electric brake

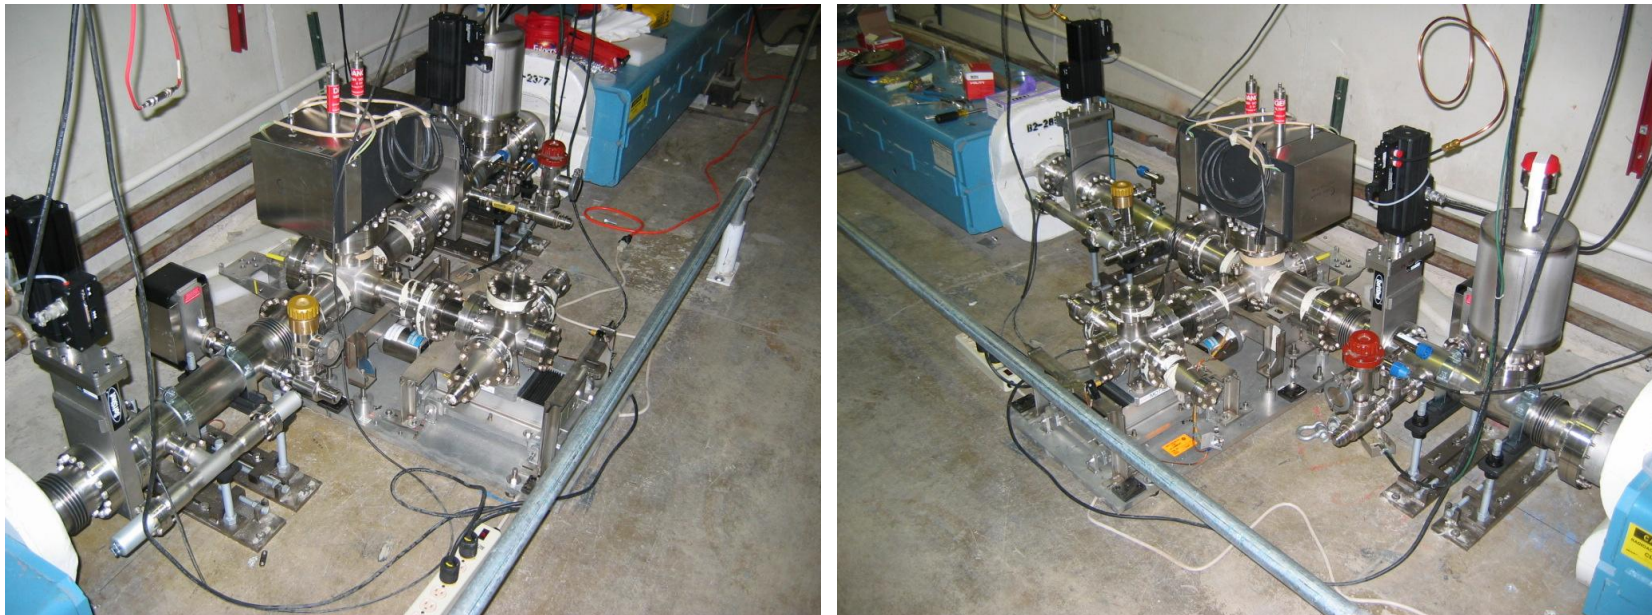
- Angular swing motion precision not satisfactory, internal LVDT problems
- Horizontal insertion drive motion not satisfactory, vacuum wants to pull the carriage in, horizontal drive slide is a ball screw, not self-locking, electric brake required

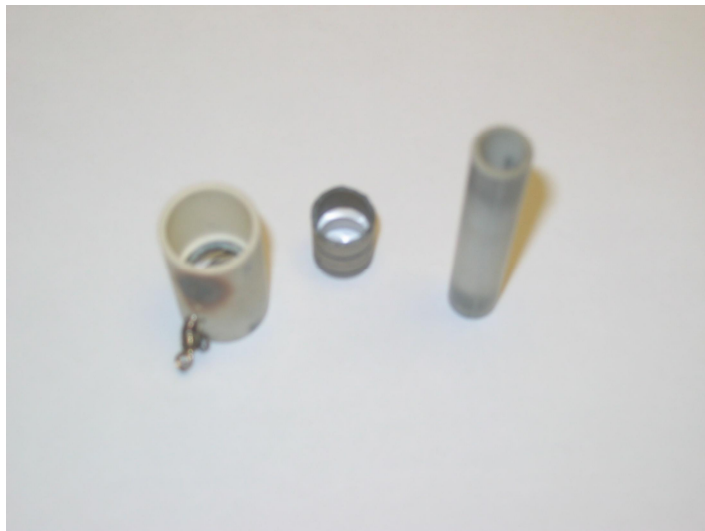
Malfunctioning inchworm motor in 2006, 2007

- Made different wiring holding bracket
- Rewired inchworm
- Repaired inchworm limit switches several times
- Repaired burned out inchworm
