# Recent operational experiences at NuMI

Jim Hysten / FNAL AD Target Systems Dept.

NoVA PASI Workshop

November 11, 2015

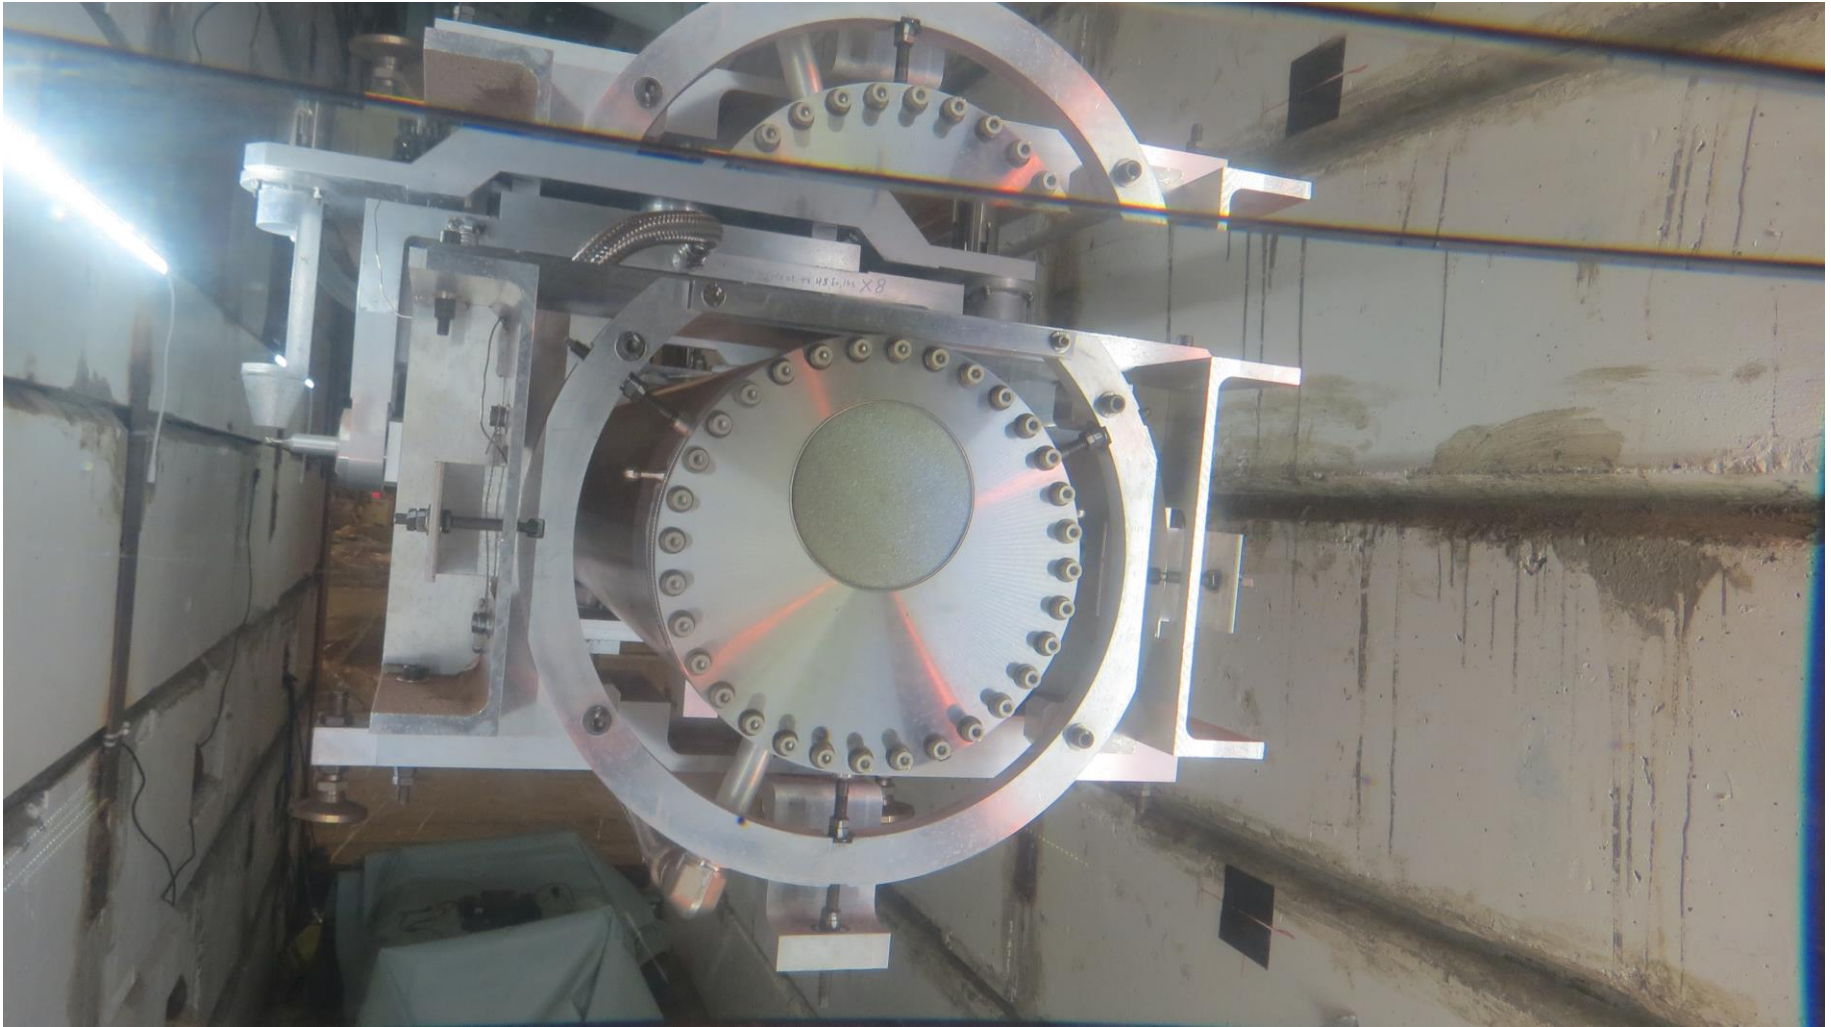
# Downstream end of MET-01

*after two years operation*

Looks very good !

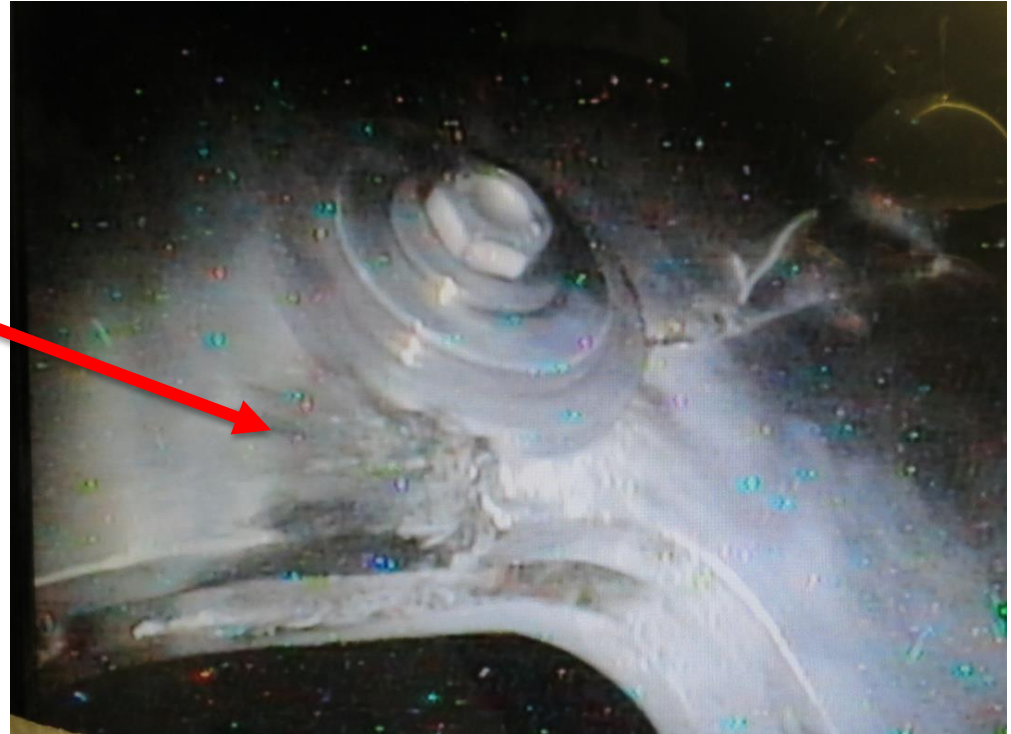
Find and remotely photograph  
cracked strip-line at horn

Piece of strip-line that cracked is permanently attached to horn,  
so had to replace horn

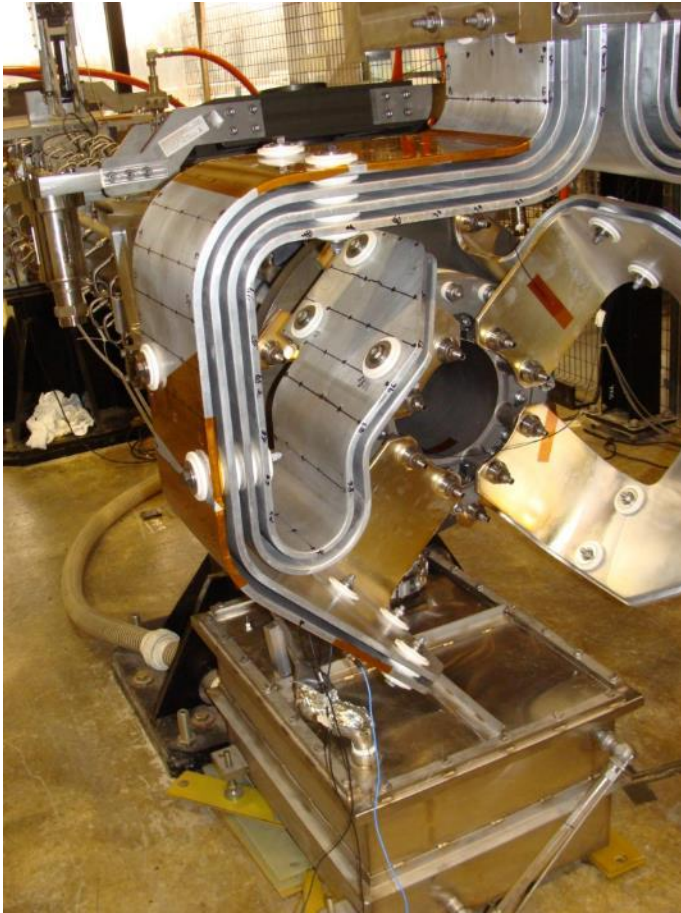
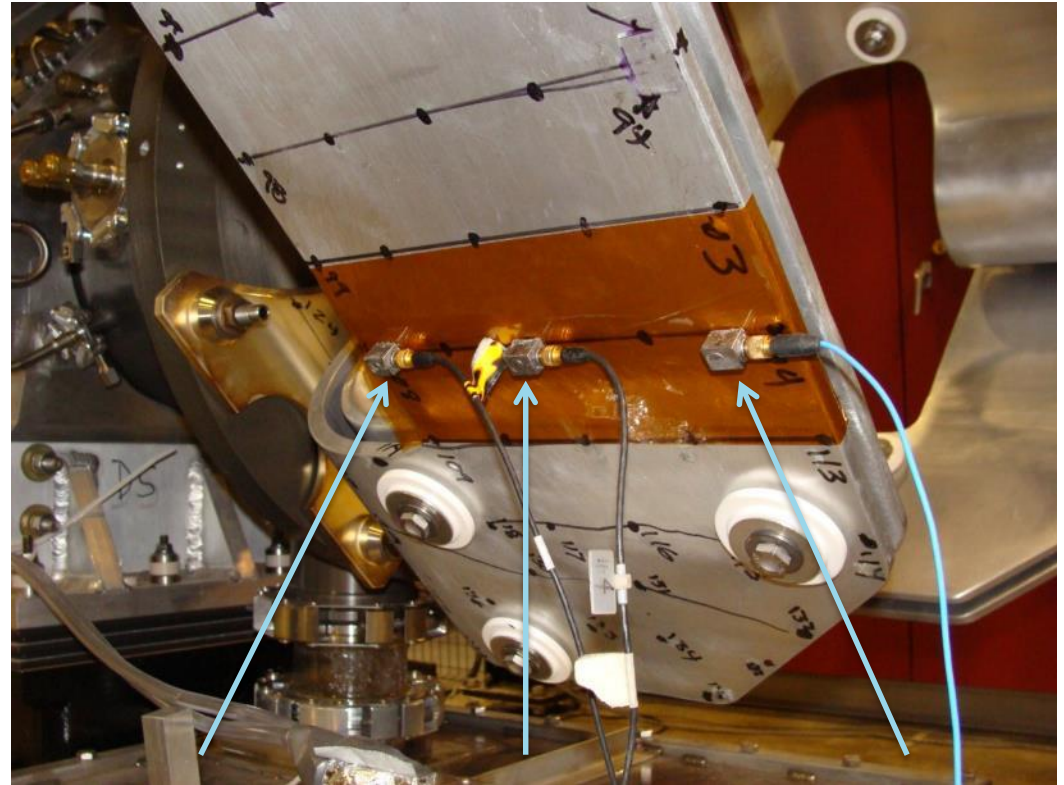
## Horn strip-line vibration measurements

PH1-04 style strip-line has **larger motion,**  
**longer ring-down (more fatigue cycles)** than PH1-03 style

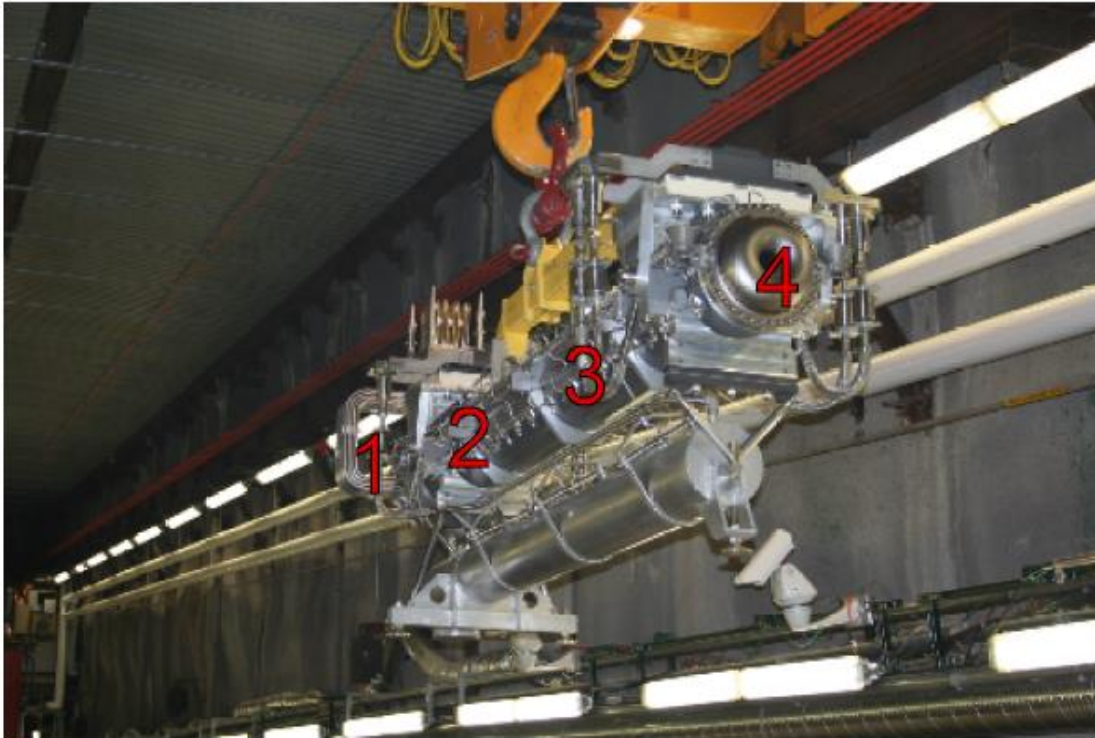
NuMI Horn PH1-04  
After 2 month cool-down

Point	Doserate @ 1 foot (mr/hour)
1	50000
2	100000
3	110000
4	80000

- Worker would accumulate weekly dose limit in 2 seconds

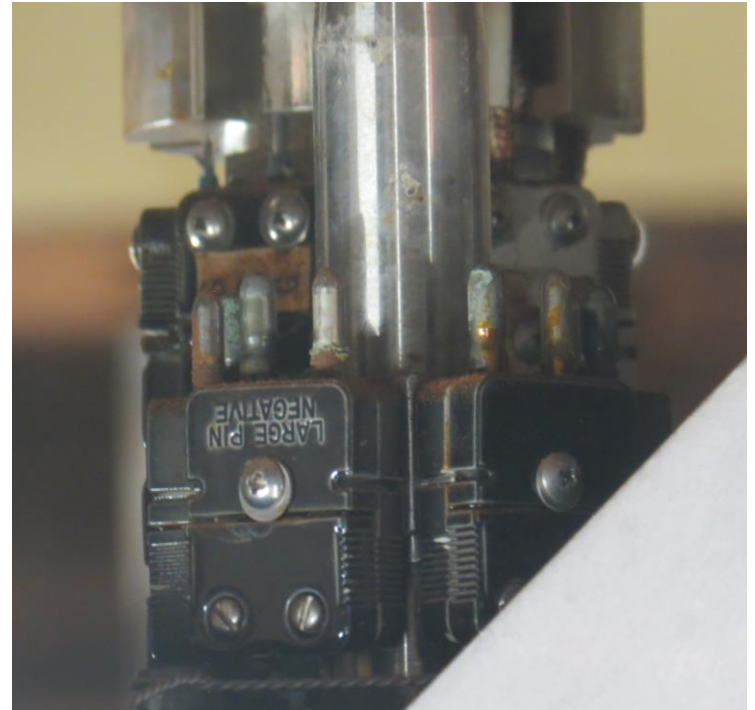
# TVPT connector problem on MET-01

Lost contact with sink thermocouple  
last run

Corrosion of remote connection  
thermocouple pins

Recovered connection during  
summer shutdown,  
sink thermocouple is working again

Need to better protect the connection – grease helps

May be better to use type K thermocouple (we have type J)

Best would be to have plug connection accessible/repairable
