MICE Spectrometer Solenoid Repair

MICE Spectrometer Solenoids

Lead failure

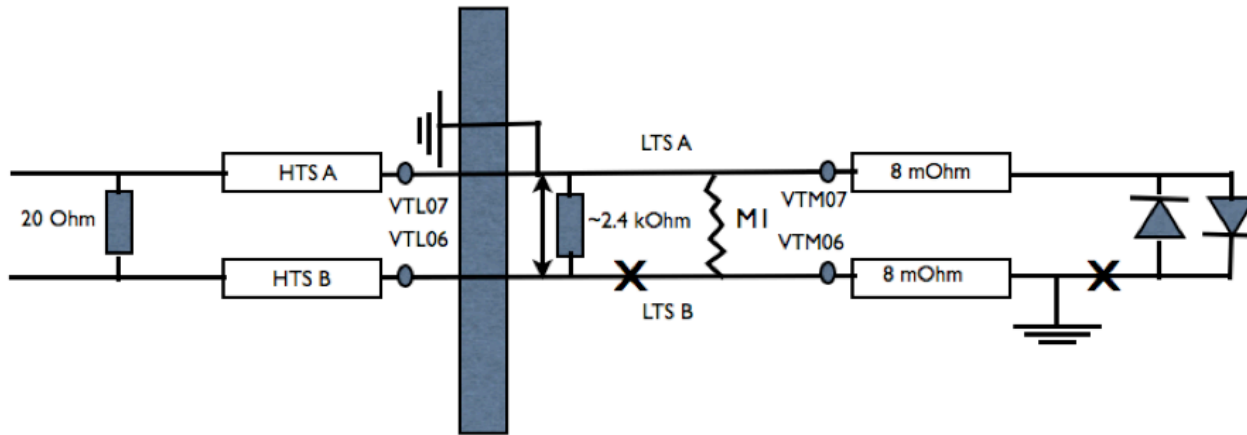
M1 circuit after fault

Diagram of the M1 circuit. Resistance (four wire and two wire) measurements revealed:

- i) Lead A has hard short to ground,
- ii) LTSA is shorted to LTSA through 2.4 kOhms and LTSA is not connected to the M1 coil on the Lead B side.

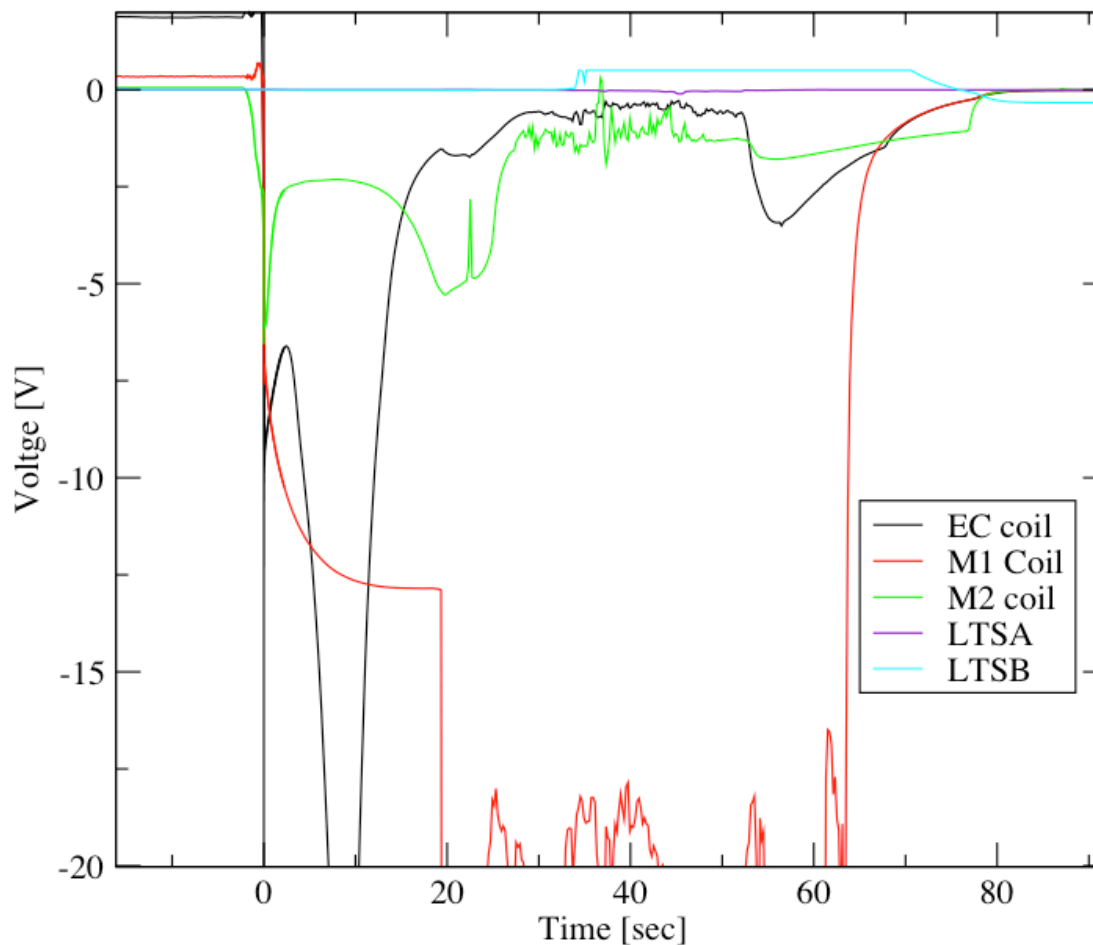
QP data – M1 (80 sec)

Quench on September 13th

- Quench initiated on ECE and initially proceeded normally
 - There is no evidence that any LTS leads were involved initially
- At ~ 20 sec, the internal QP for coil M1 failed
 - The voltage on the coil increased rapidly and, it appears that an arc at the LTS power feed through (from vacuum to LHe volume) occurred which burnt out the lead and effected M2 (the power leads for M1 and M2 utilize the same 4 pin feed through).
- What caused the QP failure?

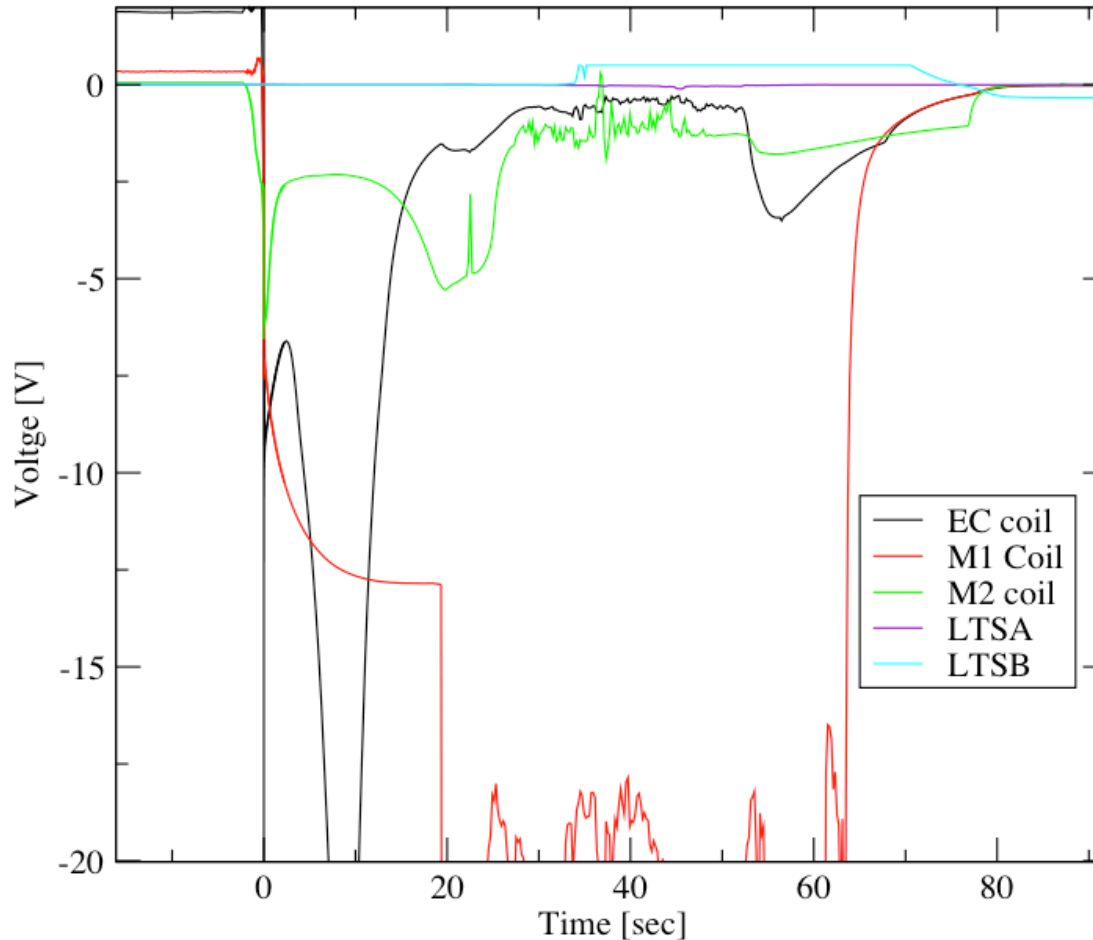
QP data – M1 (80 sec)

Quench on September 13th

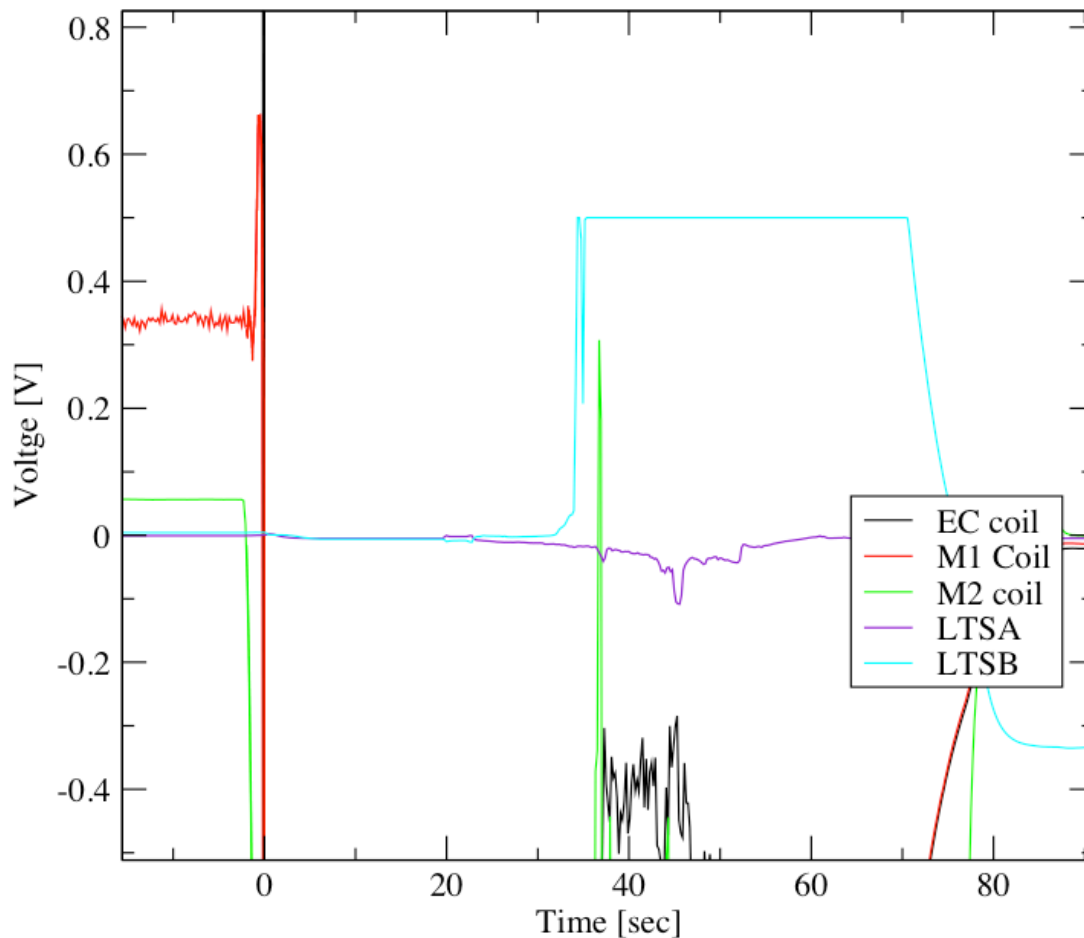
QP data – M1 (80 sec)

Quench on September 13th

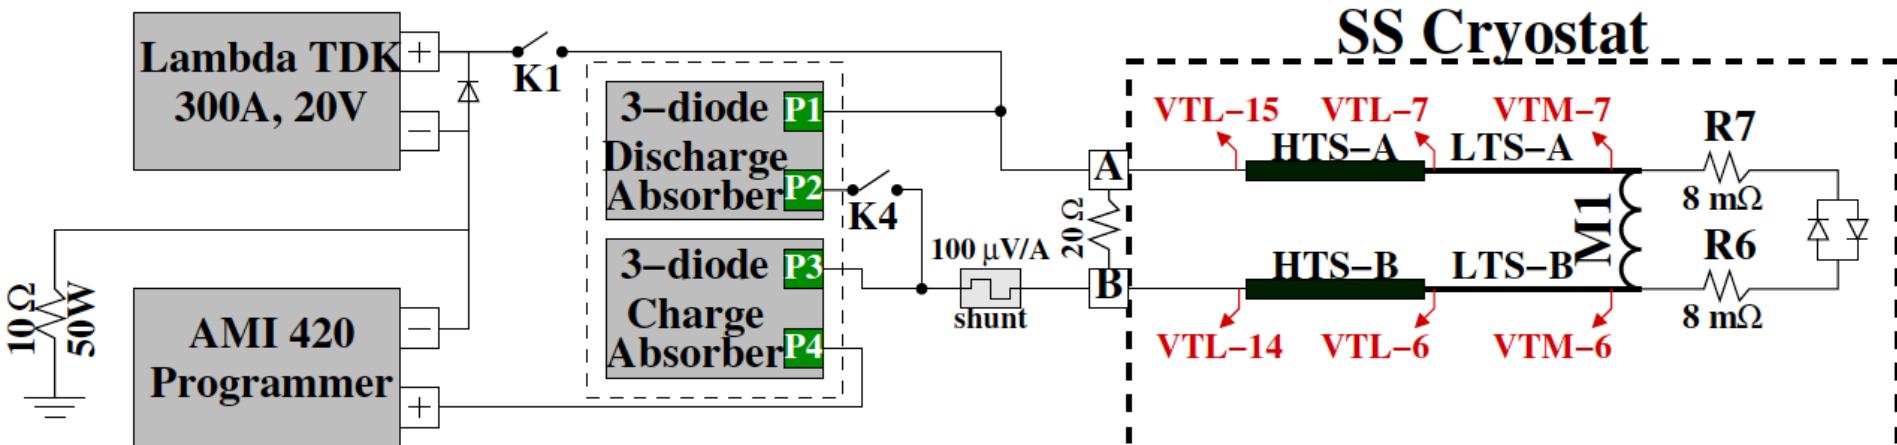
Circuit diagram

Failure in electrical circuit from the point of VTM-7 to VTM-6 as indicated in diagram on Slide 7

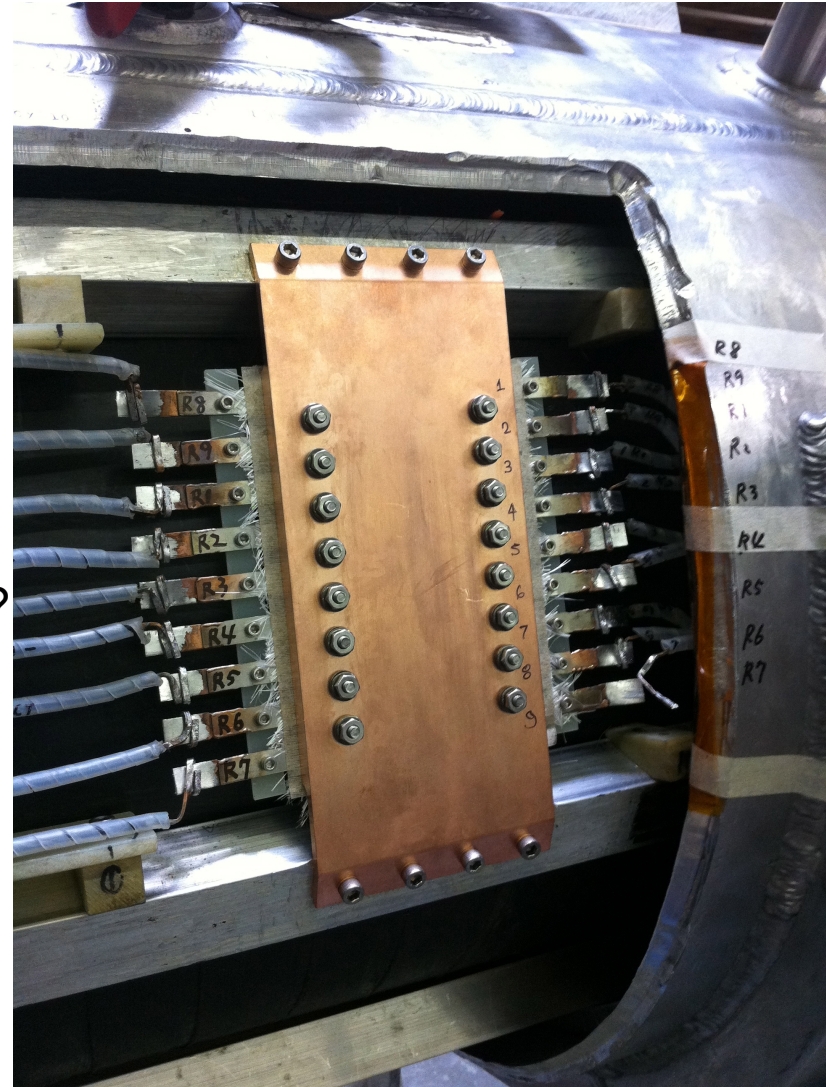
SSD/SS1

This is a photo of the QP pack for SSD/SS1. What is not known at this time is whether or not the terminations of the leads were complete when the photo was taken or exactly how the terminations were made. Did Wang follow the procedures used on SSU/SS1?
