Dielectric Loaded HPRF Cavity Update

B. Freemire
IIT
MAP Weekly Meeting
October 23, 2015

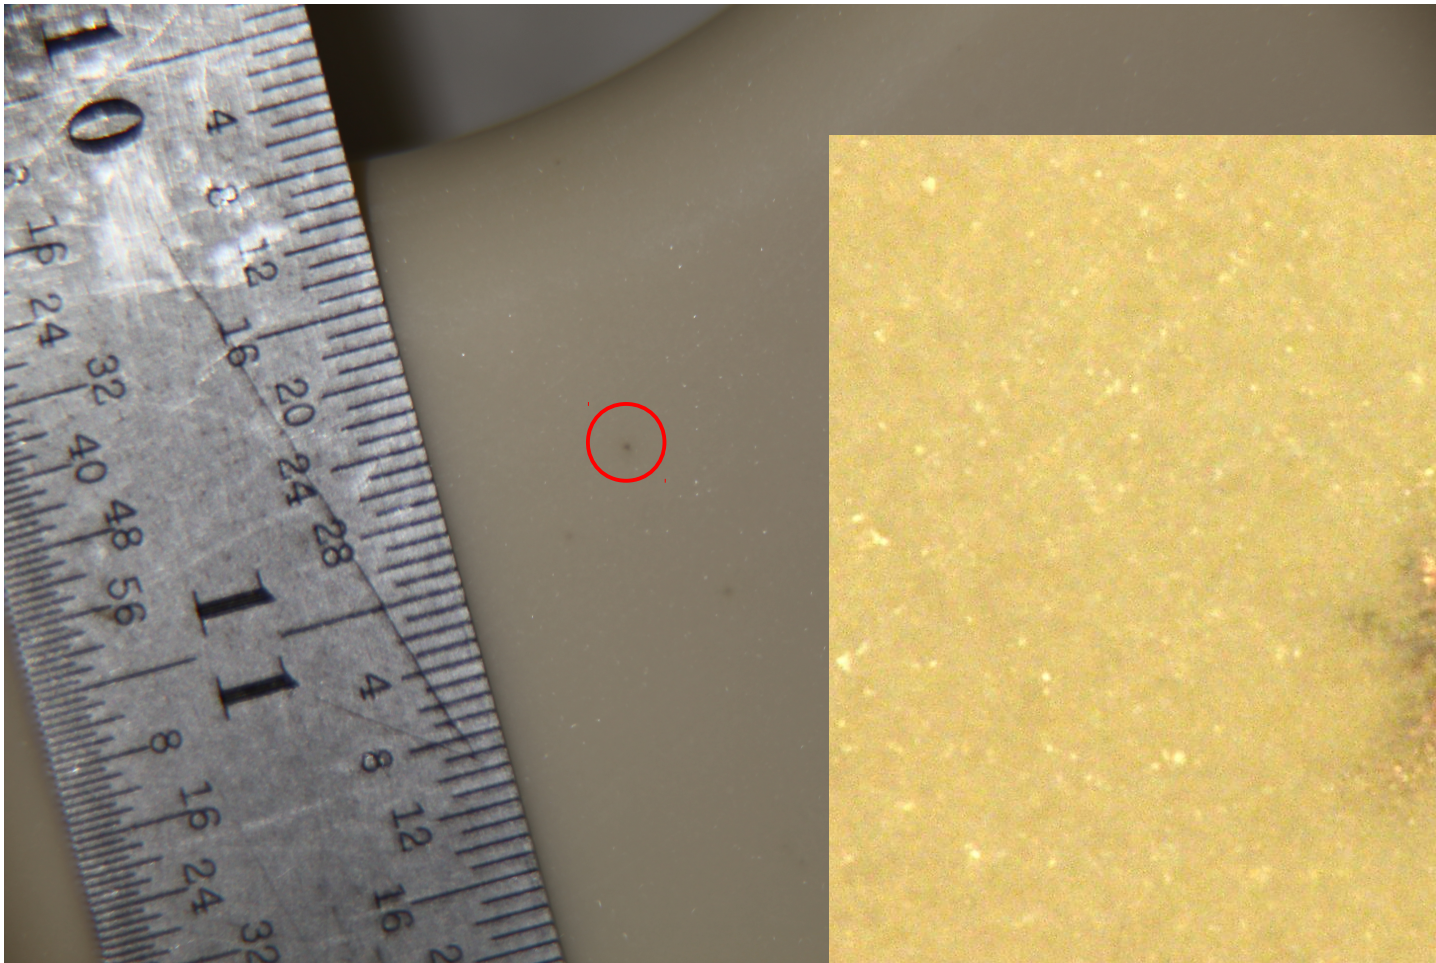
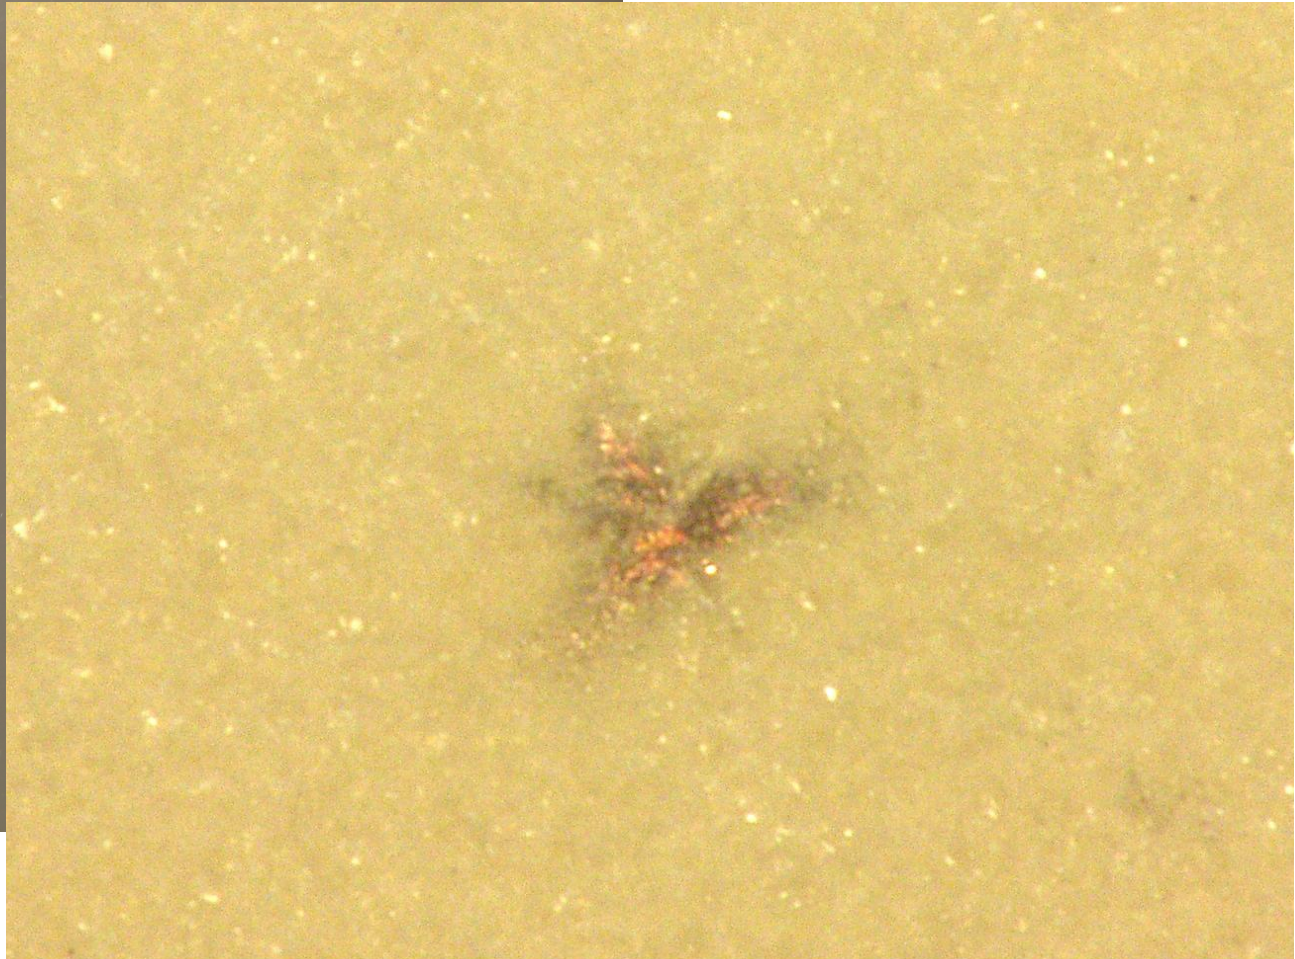
99.5%

- Very few visible signs of sparks
- Confined to one side

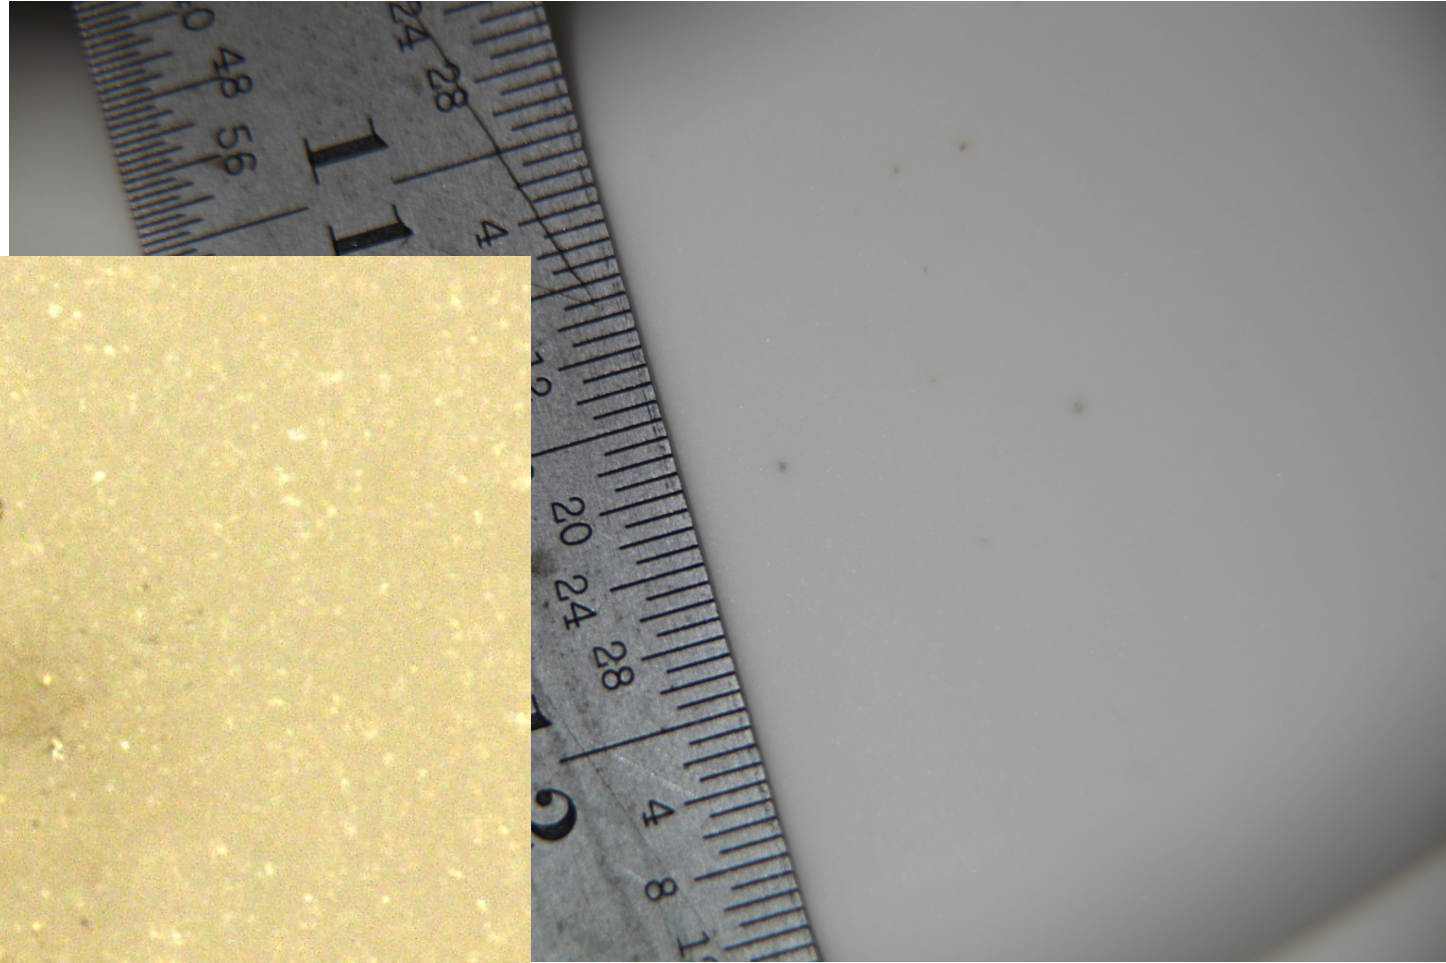
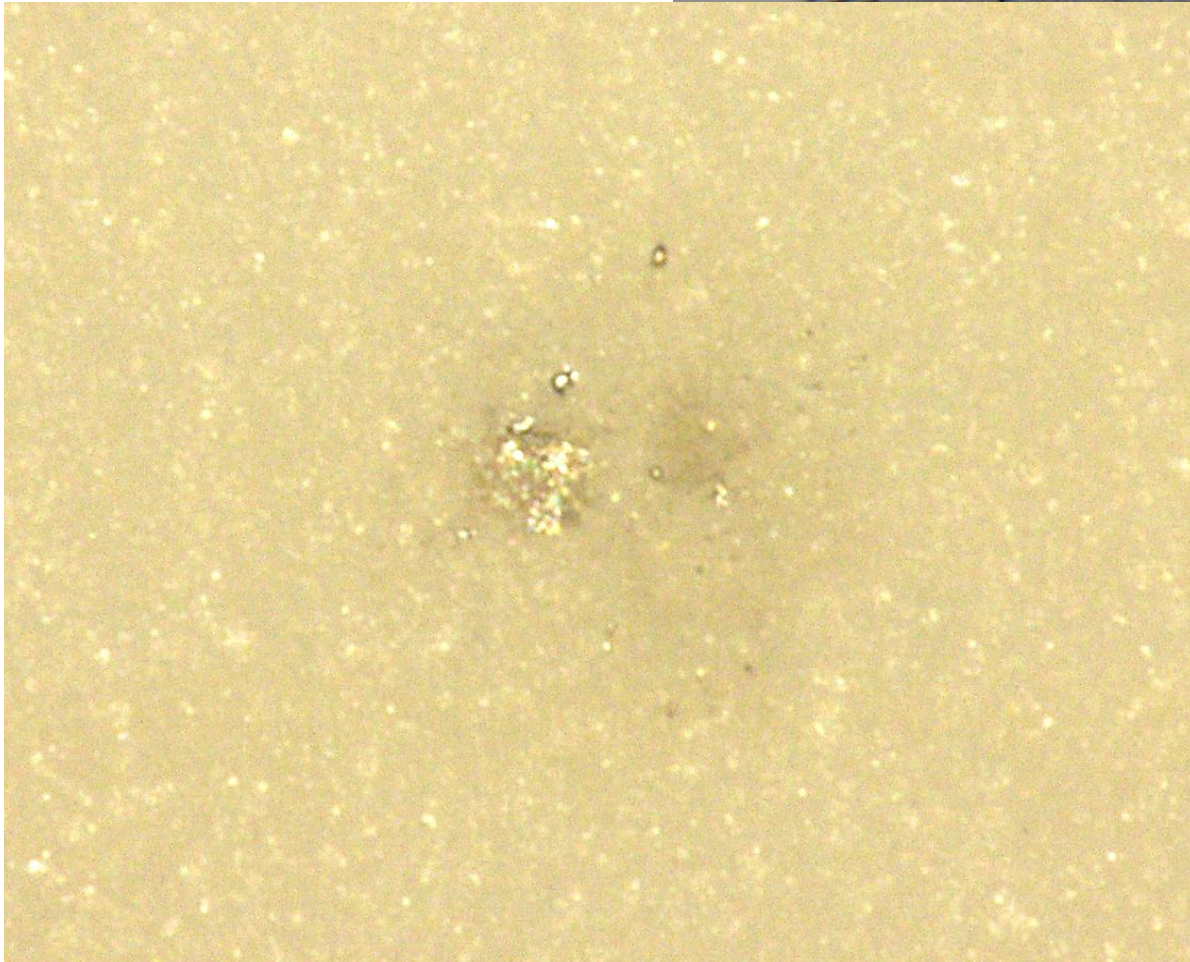
98.5%

- More visible signs of sparks (12 – 15)
- On both sides
