Modular Cavity Status

D. Bowring, A. Kochemirovskiy

MAP Meeting

November 13, 2015 *

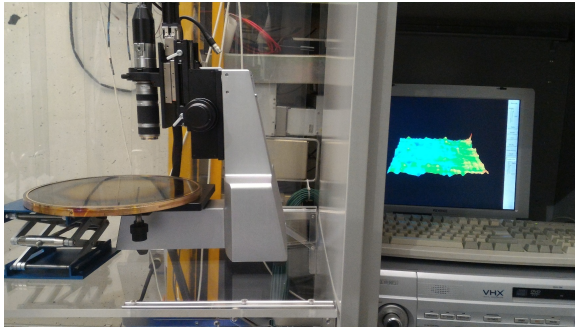
Interior surface inspection is complete.

- All features imaged, coordinates recorded.
- Common features shown at right.

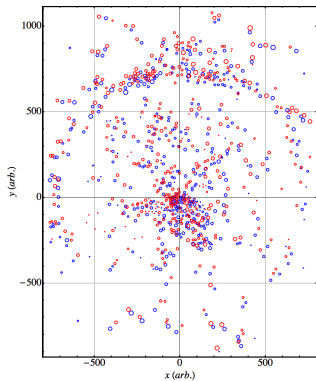
Figure : All-Seasons cavity damage map. 1-to-1 spot map.

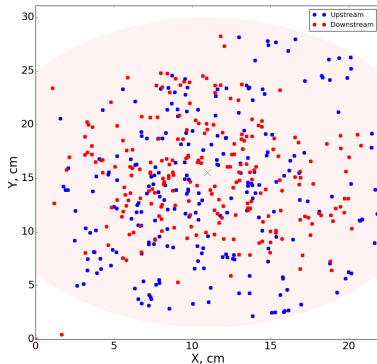
Feature positions from $B = 0$ run show no obvious pattern.

Figure : Modular cavity damage map. No discernible pattern.

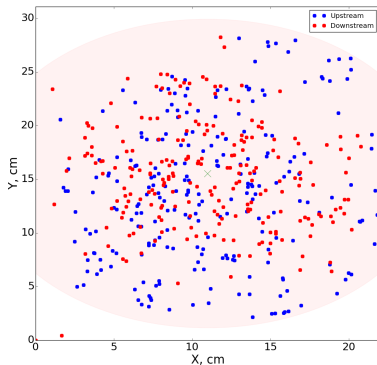
- 117 sparks recorded by DAQ in last run. ~ 130 total.
- On upstream plate: 211 features imaged.
- On downstream plate: 158 features imaged.
- Obvious questions for ongoing analysis effort.

Figure : Modular cavity damage map.
No discernible pattern.
