# 35T Electronics Qa/Qc Overview

Alan Hahn  
FNAL

35 T LL Review

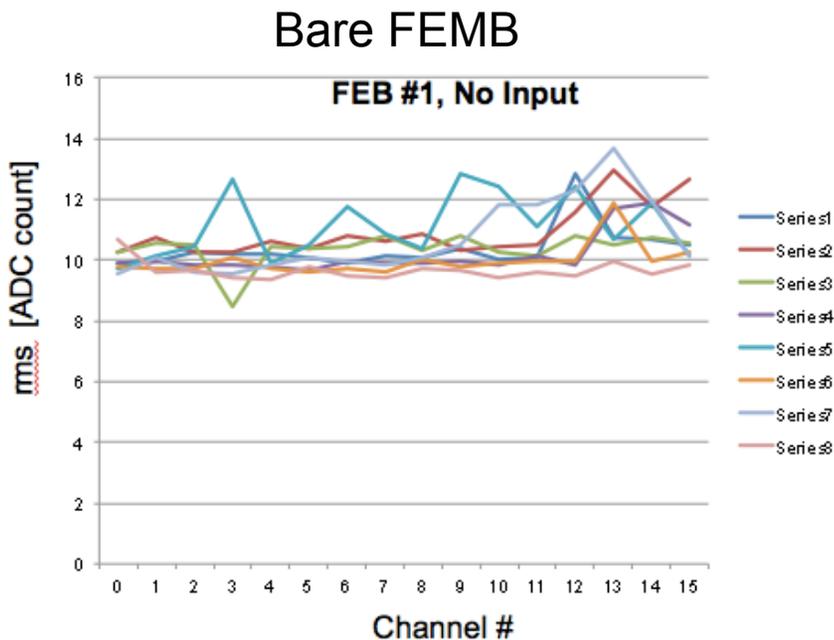
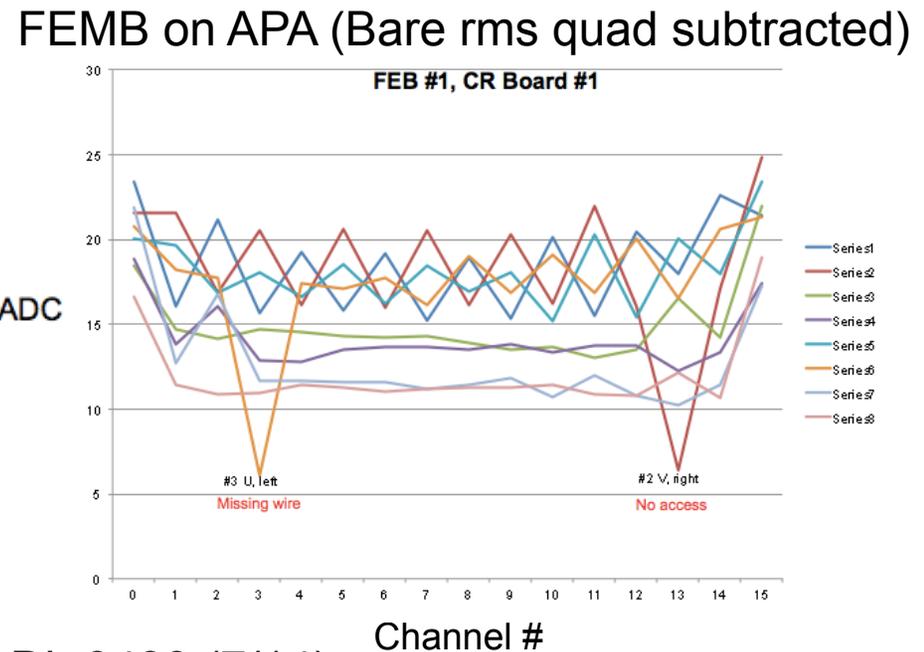
LBNE DocDb 9439 (7/14)

- Previously one APA (3 Bd) was shipped (6/14) to BNL to be checked out with preproduction FEMB.
- Found several wires on APA that were apparently not connected—fed back to PSL

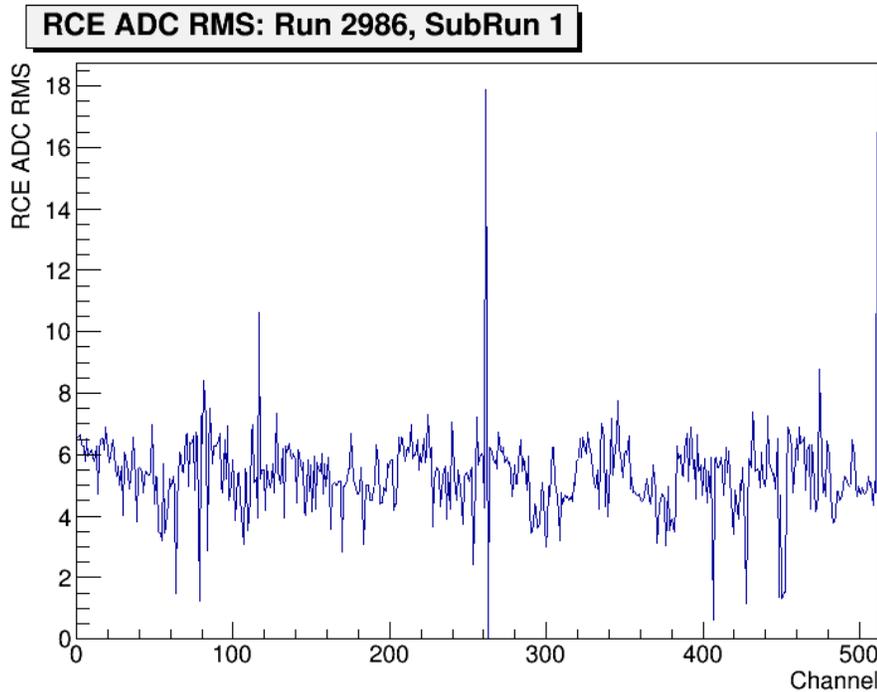
At DAB just before sending to PC4

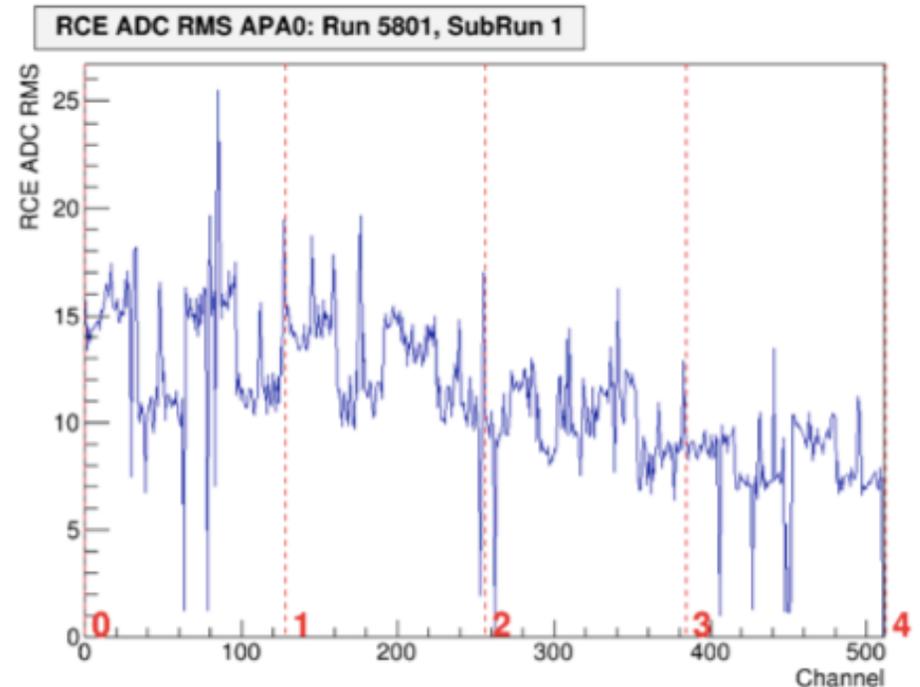
After installation in cryostat  
~12/16/15 while 35T is being  
leak-checked

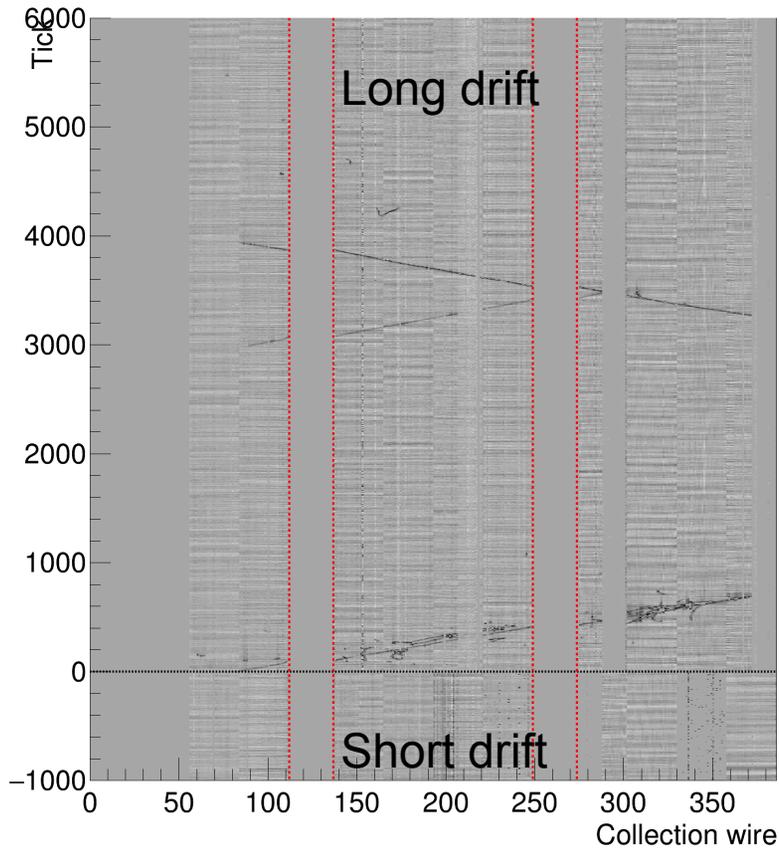
“Low” Noise State

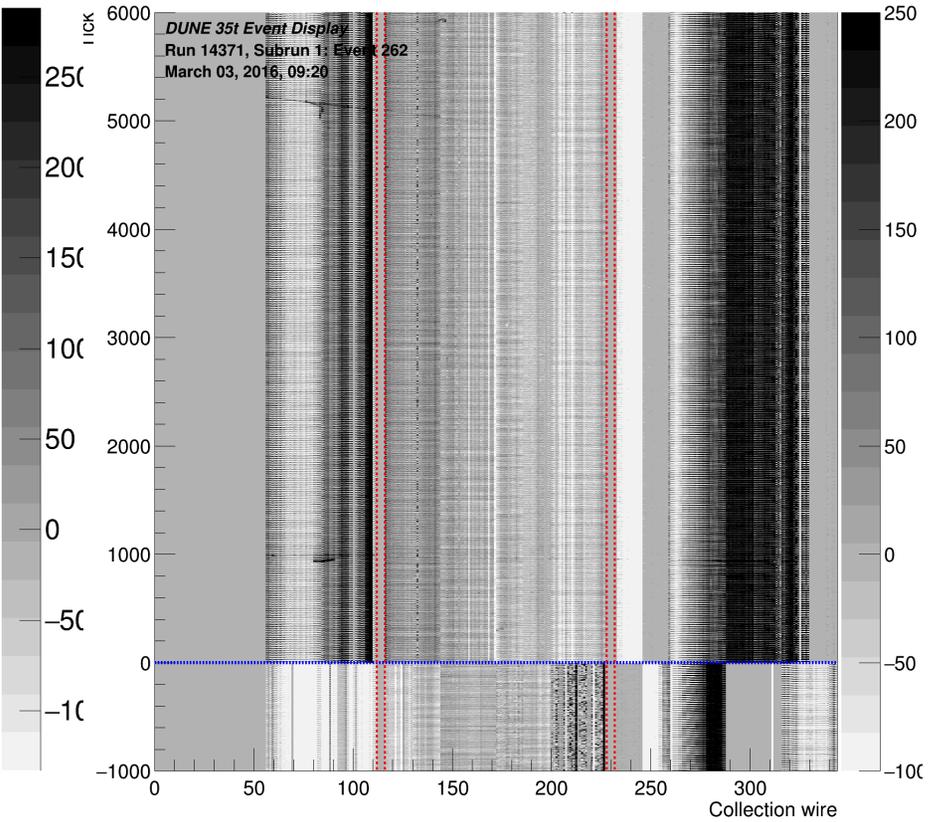
Very High Noise State
