Lessons Learned from the DUNE 35-ton Prototype

M.Convery, T. Junk. M. Stancari

June 2, 2016

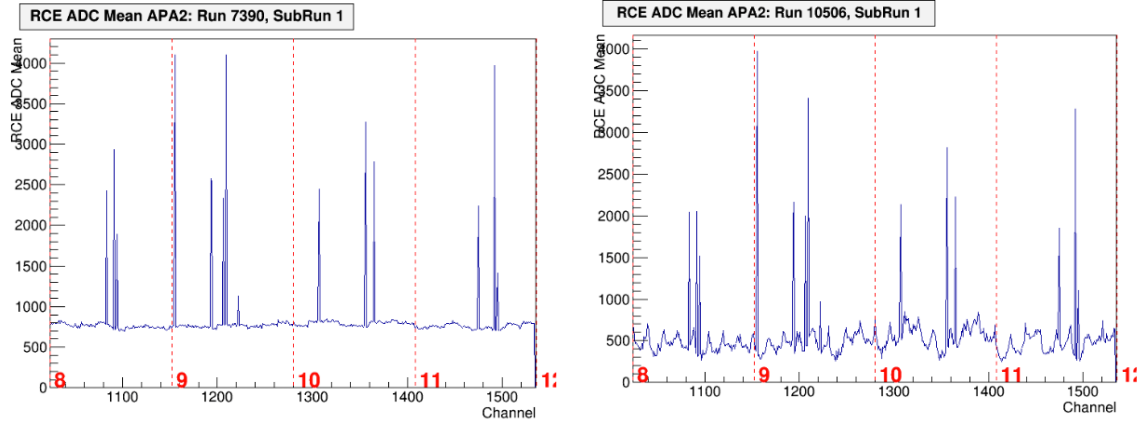
Figure 3: ADC mean values when warm (left) and cold (right).

During the initial warm testing of the 16 FEMBs installed on the 35-ton APAs, all FEMBs were functional and only isolated dead channels were observed. During the initial cooldown of the 35-ton, channels 64 to 127 of FEMB 3 were observed to "die". Their pedestal ADC mean values and RMS values dropped to zero. This would seem to indicate a problem with the digital part of the FEMB. Subsequently, over the course of several weeks, 5 more groups of 16 channels each were observed to exhibit similar behavior. However, in this case, the pedestal ADC mean remained at normal values, and the RMS value dropped very low but not zero. This would seem to indicate a problem with the analog part of the FEMB, perhaps related to the FE analog ASIC. These two problems led to 208 dead channels. In total, there were 275 of the 2048 channels that were dead for the whole run.

As shown in Figure 3 (left-hand side), the warm pedestals were relatively uniform except for spikes due to dead channels. In contrast, as shown in the right-hand side of the figure, the cold ADC means displayed a wide variation. The "wavy" pattern follows the boundaries of the FE ASICs and may indicate a problem with power distribution, or other channel-dependent effects.

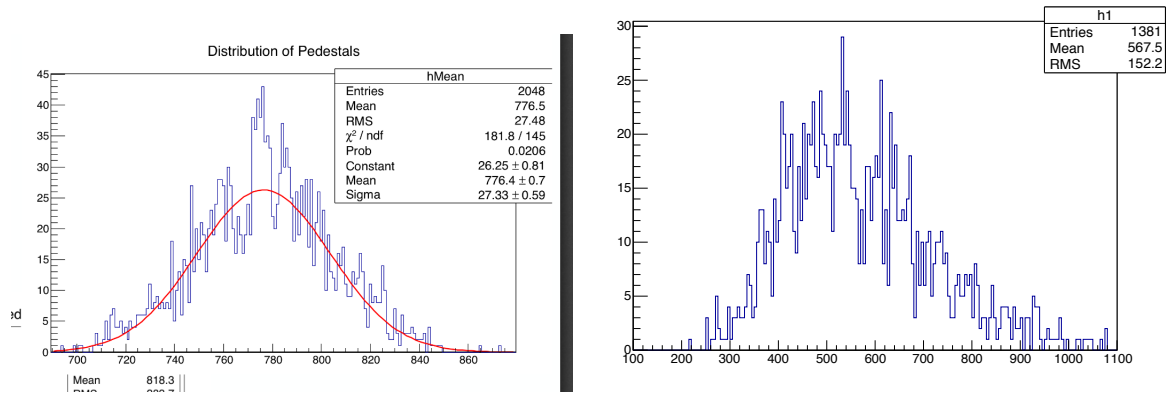
Figure 4: The distribution of pedestal means, or baseline, for functional channels at room temperature (left) and liquid argon temperature (right).

The variation of the pedestal or baseline channel to channel was much larger than naively expected by the online/offline crew. A histogram of these values at room temperature for functioning channels is shown in the left plot of figure 4 and for liquid argon temperature on the right plot.
