Update on the WA105 PMMA cathode

ITO coating defects

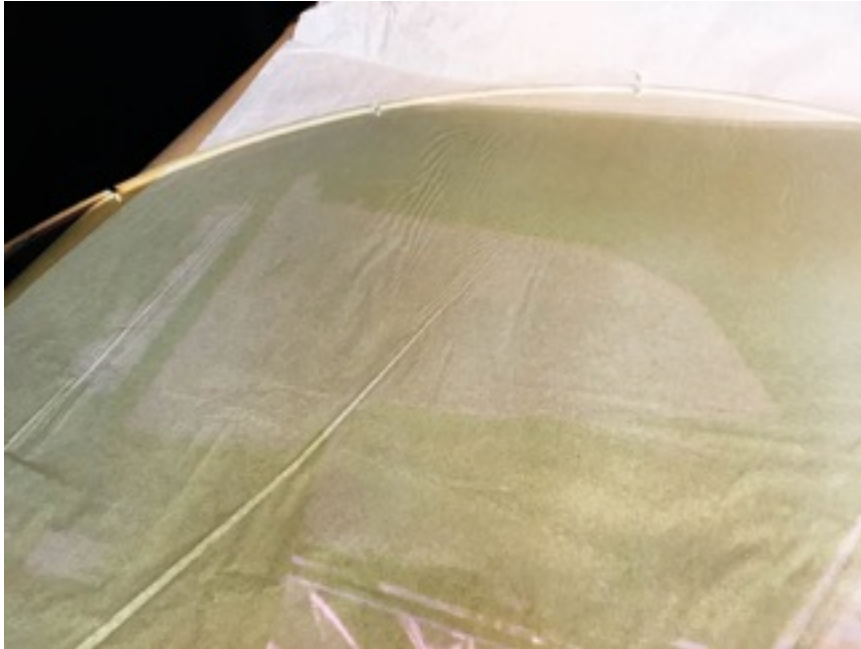
**Appeared on 2 surfaces out of 6
Presently under investigation with Visiontek**

A panel was returned due to damage and coating loss. There has been reported a coating loss and is shown here in a contrast enhanced image (enhanced as it's difficult to see in a standard photograph)..

The surface of the part is badly scratched. These scratches are certainly on the same side and area as the coating loss.

- The part would not have passed our inspection here (either incoming prior to coating or after coating and prior to shipment).
- We don't know what has been done to the parts to scratch them so badly, and how this might have affected the adhesion of our coating.
- In the light of the scratch damage can a harder substrate such as glass be considered?

- **Replacement panel was sent free of charge**
- **Plate would not have passed inspection @Visiontek**
- **Need to develop QA procedure**
