SNS Core Vessel Water Leak Saga

7th High Power Targetry Workshop

Michael J. Dayton

ORNL-SNS

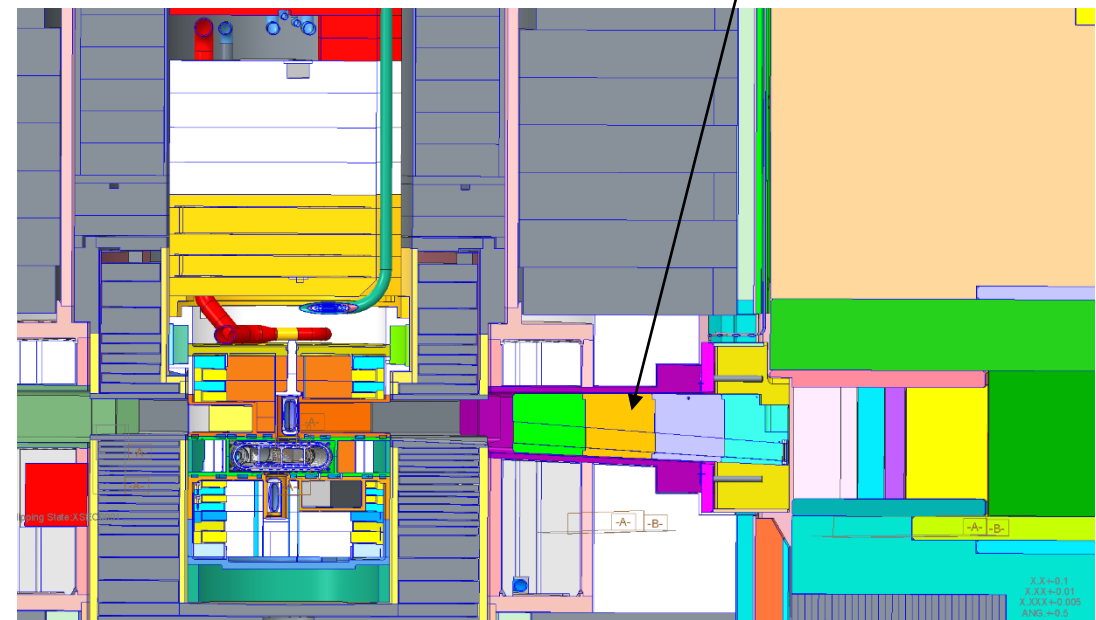
BL-4B CVI

BL-4B Core Vessel Insert beam guide is the only guide at SNS that has a downward slope. Neutronics studies indicated that the flux was decreasing in a manner consistent with the guide slowly filling with water.

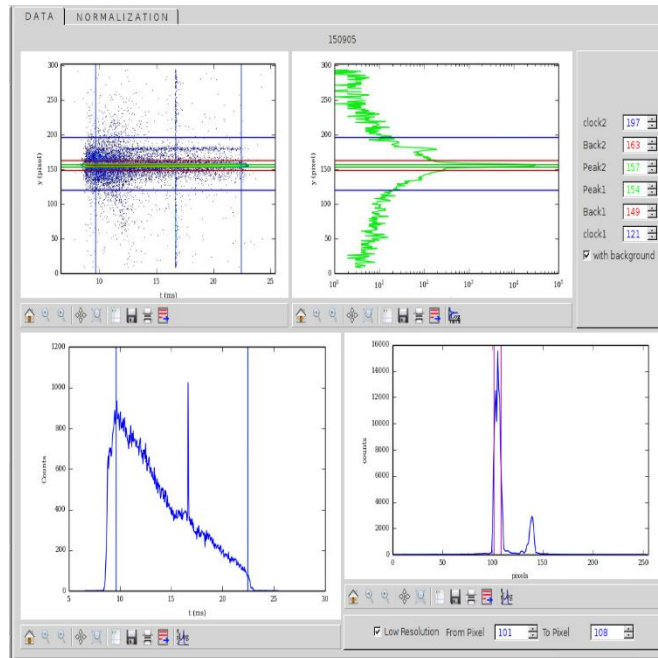
Consistent with **7.3 cm** of 8.0 cm window blocked at CVI exit

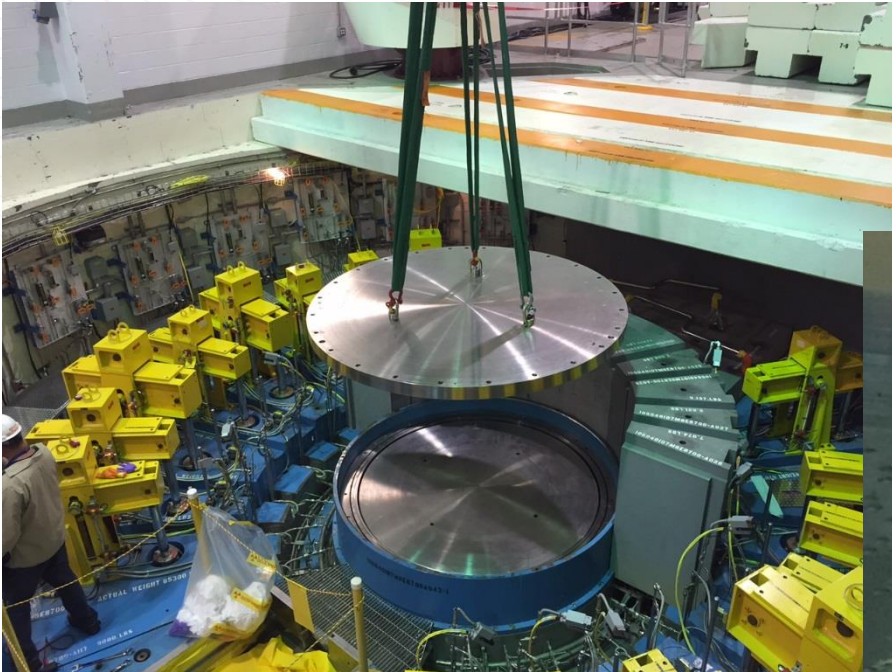
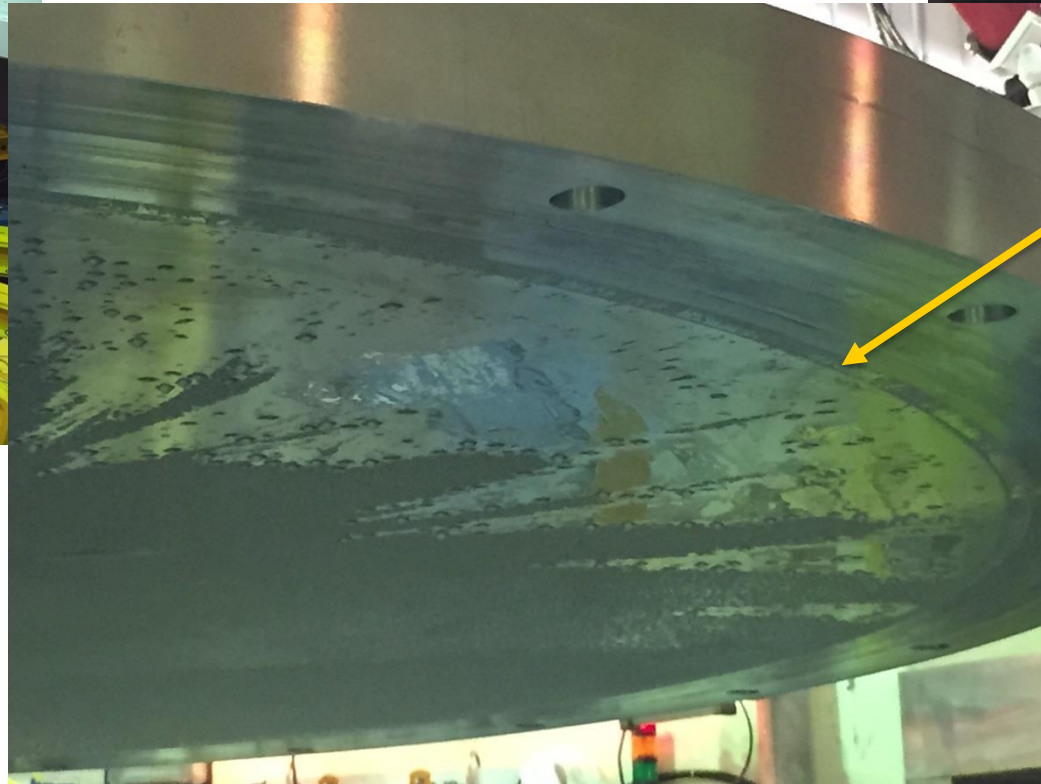
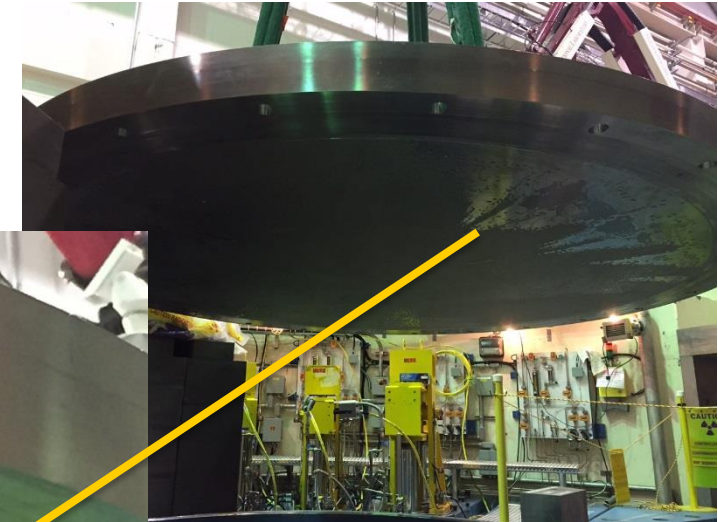
Significant condensation was found on lower surface of Lid
- Sampling indicated water was highly tritiated

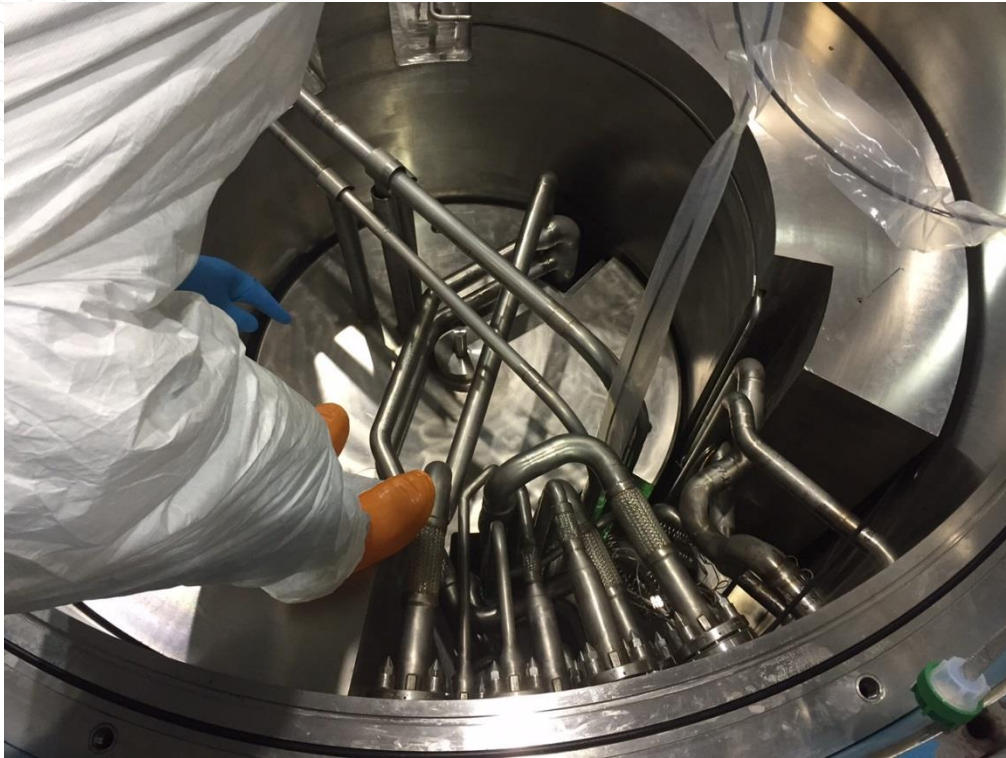
Water was observed leaking from the helium jacket tubing around the Top Downstream Moderator LWS#3 hydrogen transfer line

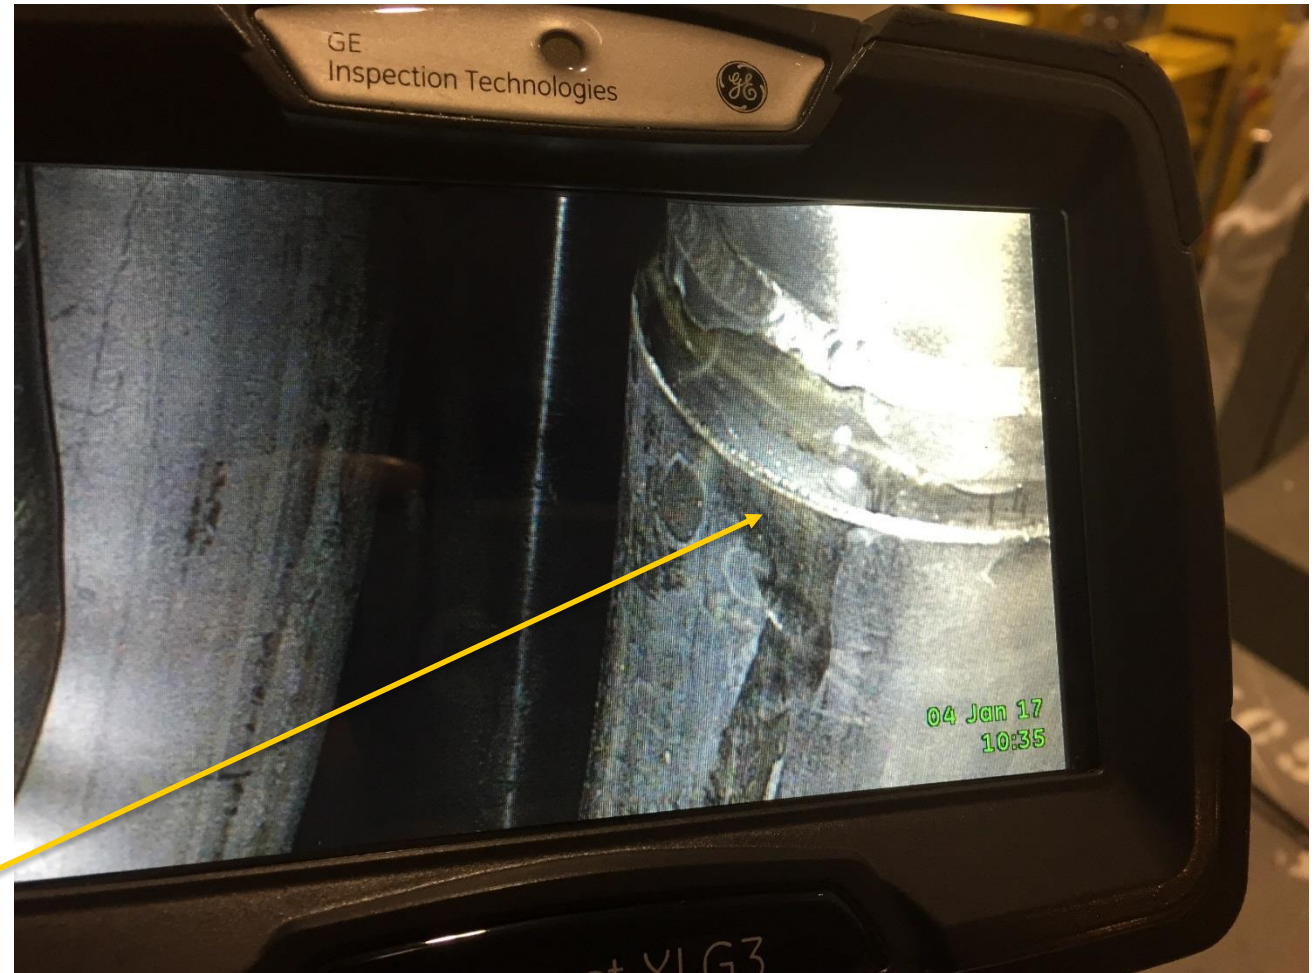
- “Stopping” this leak was not possible
 - The observed leak was not the leak location
 - only where the water was exiting the helium jacket
 - The leak itself was likely much deeper in the IRP and inaccessible
 - This line was a hydrogen transfer line for the cryogenic moderator – the presence of water in this location involved safety basis implications
 - Capping this line was not possible due to potential unacceptable pressure increases on moderator piping
- Decision was made to attempt to capture water and route out of Core Vessel

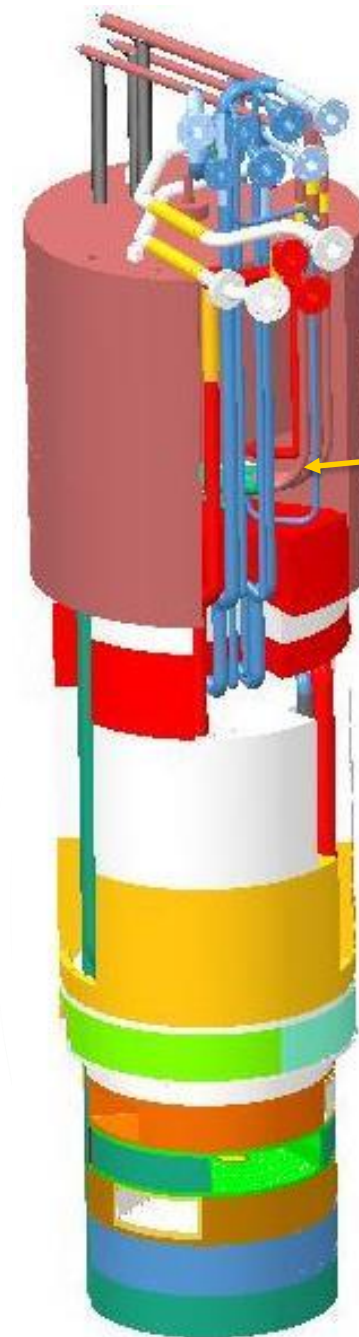
Water was found exiting the helium jacket approximately 1 meter below the top surface of the IRP
- Access was very limited

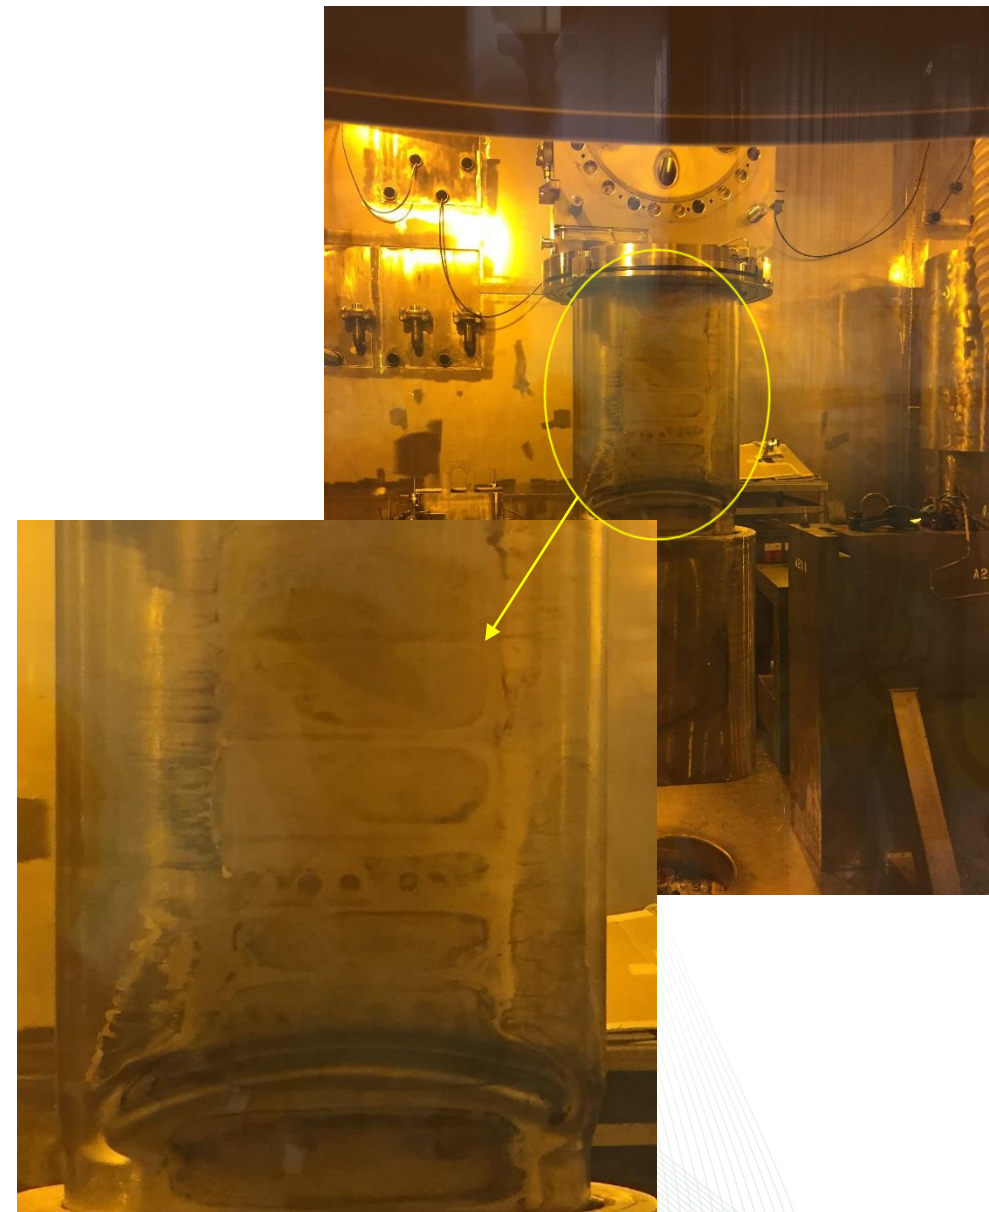
Water Stains Visible on Target Water Shroud

- Evidence began pointing to a leak in HWS#4
 - Trending data over time showed distinct drops in the Gas Liquid Separator for loop 4 versus the other two loops
 - Targets removed from service showed signs of water staining
 - BL-4B began filling with water again
- Testing during the June 2017 outage indicated a leak in a HWS#4 circuit internal to the IRP
- Remediation would have to wait until IRP replacement (winter 2018)
