ISIS Target Station 2 Proton Beam Window (PBW) Failure and Replacement

Dan Coates Target Group Design Engineer

HPTW 2018, East Lansing, USA

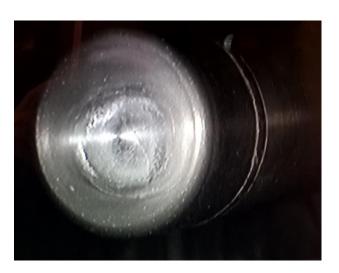
- A camera was attached to the target trolley and driven into the void vessel to inspect the window.
- The image taken below illustrated some marks on the surface. However, it was difficult to determine the location of the breach. Vacuum was applied but there was no change in the surface of the window.

A decision was made to change the window in the January 2018 shutdown with the aim to have beam on TS2 at the beginning of February. This gave 2 months to –

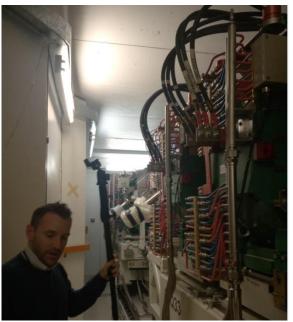
Remote EPB Clamp Assy

Clamp assembly is buried between magnets and shielding. Operation is carried out by hand, driven through universal joints and shafts.

- Clamp actuator seized in place? Very difficult to access location with high on contact radiation levels. (The target was still fitted, but pulled back into the remote handling cell).
- Will the bellow detach from the EPB tube when drawn back?
- When drawing back, would the released EPB tube spring out of alignment due to unknown subsidence?
 Will it realign when driven back?

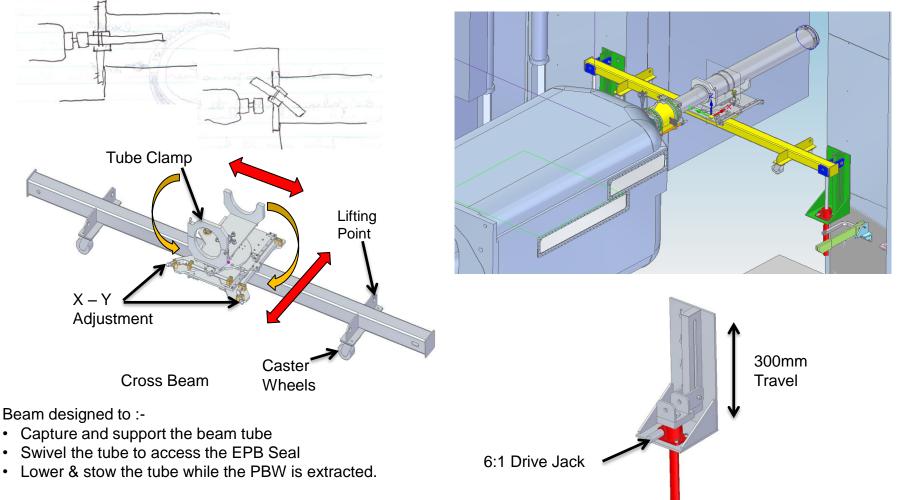
Tooling Design

Nothing in place to handle the EPB tube. However!, the operations manager had the foresight in 2008 before beam to target, to drill some fastening holes in the cell north wall and scope out an idea.

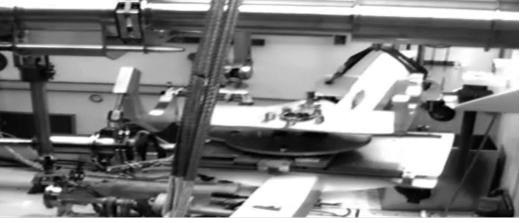
Cross Beam wheeled across the floor and rails.

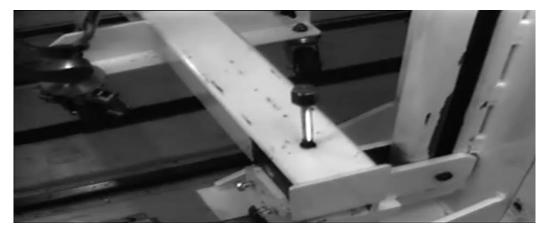
Cross Beam hoisted by crane below the EPB tube

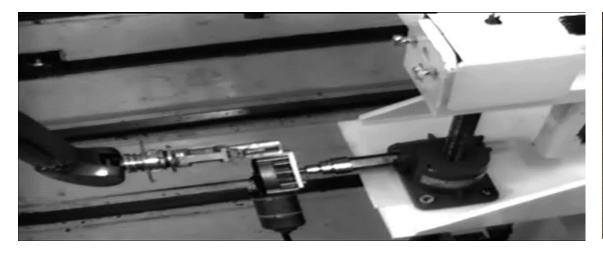
ISIS developed, power drivers used for the first time. 2 used in tandem to jack the beam. This device was also used to traverse X & Y on the support table.

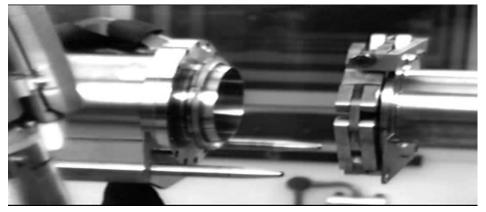
First job was to change the EPB tube seal

Release the chain clamp and using the XY table, the tube was withdrawn from the guide pins. Clamp remains captive to the EPB tube. The seal remained on the monitor

The old seal was discarded and the replacement metal seal was located onto the flange.

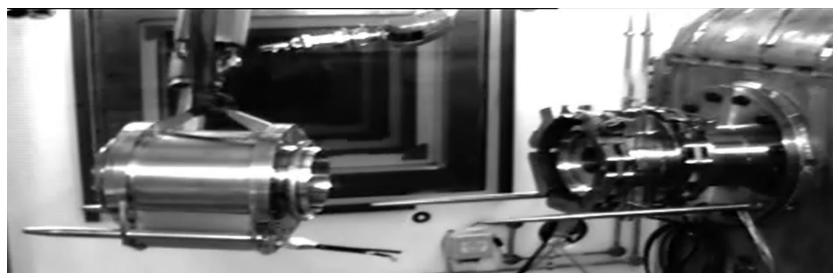
Beam Profile Monitor Removal

Monitor clamp was released and remained captive to the window assembly. The seal on this side was also captive to the monitor. The monitor was removed off the guide pins and discarded.

Cutting the monitor wires was a 2 man job With a regular pair of pliers. The outer insulation had deteriorated due to rad damage.

Grid wires looked intact within the monitor

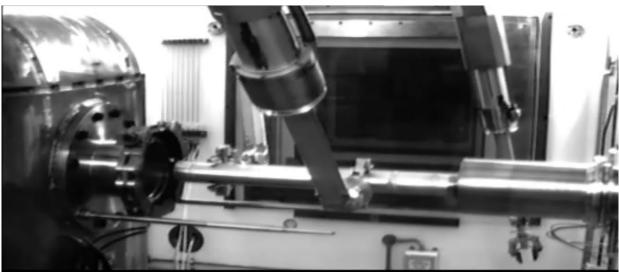
Void vessel chain clamp being released.

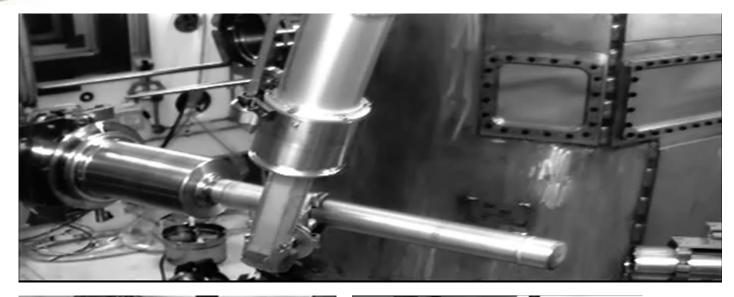
Extracting the PBW & Inspection

Inspection of the PBW with the flying lead camera

Confirmation of the window failure.
