Assessment of LCLS-II Module Production at FNAL

Version 2.0 September 19, 2017

O. Napoly

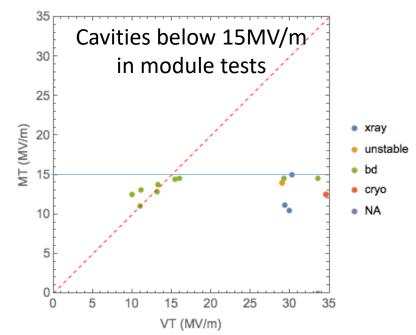
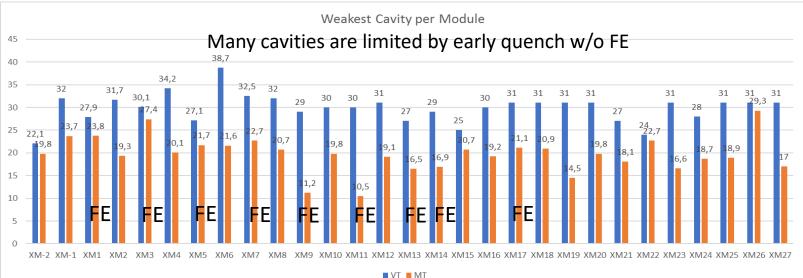
XFEL lowest performing cavities per modules

- FE limited usable gradients, represented in both figures, are more in the range of 19 MV/ or higher.
- Very few cavities are limited by FE below 15 MV/m, like in XM9 and XM11.

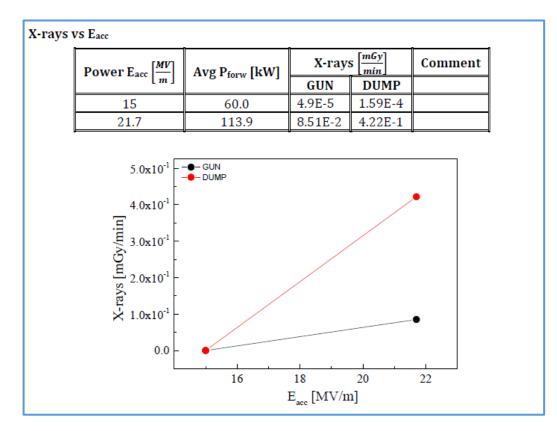
XFEL XM40 Module Test X-Rays Measurement

GUN	DUMP		
MV/m	mGy/min	mGy/min		
15	4,90E-05	1,59E-04		
21,7	8,51E-02	4,22E-01		
	2,07	1,96	(MV/m)/deca	ade

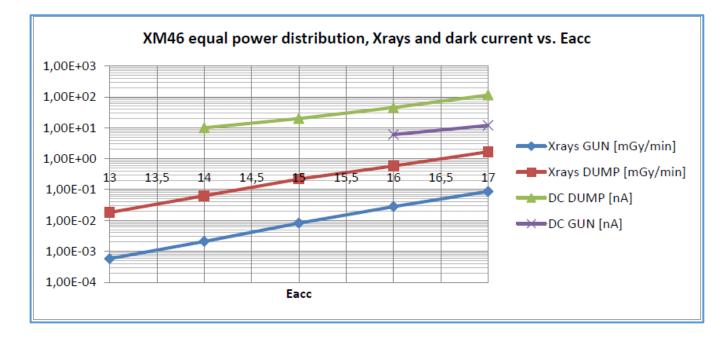
XFEL XM46 Module Test X-Rays Measurement

"XM46 is one of our dark current 'light bulbs' " (N. Walker)

GUN	DUMP		
MV/m	mGy/min	mGy/min		
13	5,80E-04	8,70E-02		
17	1,80E-02	1,68E+00		
	2,68	3,11	(MV/m)/dec	ade
