WA105

# 3x1x1 operations: Status and plans

Laura Manenti & Laura Molina Bueno

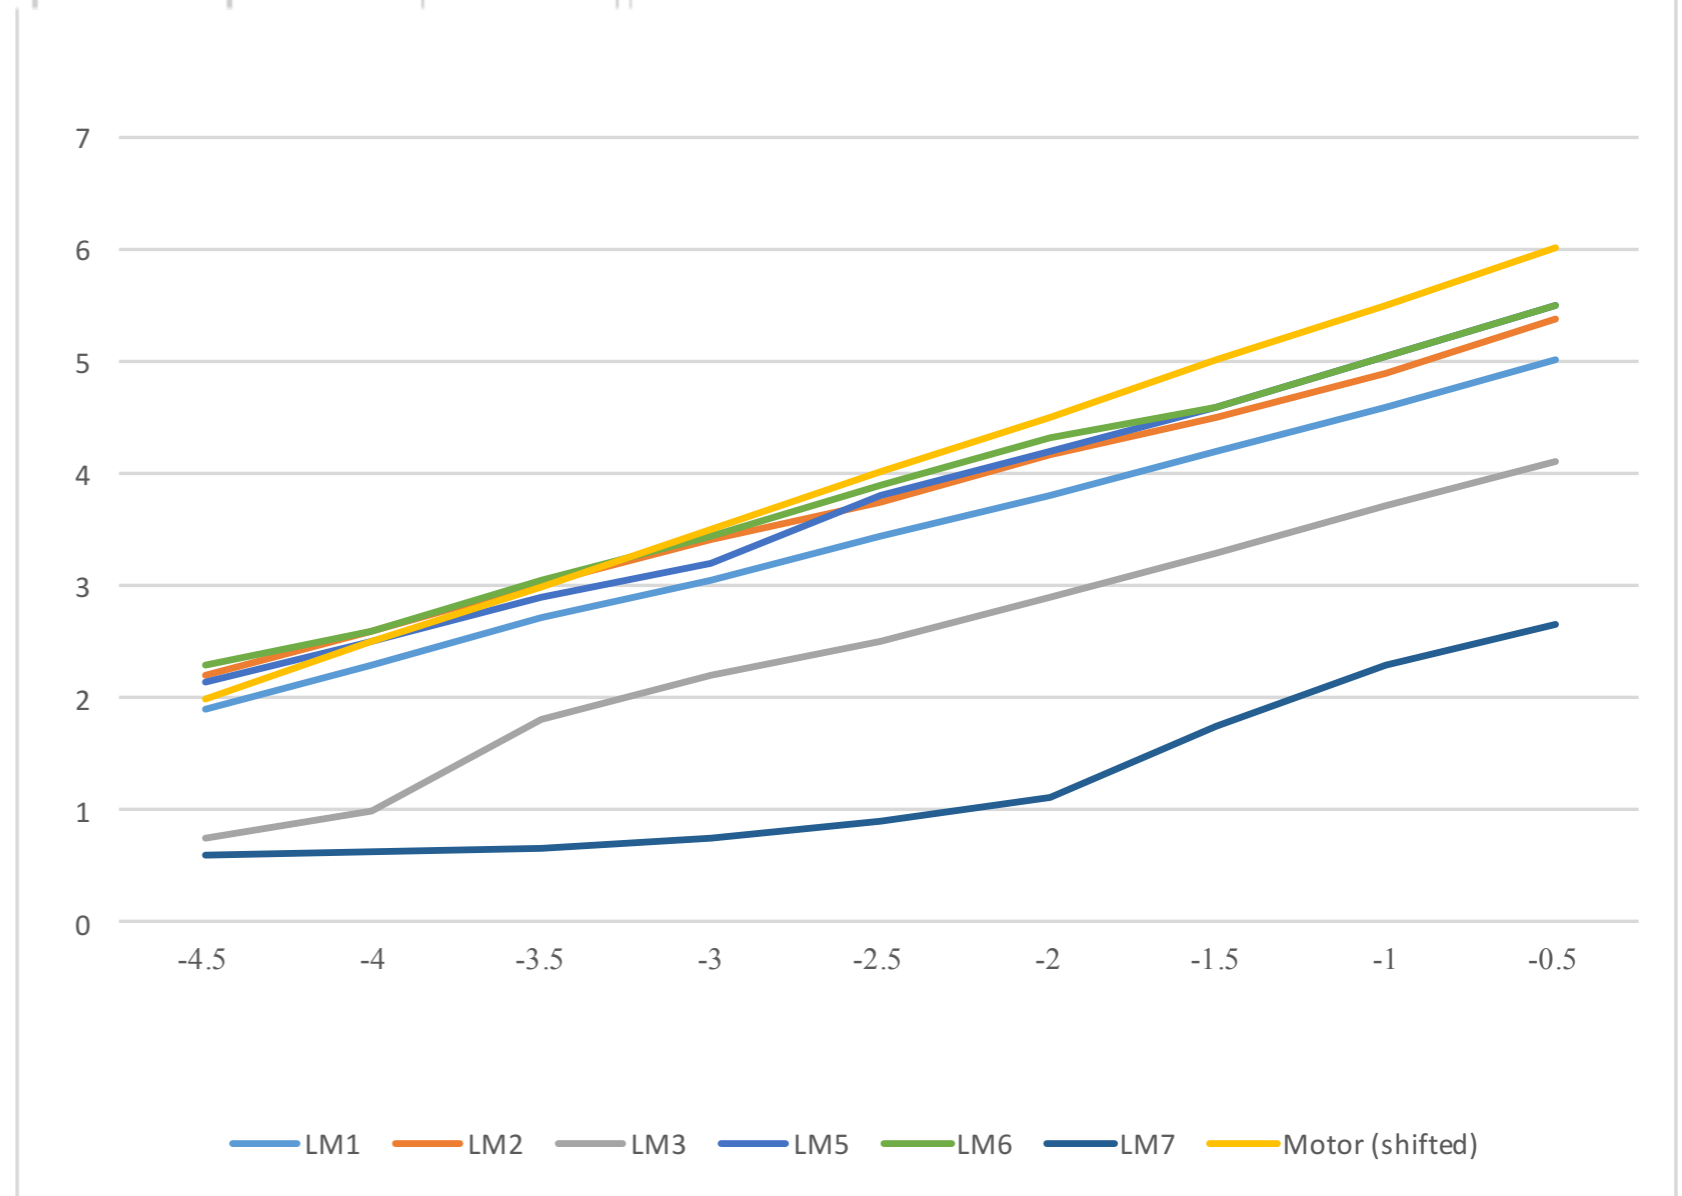
Chart Title

**Results obtained on Tuesday  
3rd October**  
**Similar results obtained in the  
tests performed after on  
October 5th (LAPP people will  
update the final result)**

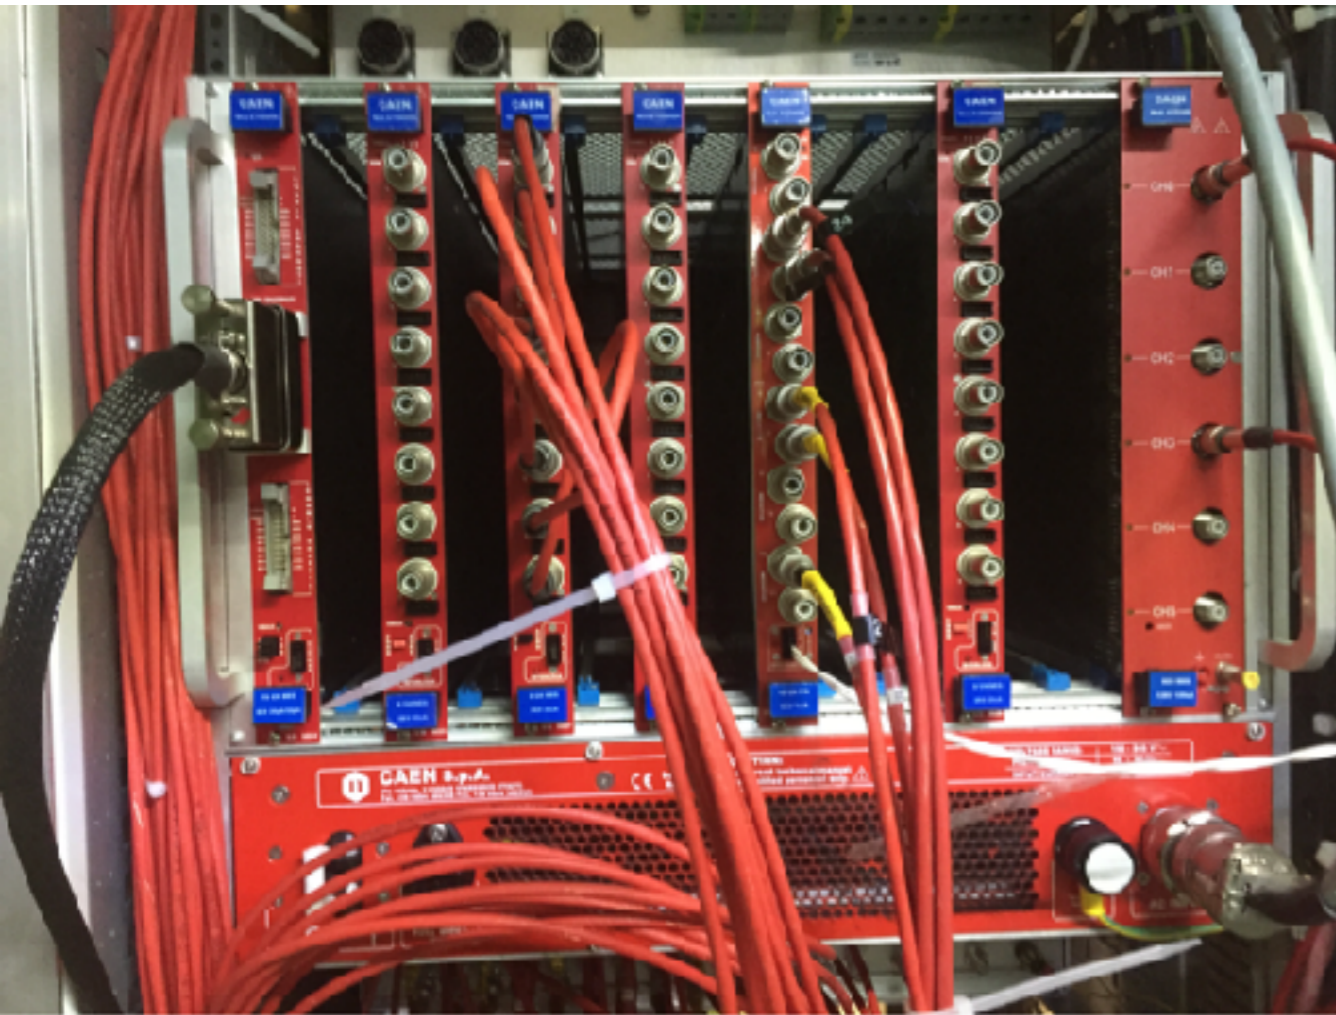
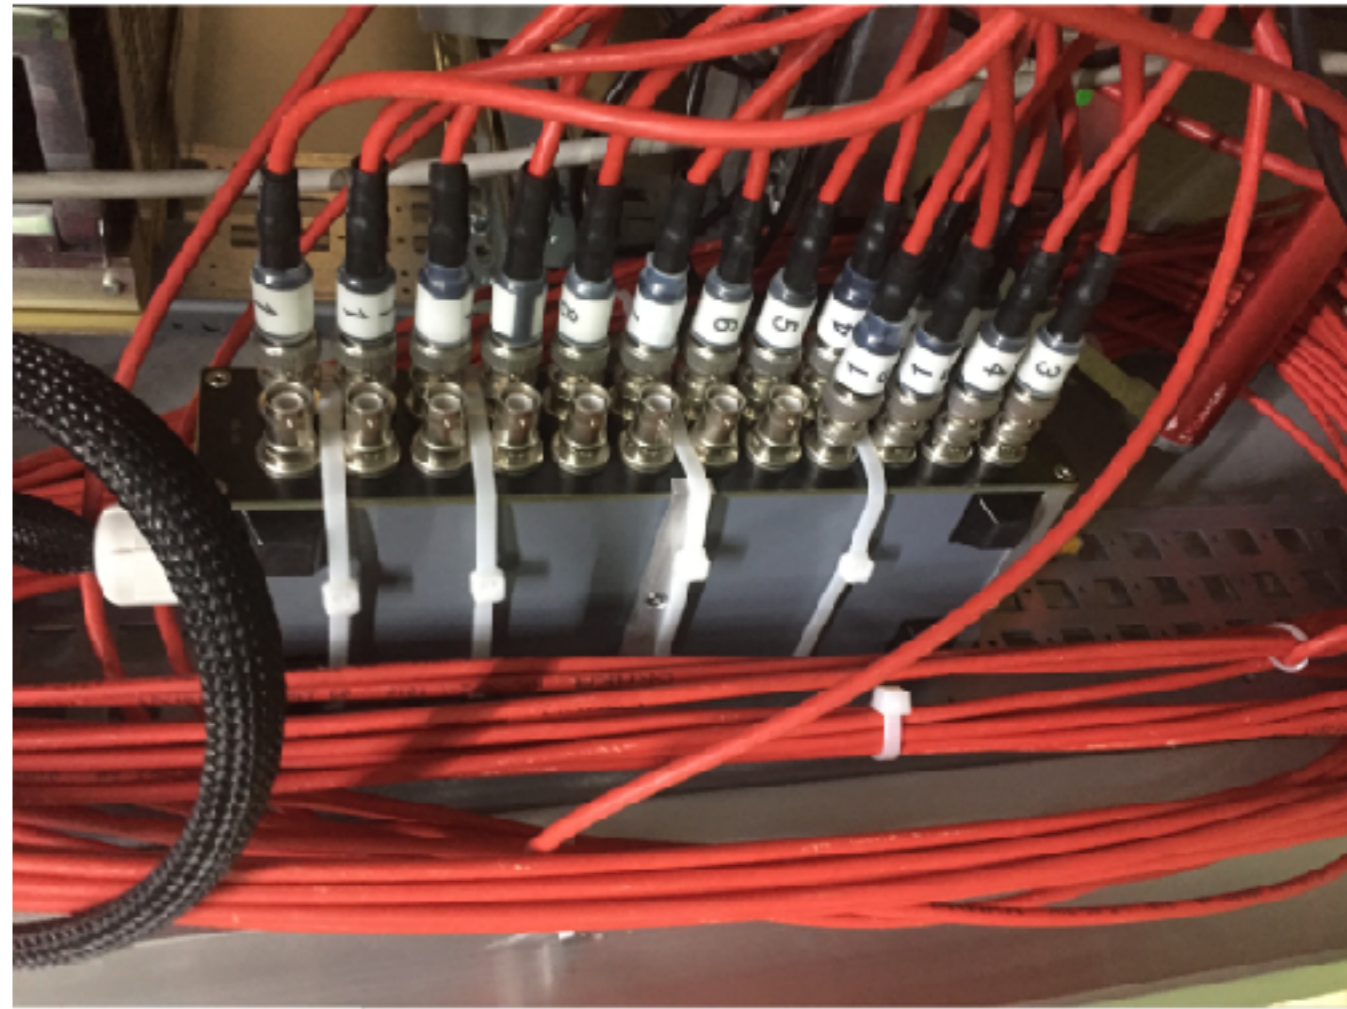
Issue	Strategy followed	Status/Conclusion
<b>LEMs trips at 23 kV/cm</b>	Resistor board disconnected  -radial -Old one	<ul style="list-style-type: none"> <li>• Not all the LEMs tripped at the same time.</li> <li>• Several tests performed and always LEM 1 and 3 tripped.</li> <li>• Once LEM 1,3 and 4 tripped.</li> </ul>
	<ul style="list-style-type: none"> <li>• LEMs 1 and 3 floating</li> <li>• LEMs 1,2,3 and 4 floating</li> </ul>	We reach 26 kV/cm in the central LEMs
	We disconnect LEM 1 and 3 from the HV flange and repeat	In progress
	Reduce the level and see the effect	Foreseen for next week
	<ul style="list-style-type: none"> <li>• Measure precisely the leakage currents.</li> <li>• We observe a reduction of the leakage current since beginning of the week.</li> </ul>	Foreseen for next week
	In general, we observe an improvement since beginning of the week.	After immersing the LEMs, some dirtiness attached on the surface?

→ The LEM HV connections reconnected through the resistor filter panel. We changed the old board (A1580HDE) used on CAEN power supply by the new one of the same type but with 16 inputs and a Radial connector (the one planned for ProtoDUNE-DP). We also closed the back of the DCS rack (CAEN power supplies are very sensitive to heat input and a lot of dust were present close to fans).
