## Investigative Summary

Report No.: 271412  
 Date: 6/4/2018  
 Order No. 645549  
 Page: 1 of 9

One (1) fractured bellows assembly (see Photo 1) was submitted to our laboratory for a metallurgical investigation.

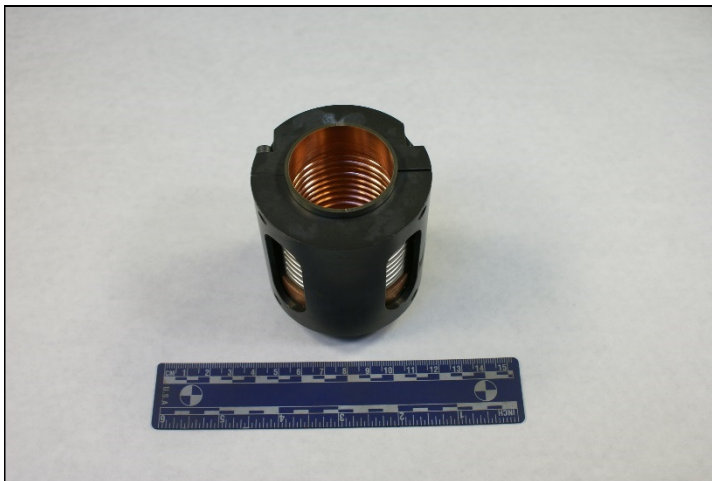
Photo 1: As-received bellows assembly.

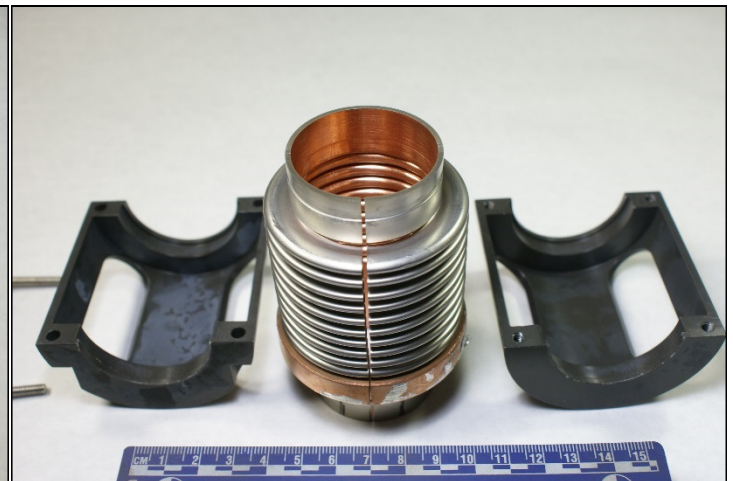
Photo 2: Bellows assembly disassembled showing the bellows with an previous EDM cut

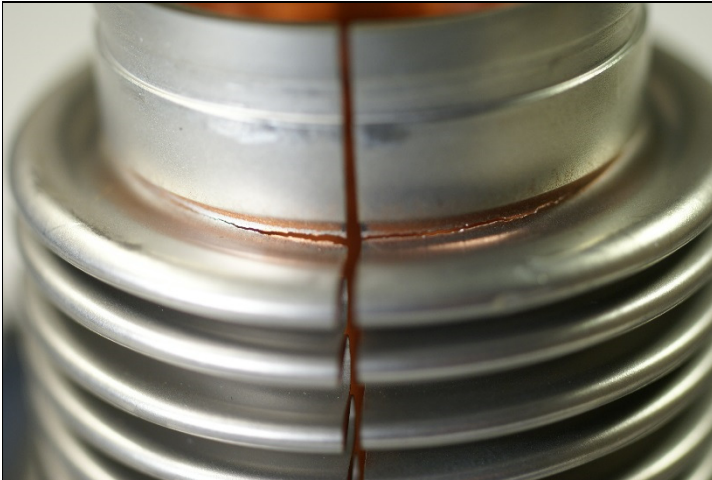
1. Visual and stereoscopic examination of the sample revealed a crack about 35 mm long with a perpendicular EDM cut about 15 mm from the left end of crack (See Photos 3 – 4). The crack is present in the intrados adjacent to the brazed end of the bellows.

Photo 3: Crack in intrados adjacent to brazed end of bellow

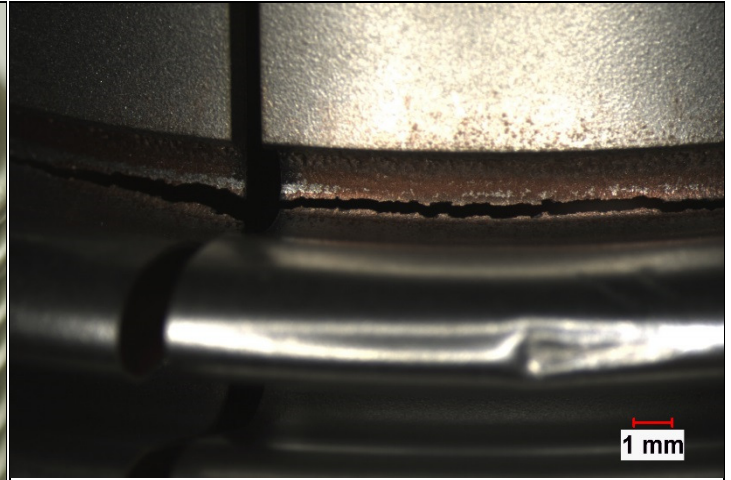
Photo 4: Close-up of crack from outside.

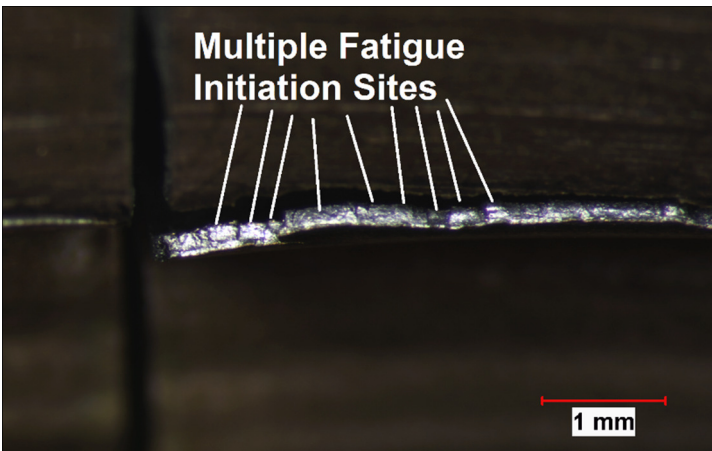
2. The exposed fracture surface as observed from inside end of the bellow shows a fracture surface consistent with fatigue fracture surface as indicated by “ratchet marks” separating multiple fatigue initiation sites (see Photo 5).

Photo 5: Close-up of crack from inside.

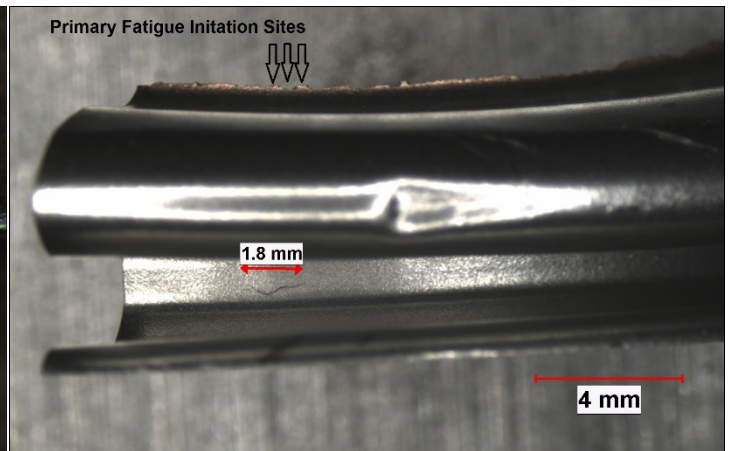
Photo 6: Secondary crack about 1.8 mm in adjacent intrados of the fold in the bellows.

3. A secondary fatigue crack was found in the adjacent intrados of the bellows and in line with the middle of the primary fatigue crack consistent with cyclic stress along this longitudinal section of the bellows (see Photo 6).

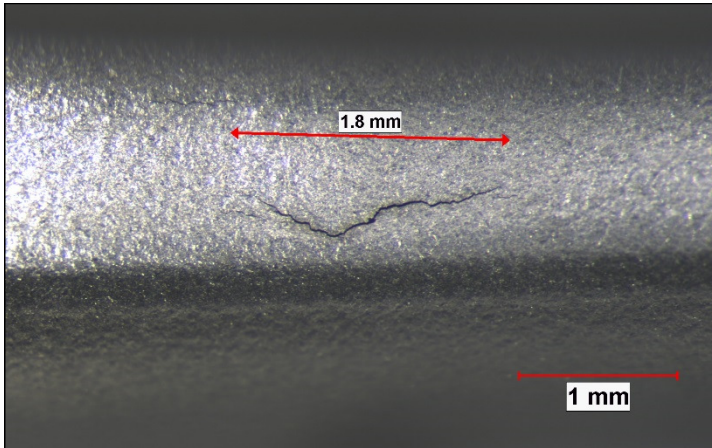
4. Stereoscopic examination shows there are several independent shallow fatigue cracks in the adjacent intrados of the bellows consistent with fatigue initiation at the outside surface of the intrados (see Photos 7 - 8). These fatigue cracks are well into stage II fatigue crack propagation and were most likely arrested when the primary fatigue crack above (i.e. closer to the braze joint) propagated enough to shift the cyclic load away arresting secondary fatigue.

Photo 7: Secondary fatigue crack in adjacent intrados fold of bellows.

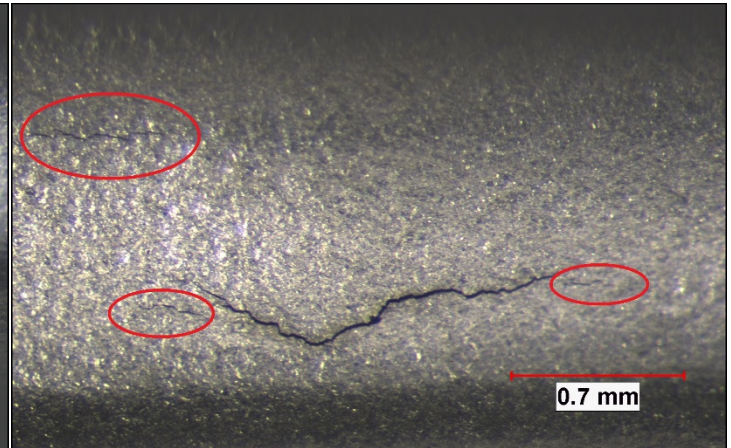
Photo 8: Three more independent fatigue cracks (circled in red) around the secondary fatigue crack.

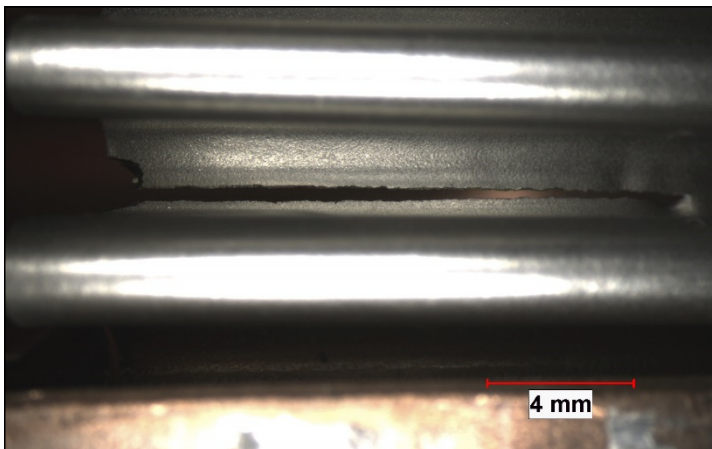
5. Stereoscopic examination also shows three additional cracks found at the opposite end of the bellows. One long crack exposed when cutting out the chemical analysis sample – longitudinally in line with primary and secondary fracture initiation sites documented above (see Photo 9). Two more cracks at the 180° opposite the primary fracture initiation sites (see Photo 10).

Photo 9: Tertiary fatigue crack found on the opposite end of the bellows exposed when removing chemical analysis sample.

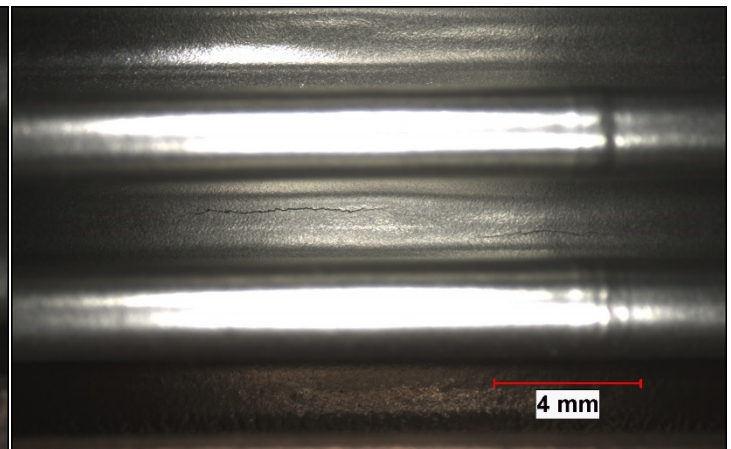
Photo 10: Another set of two cracks on the opposite end of the bellow 180° from the other cracks and adjacent to the weld seam.

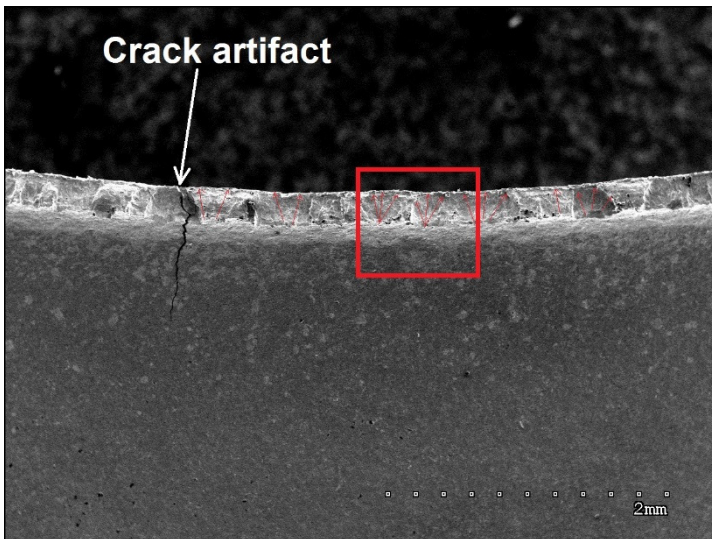
- SEM examination revealed multiple fatigue initiation sites along the intrados of the bellows bend closest to the braze joint. Red arrows indicate the direction of stage II fatigue crack propagation completely through the bellows' wall (See Photo 11) with no observed stage III fatigue (final overload fracture), which is consistent with a low nominal stress in the bellows. The stage II fatigue cracks propagate radially from the initiation sites. This is consistent with unidirectional cyclic bending fatigue with no stress concentrations present in the bellow at this location (see Photo 12).

Photo 11: SEM image Mag: 20X  
 Multiple fatigue initiation sites along intrados fold of the bellows

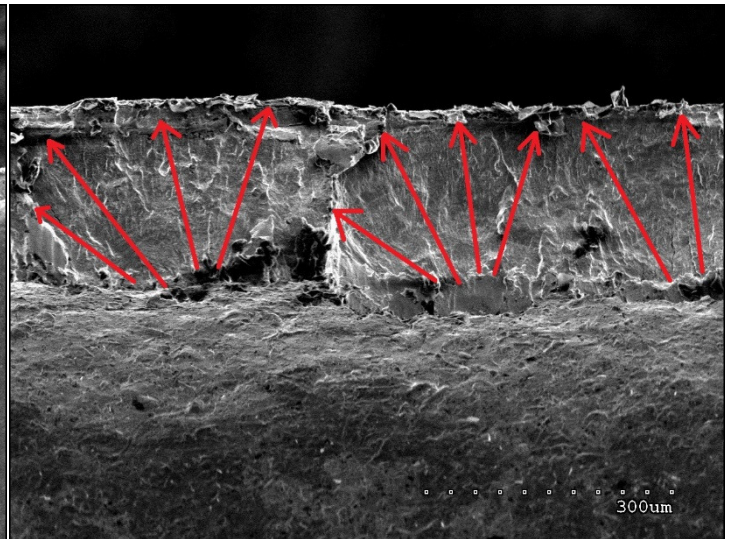
Photo 12: SEM image Mag: 120X  
 Red boxed area showing radial fatigue crack propagation through the bellow wall.

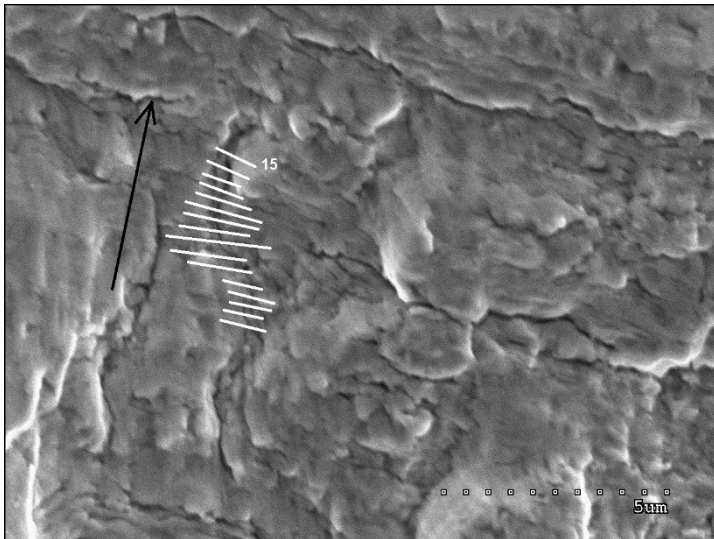
4. The length of a single fatigue striation is about 0.24  $\mu\text{m}$ . The bellows’ wall at the fracture initiation site is 196  $\mu\text{m}$  thick, so it took about 817 cycles of stage II fatigue propagation for the fatigue crack to propagate from the outside surface through the wall of the bellows and terminating on the inside surface of the bellows. Assuming that stage II (the 817 cycles) represents only 5% of the total fatigue life of a single fatigue initiation site is approximately  $817/0.05 = \sim 16,300$  cycles.

- SEM examination revealed fatigue striations on the stage II fatigue surface. Stage II crack propagation extended through the bellows wall to the inside surface (See Photos 13). The length of a single fatigue striation is about  $0.24 \mu\text{m}$ . The bellows' wall at the fracture initiation site is  $196 \mu\text{m}$  thick so it took about 817 cycles in stage II fatigue for the fatigue crack to propagate from the outside surface through the wall of the bellows, terminating on the inside surface of the bellows.

Photo 13: SEM image Mag: 6400X  
Fatigue striations on stage II fatigue fracture surface marked with parallel white lines. The black arrow indicates the direction of fatigue crack propagation.

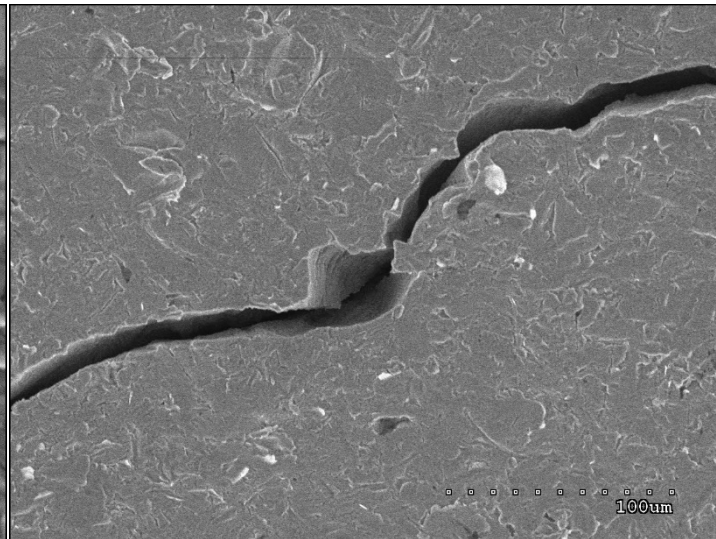
Photo 14: SEM image Mag: 320X  
Secondary fatigue crack in adjacent intrados with small section of surface missing and most likely becoming micro fatigue debris.

- SEM examination revealed the secondary fatigue crack confirmed that it is a fatigue crack as indicated by the observed fatigue striations inside the crack (see Photos 14 – 15). Cutting out the 1.8 mm crack and opening it for direct SEM examination revealing fatigue striations on the order of those observed and measured on the primary fatigue fracture surface (see Photo 16).

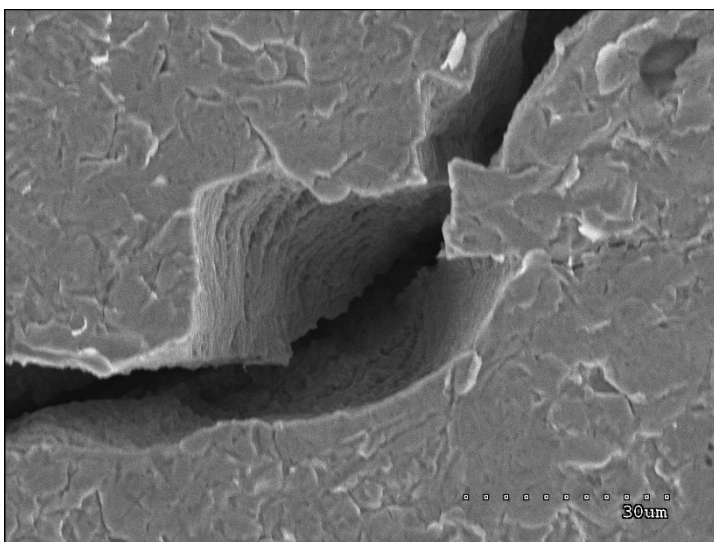
Photo 15: SEM image Mag: 1000X  
Close-up showing fatigue striations in secondary fatigue crack.

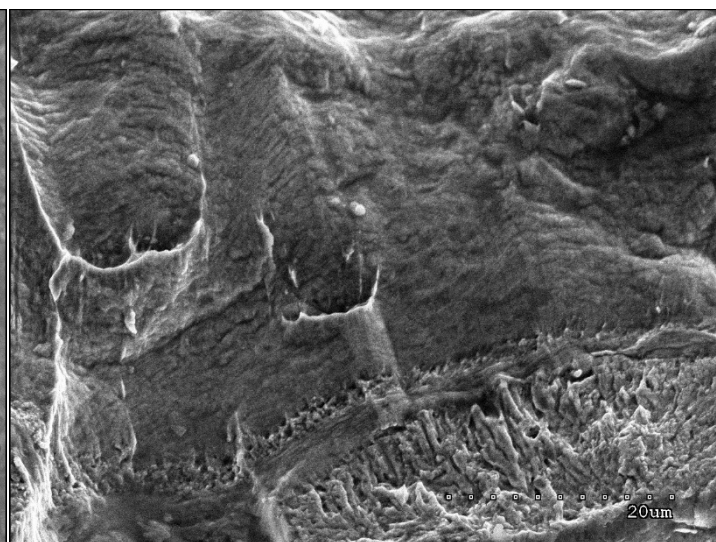
Photo 16: SEM image Mag: 1600X  
Fatigue fracture surface of secondary fatigue crack after opening the secondary fatigue crack by cutting.

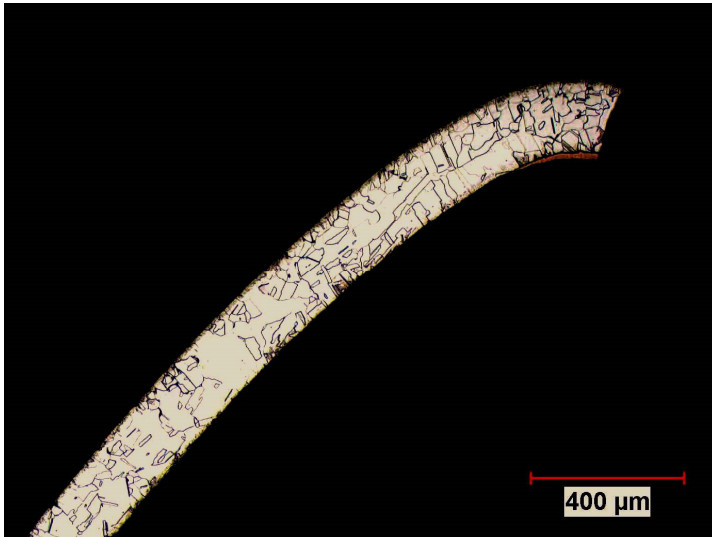
1. A metallographic cross section through the middle of the primary fatigue initiation site (see Photos 17 – 18) revealed braze metal infiltration into the austenitic grain boundaries with some braze metal present on the fracture surface near the initiation site (see Photos 19 – 20).

Photo 17: Magnification: 50X; Etchant: Acetic Glyceregia  
Cross section through middle primary fracture bellows side.

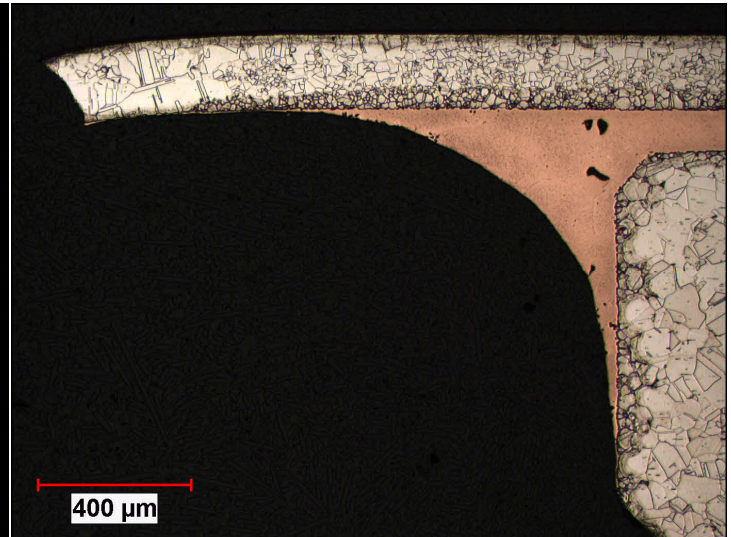
Photo 18: Magnification: 50X; Etchant: Acetic Glyceregia  
Cross section through middle primary fracture braze side.

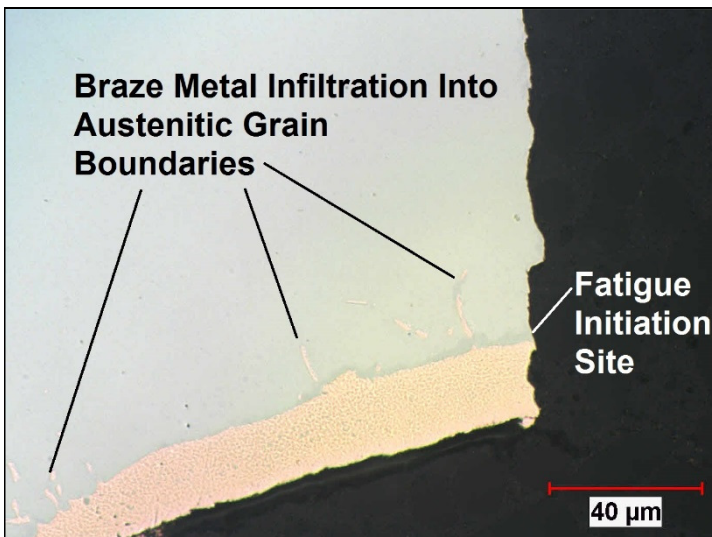
Photo 19: Magnification: 500X; Unetched  
Cross section of primary fatigue initiation site on bellows side of fracture.

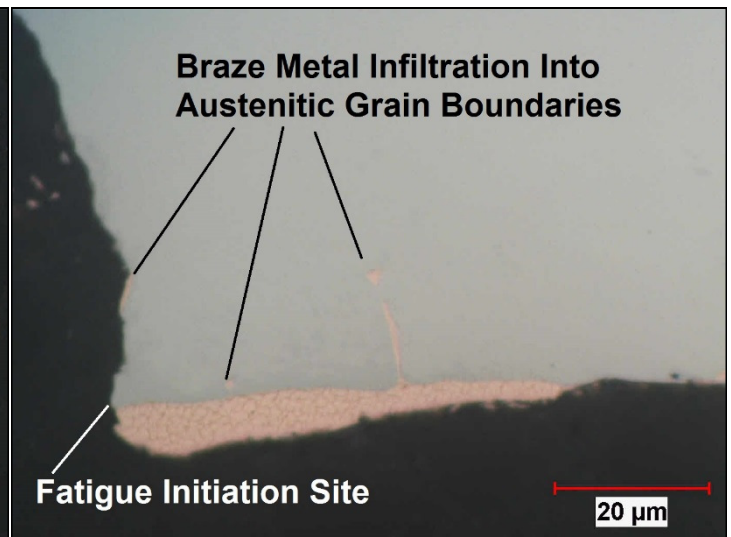
Photo 20: Magnification: 1000X; Unetched  
Cross section of primary fatigue initiation site on brazed side of fracture with braze metal present on fatigue fracture surface.

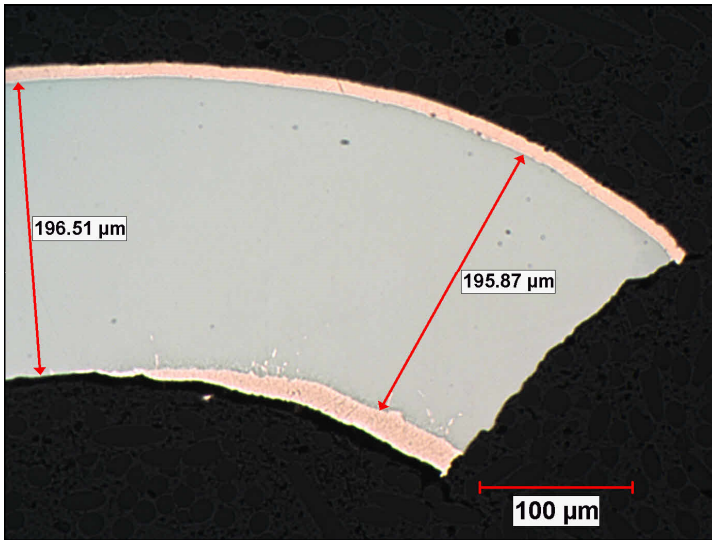
2. The thickness of the bellows walls varied from the thickness at the fatigue initiation site of 196  $\mu\text{m}$  (see Photo 21) to the thinnest walls of 112  $\mu\text{m}$  in the middle of the bellows' bend (see Photo 22).

Photo 21: Magnification: 200X; Unetched  
 Thickness of bellow at fracture initiation site (bellows side of fracture).

- The microstructure at the primary fatigue initiation site showed transgranular fracture through the coarse austenitic grains with cold working slip bands (see Photos 21 – 22).

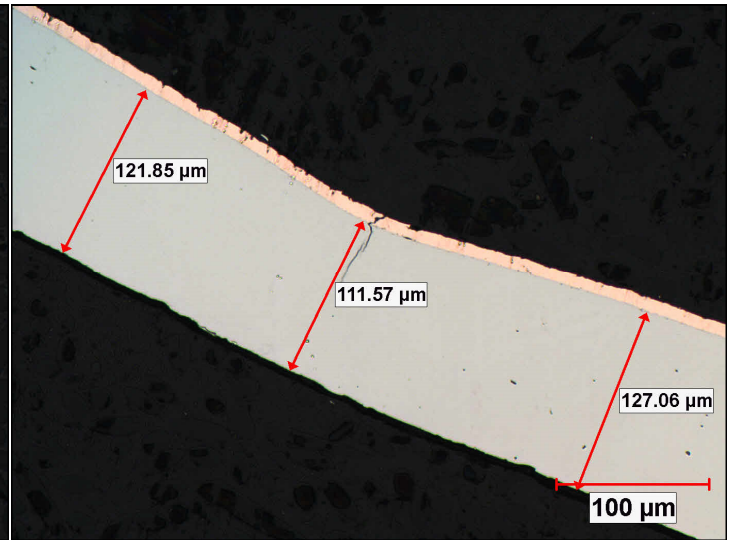
Photo 22: Magnification: 200X; Unetched  
 Thinnest bellows wall observed in middle of 180° bend with short crack initiating on inner wall – most likely an artifact from cutting.

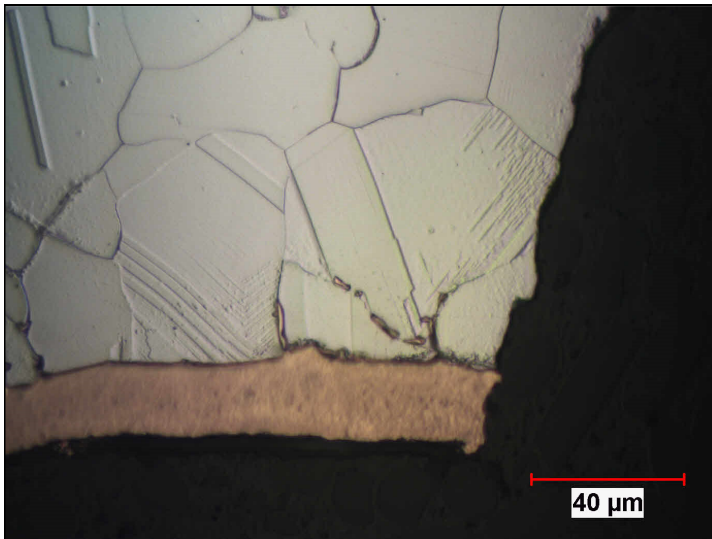
Photo 23: Magnification: 500X; Etchant: Acetic Glyceregia  
 Cross section through middle primary fracture bellows side.

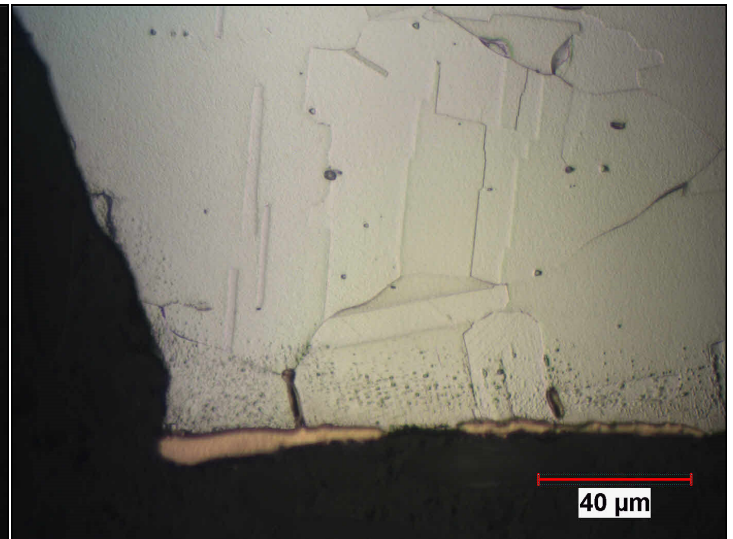
Photo 24: Magnification: 500X; Etchant: Acetic Glyceregia  
 Cross section through middle primary fracture braze side.
