# Cryomodule Lessons Learned

A. Klebaner, G. Wu

International Workshop on Cryomodule Design and Standardization

September 7, 2018

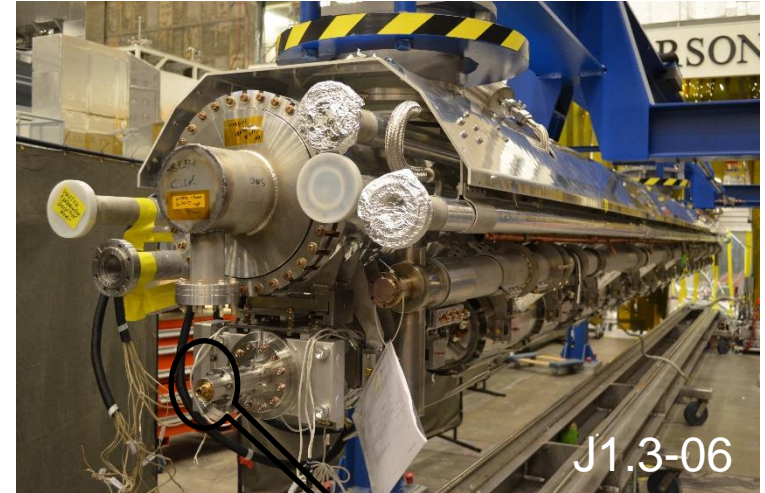
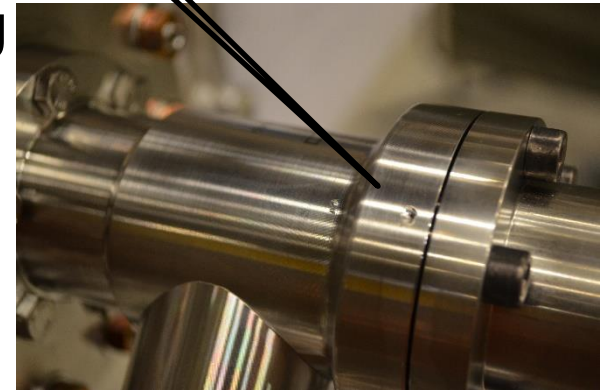
## J1.3-6

- Accidentally vented during preparation for leak check of 2 phase circuit
  - GHRP cap slipped and impacted right angle valve
  - String fast bled up to just under 100 torr.
- Cavity and couplers will require reprocessing

New assembly procedure and tooling for GHRP cap installation at WS3 and WS5.

- Portable lift used to both lift GHRP cap and protect the Right Angle Valve; Safer for both employees and equipment.
- Looking into a plug with o-ring to replace GHRP cap for vacuum leak checks. Lighter, safer.

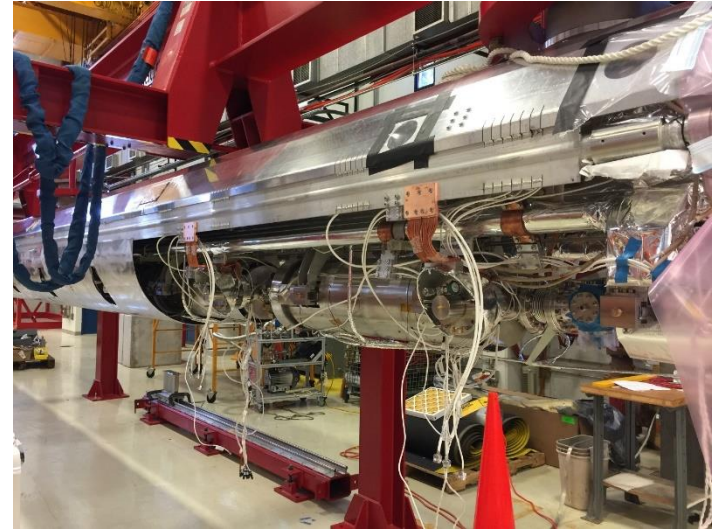
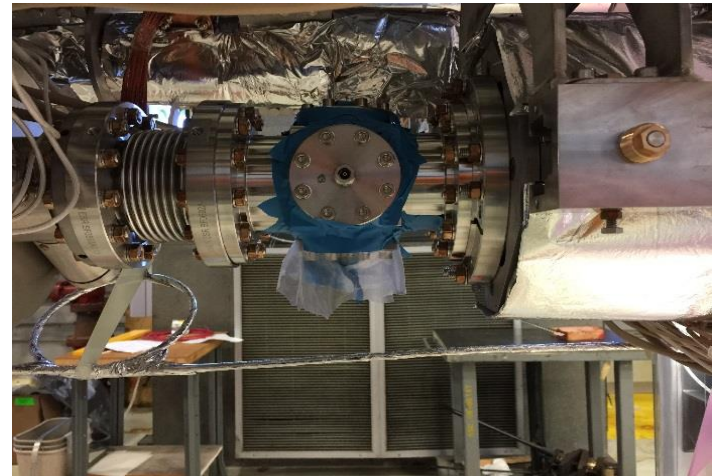
## F1.3-03

- Cold Leak Discovered during Cryomodule Warm up
- BPM Feedthrough flanges leaked
  - Three out of four seals leaked
  - Leak rate was  $\sim 8.5e-5$  mbar.L/sec
    - Leak was considered too big for clean beam line.
    - Decision was made to disassemble
- Possible stress on magnet spool pieces
- Grade 2 Titanium bolts did not provide sufficient sealing force.

- Replaced Grade 2 titanium bolts with Gr5 titanium studs.
- Increase the torque strength from 12 to 16 N.m
- Measure seal crush to ensure sufficient sealing cross section
- Improved procedure to avoid any stress to the BPM/magnet spool beam pipe.

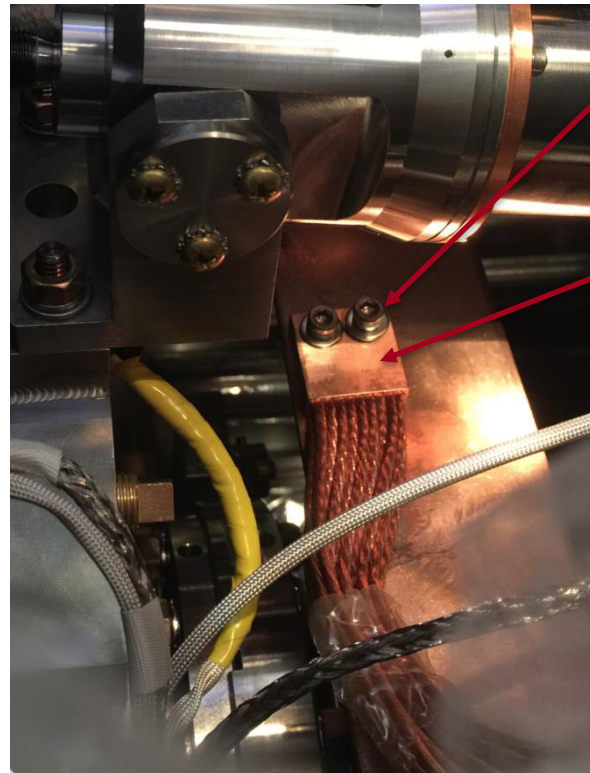
## F1.3-03

- CAV3 quenched prematurely at 11 MV/m.
  - HOM end group heating

Washer  
loose

Thermal braid  
head completely  
loose

- Improved procedure to double check the integrity of the HOM thermal Straps

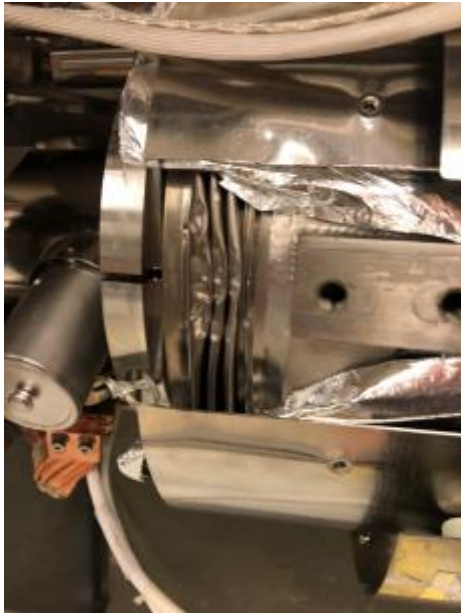
- J1.3-09 Bellows was found damaged on 5 July,
  - Visual inspection of all bellows on in process cryomodules (J1.3-09-11-12-13) followed
  - We found one additional bellows damaged on J1.3-11
  - Completed cryomodules (J1.3-02 – J1.3-07) will be inspected during subsequent work
  - JL1.3-08 and JL1.3-10, were in the process of acceptance testing, no leaks found

J1.3-09 damage was found after a failed leak check and disassembly of the cryomodule

- The JLab team has extended the risk matrix to all bellows in the cryomodule
  - Continuous improvement extends this to the cryomodule as a whole
  - FNAL will be included
- Apply lessons learned to other cryomodule production activities
  - CEBAF cryomodule production and rework
  - Cryomodules for other projects (SNS PPU, LCLS-II HE)
- Training matrix developed as part of the improved work controls identifies individual's qualifications
- Matrix is now the basis for staff development plans and will be a continuing part of the cryomodule production at JLab
  - Every supervisor has the matrix and only assigns work to qualified technicians
  - Every technician and supervisor has their own qualification matrix
  - Each individual is expected to know their qualifications and work only those activities they are qualified for

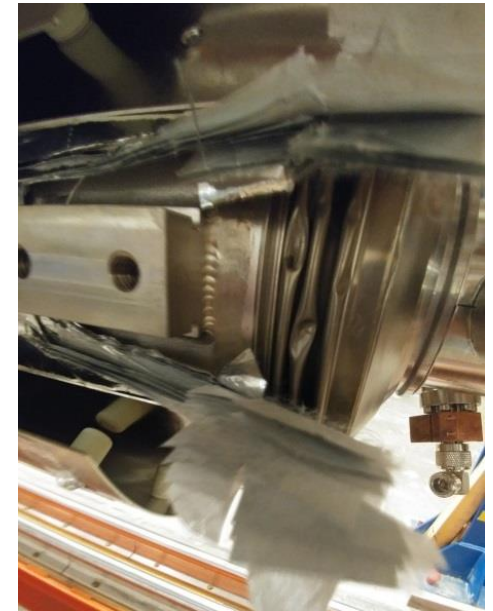
J1.3-11 was in an earlier stage of assembly and the damage was found during a visual inspection

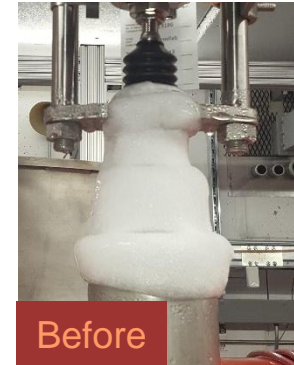
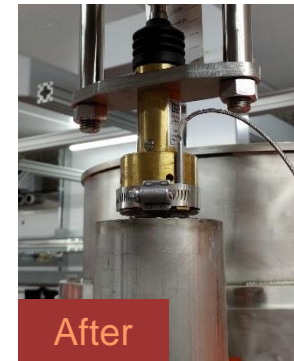
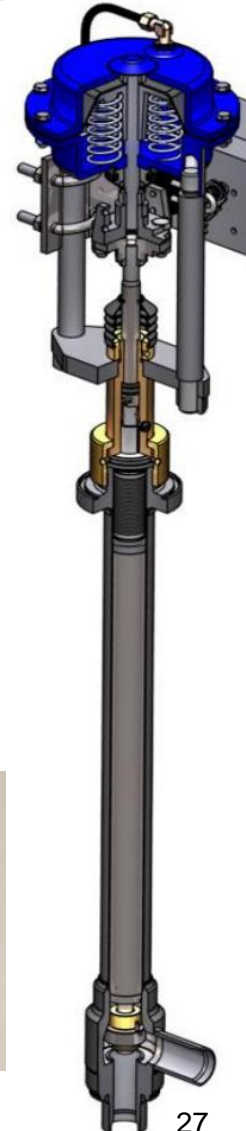
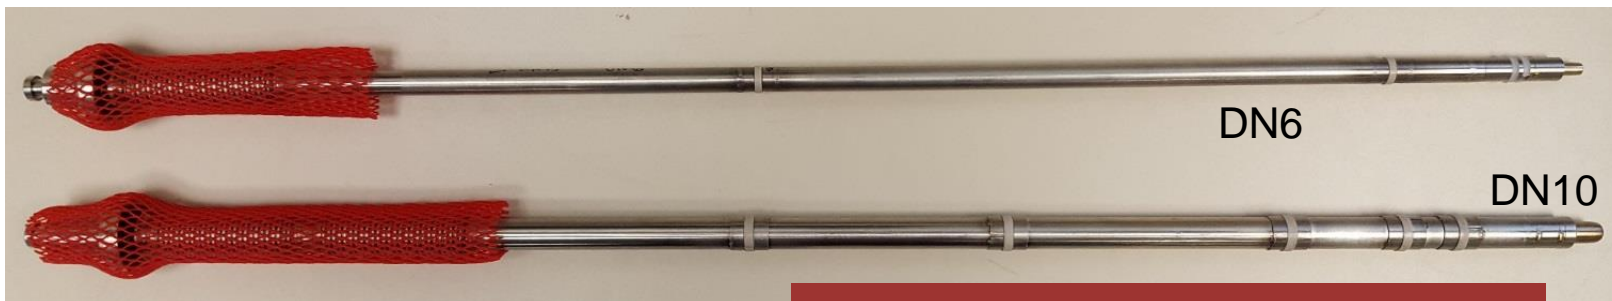
- TAOs are a pressure/temperature oscillation in cryogenic lines (in this case, valve stems)
  - During testing, wipers were added to close space in valve stem, acting as a damping term for the TAOs
  - Significant improvement in heat load and microphonics levels and stability for *both* F1.3-01 and J1.3-01
  - Optimized valve stems with wipers were used during F1.3-02 testing, *and will be used going forward for both labs*
    - 4-5 wipers, positioned to keep temperature ratio  $<4$  as recommended by literature
    - Radiation hard material (PEEK)

Optimized wiper placement going forward

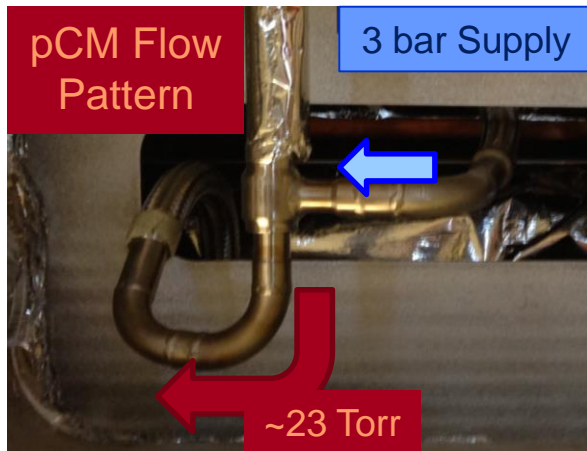
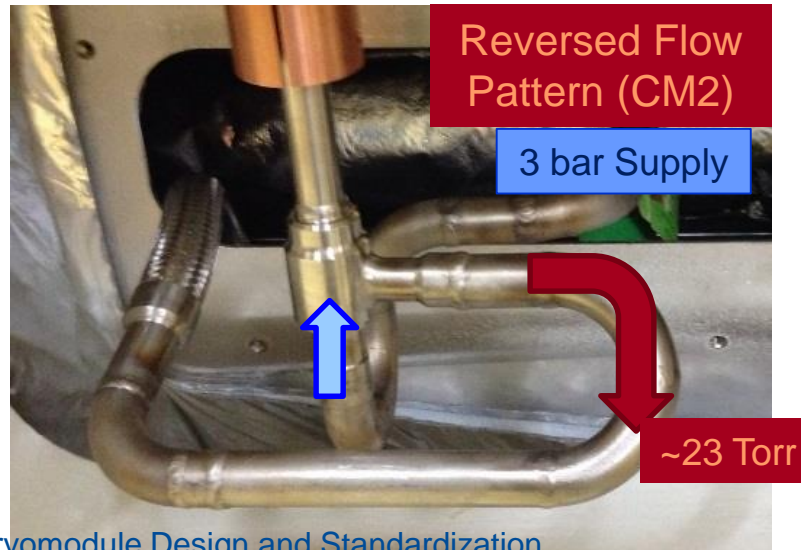
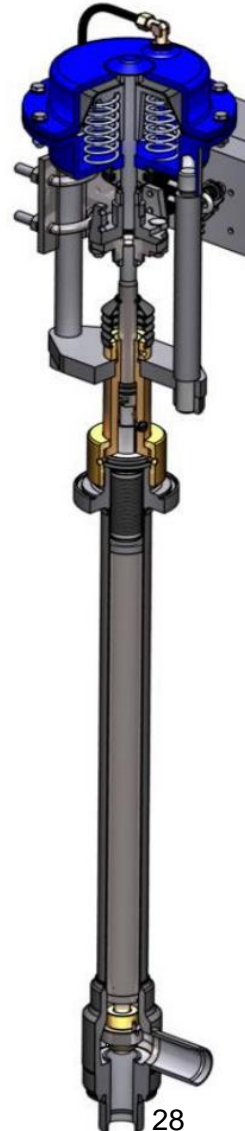
- Test results show valve reversal (lower press in stem) significantly reduces/eliminate TAOs there
  - F1.3-01 configuration has valve stem at supply pressure (~3 bar)
  - Reversing flow will lower this pressure to sub-atmospheric, requiring guard gas to prevent contamination
  - All cryomodules will have guard gas, reversed valves
- Additional effort to mitigate TAOs in cryogenic distribution system should improve inlet temperature at test stand

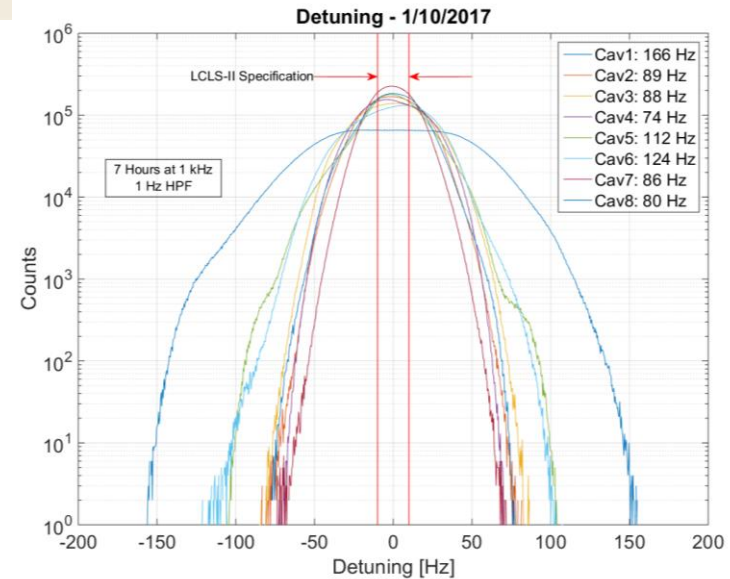
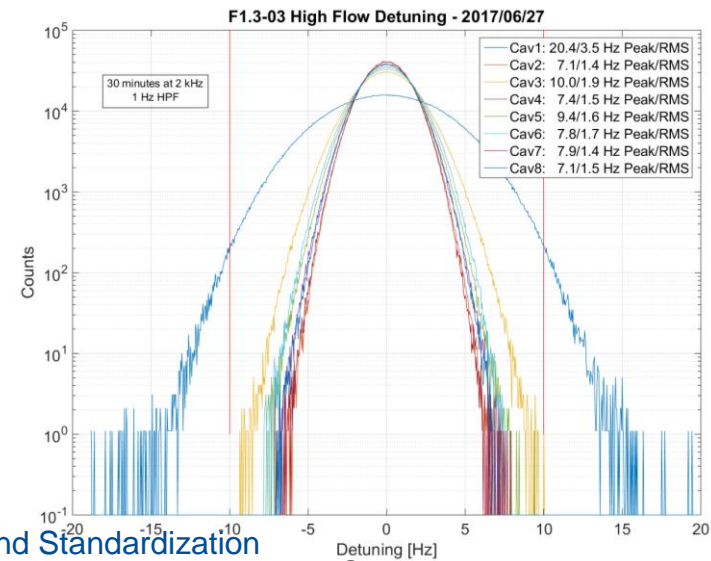
- Comparing performance of the standard cryogenics configuration, the microphonics environment in the F1.3-02/03/04 is a factor of  $\sim 10$  improved
- Significant improvements in stability of the system, leading to a far more predictable detuning environment

PCM As Cooled Down

After Improvements  
F1.3-03

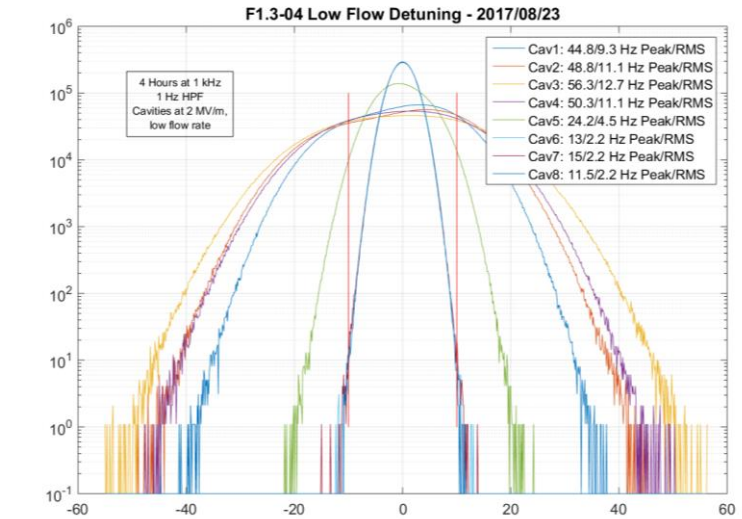
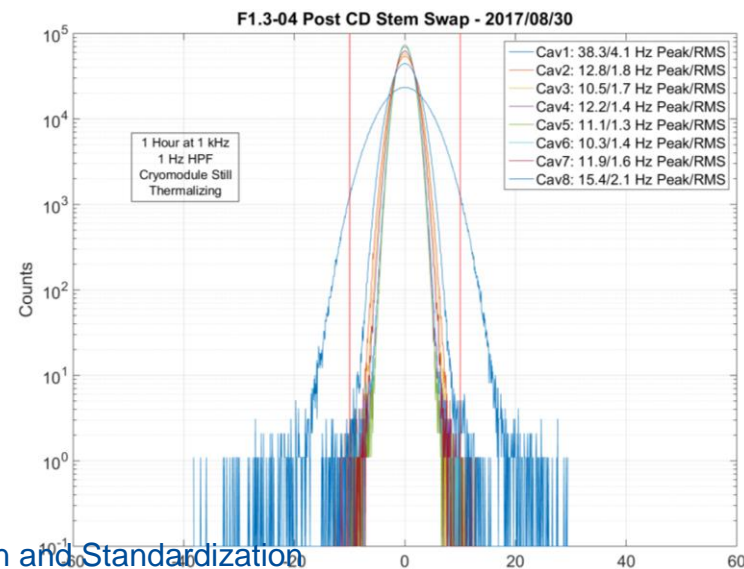
- F1.3-04 presented with higher than expected microphonics, worsening as the cryomodule thermalized
- Noise was narrowband and showed complex spatial and spectral distribution in cryomodule
- Testing showed strong correlation with cooldown circuit, eventually proven to be coherent bubbling due to cooldown valve leakage
- Swapping valve stem returned expected performance, although testing schedule prevented detailed studies
- Tails seen in 'post-swap' data are likely due to continued thermalization of cryomodule after cooldown
- Additional QA check step now included to prevent valve leakage in the future

Thermalized Detuning

Post CD Stem Swap

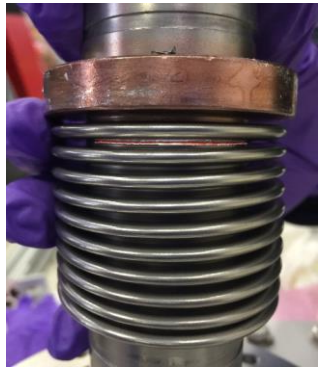
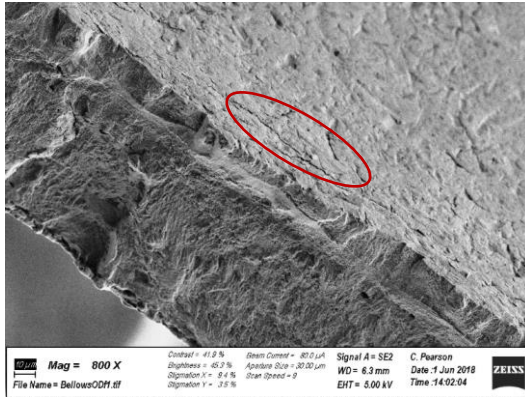
- Failed bellows examined after sectioning them:
- SLAC (Chris Pearson) Report on Cavity 4 Bellows: “*This is an example of **high stress low cycle fatigue**. That is, the material at the fracture location experienced multiple bending stress cycles at or above the yield strength, work hardening locally and eventually failing in a brittle manner.*”
- SGS report on Cavity 5 Bellows: “*Fatigue fracture initiated on the outside surface at multiple locations at grain boundaries that were infiltrated with braze metal. Uni-directional bending stresses initiated and propagated the multiple fatigue cracks completely through the bellows.*”

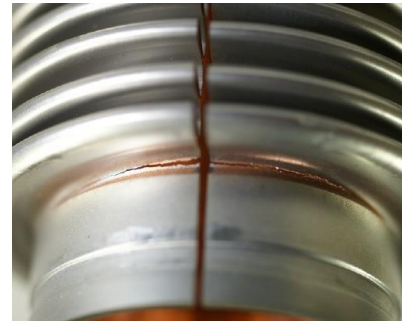
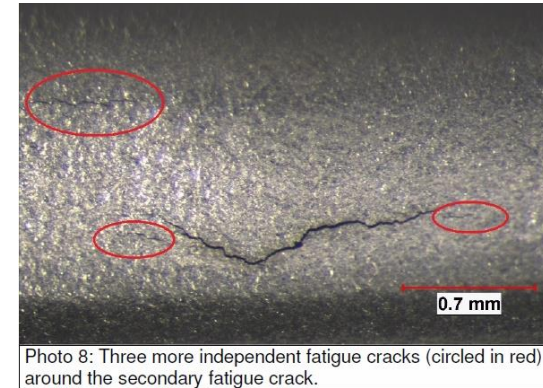
Cavity 5

Photo 8: Three more independent fatigue cracks (circled in red) around the secondary fatigue crack.
