# High Voltage Activation

Kevin Wood, for the team

September 20, 2018

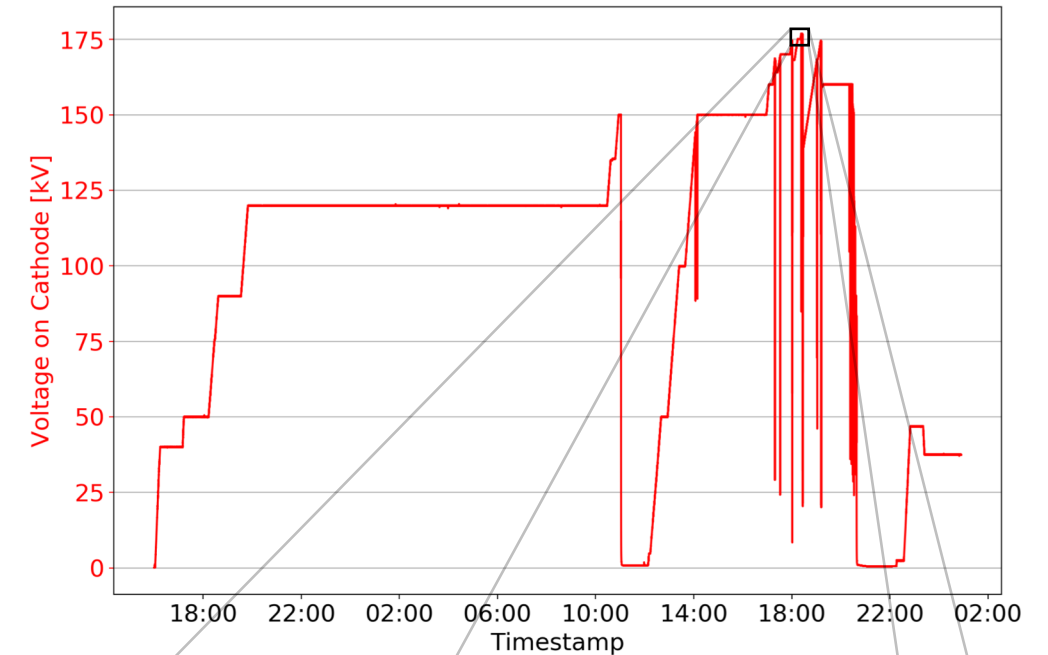
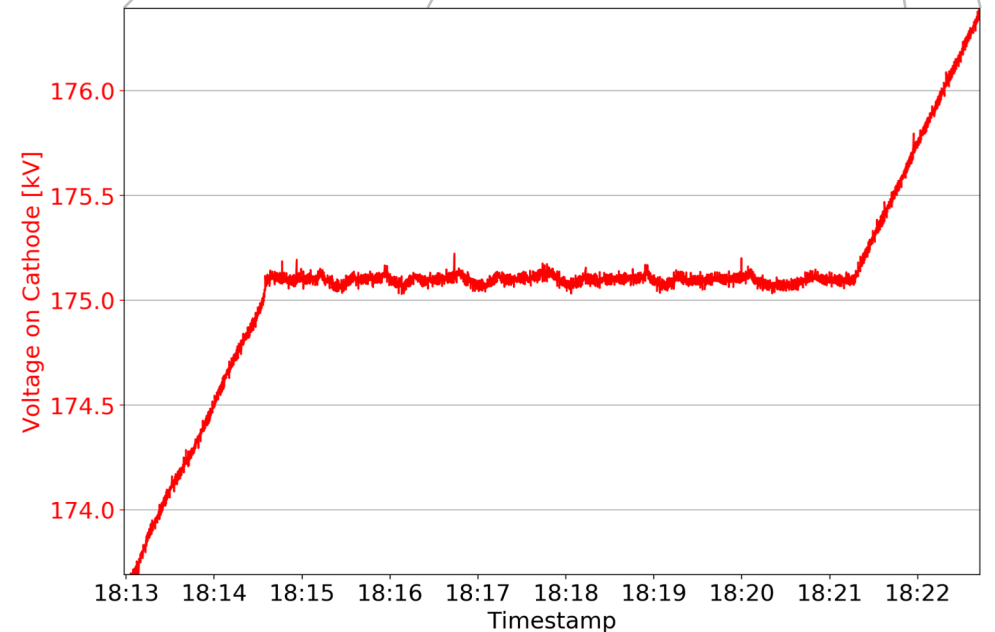
- Top right: September 13, 4PM to September 15, 2AM
- Day 1:
  - The ramp to -120kV went very smoothly
  - Stable over ~14hrs.
- Day 2:
  - Ramped up to -150kV and tripped due to a relatively small and fast fluctuation
  - Hit a couple of current limits on the way back up to -150kV, but we made it and were stable for ~2hrs.
  - Increase to -160kV, no problem
  - Increase to -170kV, hit some current limits, but got there
  - Increase to -175kV, hit one current limit, but got there and held for several minutes
  - Push to -180kV was unsuccessful.
  - Decrease to -160kV with intention of sitting overnight, but it “tripped” ~45 minutes later

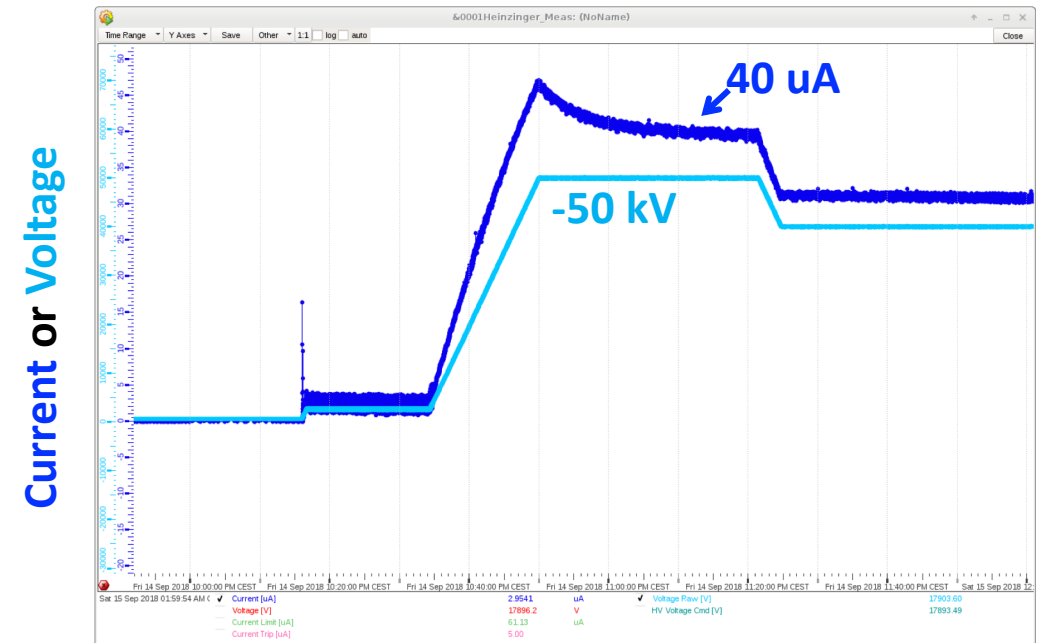
- When trying to ramp back up after the trip Friday night, we noticed an excessive current draw
- The shape of the current draw vs. time also indicated *something* was wrong

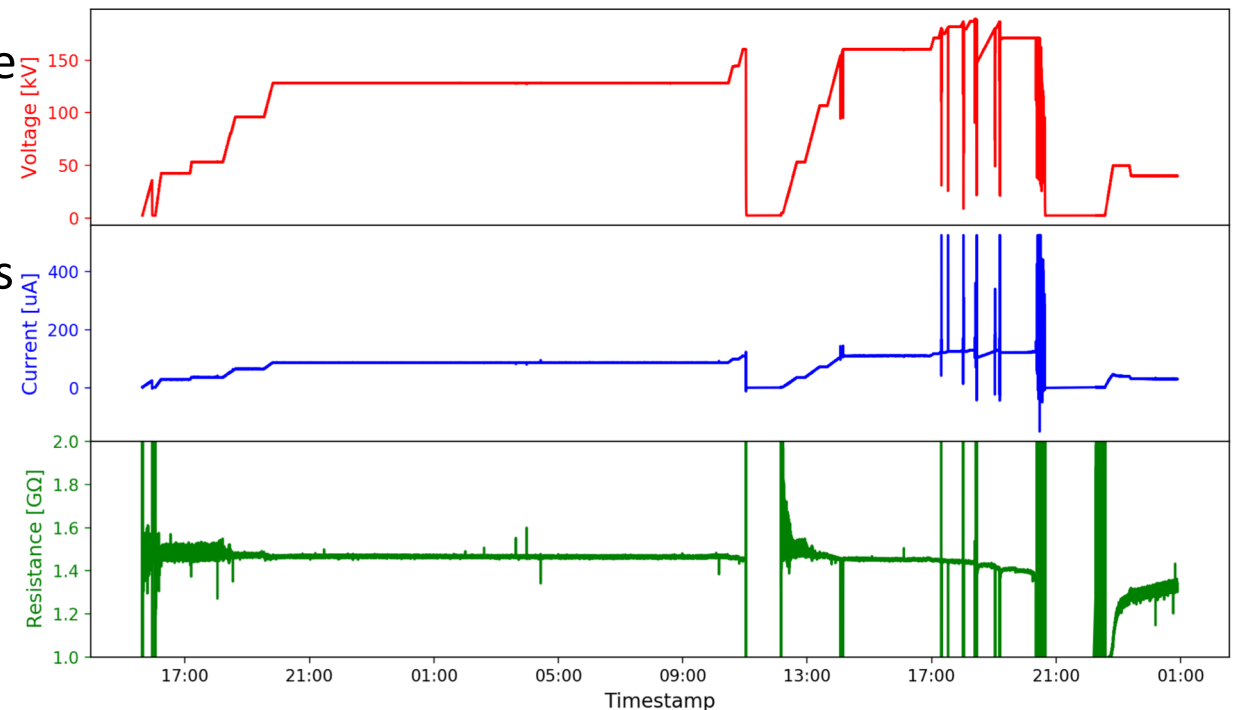
- Looking back at the current draw over time, we see the resistance decreasing ever since we tripped trying to go from -175kV to -180kV
  - Even a bit *leading up to the trip at -150kV*
- Even when the resistance was stable the value was less than we expected
- Immediately suspected the downstream filter, which has been leaking
- The value towards the end corresponds to about a 7.25G $\Omega$  resistor in parallel circuit

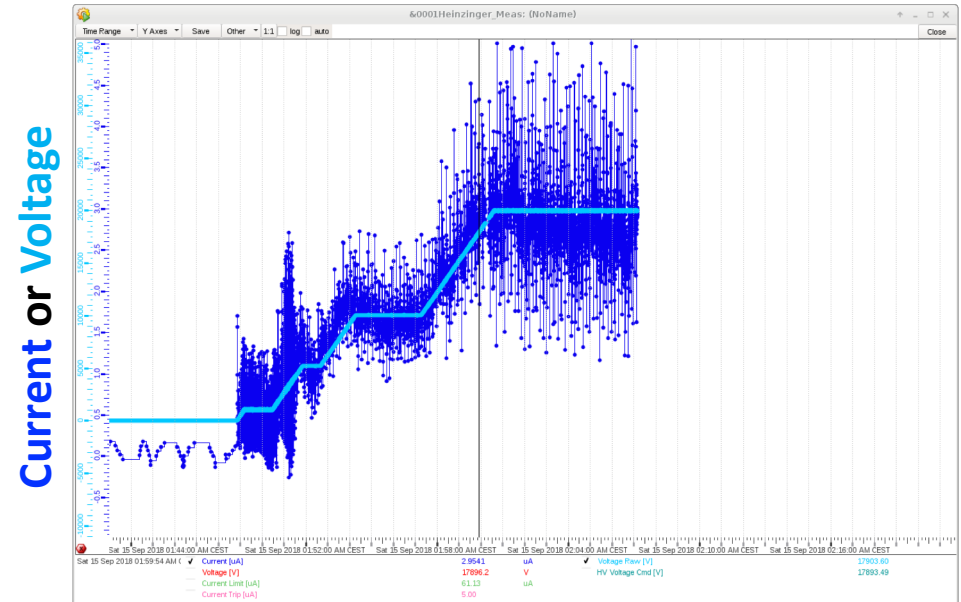
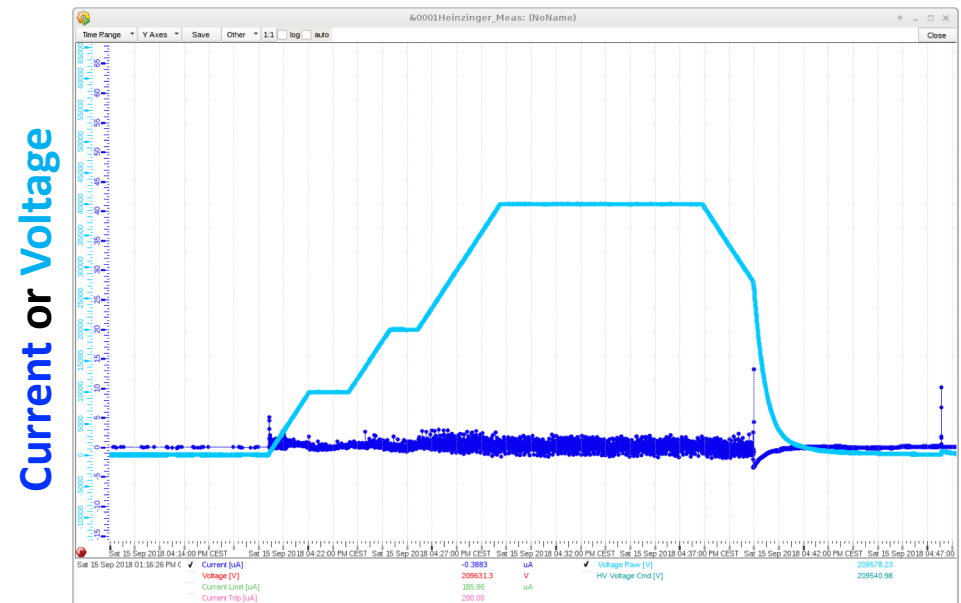
- Removed the feedthrough cable insert to break connection from the detector and test the warm part of the HVS
- Ramped the voltage to -20kV, and sure enough there was a leakage current corresponding to about 7G $\Omega$
- The next morning we replaced the cable+filter line with a continuous HV cable which was attached to the feedthrough insert
- When changing the cable at the Heinzinger end, *water* was found inside
- The water was removed and the “warm side” held its voltage with no noticeable leakage current

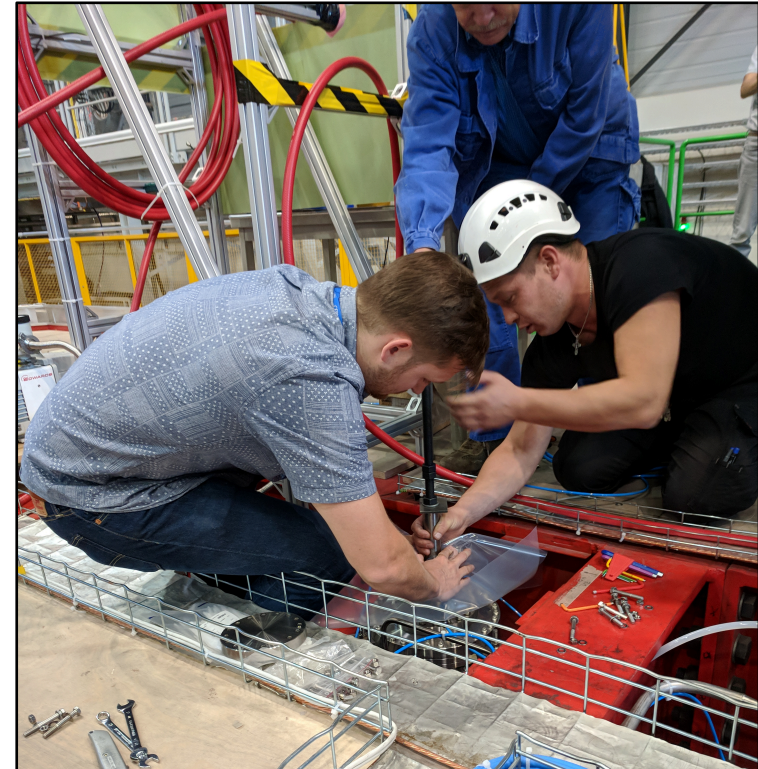
- Reconnected to the detector in the “dry Heinzinger + no filter” configuration and saw *a lot* of noise on the current draw (+/- 10uA)
- We found that the solder connection holding the cable onto the metallic tip of the insert came off. The cable was loose and could be pulled up away from electrical contact
- The insert was again removed, but the tip remained in the cavity...
- Machined a special tool and removed the piece

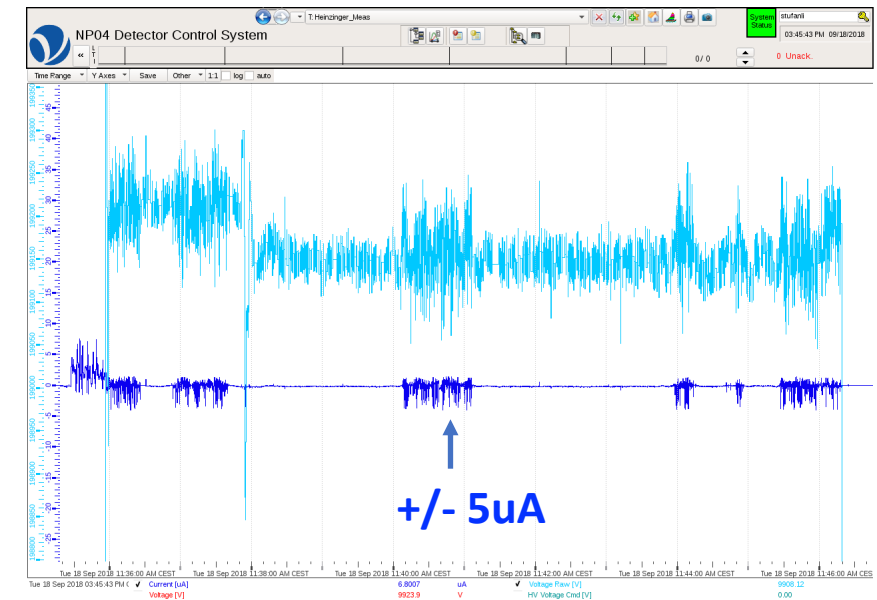
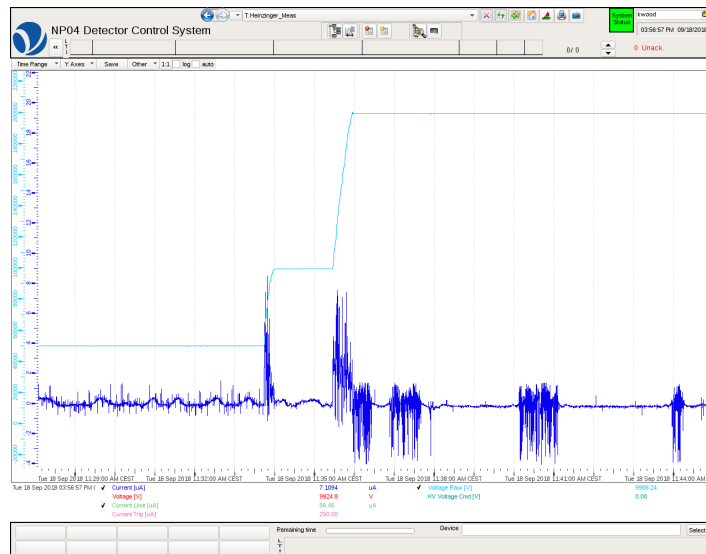
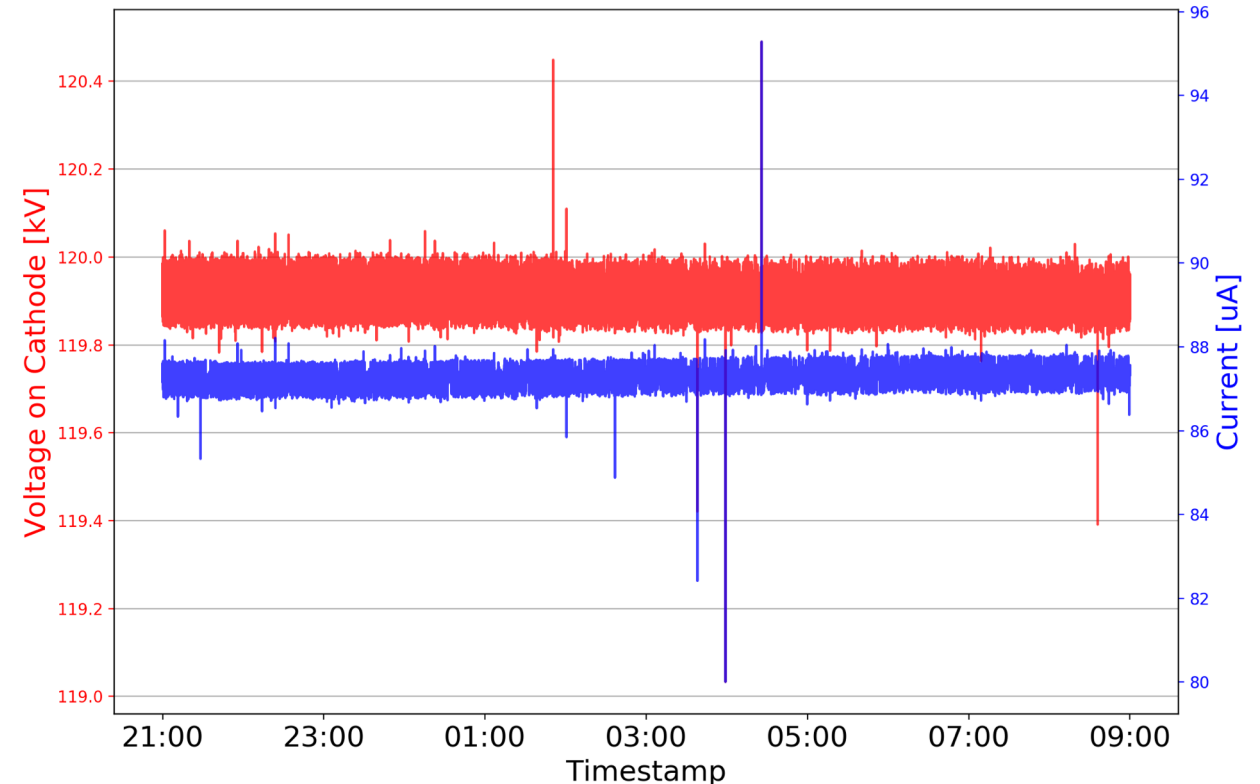
- We are a little concerned with the current fluctuations we see on the Heinzinger
  - e.g. with no load (no cable inserted) we see the activity shown at top right at -200kV
  - e.g. while connected to the detector after the first day of ramping, while sitting at -120kV overnight
  - etc...

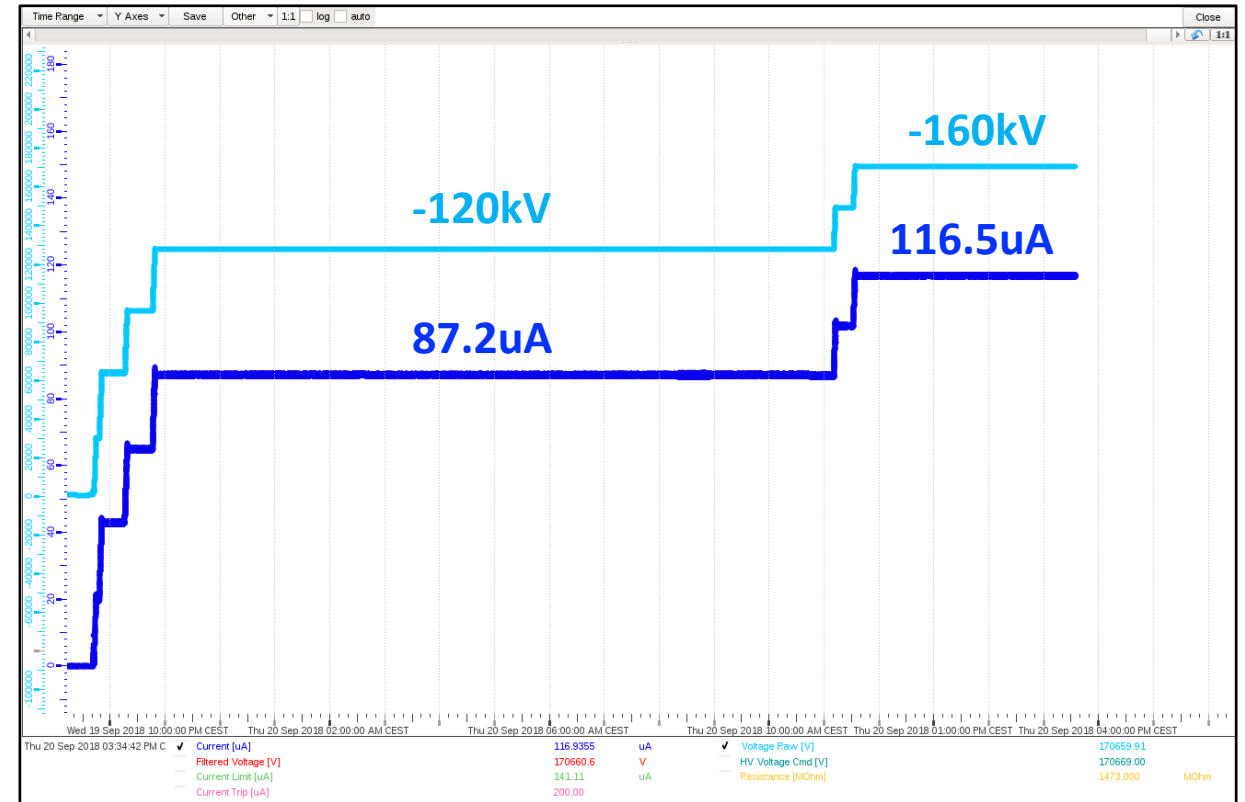
- We tested the Heinzinger (with and without test loads), the filtered-cable, and the connectivity from the PS to the FC termination extensively
- Everything was shown to be in an acceptable condition, so we initiated a new ramp
  - -0kV to -30kV – check current draws and voltage stabilities of wire biasing PS's, FC termination PS's, and WIB/FEMB PS's
  - -30kV to -60kV – check current draws and voltage stabilities and run the DAQ
  - -60kV to -90kV – check current draws and voltage stabilities
  - -90kV to -120kV – check current draws and voltage stabilities, take a long DAQ run, and sit overnight
  - -120kV to -140kV – check current draws and voltage stabilities
  - -140kV to -160kV – check current draws and voltage stabilities, run the DAQ, and sit all day and overnight
