protoDUNE-SP Cold Electronics Status

Matthew Worcester (BNL)
representing the Cold Electronics team

protoDUNE DAP Meeting
September 20, 2018

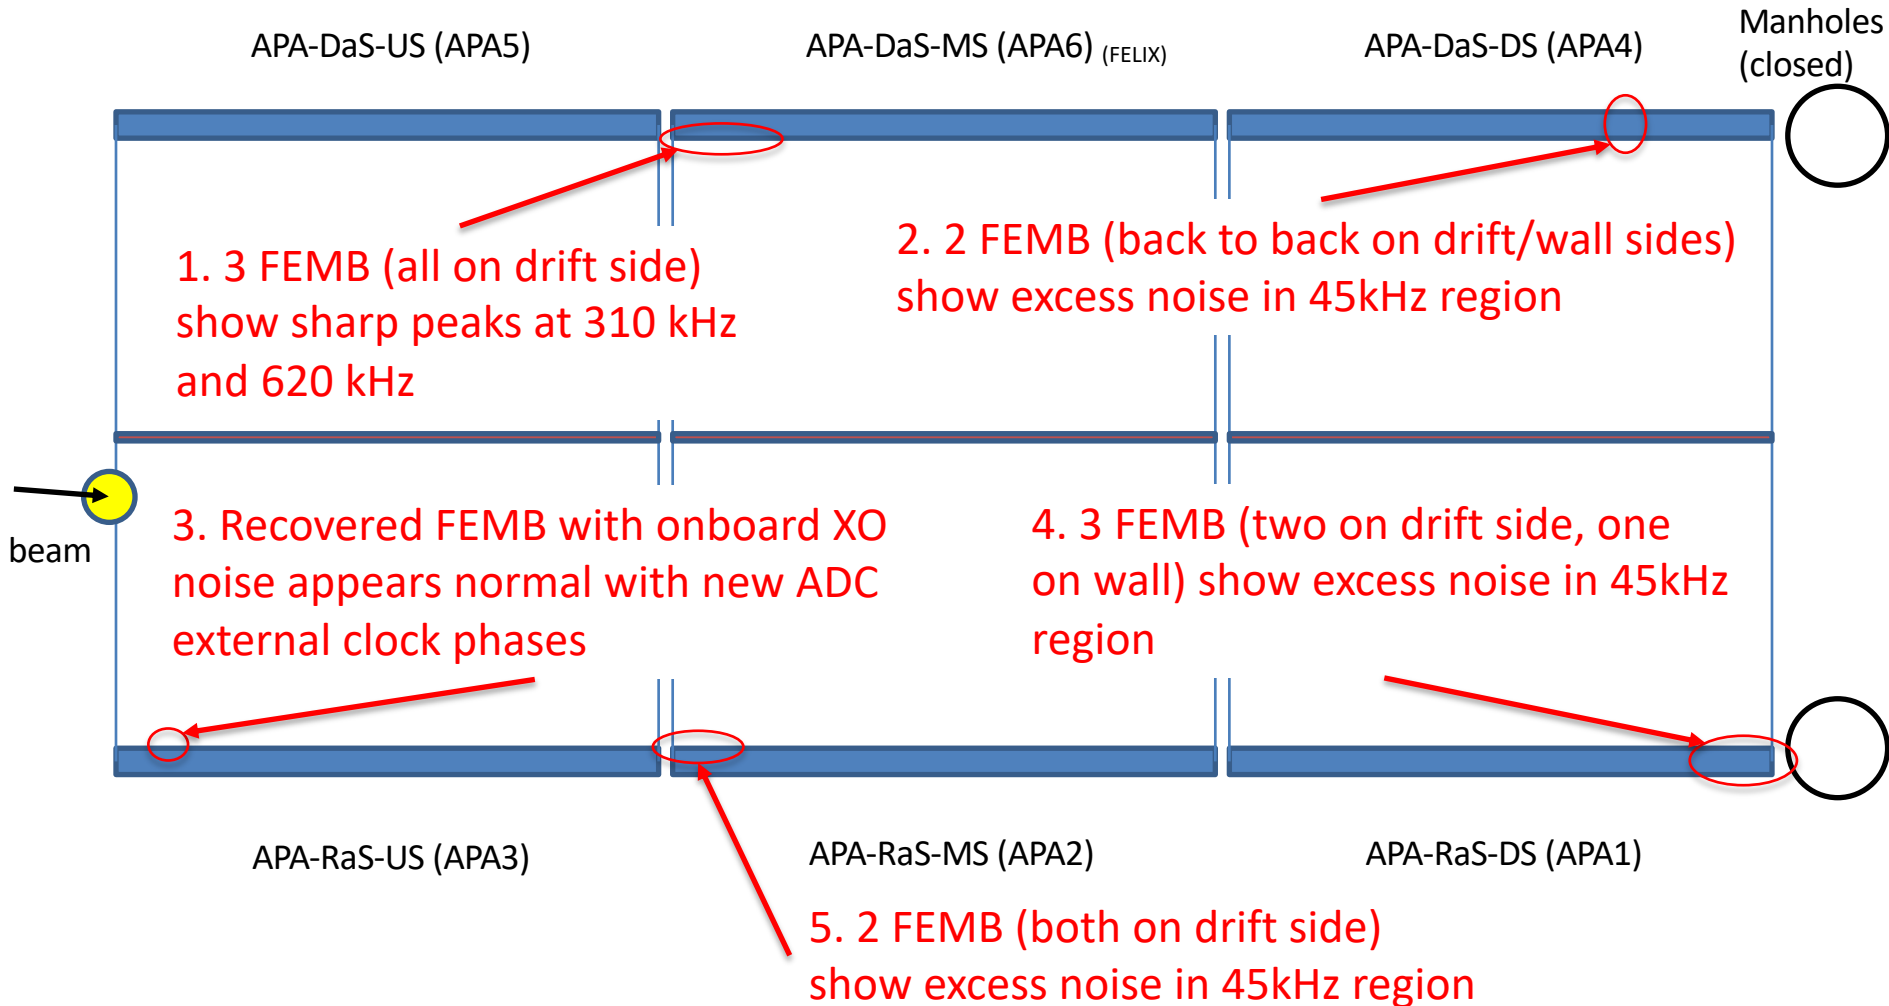
protoDUNE-SP noise status

Using 9/13 expert data (DAQ noise is consistent)

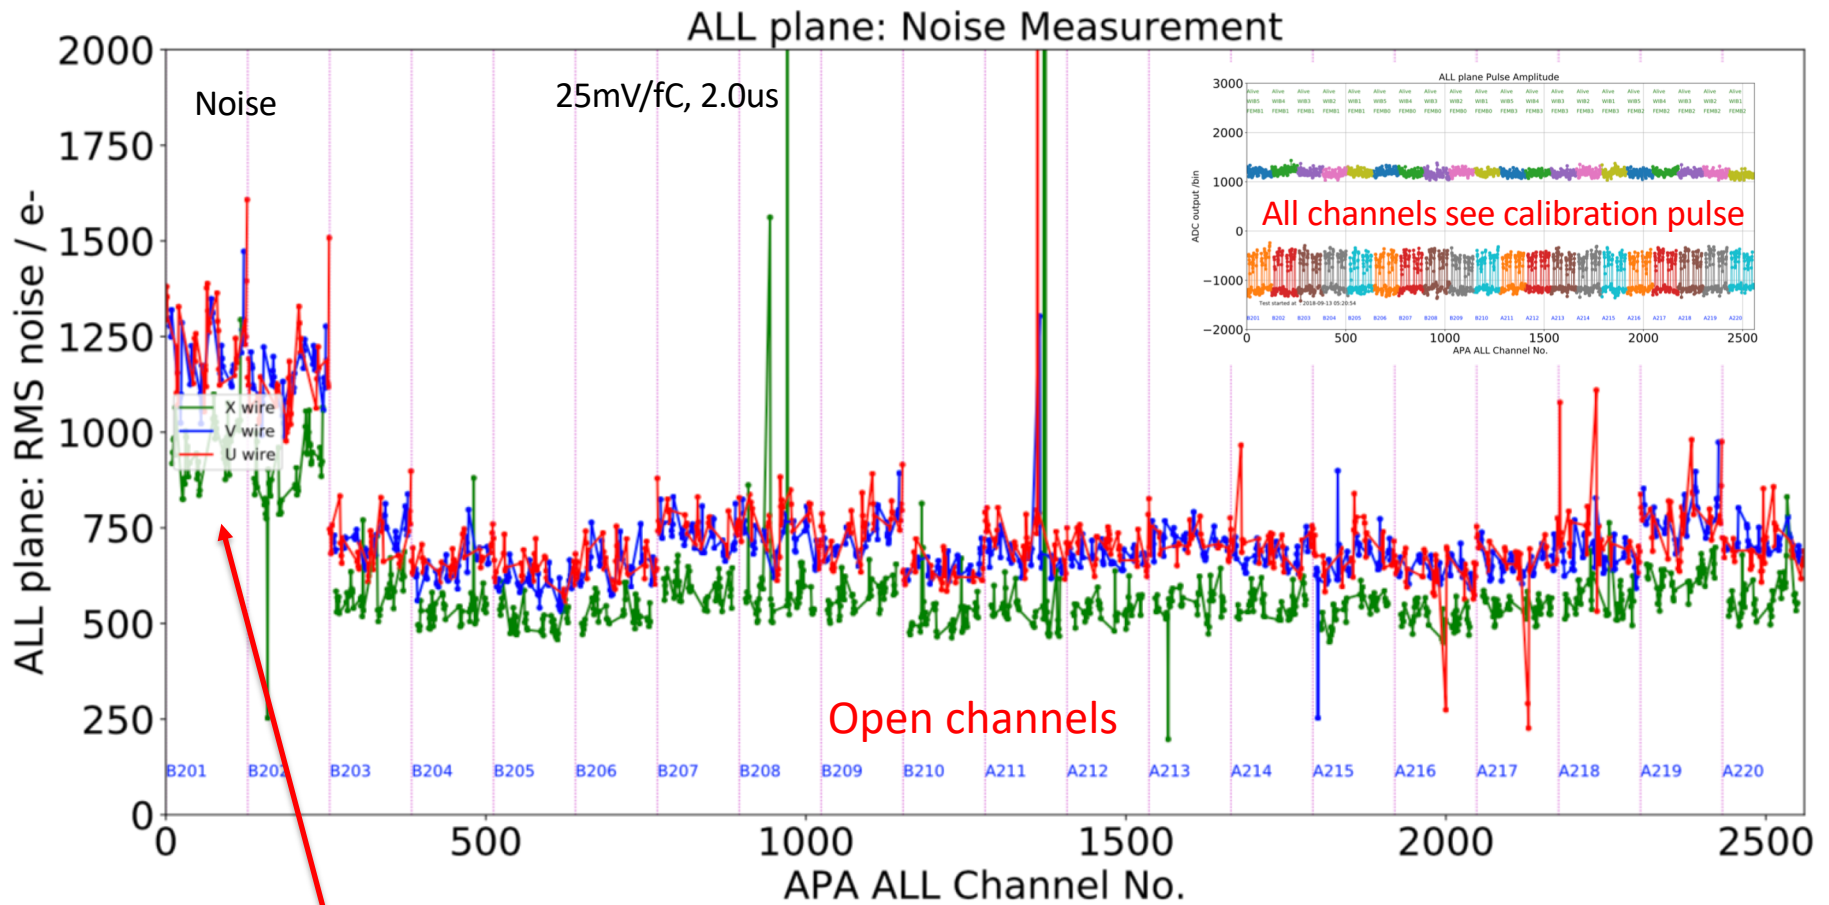
APA2 (from 9/13)

5. 2 FEMB (both on drift side) show excess noise in 45kHz region
Tested twice without power cycle, same result

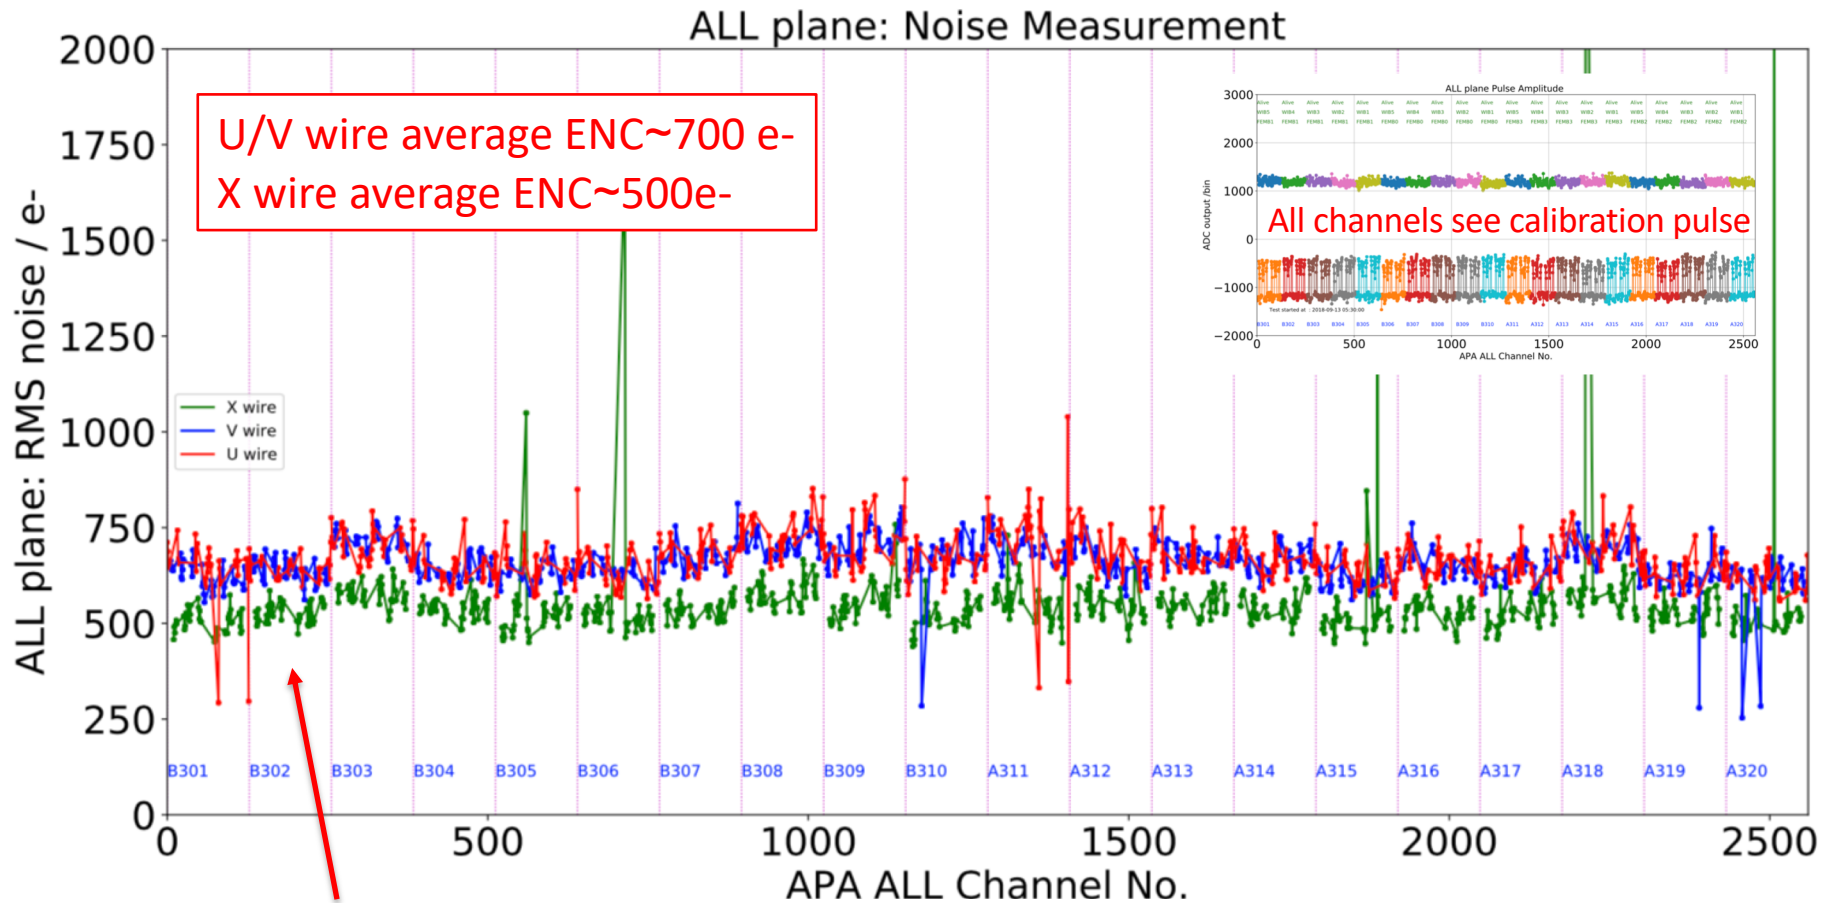
APA3 (from 9/13)

3. Recovered FEMB with onboard XO, noise appears normal with new ADC ext. clock phases

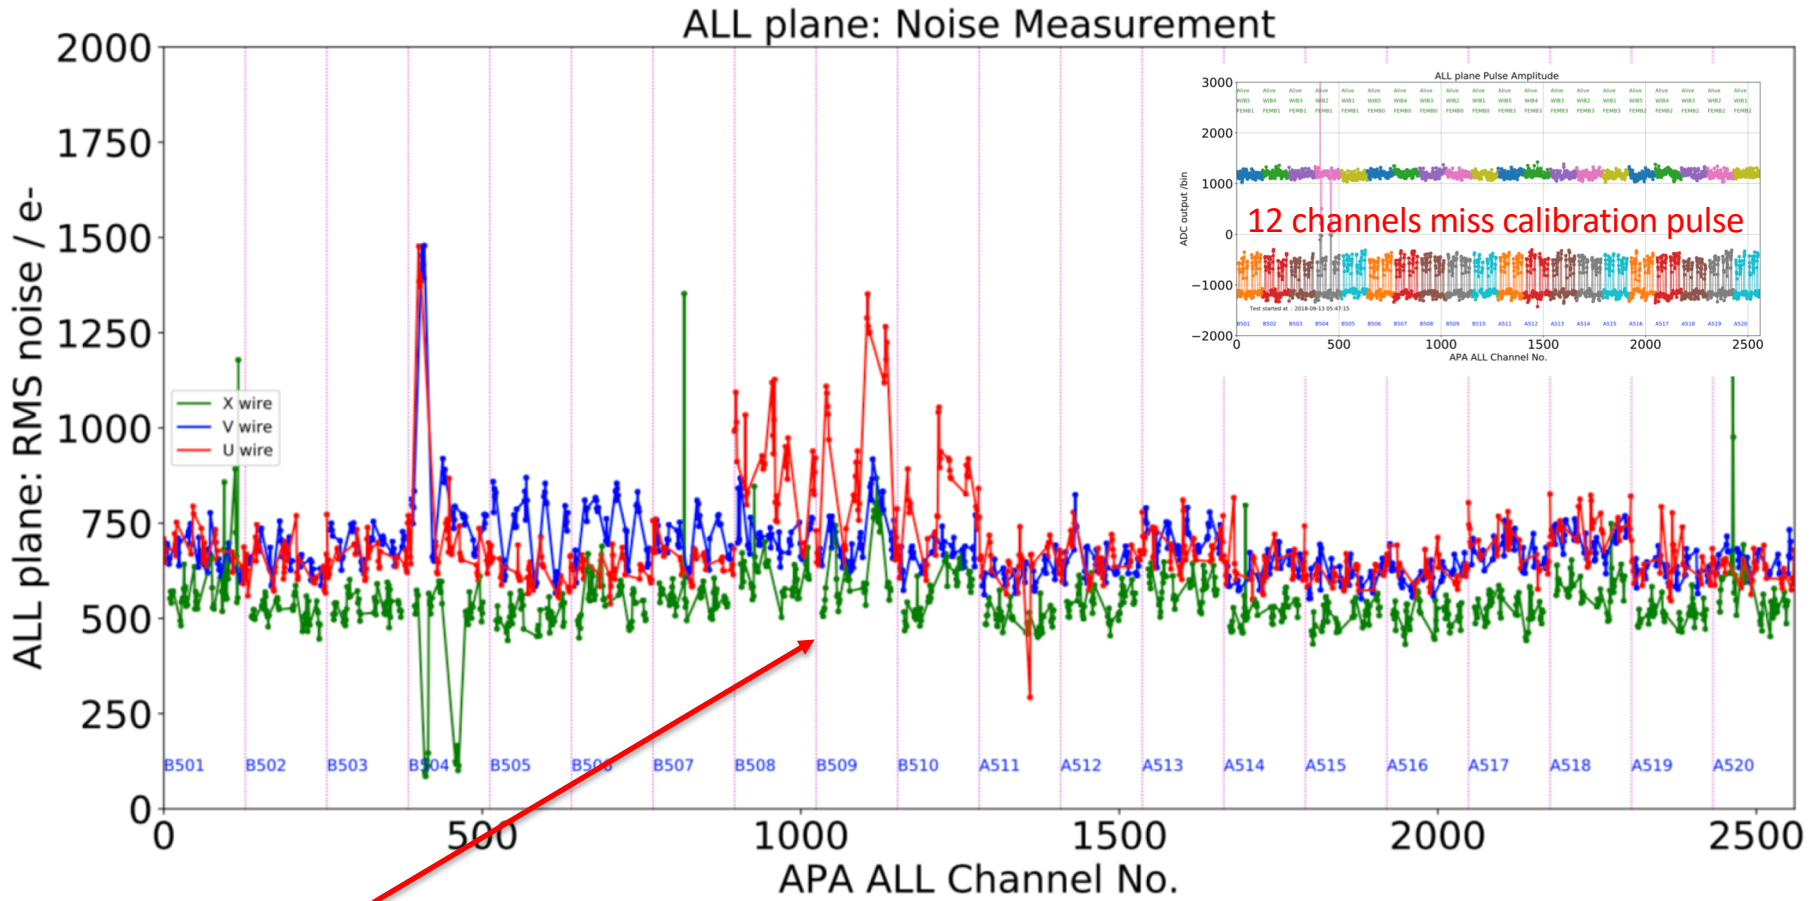
APA5 (from 9/13)

1. 3 FEMB (all on drift side) show sharp peaks at 310 kHz and 620 kHz
