ProtoDUNE-Dual Phase

CRP construction, cold box operation and tests

D. Duchesneau

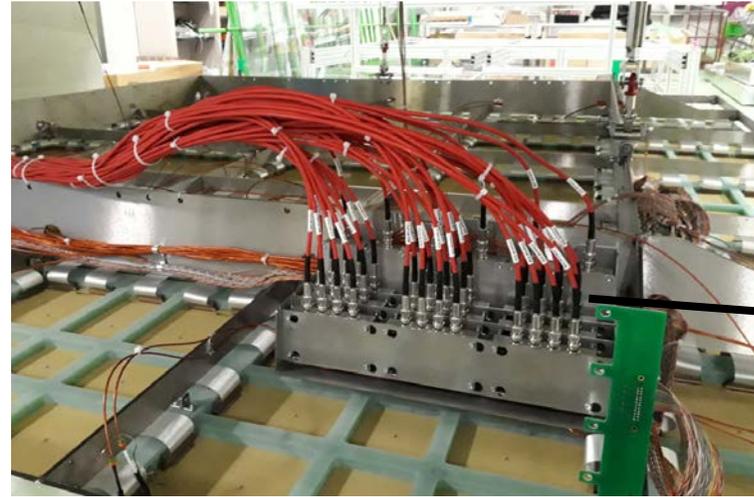
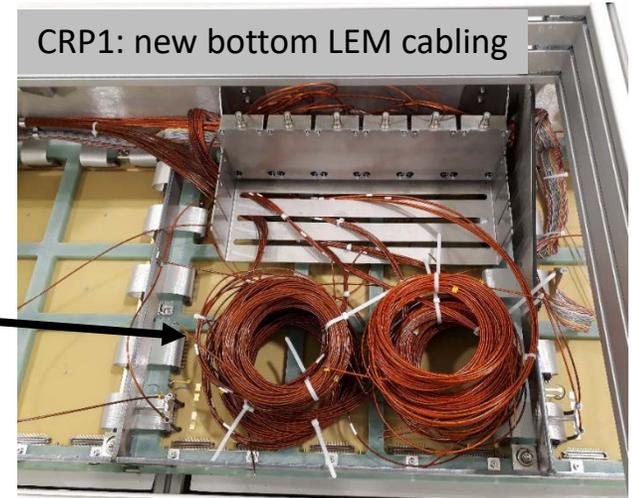
Firs modification on the HV distribution of the LEMs bottom on the CRP1 in order to avoid any possible limitation due to sparking in the SHV connectors

- ✓ => distribution boxes have been removed during first week of September (3-5/09) and replaced them by 6m long HV cables going directly from LEM to outside of the cryostat.

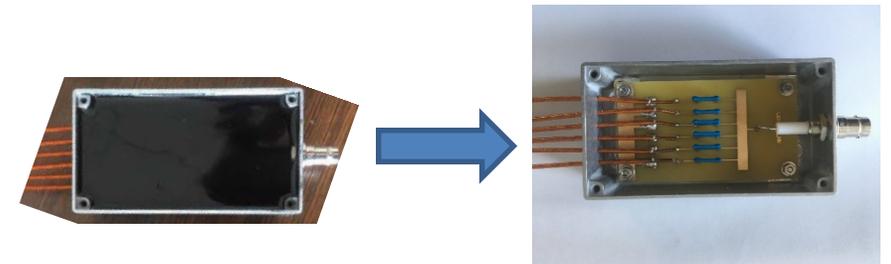
Second modification on the LEM top distribution box (DB) done in Sept 2018 a few channels have lost the contact within the distribution box. This has been traced back, after a deep investigation, to a failure of the resistor which is embedded completely in Arathane glue in the box and suffer from some differential thermal behaviour. This happened only on 1 or 2 channel per box (each having 6).

new PCB boards without the use of Arathane

The CRP1 and CRP2 cold box tests in October and November ran with those modifications: no problem was seen with this new design

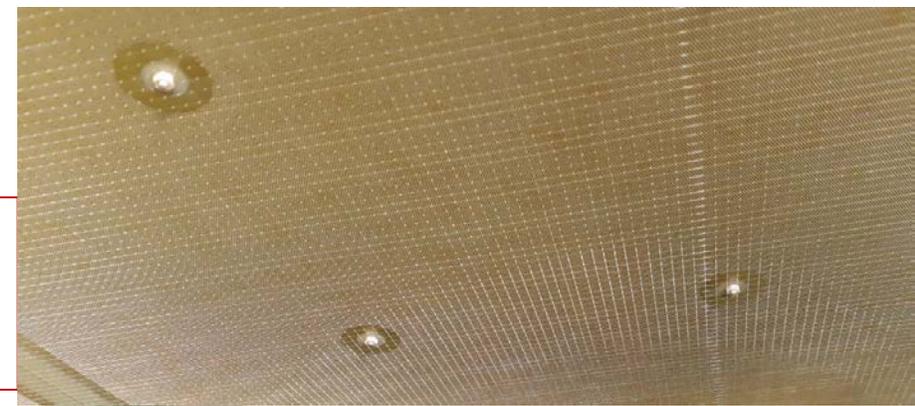
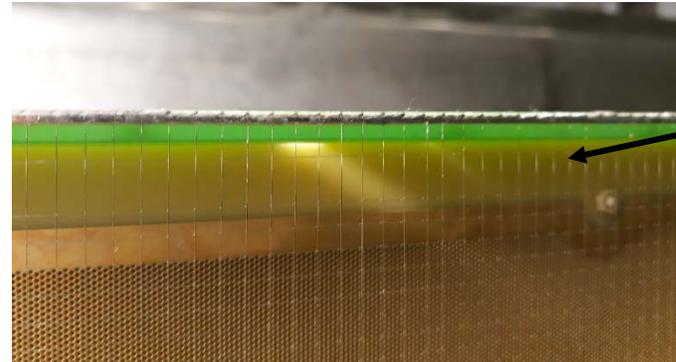
- Shorts were present with a few (6 to 8) LEMs
- The maximum voltage was limited of the order of 2 kV in nominal CRP position

Add 1.5 mm spacers to increase the grid wire tension along the 4 sides of the CRP

Net result: tension at warm went from 0.6 N to 2 N

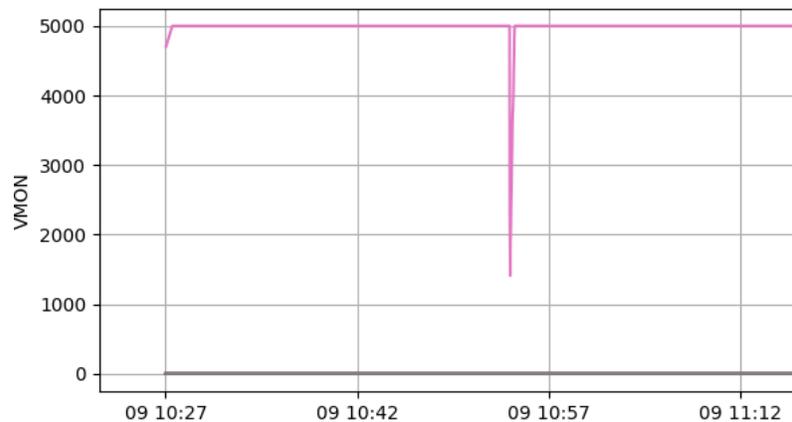
Before that the situation was not simple:
Current fluctuating and some discharges from time to time

The solution was to remove the humidity around the SHV connector outside of the cold box to avoid discharges in the connector => thanks to the hair dryer which was heating the outside connector

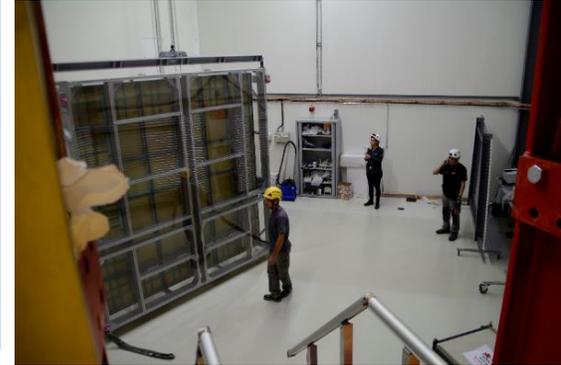
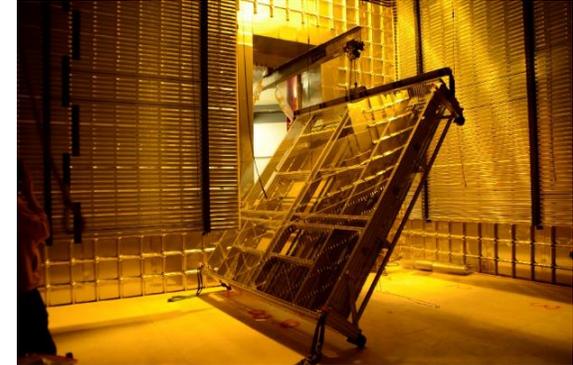
- Unfortunately a problem appeared during the insertion of CRP3 in the cryostat where 3 wires broke in the process and 7 more in the following days.
- The manipulation was not soft at all due to an abnormal use of the chain hoist and it has been requested to proceed much more smoothly for the next manipulations

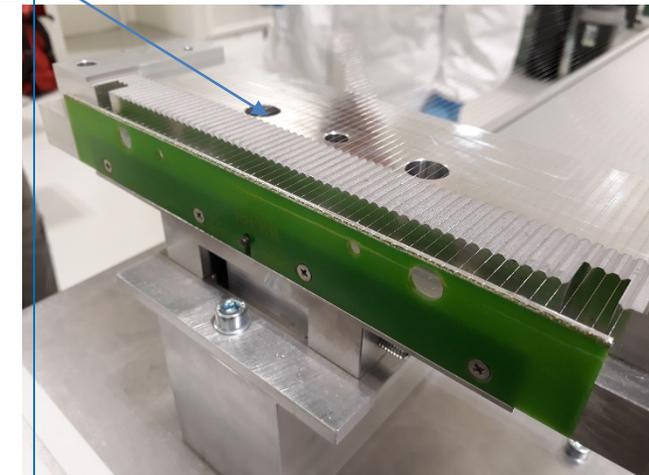
After investigation and careful check of the 1920 wires it appeared that on a few wires of this CRP there was a sort of small coloration with small deposit along the wires. This was usually located between 1 and 10cm from the PCB supporting plate

- This is identified as a possible remnant of soldering flux which was not cleaned as it should have been after soldering. This flux is usually aggressive and may attack the metal. This could eventually explained the breaking of wires.
- The process of cleaning with distilled water was not properly done on a few wires for this CRP.
- We artificially increase the tension of the full grid to see which wires could have been weakened.
- In the meantime a thorough inspection of the other CRP grid wire by wire is going on.
