# LCLS-II Cryomodule Assembly and Design Changes/Issues at Fermilab

Tug Arkan

LCLS 2-HE CRYOMODULE PERFORMANCE WORKSHOP

April 25-26, 2019

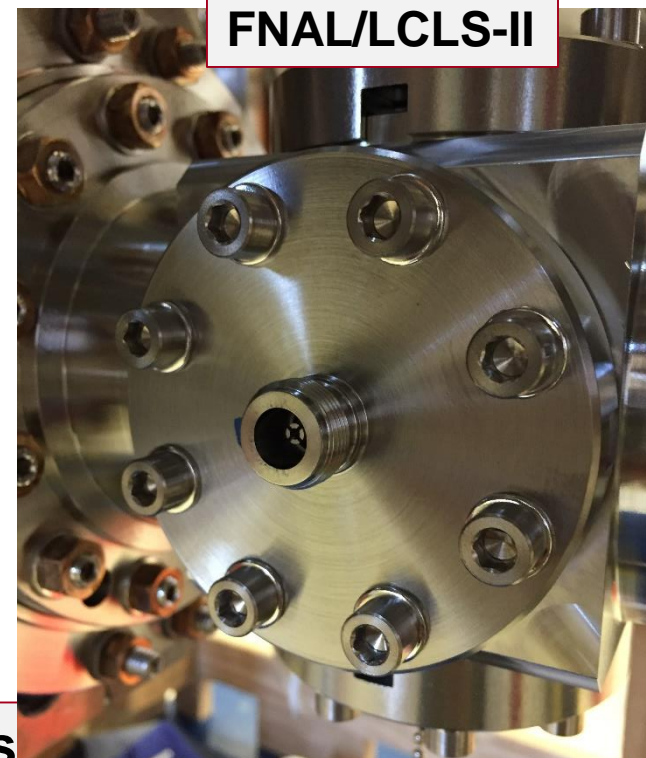
FNAL/LCLS-II

Titanium grade 5 SHCS fasteners intended, not spec'd

Titanium grade 2 SHCS fasteners ordered/received

F1.3-06 assembly was missing the SS washers – all others checked and ok

- Replaced grade 2 Titanium socket head cap screws with grade 5 Titanium studs, 316L nuts and washers
  - Materials specifications and certifications are confirmed and verified

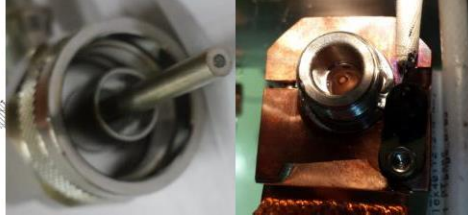
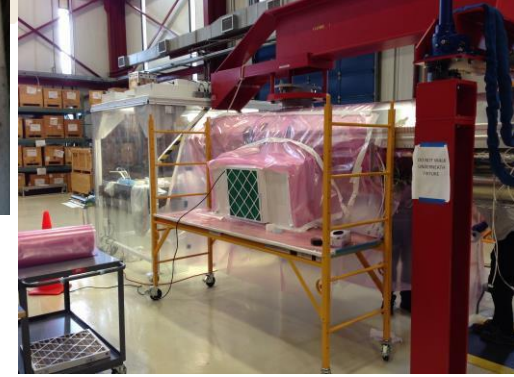
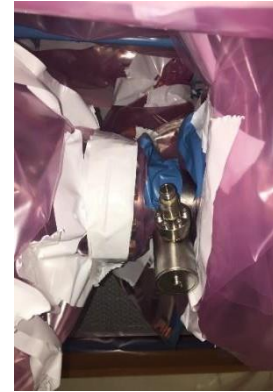
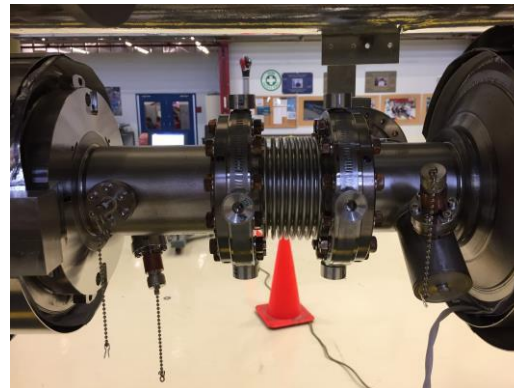
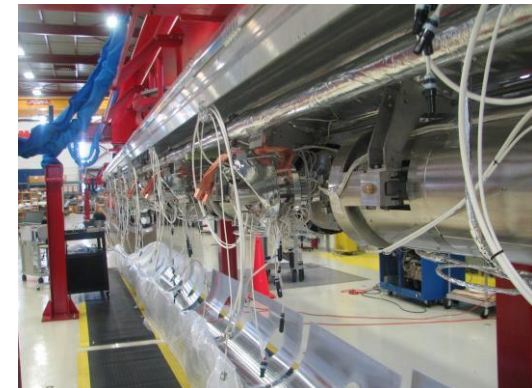
# F1.3-5 Cav#2 HOM connector replacement

- During final HOM notch frequency tuning at WS3, when the RF cable was removed, RF engineer noticed that Cav#2 HOM1 pin is broken
- Local cleanroom tent was built. Nitrogen fogger was used to optimize the location and rotation speed of the fan filter unit
- Procedures are developed, tested on a the bench with a spare cavity
- HOM connector with broken pin was replaced and leak checked successfully
- This is a one time incident. Official root cause analysis is not done
- Mitigation Strategy: ensure that protection caps are installed throughout the cold mass assembly. RF group changed the procedure for HOM notch frequency tuning: Keep the RF cable connected during tuning

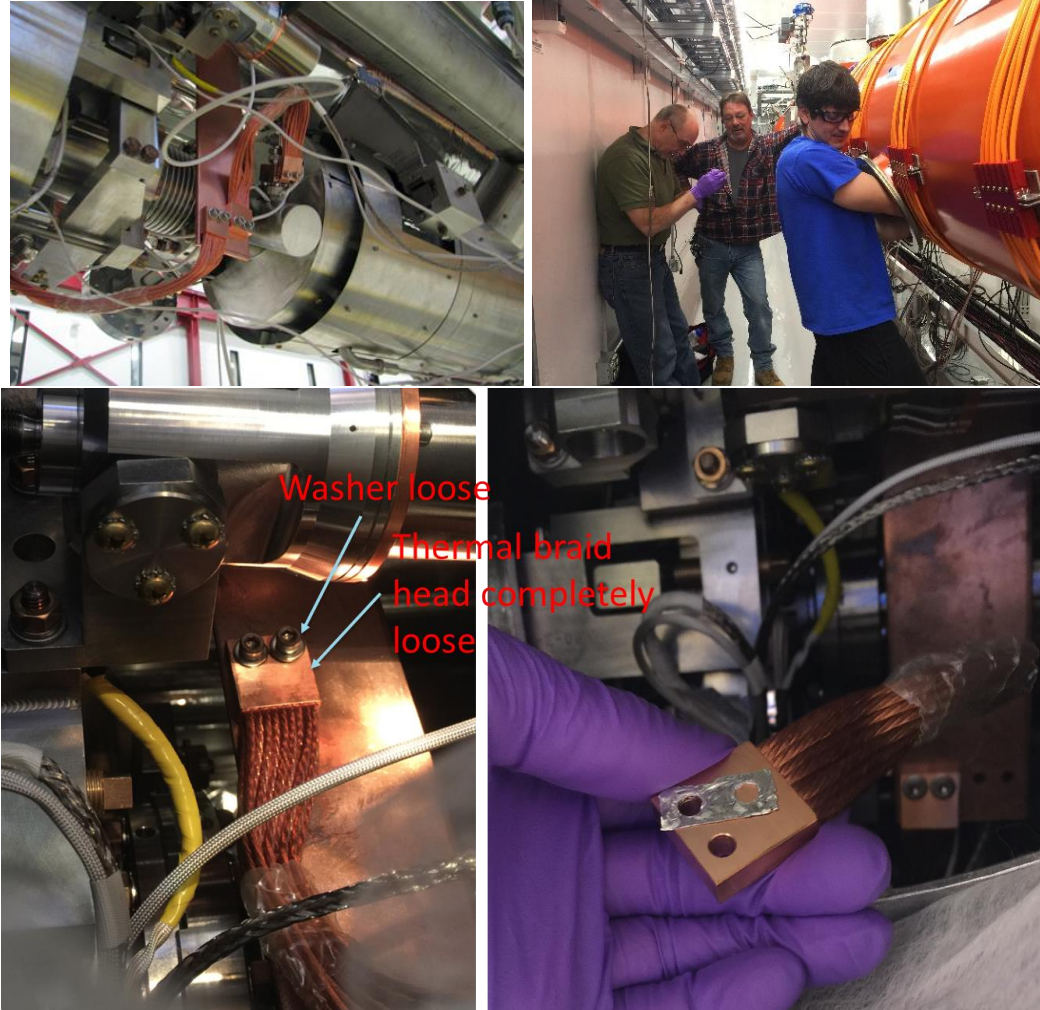
# F1.3-3 Cav#3 coupler side end group heating

- We did an autopsy by accessing from tuner access port
- The root cause of the problem was that the fastener used to bolt the thermal braid to the connector copper clamp had bad thread and jammed to the nut before properly tightening. Jamming caused faulty torque verification quality check result
- To eliminate re-occurrence, we have introduced extra QC steps such as checking the assembled thermal intercepts by wiggling the clamp, sink & more attention to the torqued fasteners by peers, lead techs and responsible engineer

A bad bolt (poor thread) caused false torque satisfaction.

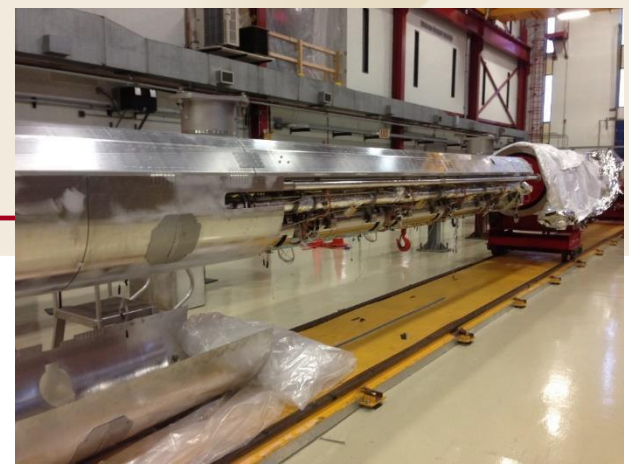
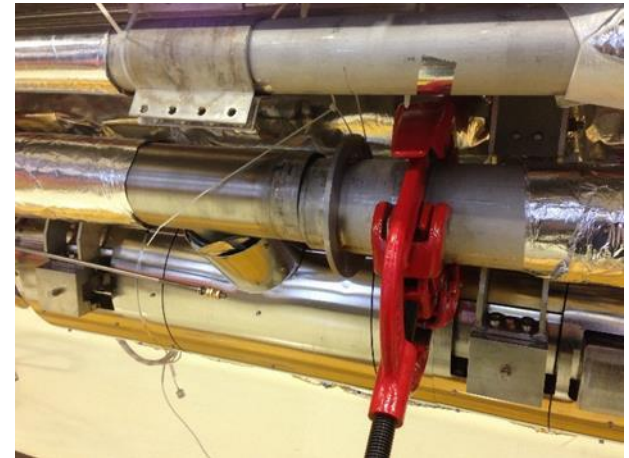
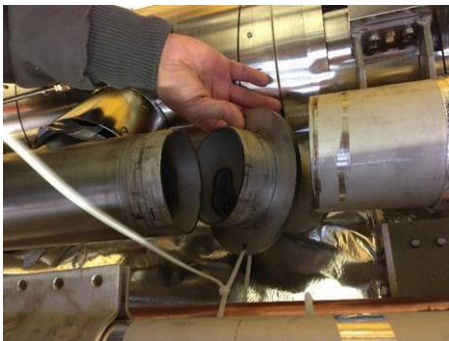
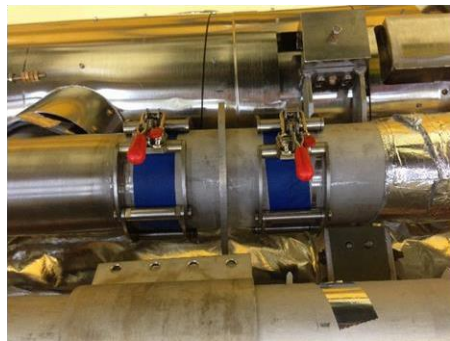
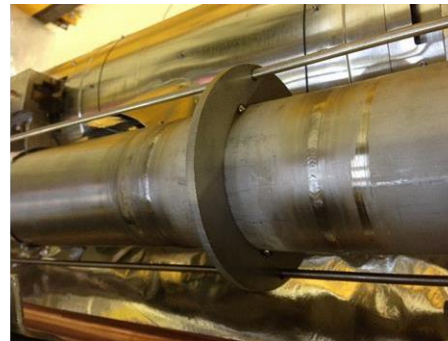
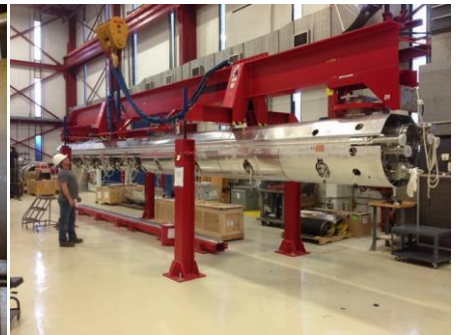
# CM08 Line G leak discovered at WS5

- During Line B+G+H leak check at WS5, a leak was found on Line G (2-phase pipe). We tried to repair this leak through a tuner access port without success.
- Four upstream lower shields were removed to expose the 2-phase pipe
- 2-Phase invar rods removed
- Pipe section with leak was cut from 2-phase line
- New pipe section has been welded

**Mitigation: Complete the longitudinal (Z) alignment of cavities at WS2, weld 2-phase pipe disks and install invar rods before Line B+G+H leak check at WS2**
