# D0 Luminosity Monitor - status and stability-

2008. 9.24 Yuji Enari

## Radiation damage on Scintillator

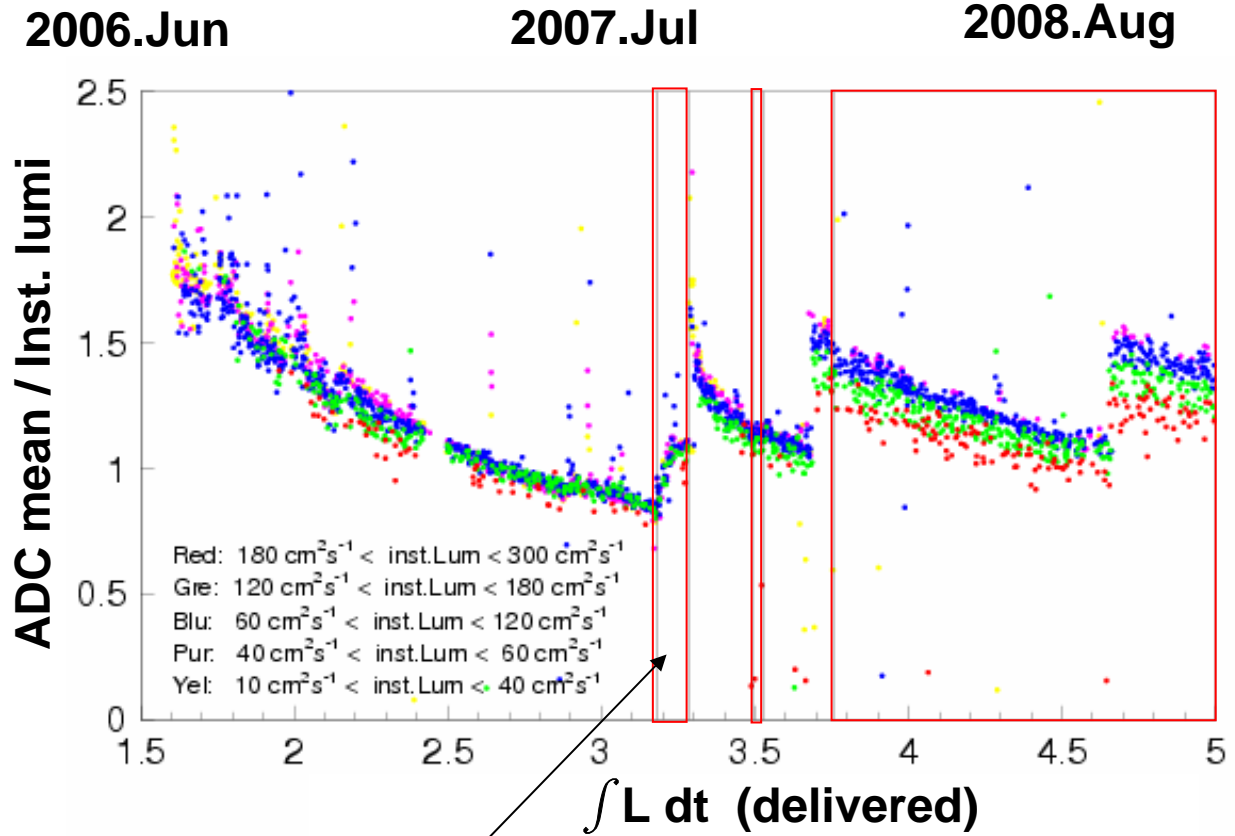
- PMT?
- Purge: Nitrogen to DryAir (period in the red box)
  - Significant improvement on light yield (2007.Jul.11-Shutdown)
  - After additional short and long term test, we decided to switch Dry Air
  - Since 2008.3.11, switched Dry Air from Nitrogen.

Monitoring variable:

$$\text{ADC / inst. lumi} \\ \text{vs} \\ \int L dt$$

In 1st order, it should be flat as far as light yield is stable.

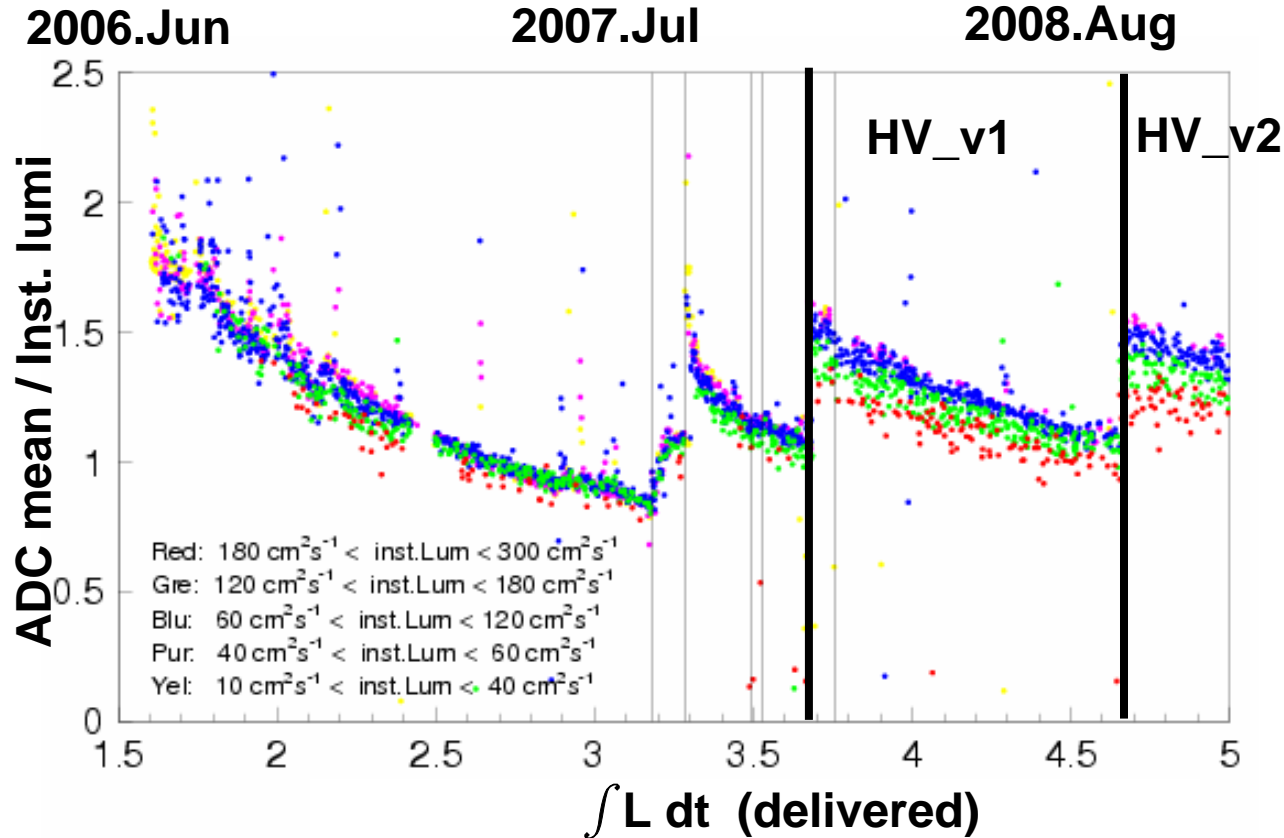
- Replacement of scintillator

- 2006 shutdown (RunIIa→RunIIb)
- 2007 Summer shutdown.
- 2009 Spring shutdown

- Raising HV

- update due to the rad damage.
  - 1<sup>st</sup>: 2008. Feb 22 (store 5924)
  - 2<sup>nd</sup>: 2008. Aug 7. (Store 6348)
  - 3<sup>rd</sup> : 2008. Dec????

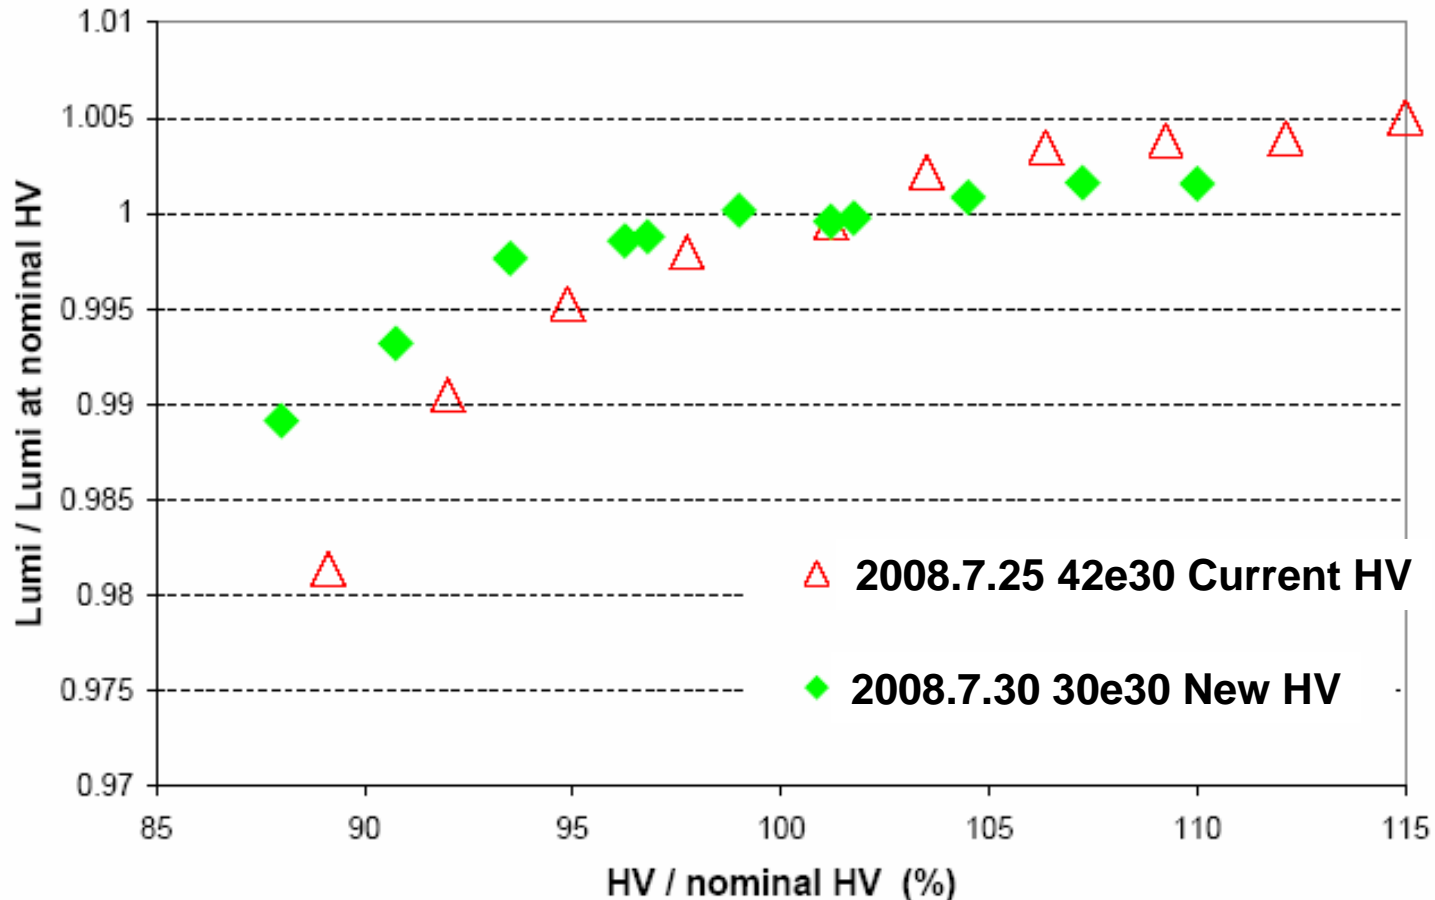
- HV scan result before and after updating HV setting.
  - Plateau nicely come back after applying new HV setting.
- On average, we raised HV by 5%.

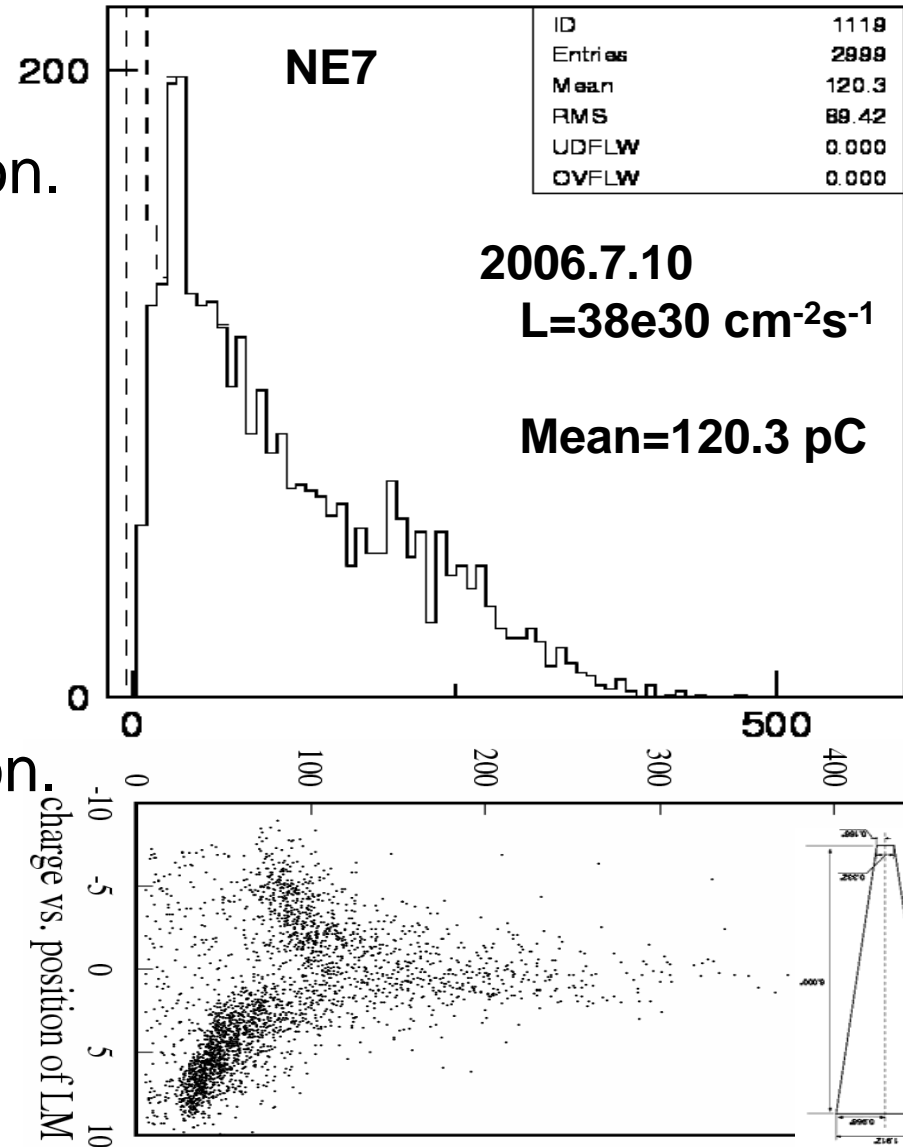
Note:

- Charge is function of hit position.
    - Higher tail: under PMT.
    - Middle: Inner (narrow) part
    - Lower tail: outer (wider) part
  - Dot hist: without TDC hit
  - Solid hist: with TDC hit
- Clear noise/signal separation.

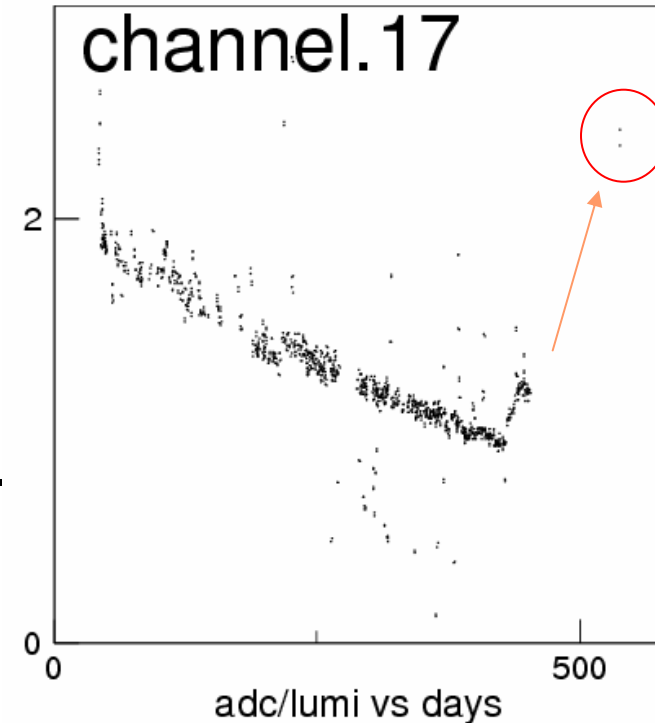
First store: Oct 28 (Sun)

- Data with HV setting of before shutdown  
Observe recovery on ADC/Lumi to same level at beginning of RunIIb.
- Update HV setting
  - Apply new HV setting mid of 1<sup>st</sup> store.
- Update T0 (pass2 constant) between 1<sup>st</sup> and 2<sup>nd</sup> store.
  - All channel look good and no problem
