Short Baseline Neutrino

ICARUS Ground Short Saga (w/ plans and recommendations)

Linda F. Bagby

August 14, 2019

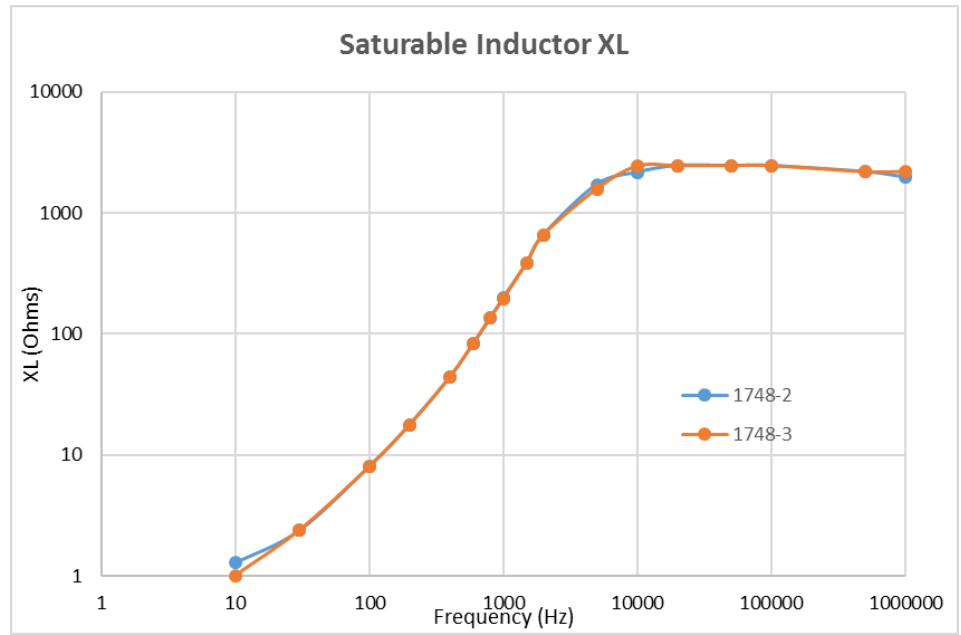
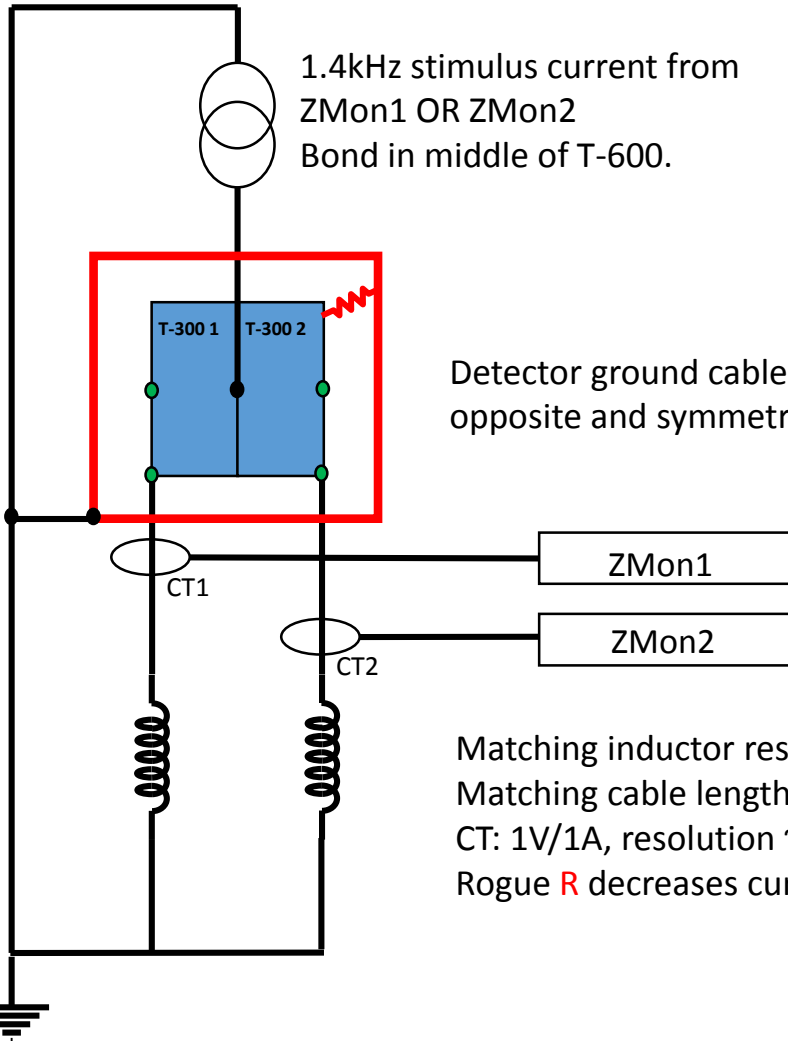
Matching inductor response curves.
Matching cable length L to T-300.
CT: 1V/1A, resolution $\sim 10\mu\text{A}$.
Rogue **R** decreases current seen by specific CT.

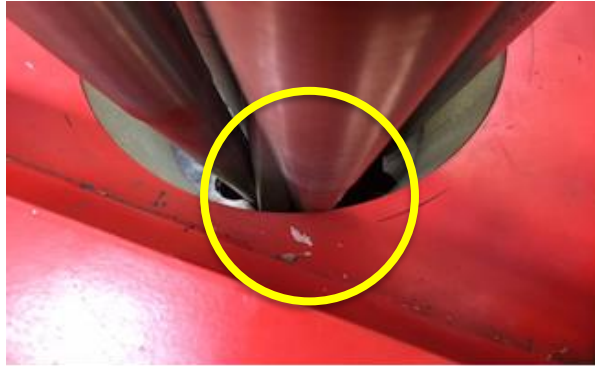
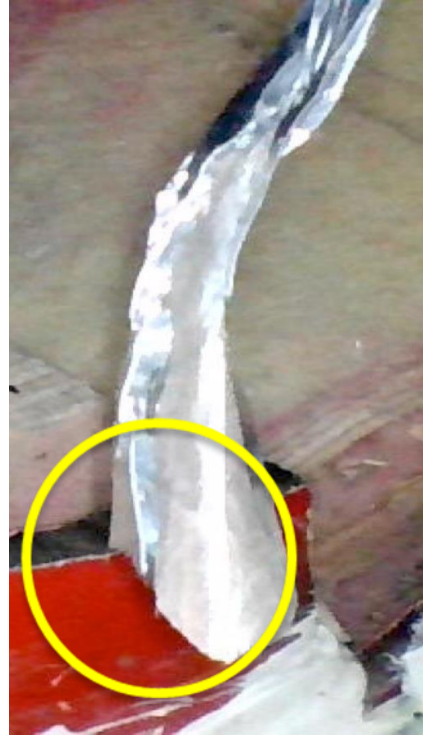
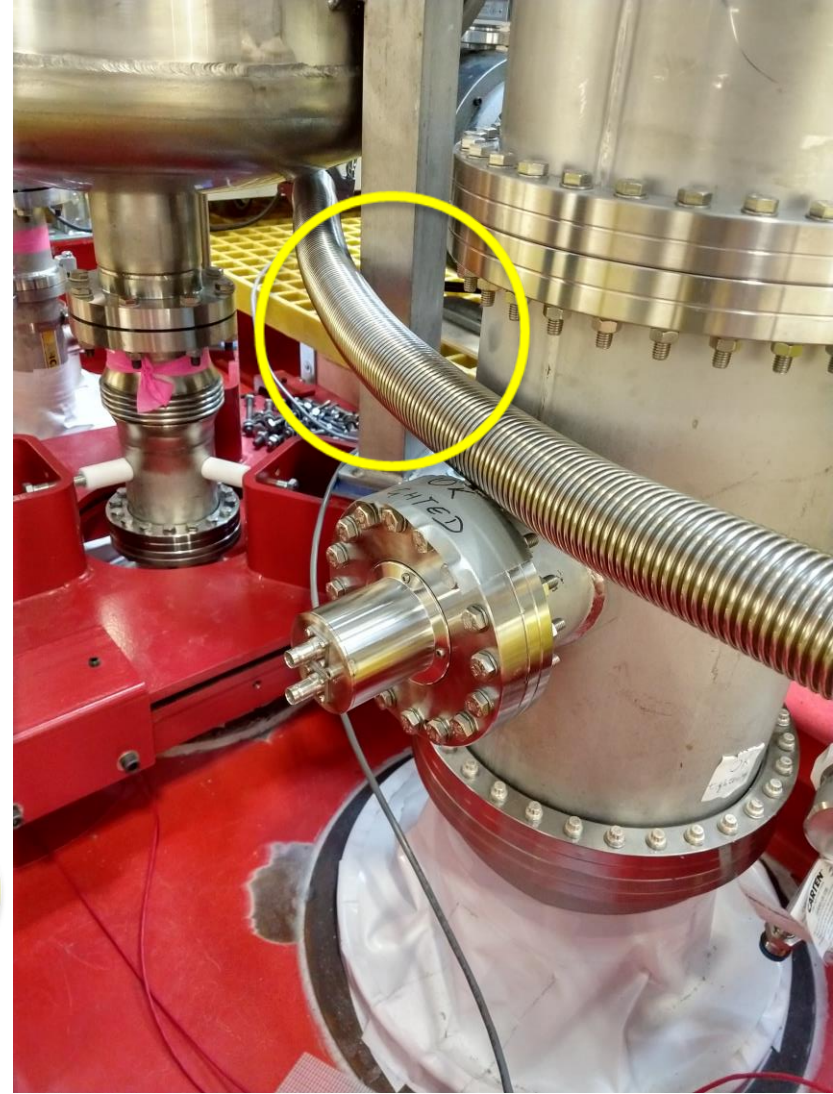
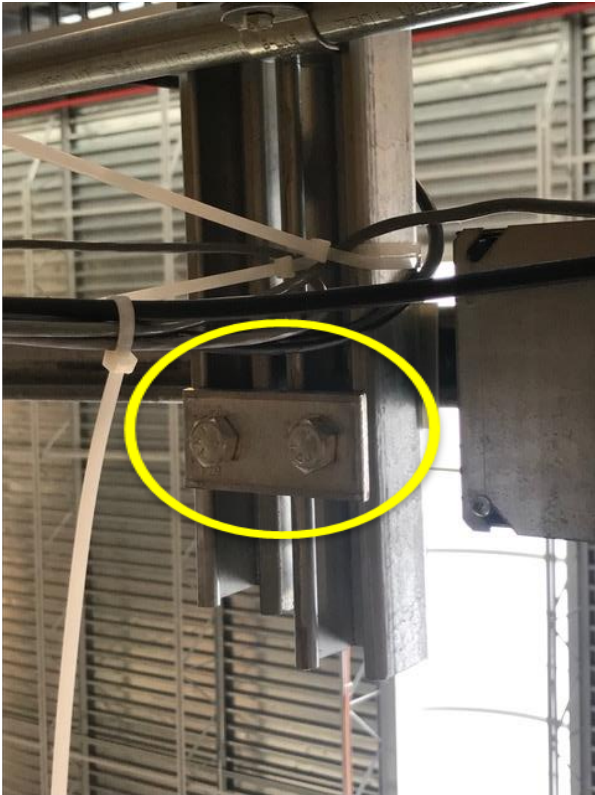
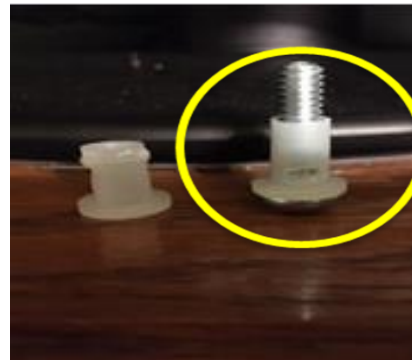
Short Source Gallery

- Began in earnest June 27
- Day to day updates are in the SBN elog and DocDB #12639
- A variety of sources were found for two types of shorts
 - Stable direct connection
 - Vibrational intermittent

- Plans
 - Due to the sensor cable shield finding, all currently installed cables, attached to detector referenced sensors from Cryogenic cabinet electronics, are being inspected and heat shrink applied to cover trimmed foil edge.
 - All subsequent sensor cables will be terminated in the same fashion.
- Recommendations: ACTIVE ALARM
 - While working on the top plate, be aware of the alarm.
 - If the alarm sounds (gong) and the beacon illuminates (flashing orange), stop what you are doing and try to resolve the source.
 - The normal display impedance value is $\sim 68-73\Omega$.
 - If unable to resolve, send email to bagby@fnal.gov.
 - Record where the work was being done, the time, and monitor display values in the elog.
 - If you know what is causing the short but need to finish the job, try to remove the short before you leave for the day.

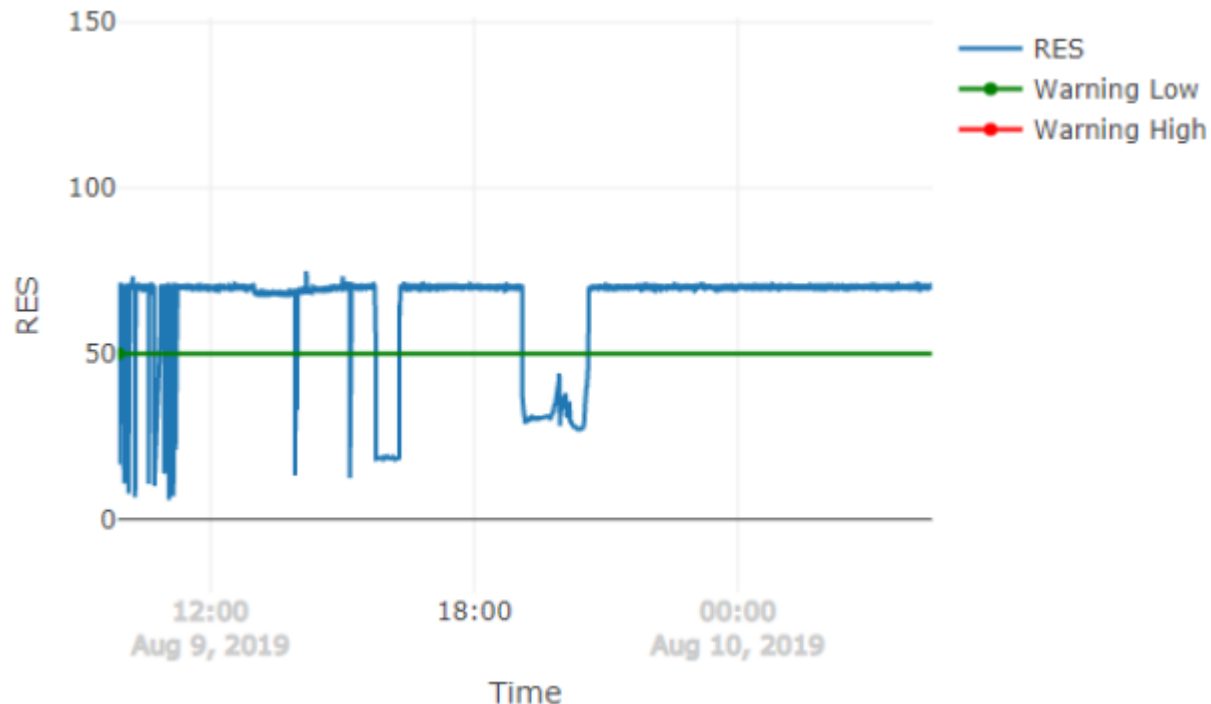
- Friday afternoon, August 9, an 18Ω short developed and disappeared.
 - An effort was made to resolve the short. No definitive source was found.
- Friday evening, between 7-8:40PM another intermittent, resistive short (33Ω) developed and disappeared. Appears to be vibrational in nature. Do not know if anyone was on the top plate.
