PAL-XFEL(Pohang Accelerator Laboratory X-ray Free Electron Laser) started RF conditioning in October 2015 and has been operating reliably for ~ 4 years. The machine's LLRF and SSA systems contributed to the stable operation of PAL-XFEL with over 99% availability. The LLRF and SSA systems showed some problems in rare cases. The delay caused by the problem is very small, but PAL-XFEL can stop working. Some issues have been identified and resolved. We want to share the experience.

Issue #1 (LLRF) : PPC Freezing

Issue #2 (LLRF) : Incomplete Connection

Issue #4 (TC Rack) : Water leakage

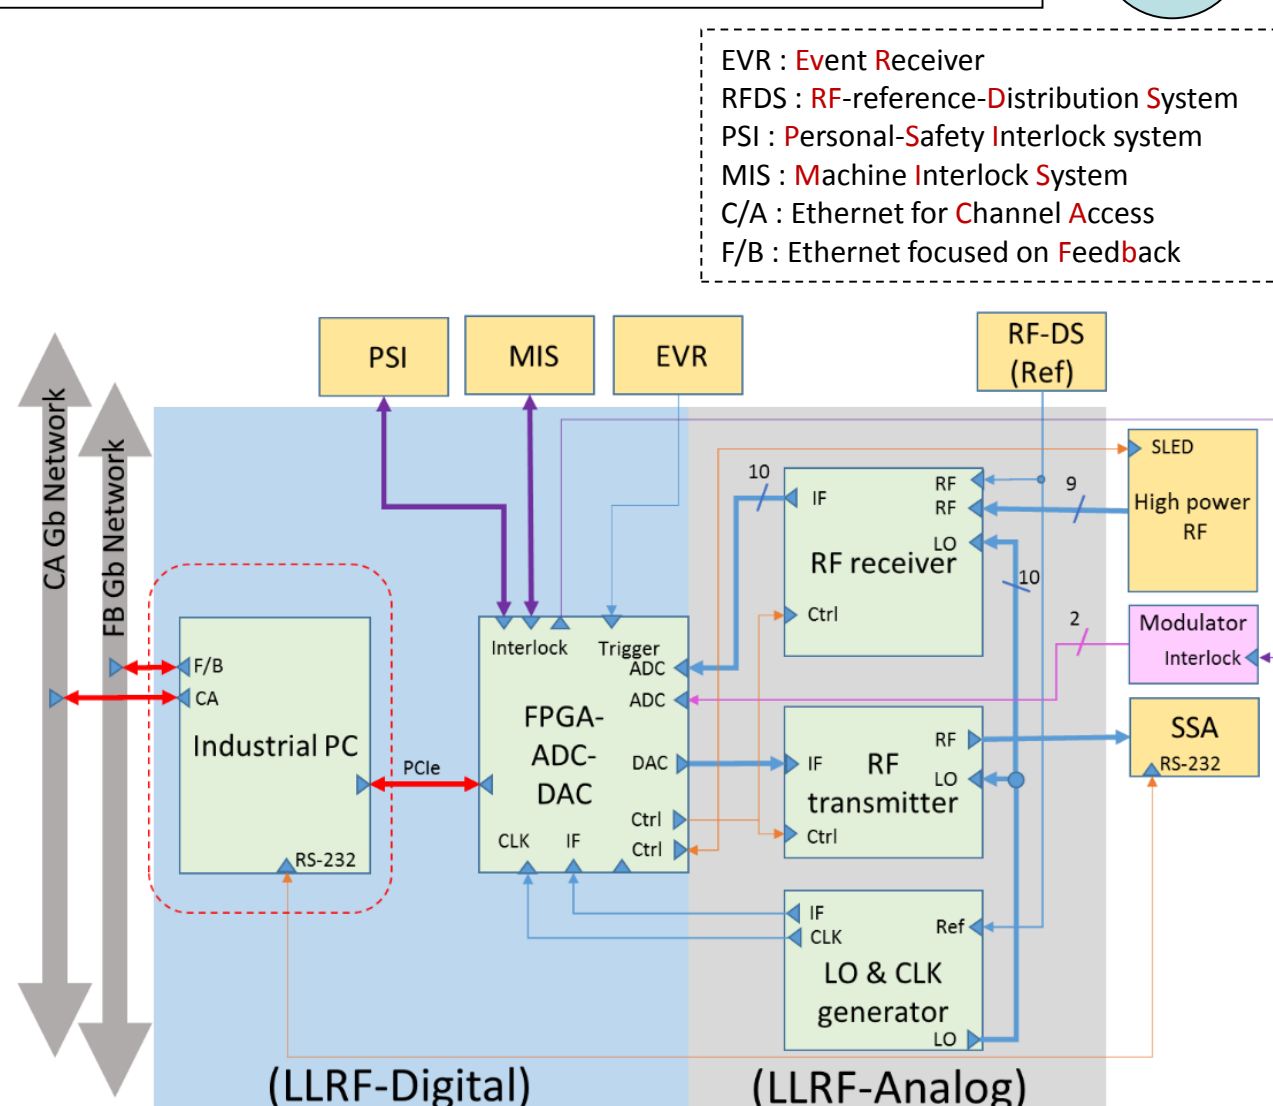
Symptom :

- 1) EPICS disconnection
- 2) PPC freezing
- 3) PPC shutdown
- 4) Occurred randomly and rarely
- 5) 1 occurrence/station for 9 LLRF units this year (most frequent problem of LLRF)

- In non-recoverable cases, the cause was PS degradation
- From a simple current analysis, the cause was judged by the use of PS more than 70% of the indicated capacity.

- 1) Reboot of PPC
- 2) Irrecoverable cases by reboot → replacement of LLRF unit

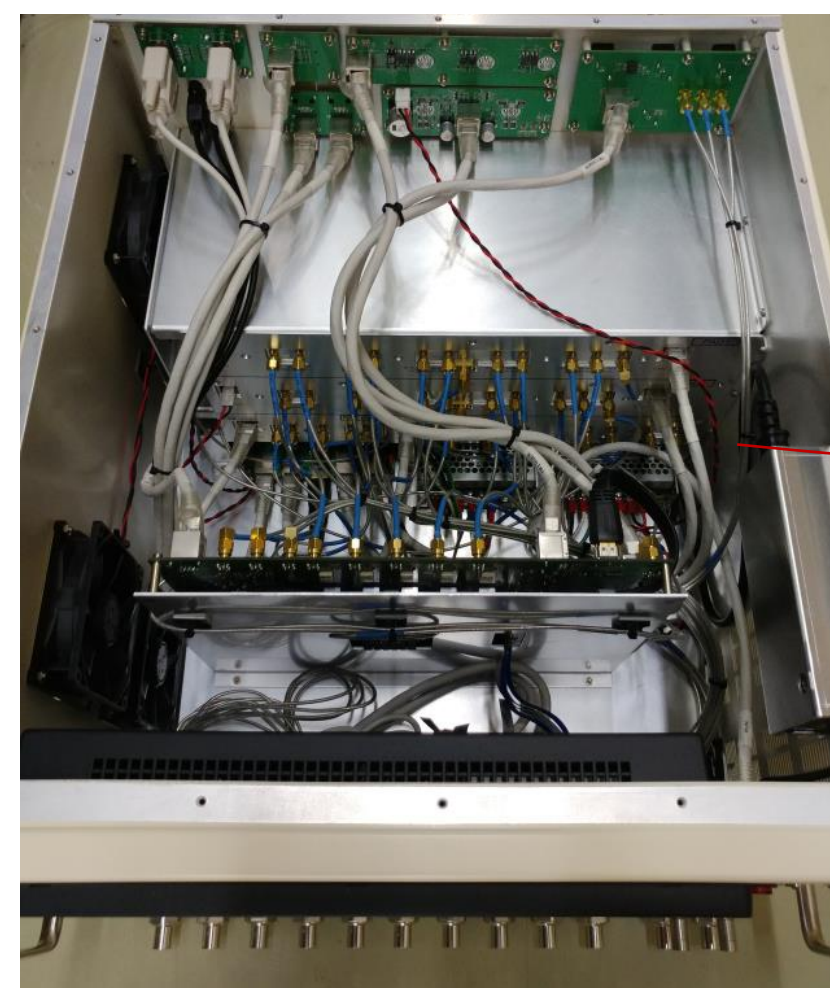
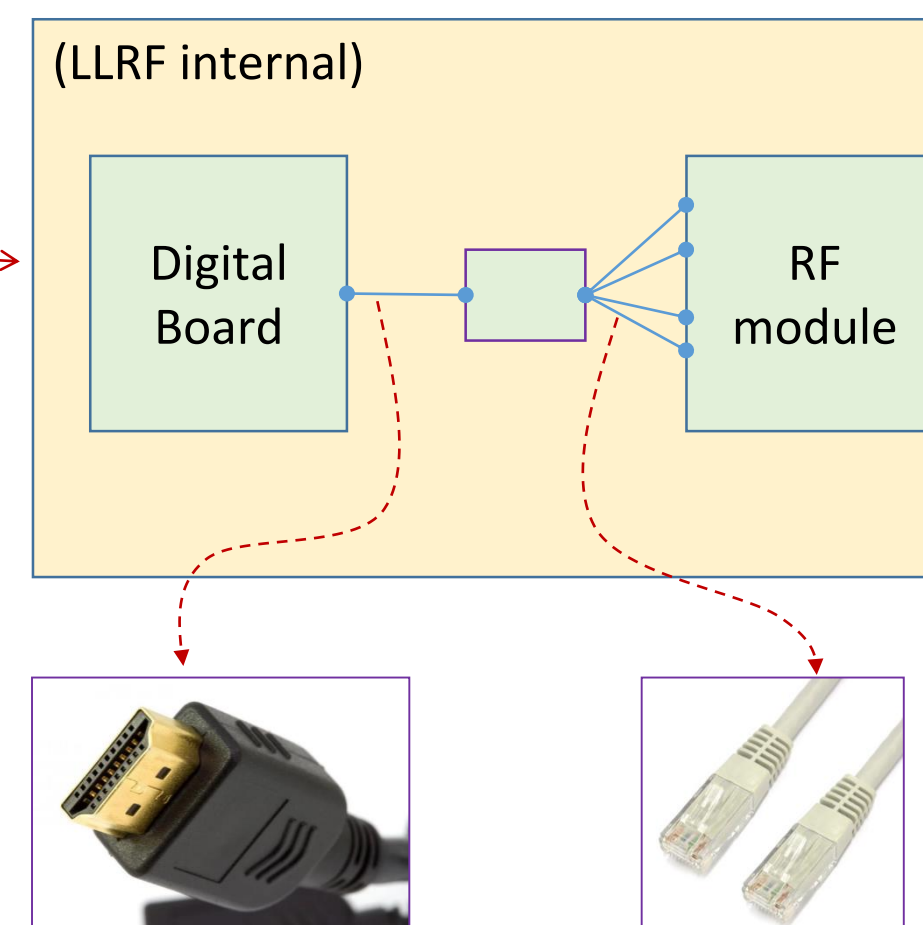
Internal view of a LLRF

- 1) LLRF output failures(no output)
- 2) PSK switching failures
* PSK : Phase Shift Keying for SLED operation
- 3) Wrong temperature values
- 4) Common features :
* Normal operation until the moment of failure
* occurred randomly and suddenly
- 5) In total, less than 5 times for 4 years

- Identified common cause : incomplete connection of connectors within LLRF case

- There are many RJ45 connectors and 2 HDMI connectors for compact cable connection and high-speed operation within PAL-XFEL LLRF box.

- The connectors prove very efficient and compact but not perfect.

- All problematic sets are recovered by reconnection of the connectors.

- We will search for better solution like better vendors or new kinds of connectors.

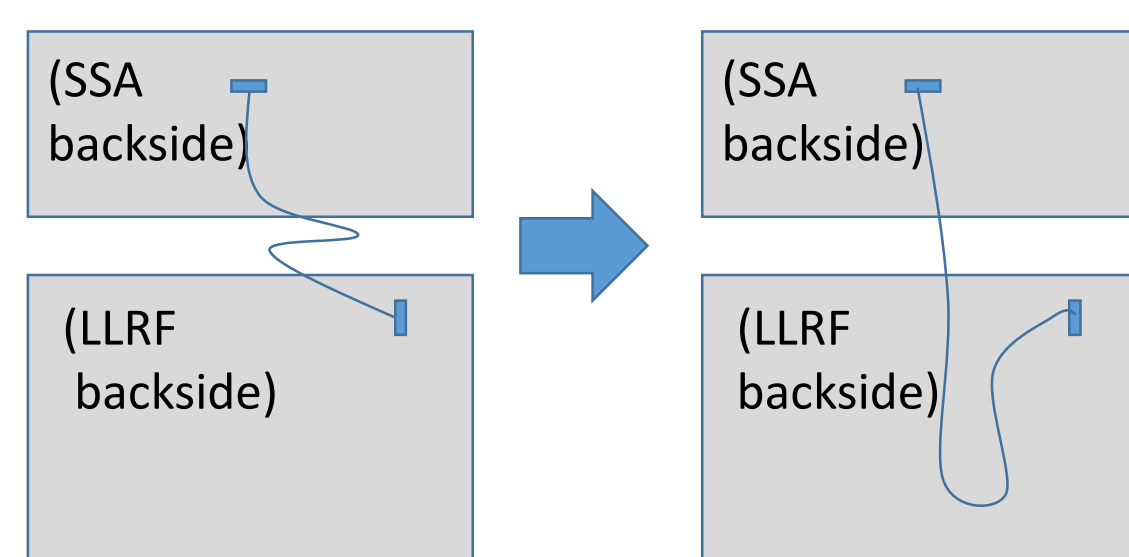
Over Repetition interlock : several times
It suddenly appeared after the February maintenance period.

- It is inferred from these hints that the strong noise from HV modulator affected RS-232 communication.
- For the L4-2 case, the abnormal interlock was disappeared as shown figure below, but some other cases, the reverse showed positive effects.
- As long-lasting solutions, noise countermeasures will be in place or more noise-resistant communications will be applied in the next version.

Solved by rearrangement of the RS-232 cable path between the LLRF and the SSA, and no problems until now

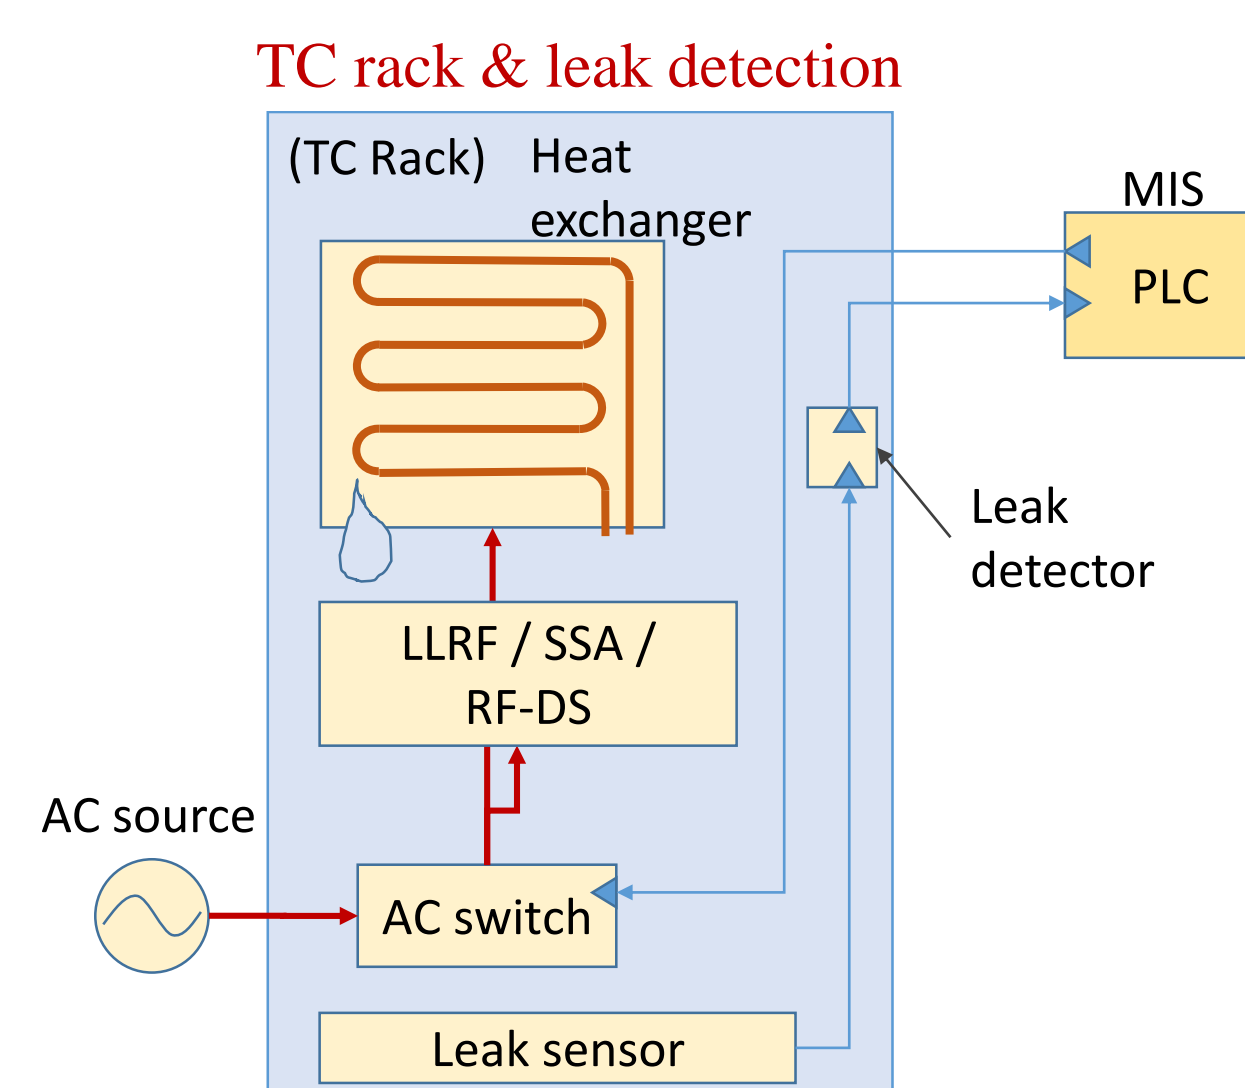
The occurrence frequency of water leakage is increasing this year → a serious problem

Treatment :
Replacing the leak exchanger to a spare (takes 1~2 hours/replace & only 2 spare parts available)

- 1) Preparing more spare exchangers
- 2) Redesigning heat exchangers
- 3) Developing a rack easier to replace heat exchanger
