# Yoke load test and box opening

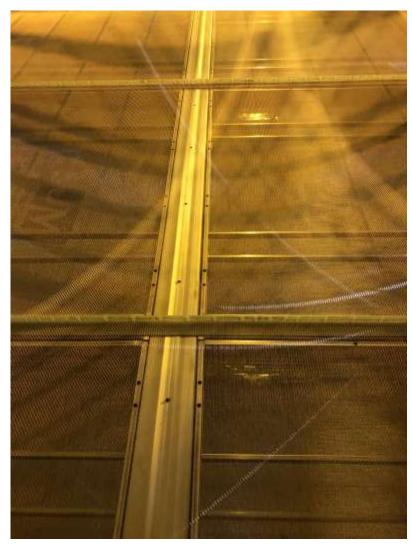
#### Visual inspection

- All protective panels off one side
- Slow inspection behind each panel from the top down
- Everything looks good by eye

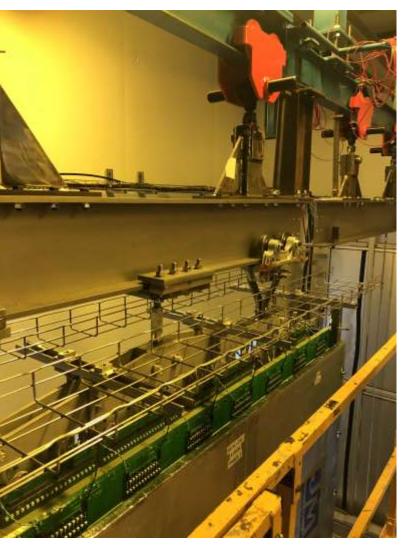
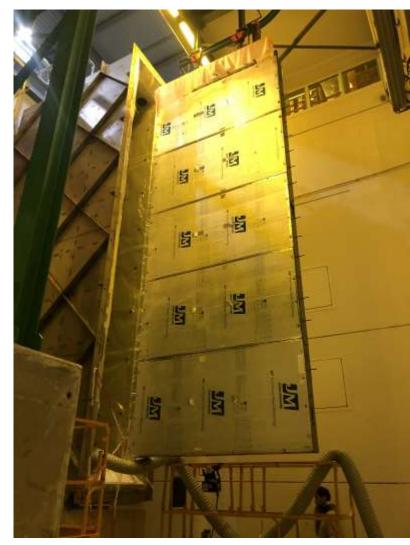
## Cable tray installed and parked

- Cable tray installed
- Center yoke support installed
- Protective plastic sheathing draped over for trip
- Parked in front of cold box
- Beam connected to cold box
- Test fit/rolled APA into cold box
  - Trolley wheels on kapton
  - Tested for NO continuity between APA frame and beams
- Ready for CE team
