Monitor Issues

Jake Calcutt
Nov. 27, 2019

From last week: Found a few issues regarding the beamline profile monitors

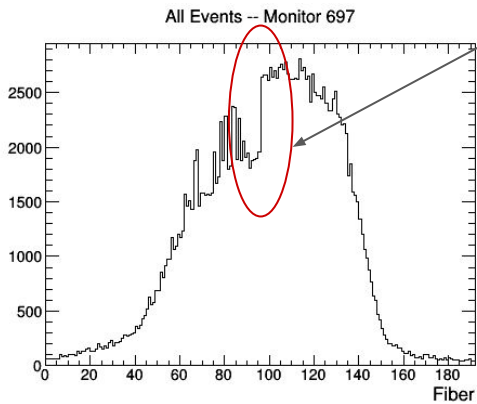
2 Separate Issues?

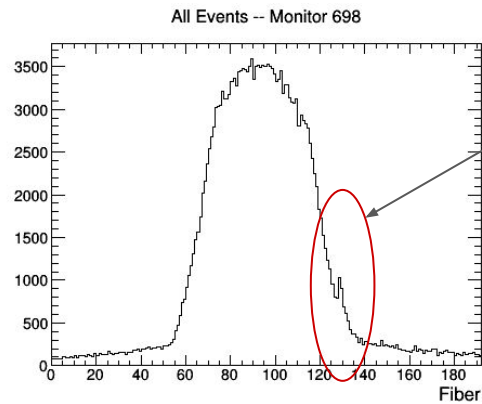
Maybe
physical?

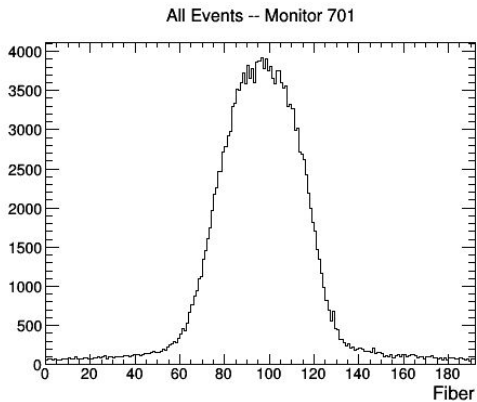
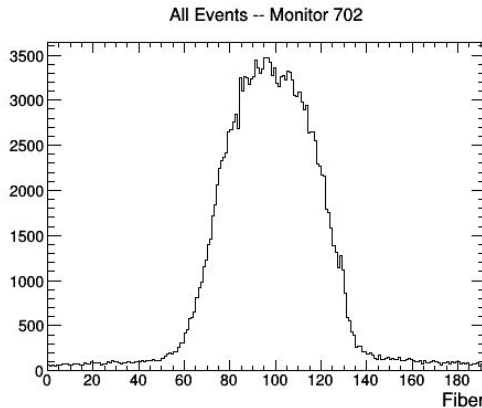
Software
glitch

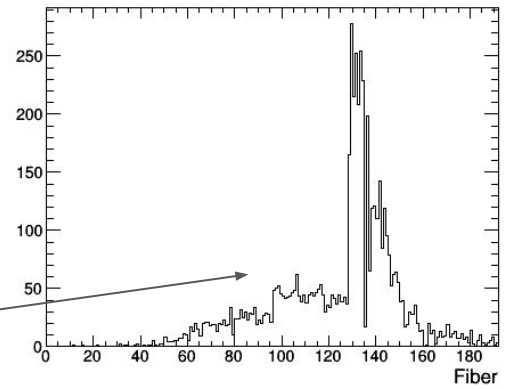
Repeated Events -- Monitor 697

Last 2 words
are likely to be
immediately
repeated

Related to
other issue
(later)

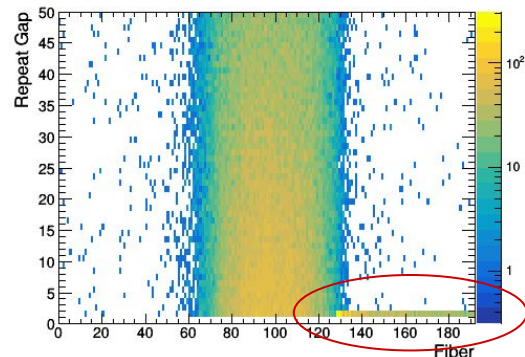
Monitor 702

Total rate
"folded in"

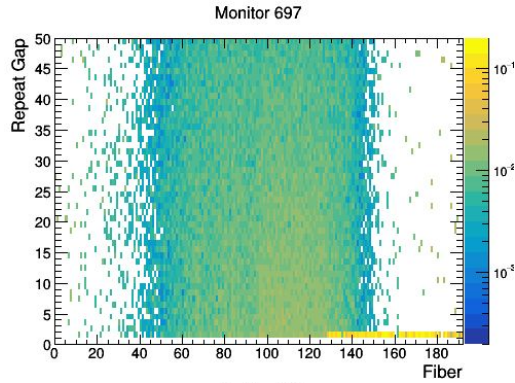
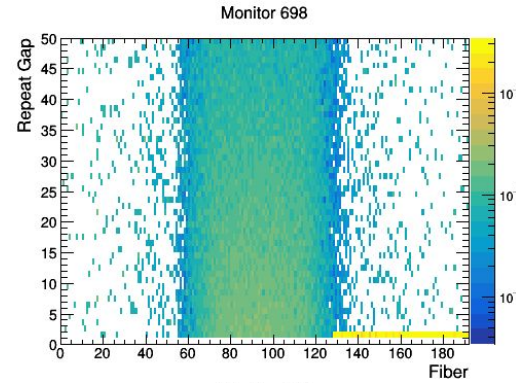
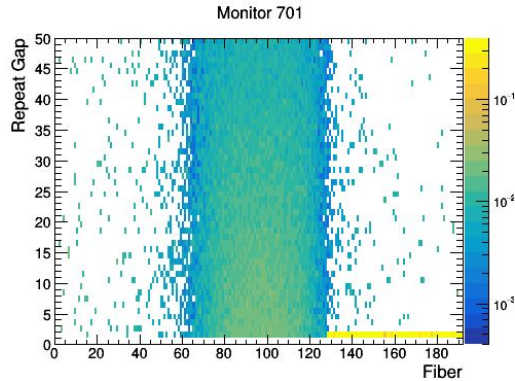
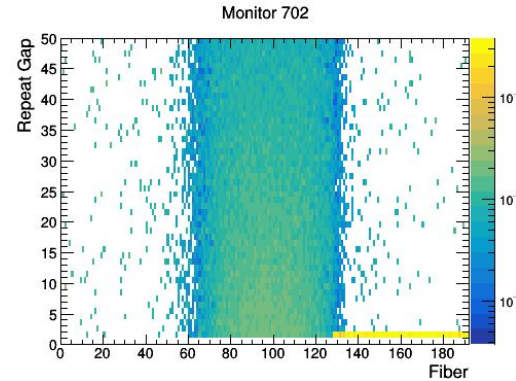
Gap Between Repeated Fibers -- Normalized

Divided by total rate in each monitor to highlight repeating bug

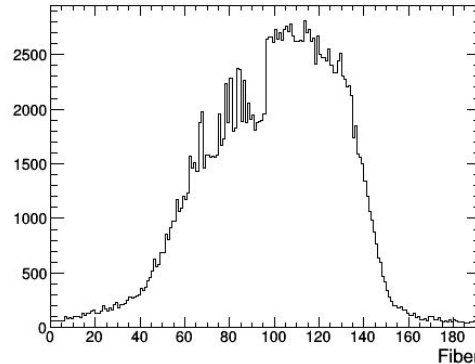
All Events -- Monitor 697

The software/repeating fiber issue is common to all monitors, but the jump in 697 @ 96 is not.

→ Appears to not be a software issue

Is this a change in efficiency?

Repeats in bins 0-95 suppressed by lower efficiency

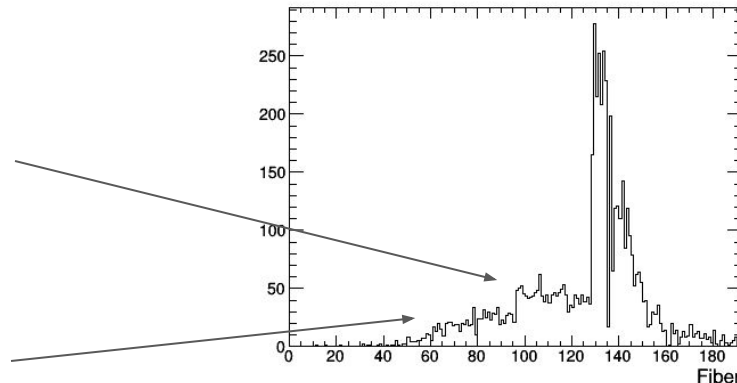
Repeated Events -- Monitor 697

Also explains higher chance to repeat in this range

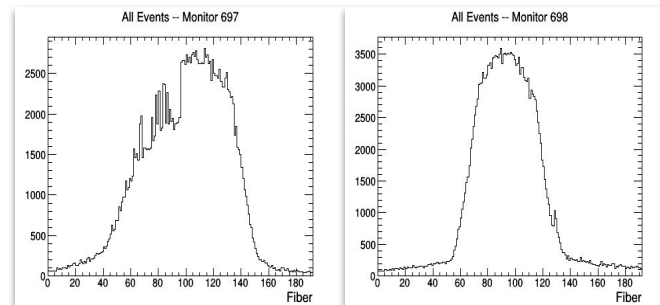
These prototypes of the XBPF have half of the fibres covered with a ~ 100 nm aluminium coating to avoid optical crosstalk: fibres 1 to 96 are coated, while fibres 97 to 192 have no treatment. The motivation for this layout is to investigate the impact of crosstalk in the monitor and the effectiveness of the aluminium coating. For this reason, the fibre-hit histograms in fig. 7.23 and fig. 7.24 are analysed for the totality of fibres (Total Multiplicity) and the two halves (Multiplicity A and Multiplicity C). However, this analysis by halves is still under development and no data has been yet extracted from it.

1. The fibers are not coated differently
2. But... There were configuration issues in the Front End boards controlling the photomultipliers in the profilers that could manifest as this issue
