Calibration and bad channels with new protoDUNE data

ProtoDUNE SP operations

David Adams

December 6, 2019

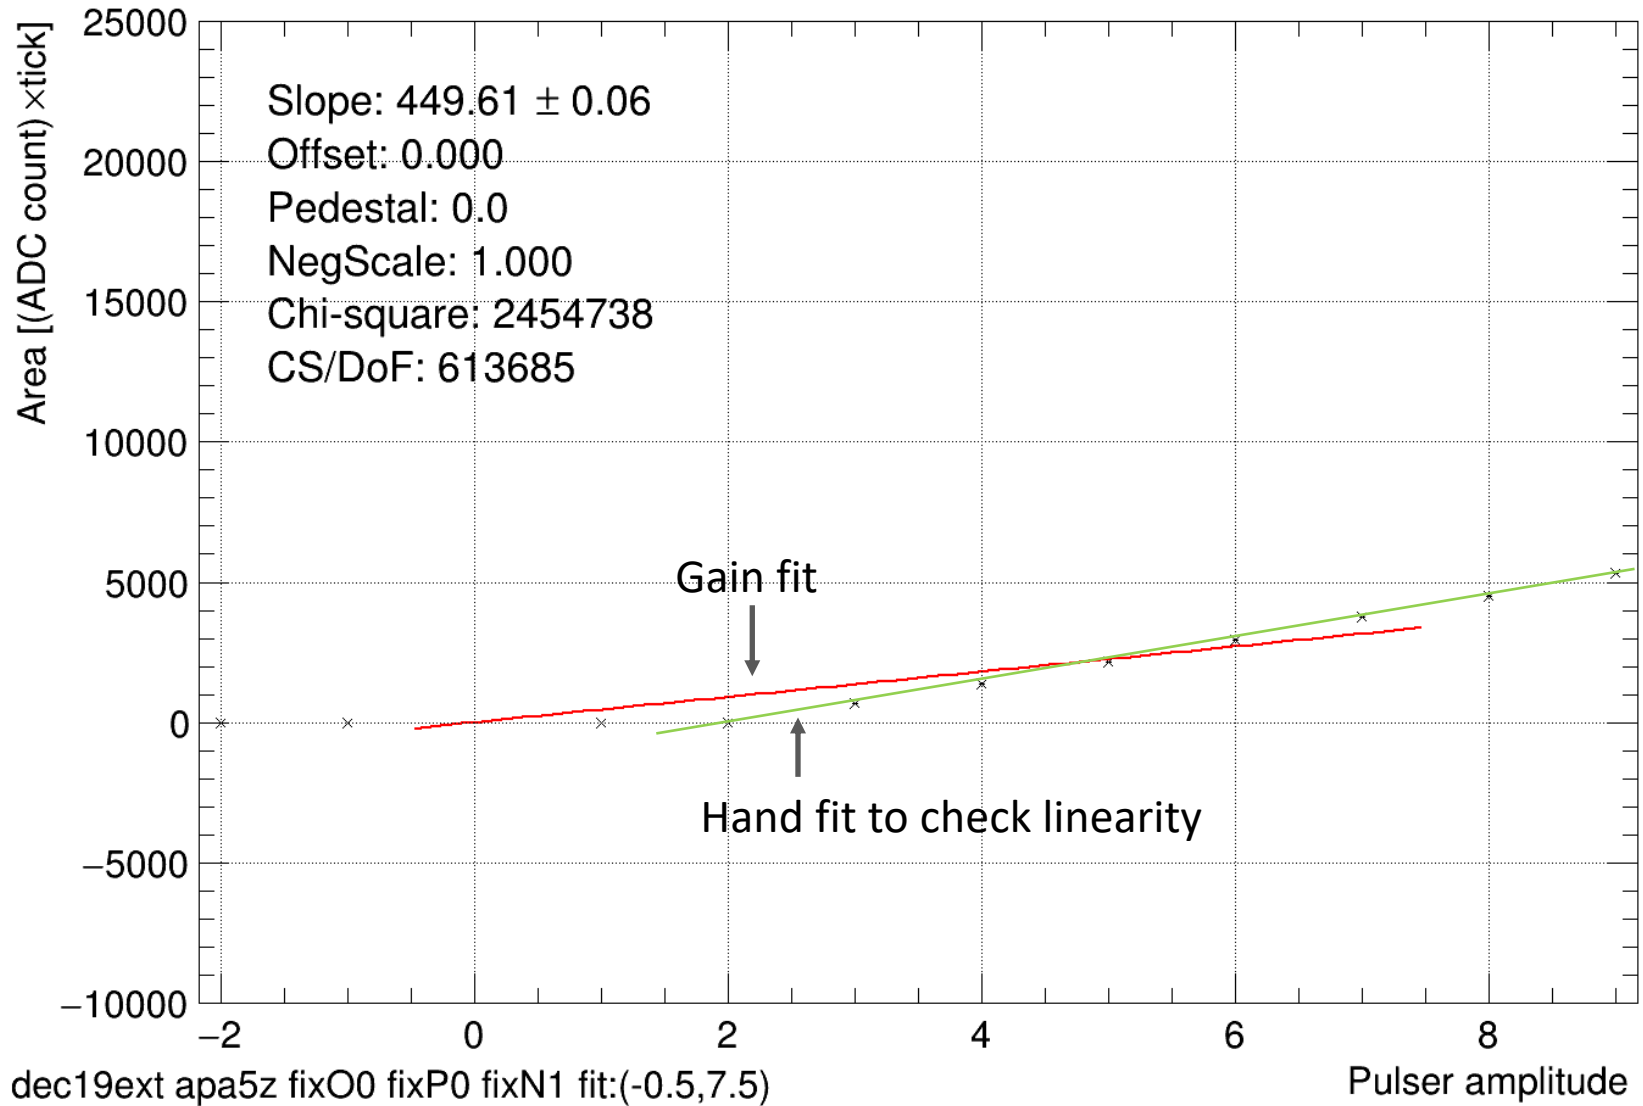
ROI area channel 4232

5z  4232 low RMS                          Big pulser offset in new data.             Recalibrate varying offset?  
5z  4234 low RMS                          Big pulser offset in new data.             Recalibrate varying offset?  
5z  4236 missing                          Big pulser offset in new data.             Recalibrate varying offset?  
5z  4238 missing                          Big pulser offset in new data.             Recalibrate varying offset?  
5z  4240 missing                          Big pulser offset in new data.             Recalibrate varying offset?  
5z  4242 missing                          Big pulser offset in new data.             Recalibrate varying offset?  
5z  4472 missing                          Big pulser offset in new data.             Recalibrate varying offset?  
5z  4473 split peak varies with DAC       Nonlinear response.                        BAD?  
5z  4474 missing                          Big pulser offset in new data.             Recalibrate varying offset?

Shift

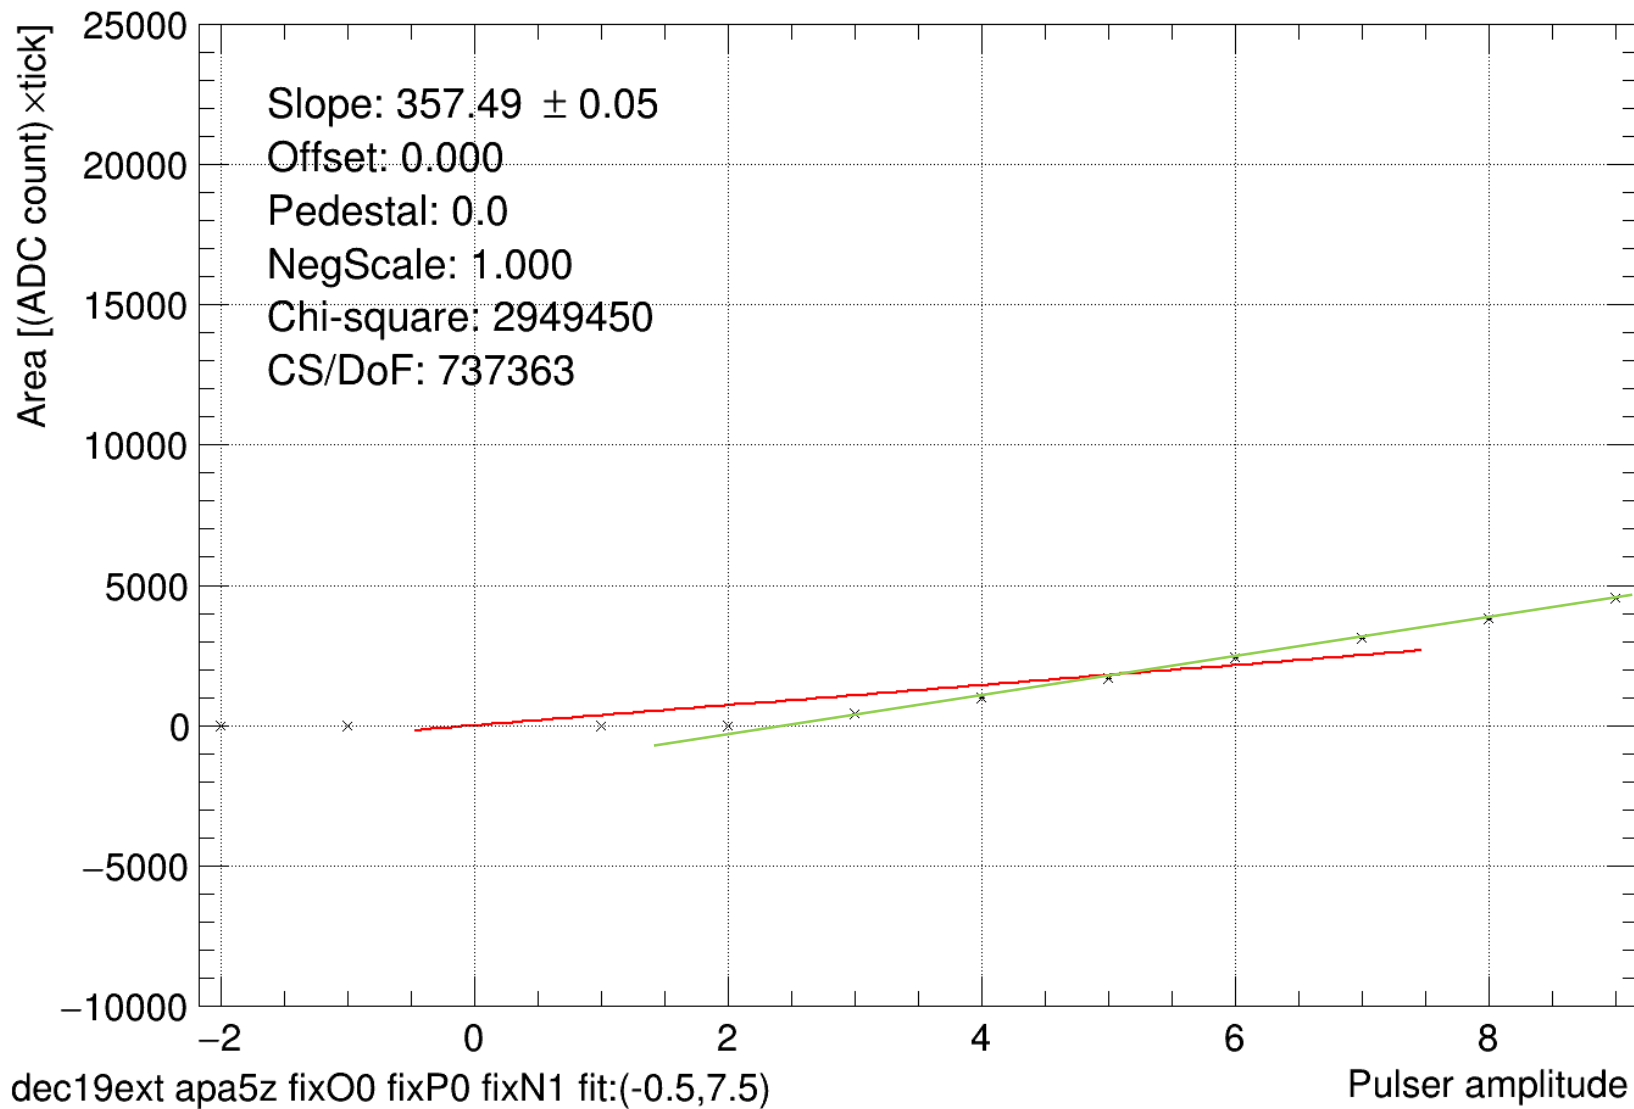
ROI area channel 4234

Shift

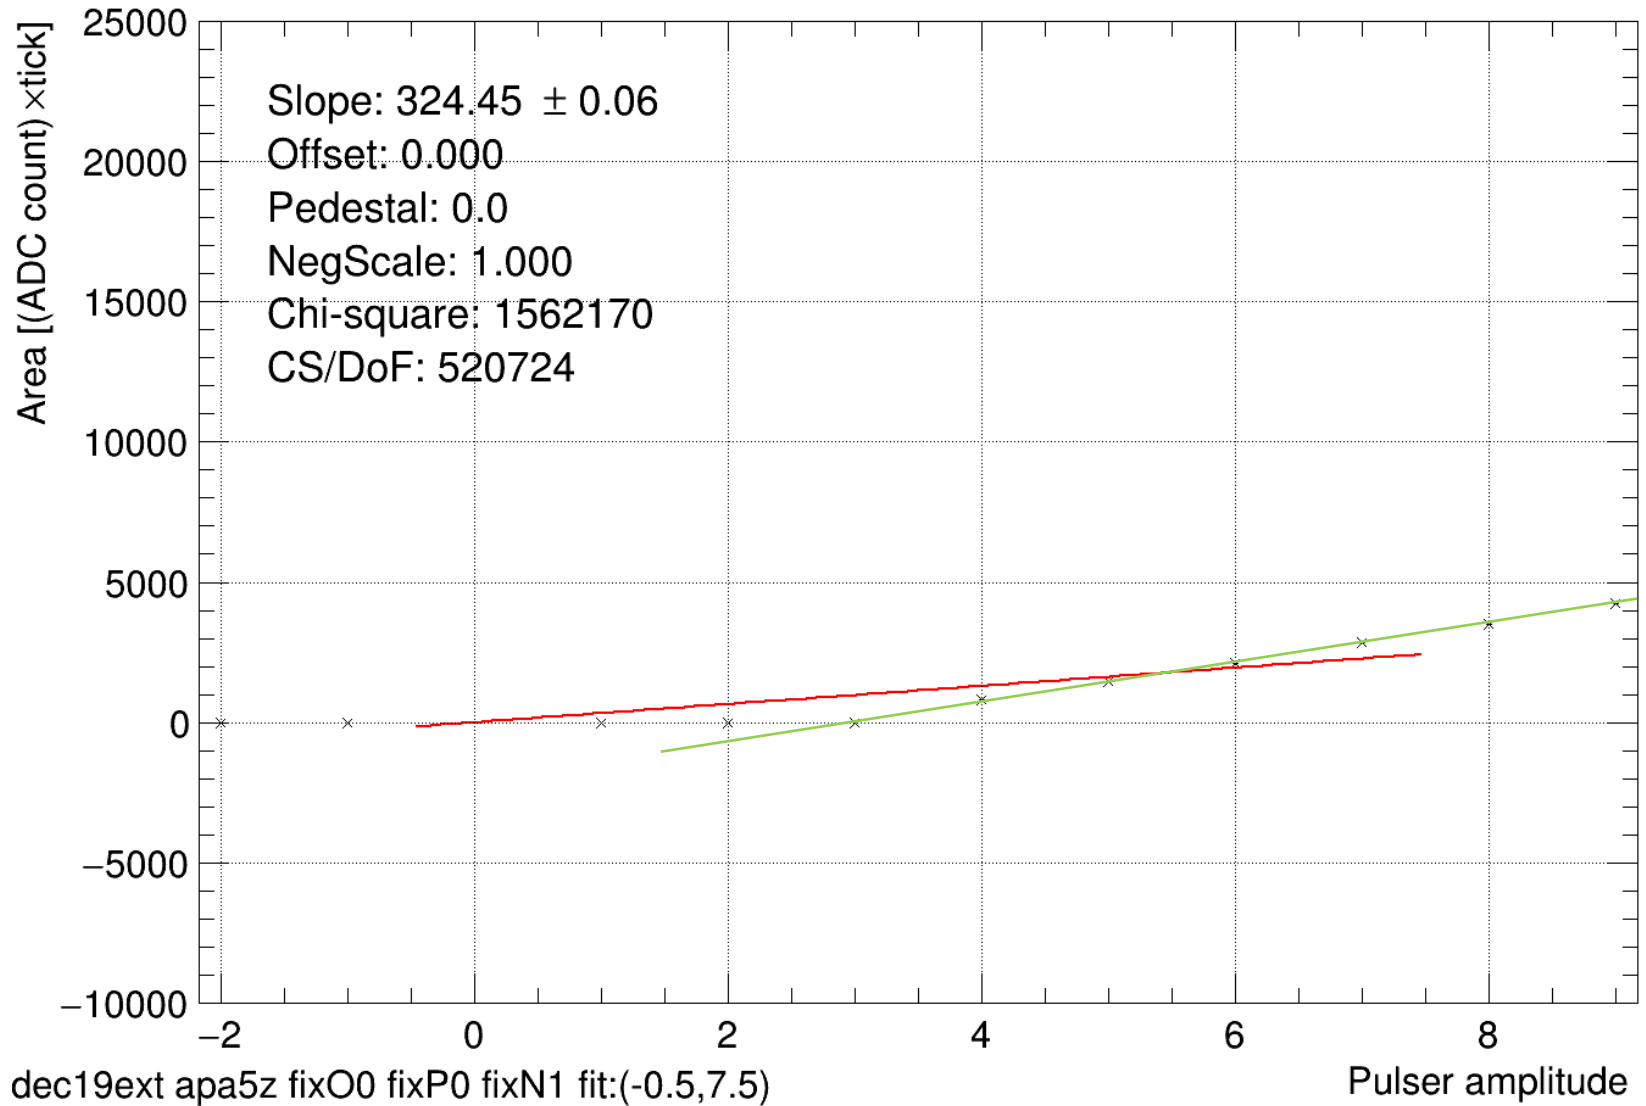
ROI area channel 4236

Shift

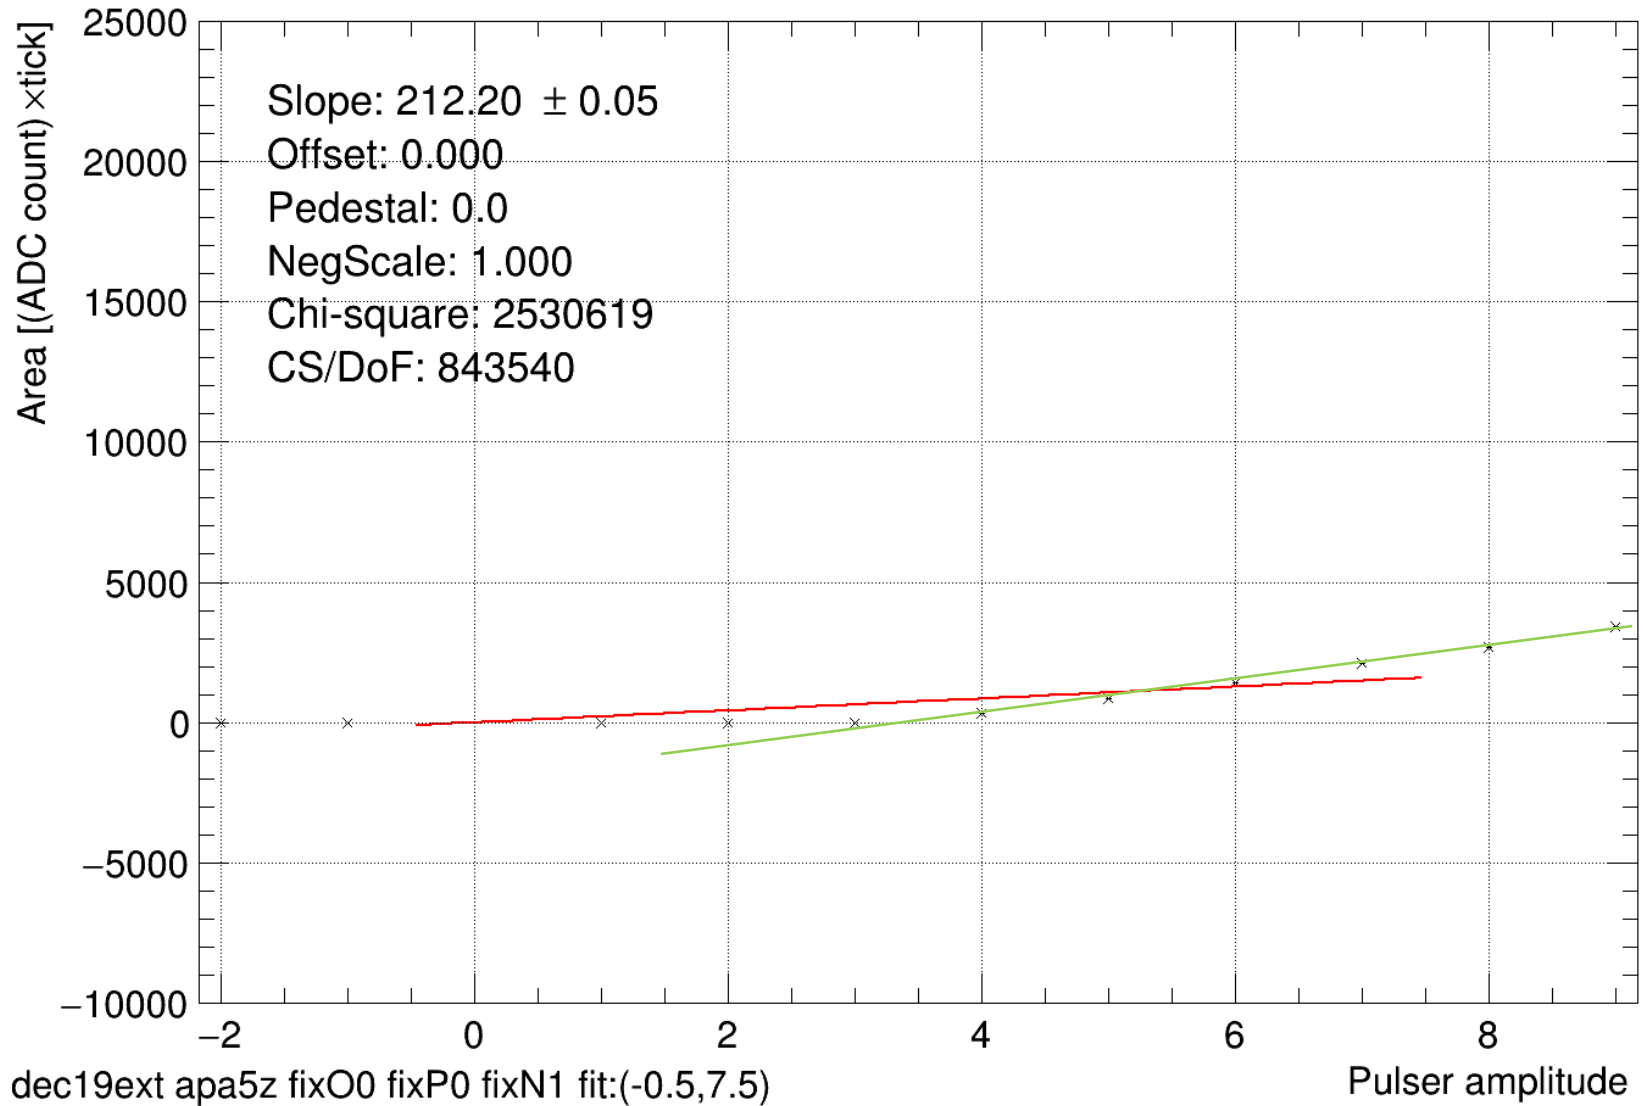
ROI area channel 4238

Shift

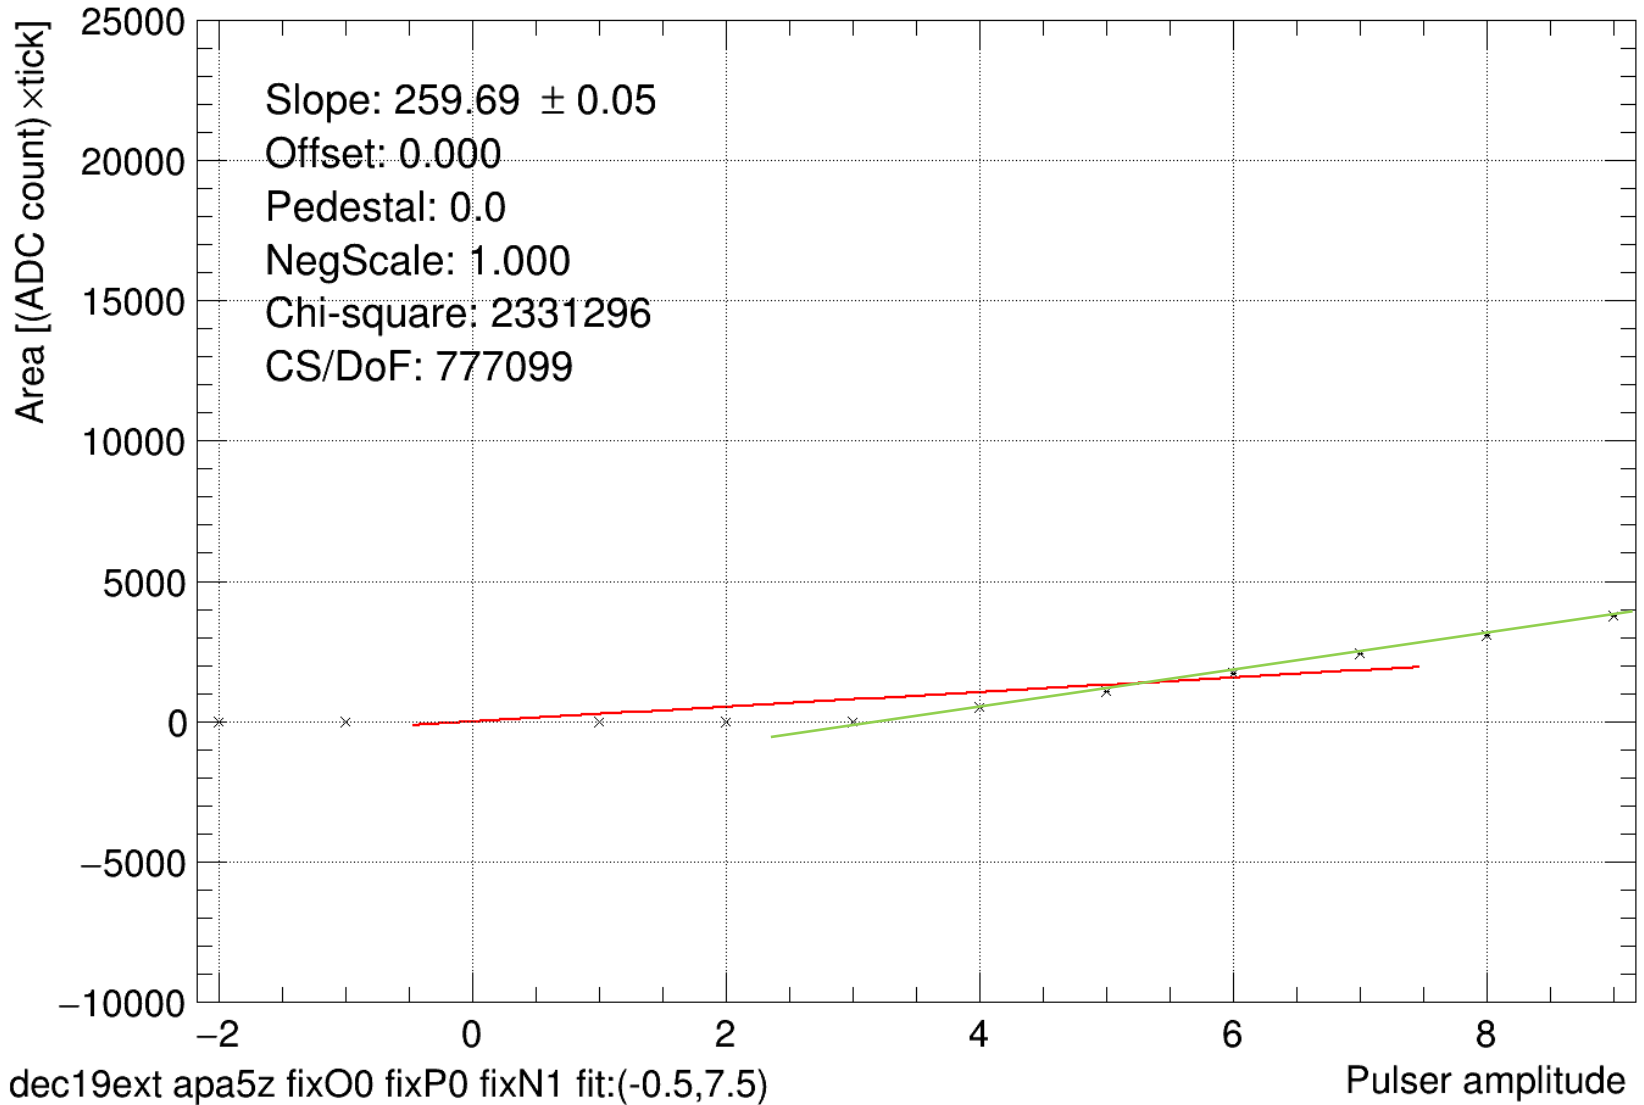
ROI area channel 4240

Shift

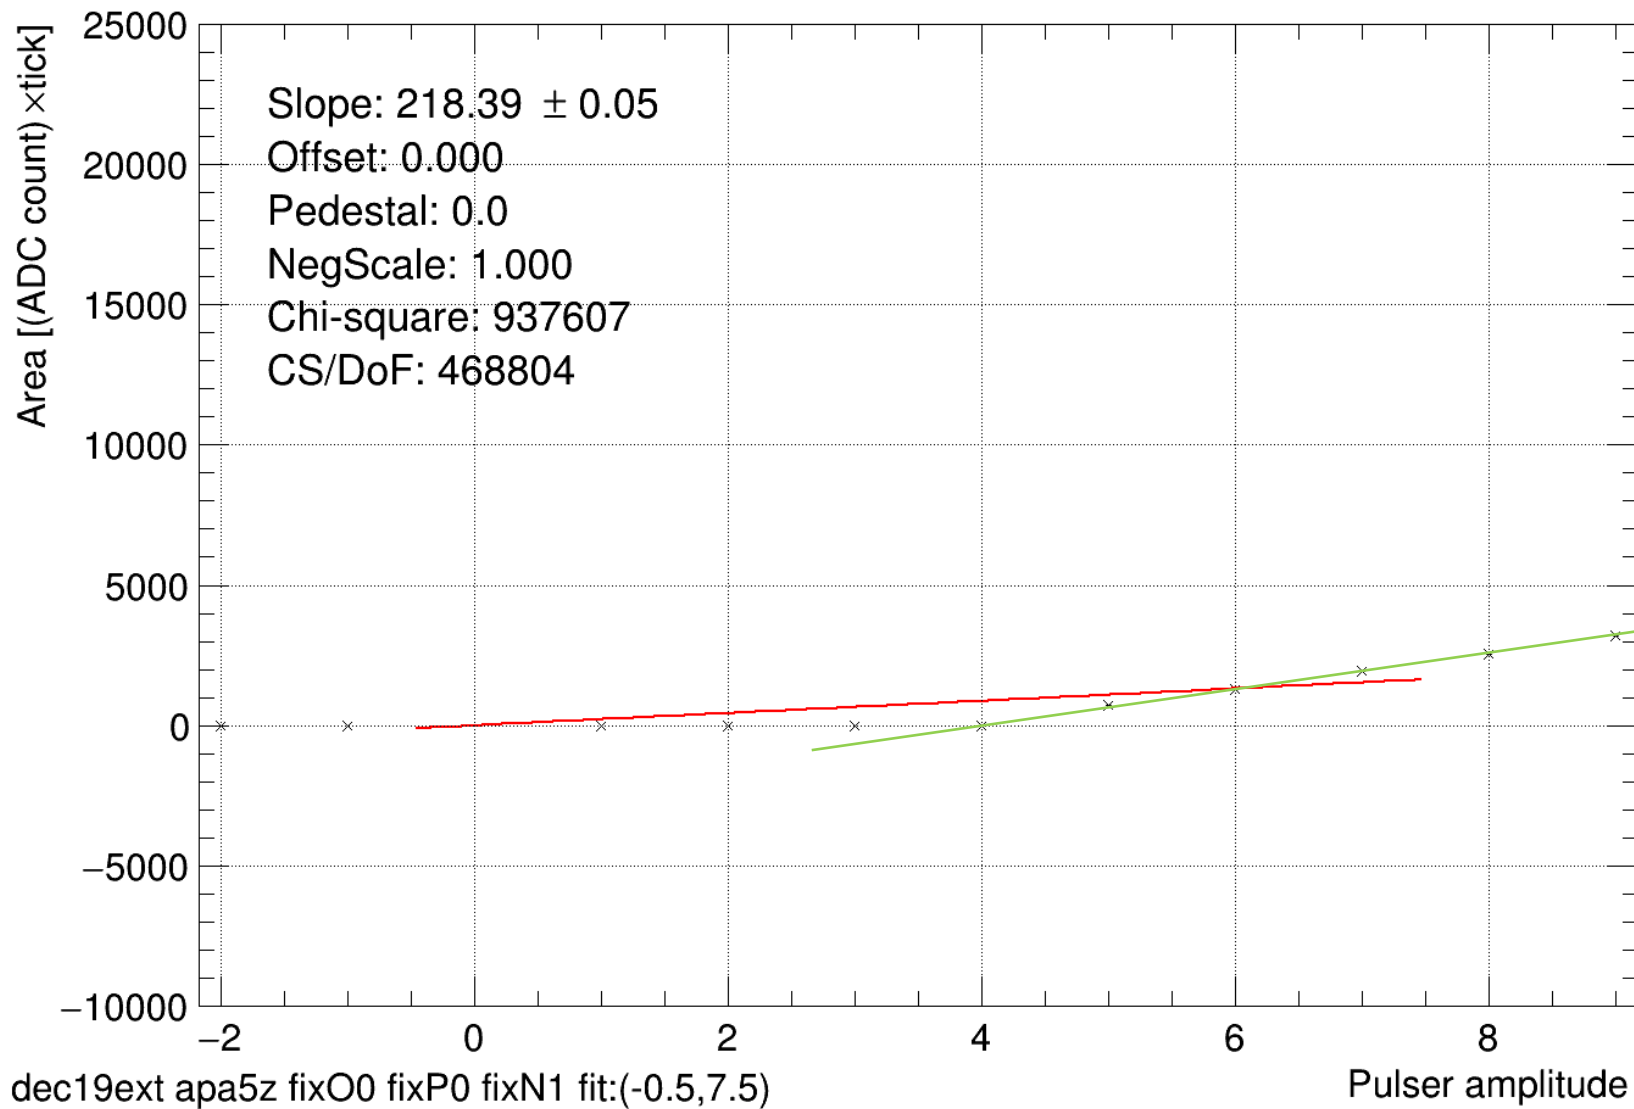
ROI area channel 4242

Shift

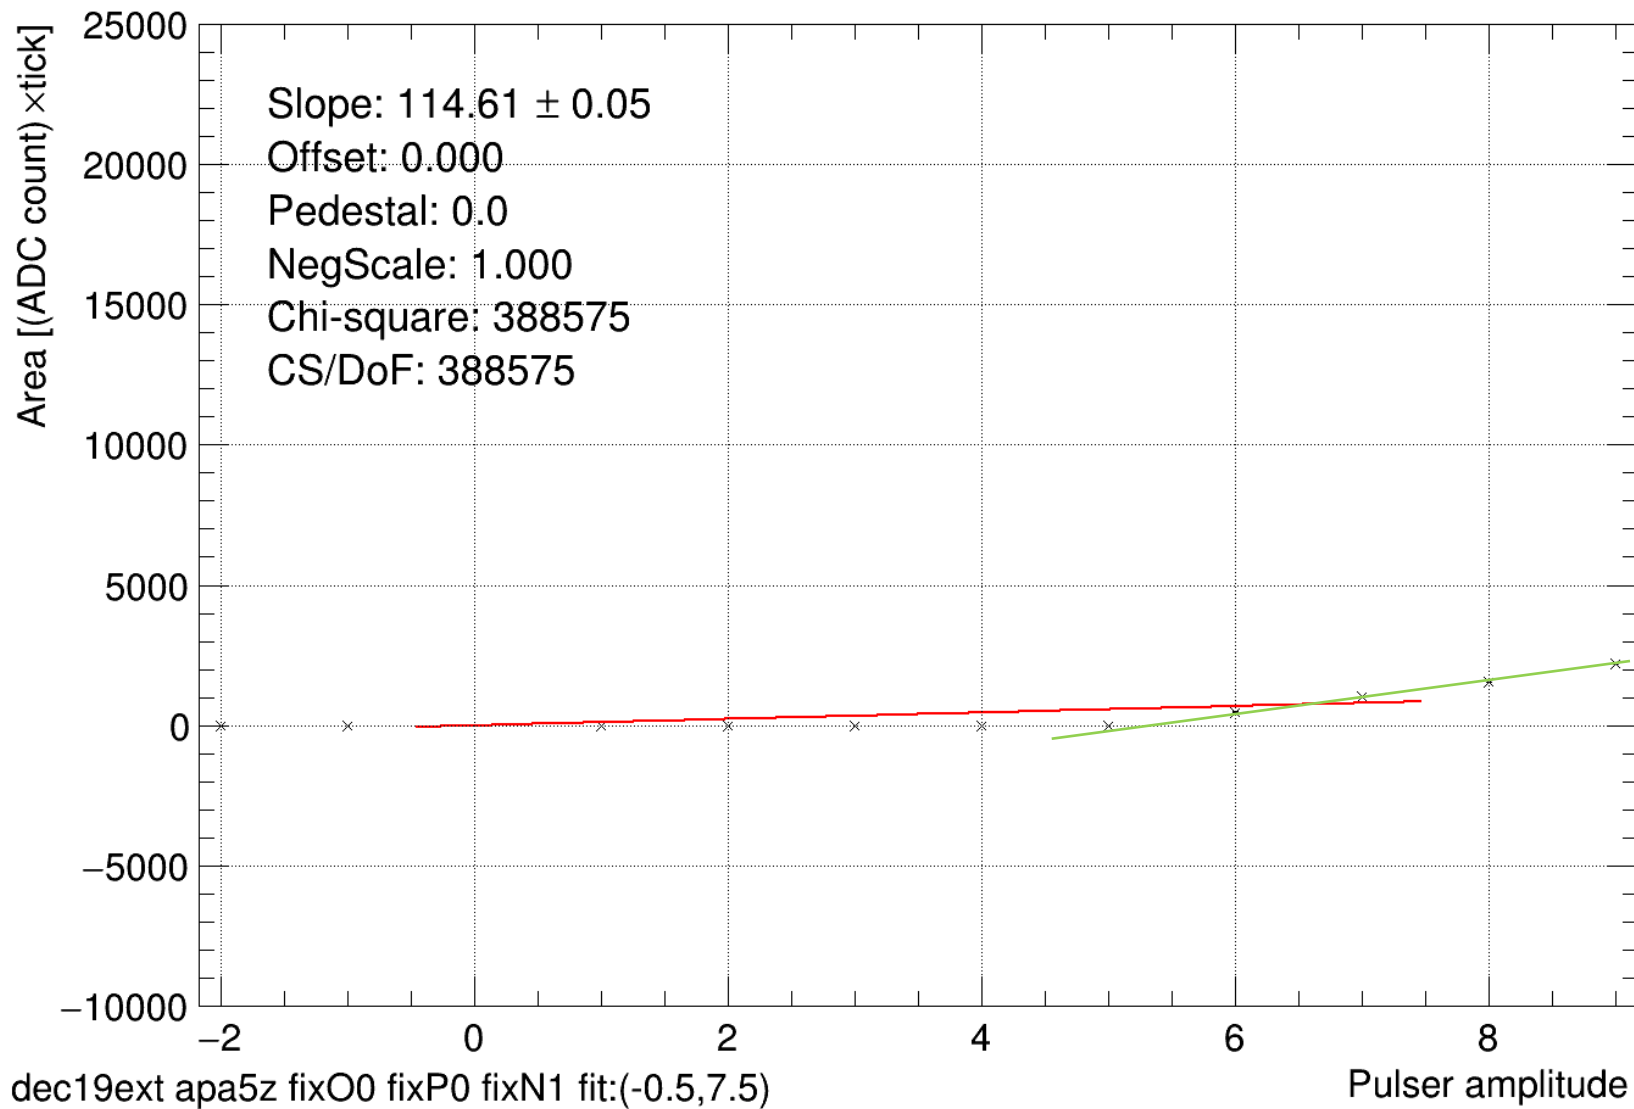
ROI area channel 4472

Shift

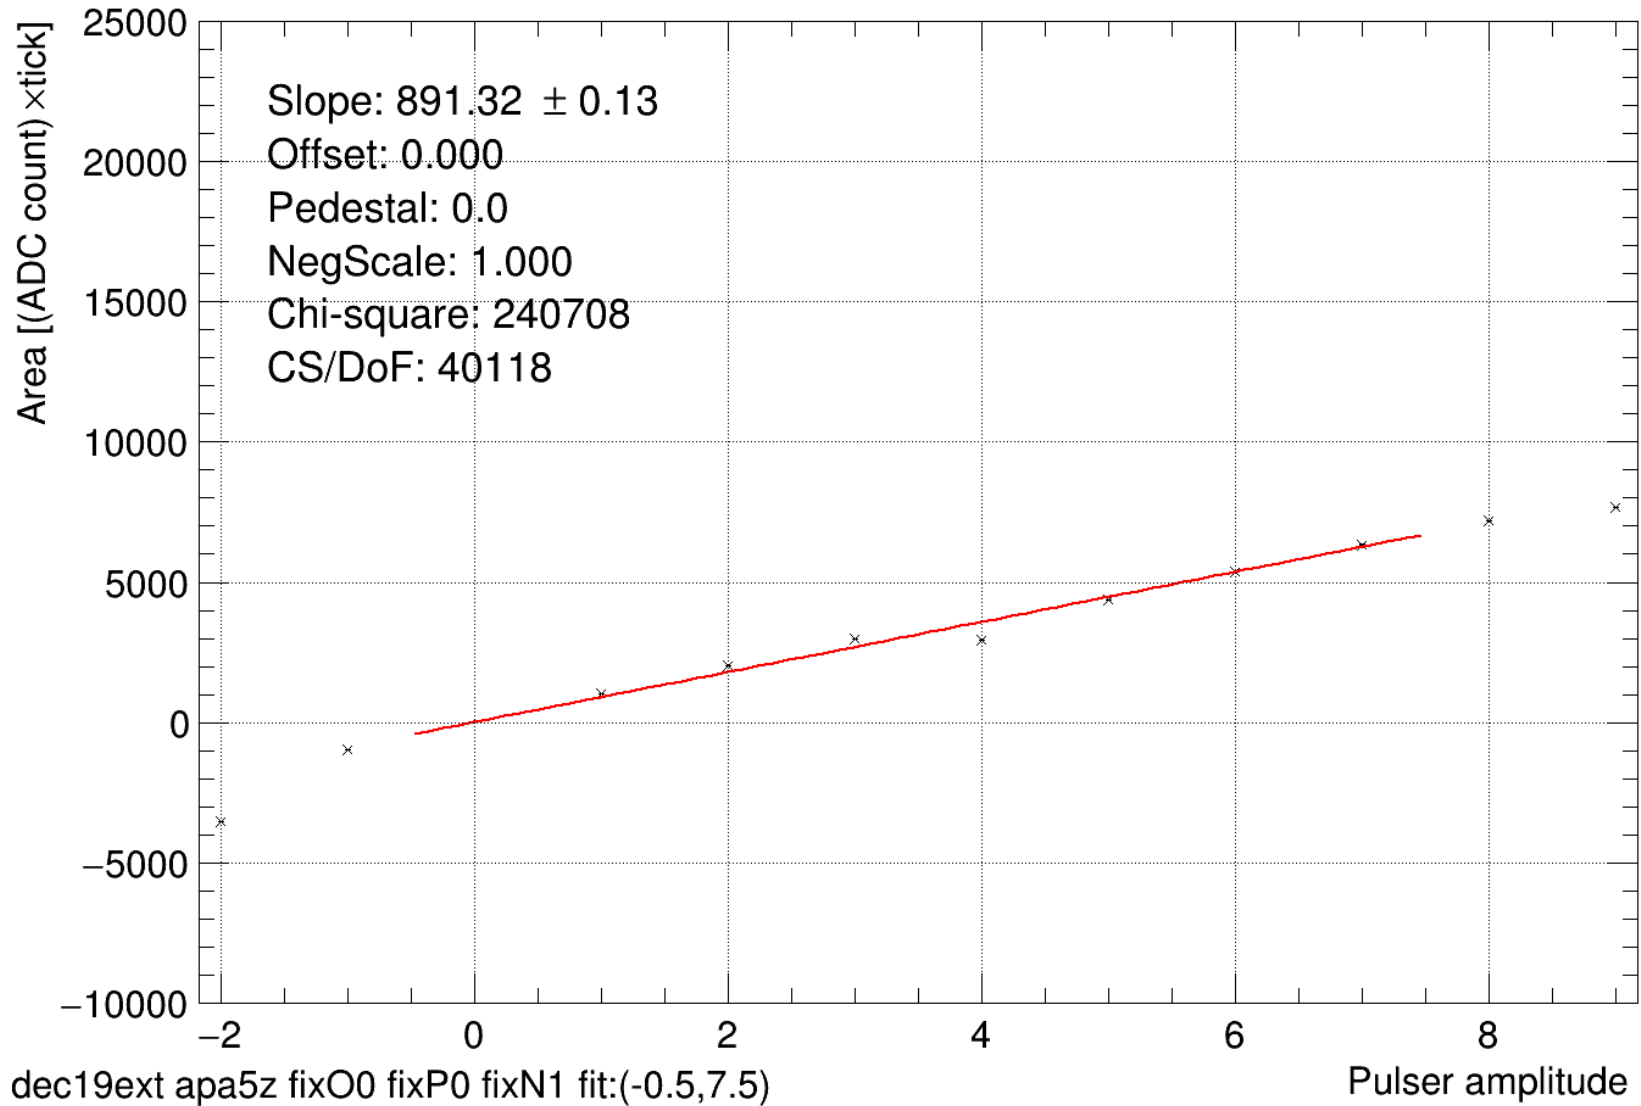
ROI area channel 4473

Jump

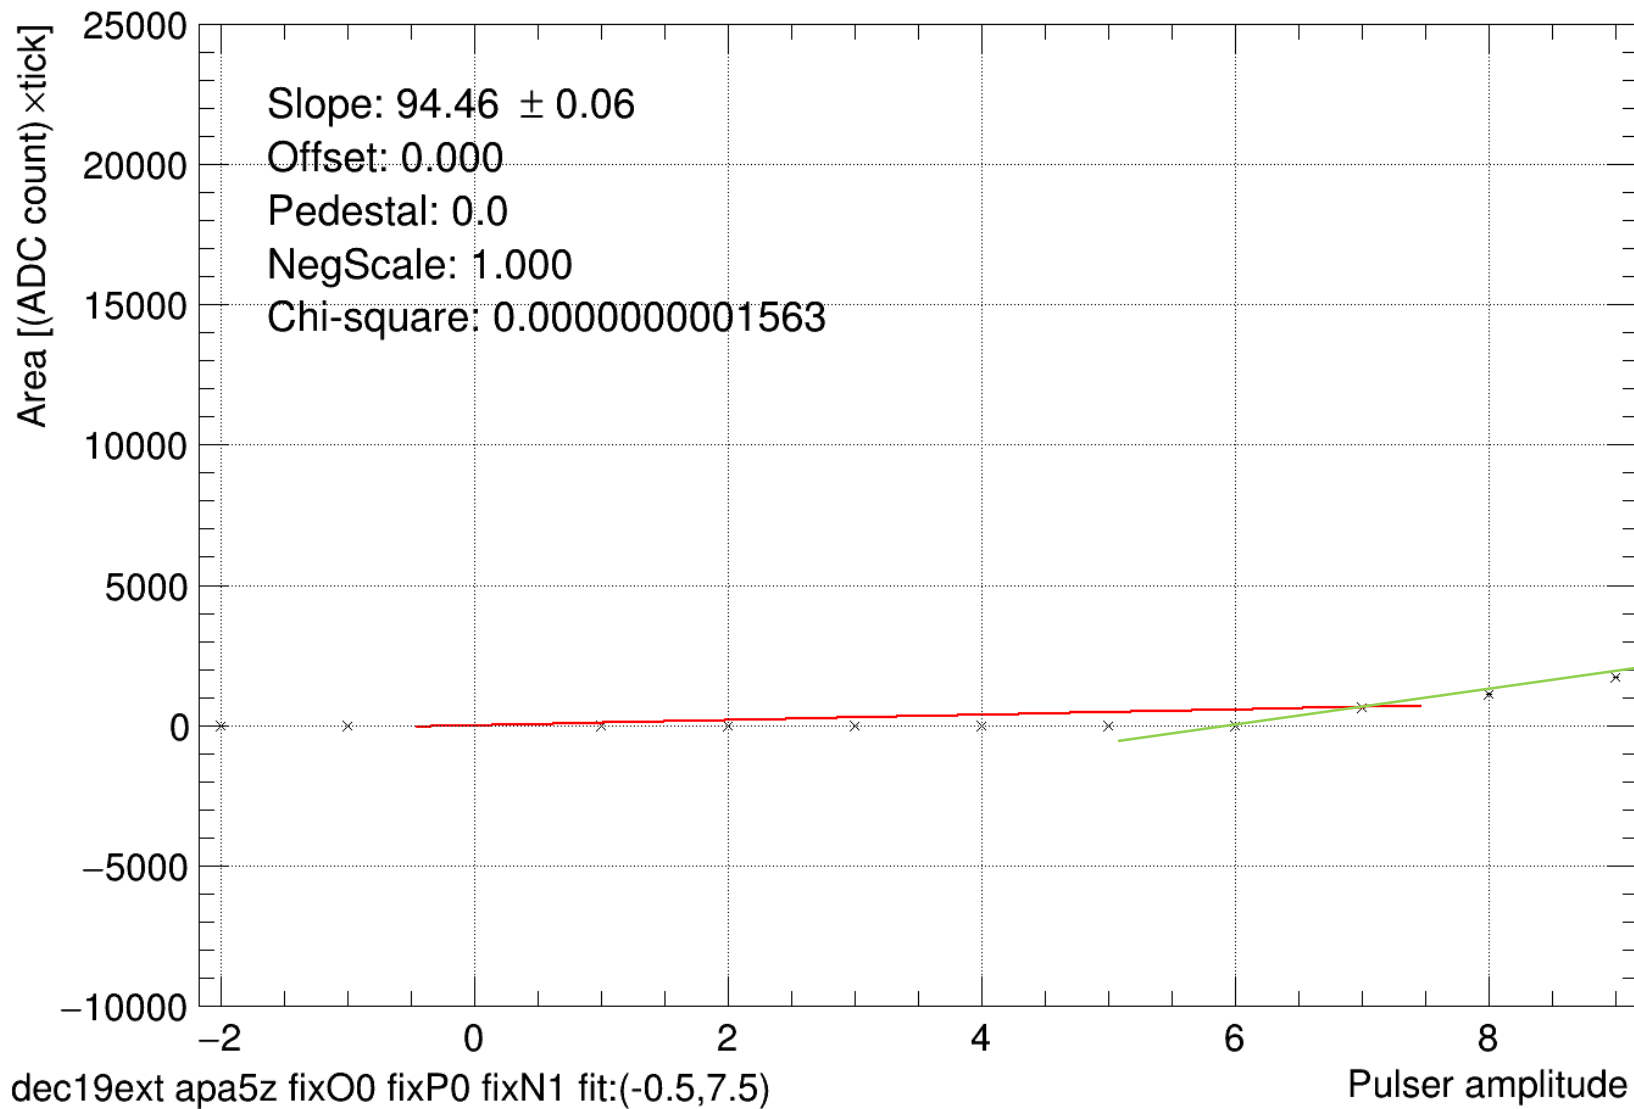
ROI area channel 4474

Shift

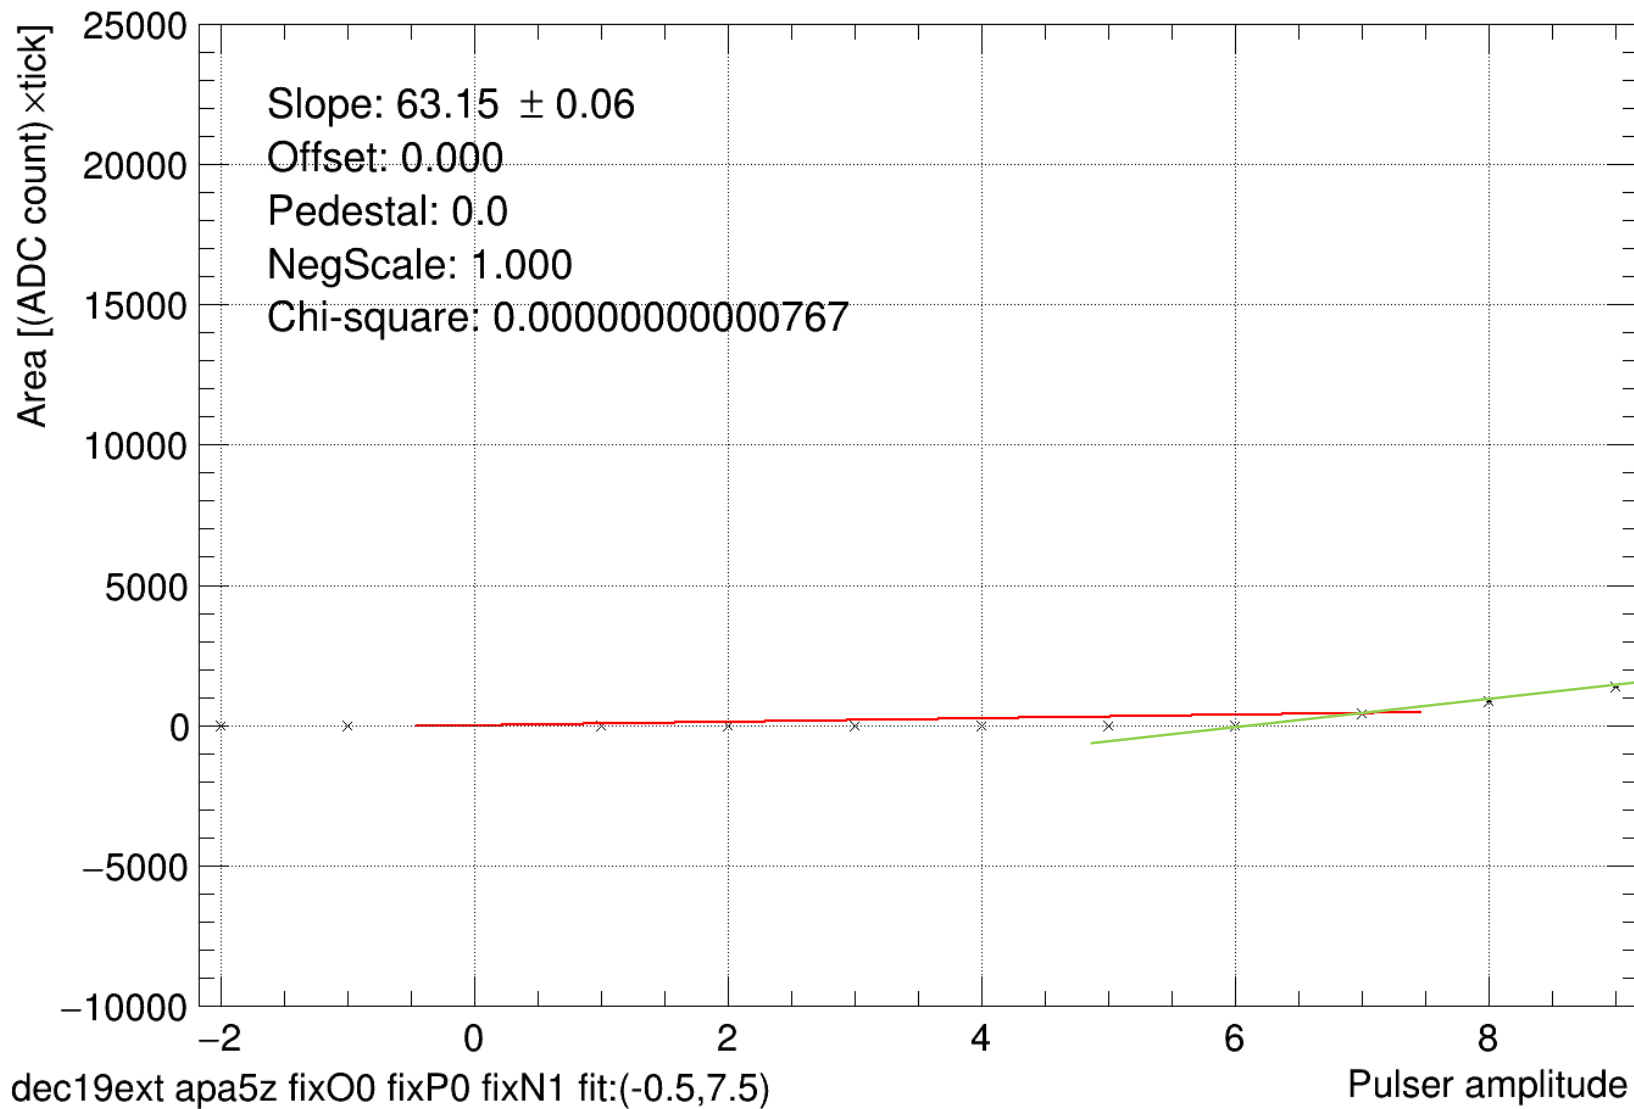
ROI area channel 4476

5z  4476 missing                          Big pulser offset in new data.             Recalibrate varying offset?  
5z  4478 missing                          Big pulser offset in new data.             Recalibrate varying offset?  
5z  4480 missing                          Big pulser offset in new data.             Recalibrate varying offset?  
5z  4482 missing                          Big pulser offset in new data.             Recalibrate varying offset?

Shift

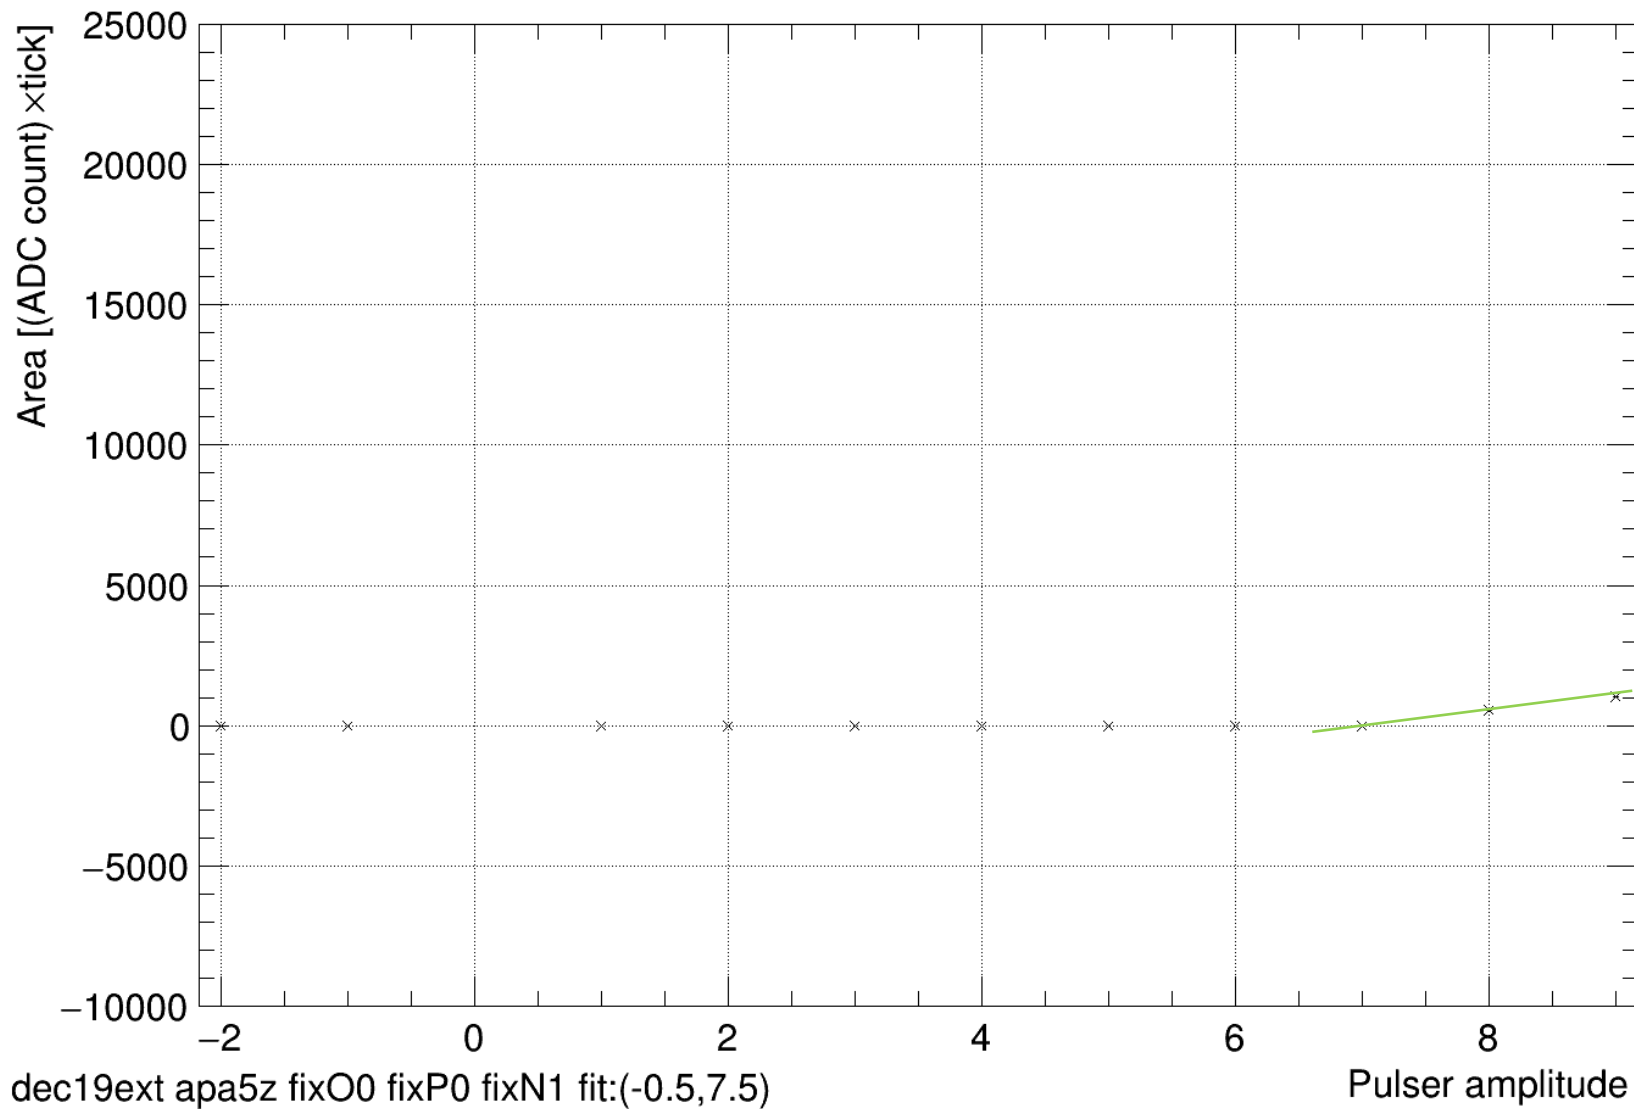
ROI area channel 4478

Shift

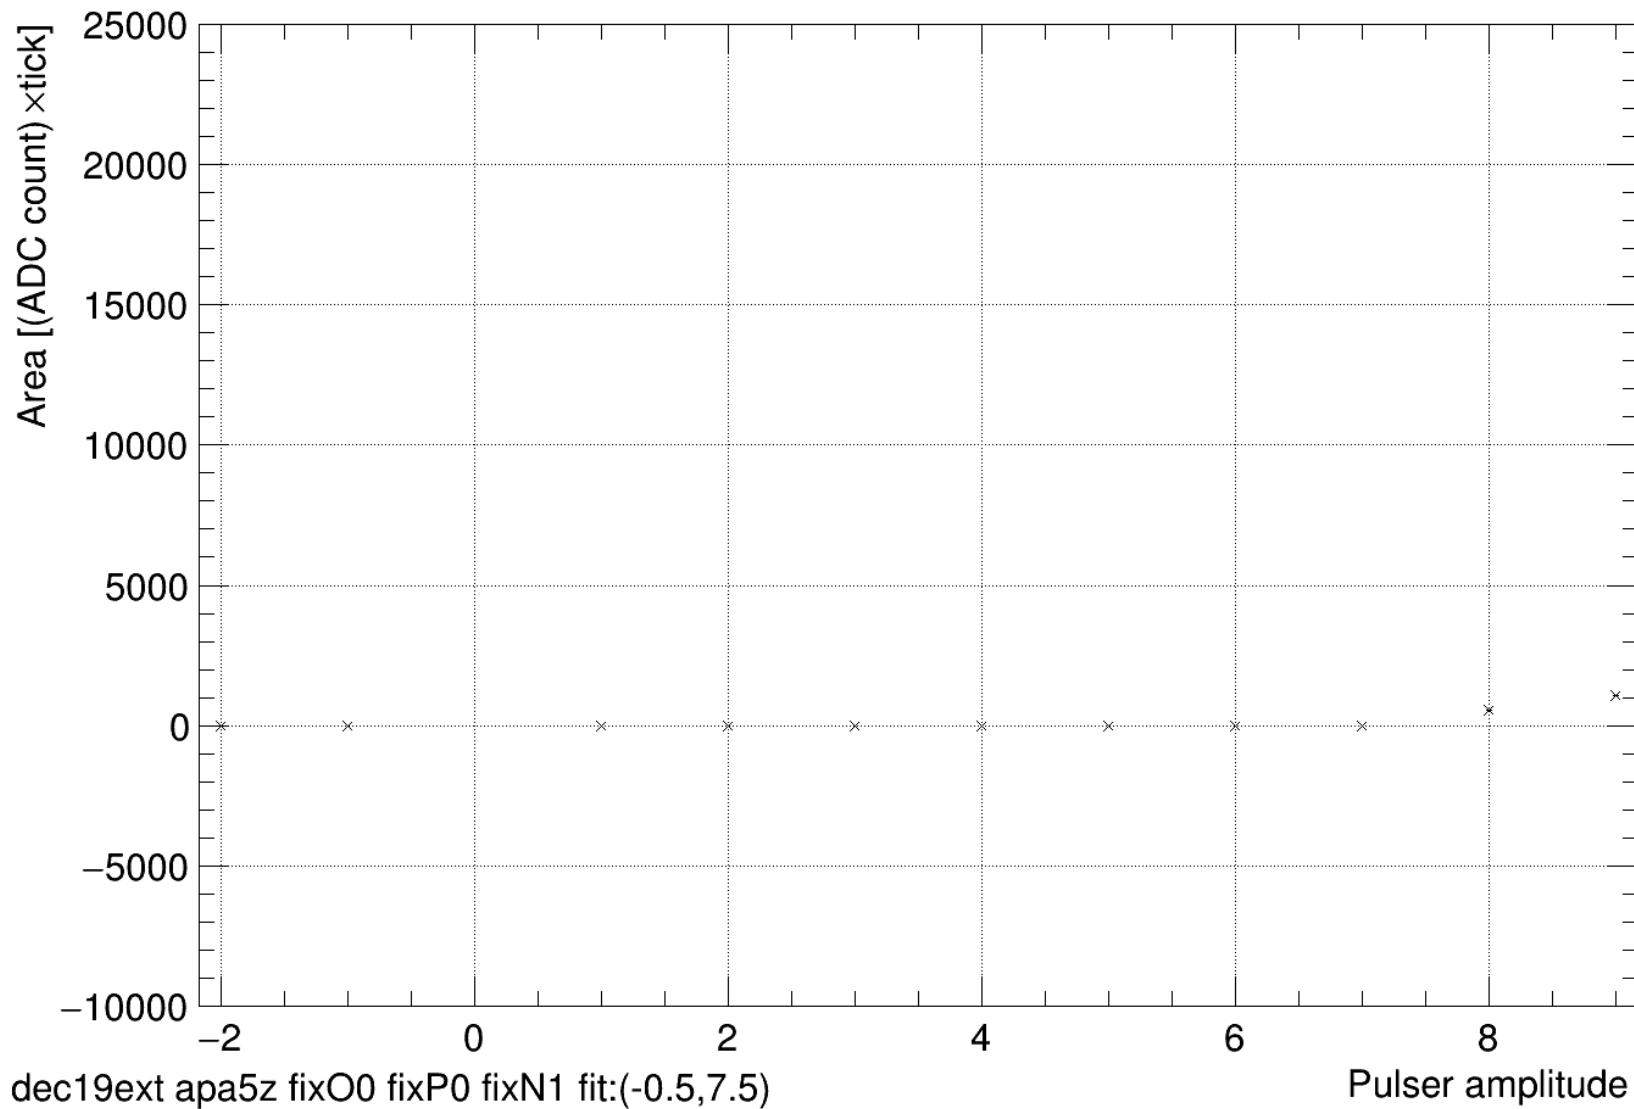
ROI area channel 4480

Shift
