Calibration and bad channels with new protoDUNE data

ProtoDUNE SP operations

David Adams

December 6, 2019

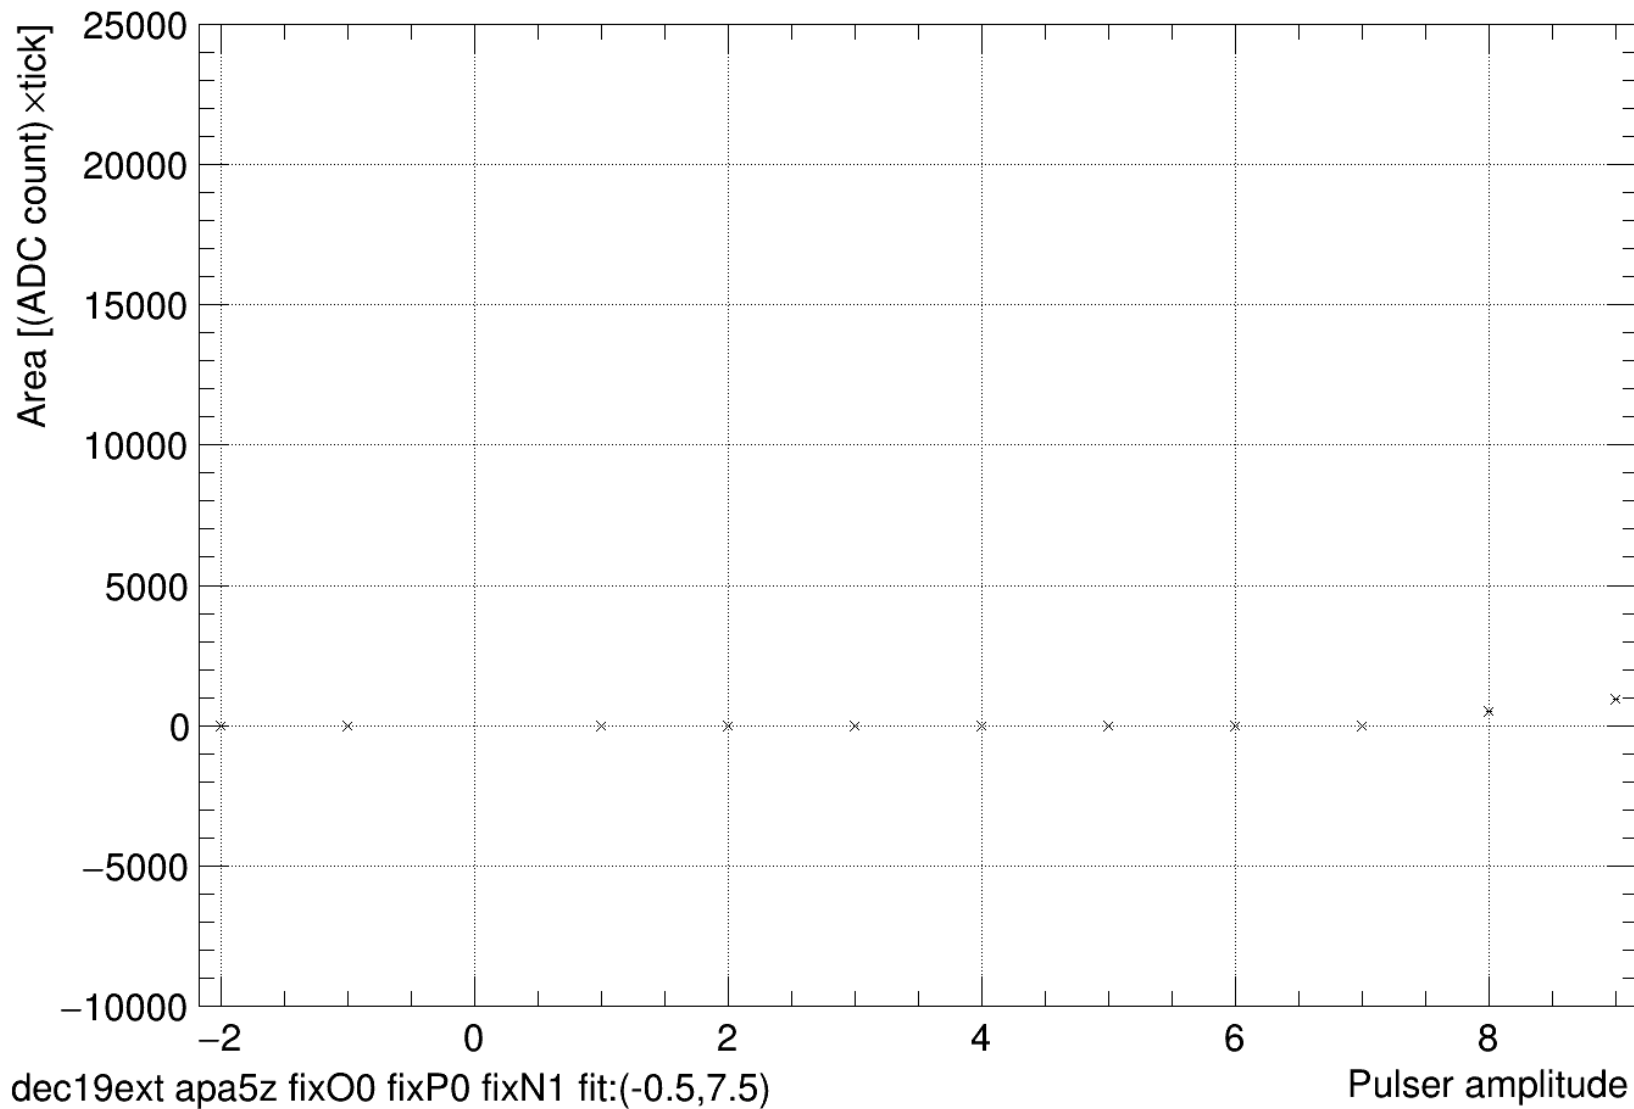
ROI area channel 4482

5z  4476 missing                          Big pulser offset in new data.             Recalibrate varying offset?  
5z  4478 missing                          Big pulser offset in new data.             Recalibrate varying offset?  
5z  4480 missing                          Big pulser offset in new data.             Recalibrate varying offset?  
5z  4482 missing                          Big pulser offset in new data.             Recalibrate varying offset?

Shift

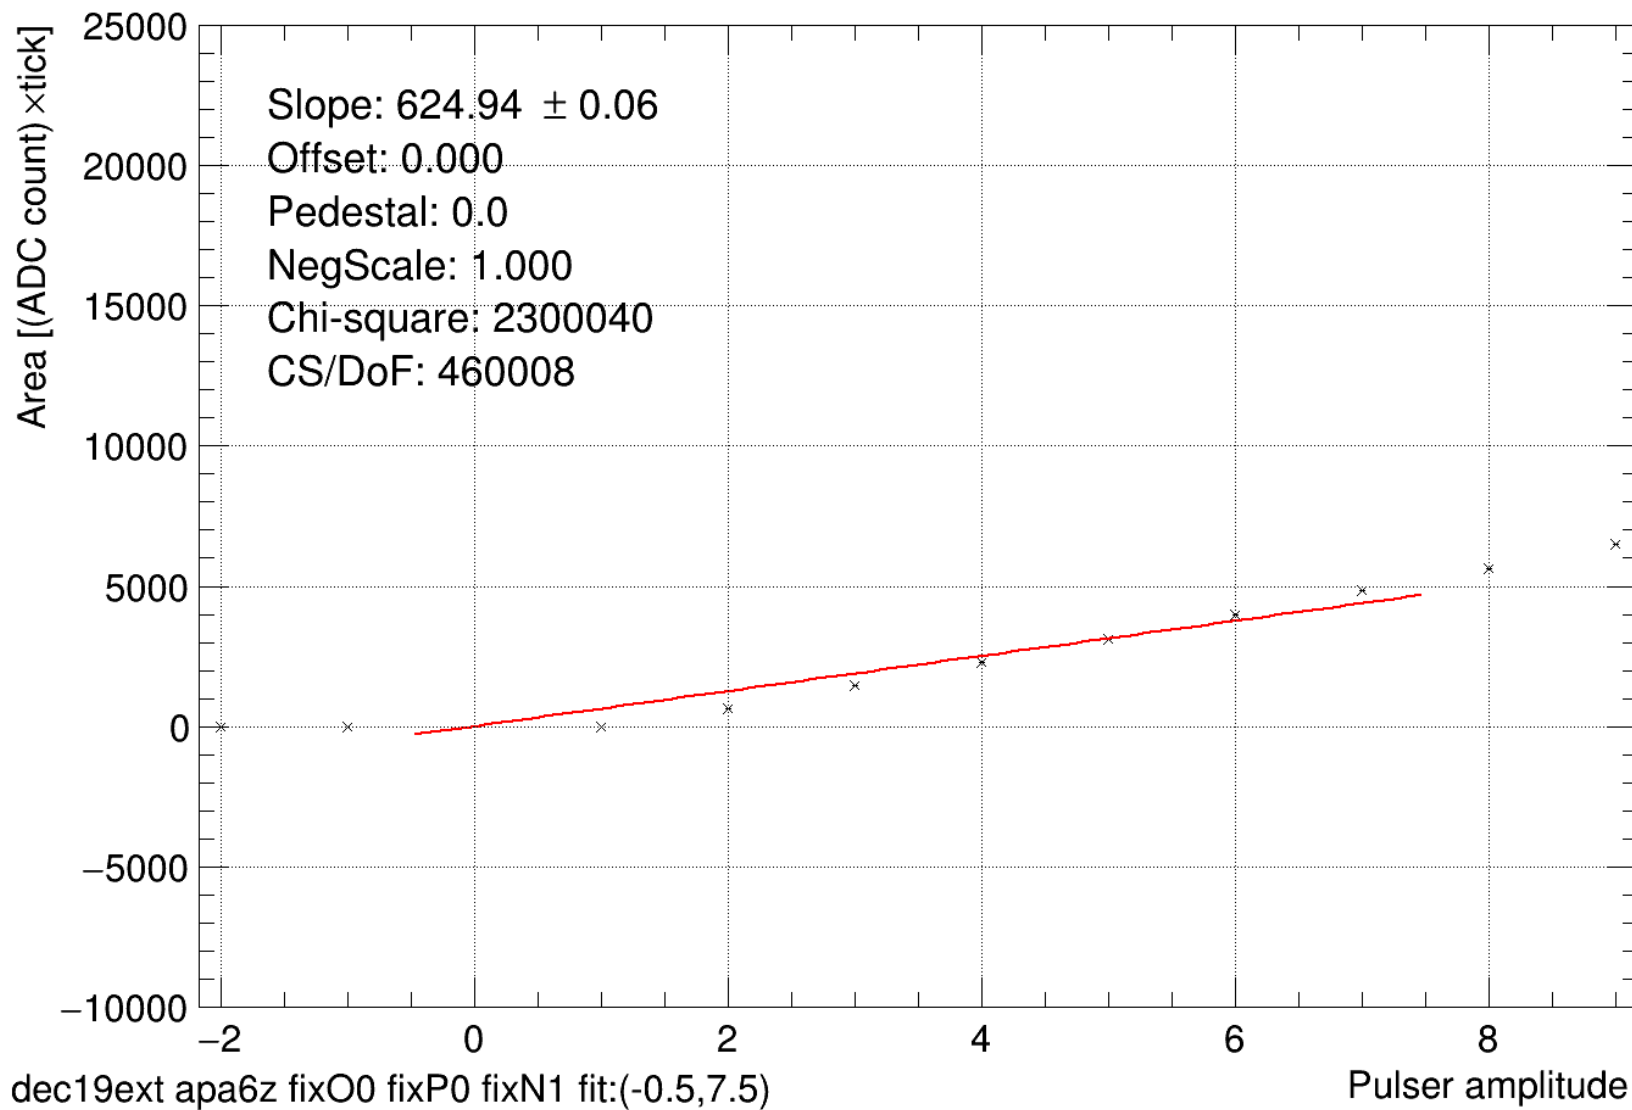
ROI area channel 9545

Shift

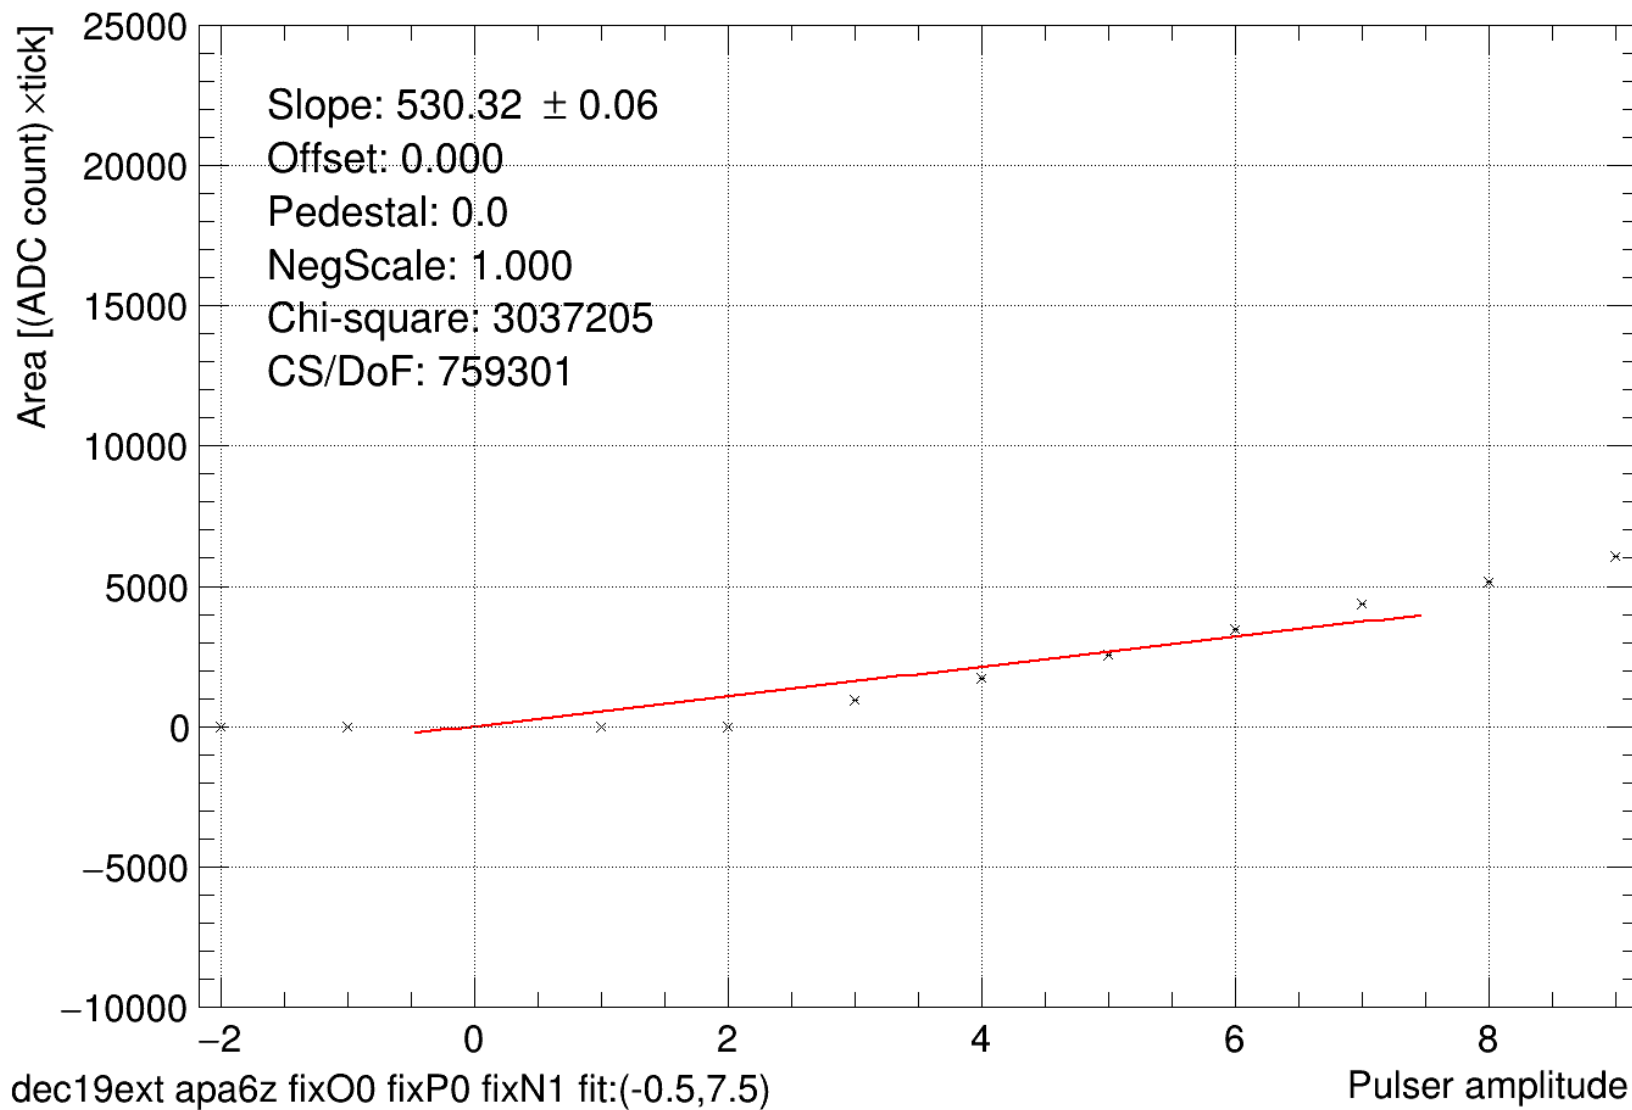
ROI area channel 9547

Shift

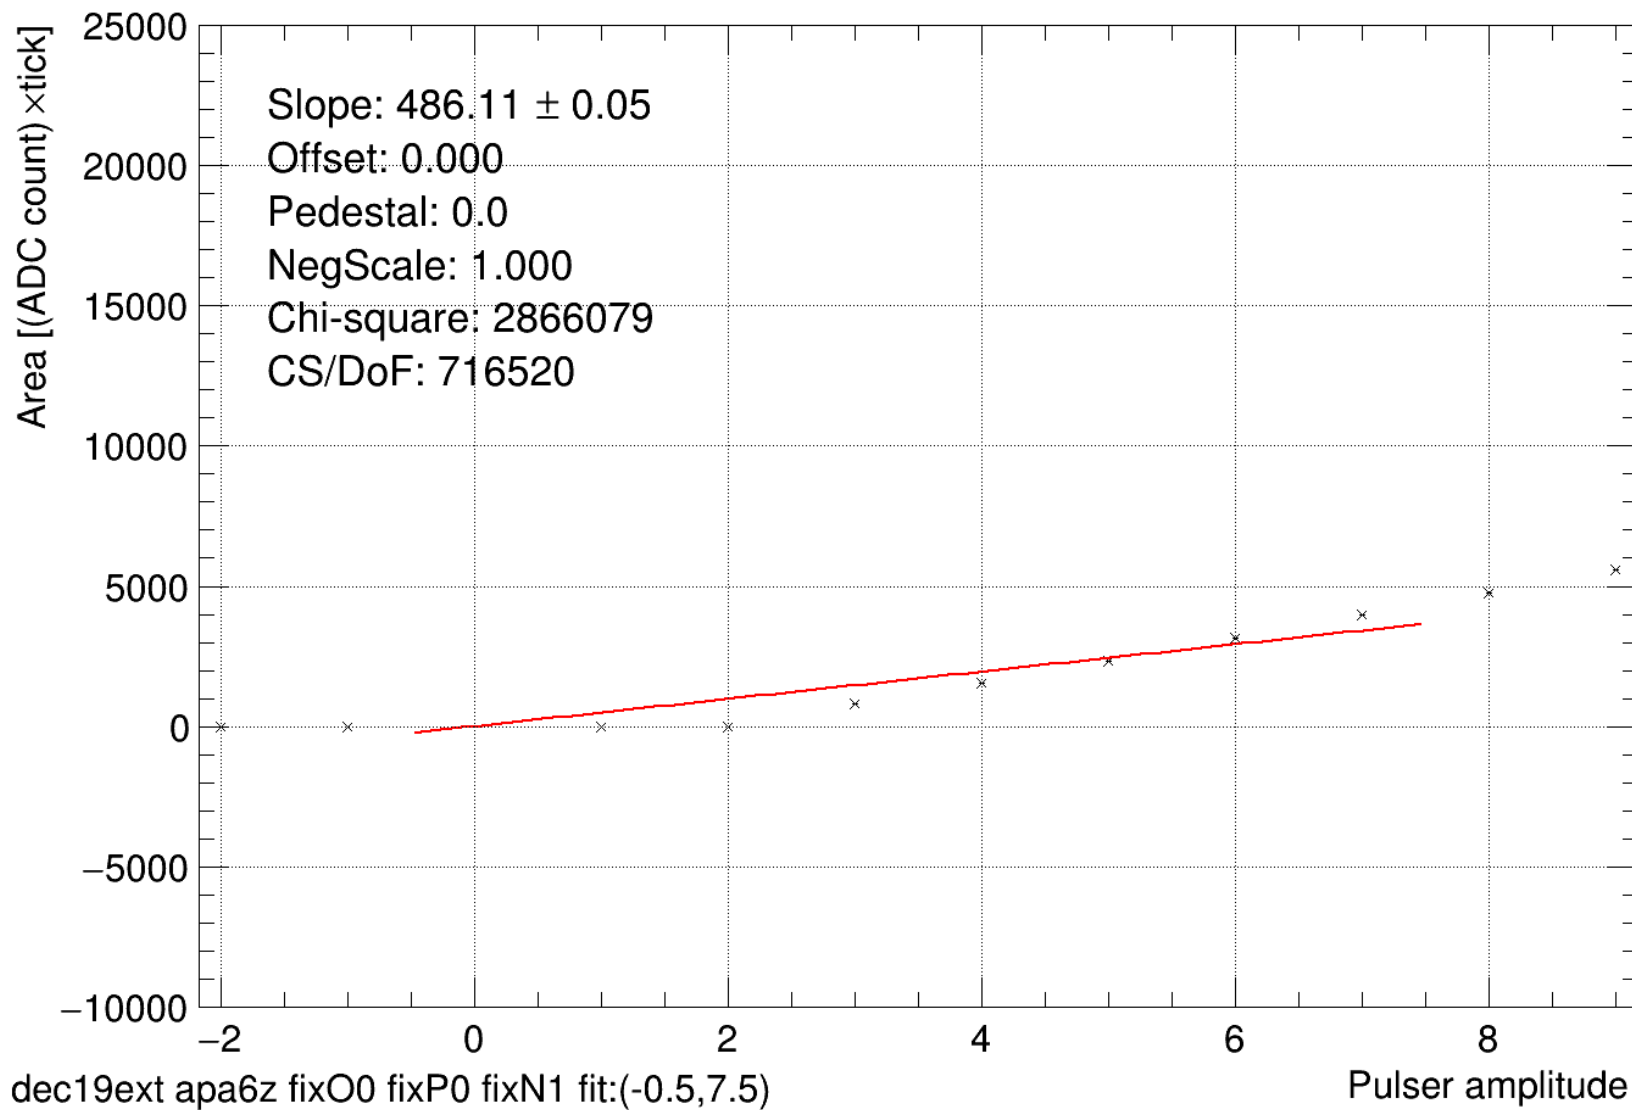
ROI area channel 9549

Shift

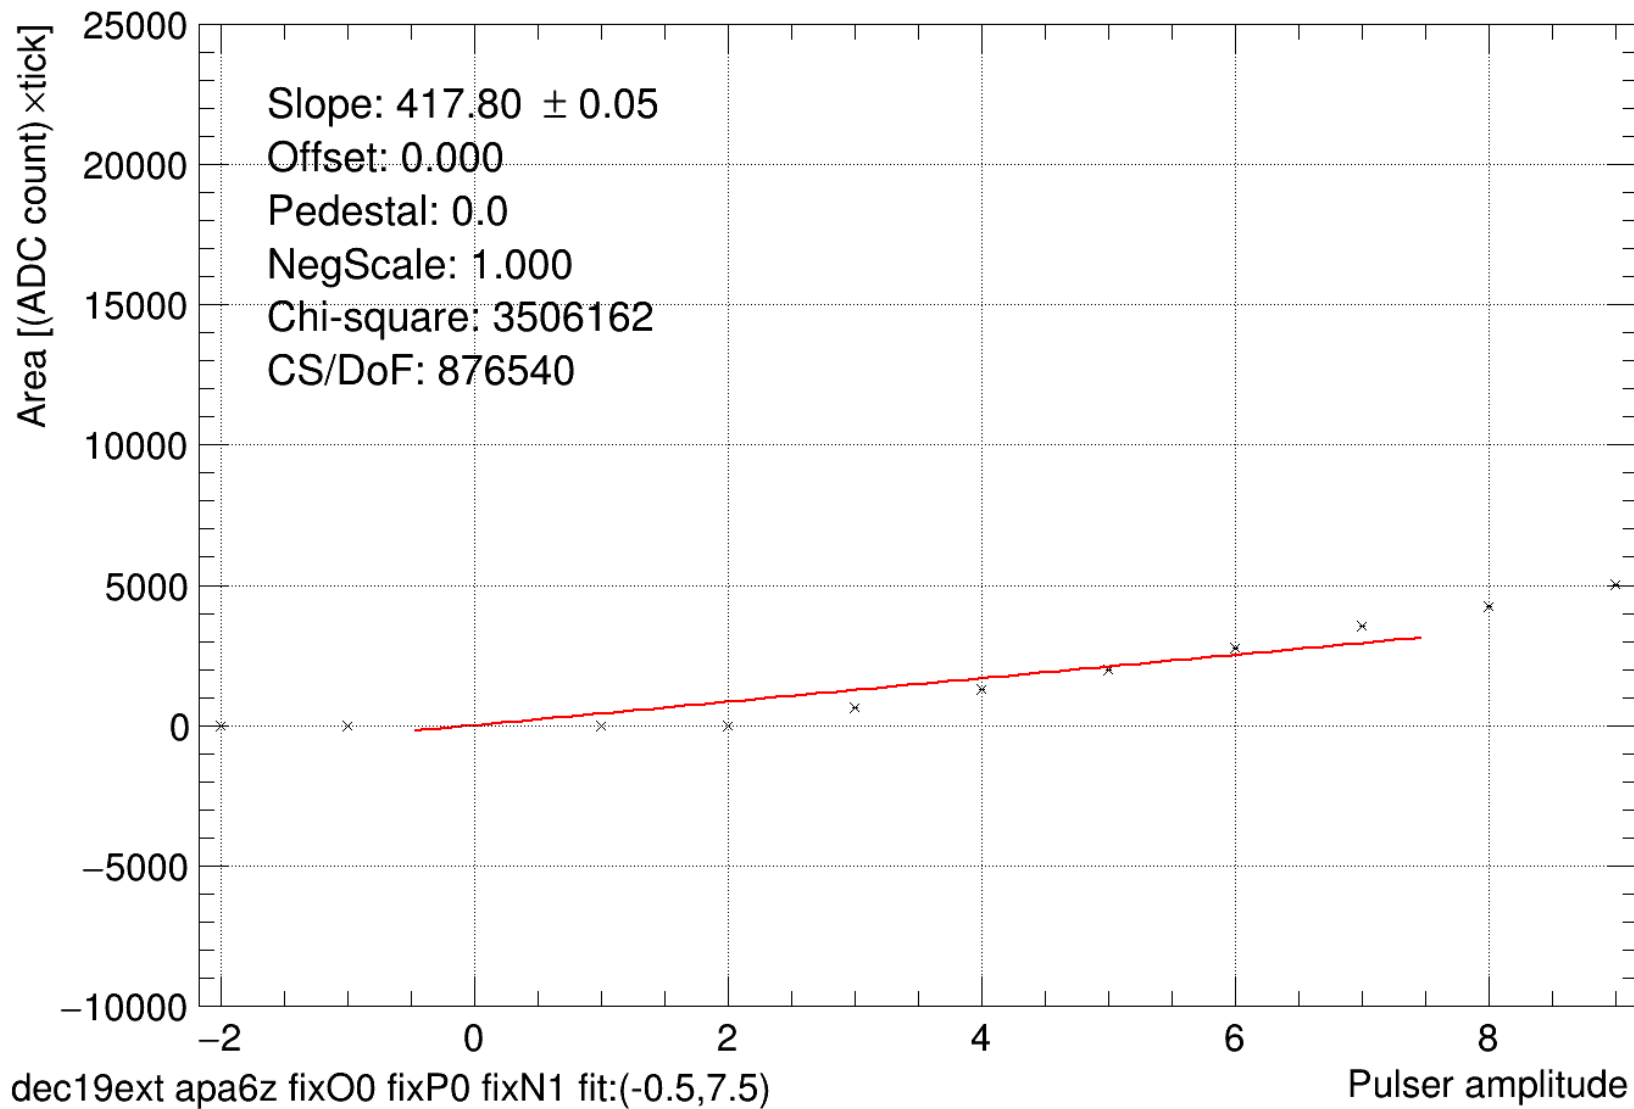
ROI area channel 9551

6u  7715 very wide (55-->2300)           Pedestal was fine, now very noisy (amp?)   BAD  
6u  8234 wide (50-->100)                   Both pedestals sticking.                   NOISY  
6u  8290 tails (10%)                       Both pedestal mostly stuck                 NOISY  
6c  9941 tails (5%)                         SC bad goes to very bad.                   NOISY  
6c 10033 missing (tail @ ADC < 500)       OK then. Now dead (I think)                BAD  
6z  9545 low RMS                          Big pulser offset in new data.             Recalibrate varying offset?  
6z  9547 low RMS                          Big pulser offset in new data.             Recalibrate varying offset?  
6z  9549 low RMS                          Big pulser offset in new data.             Recalibrate varying offset?  
6z  9551 low RMS                          Big pulser offset in new data.             Recalibrate varying offset?

Shift

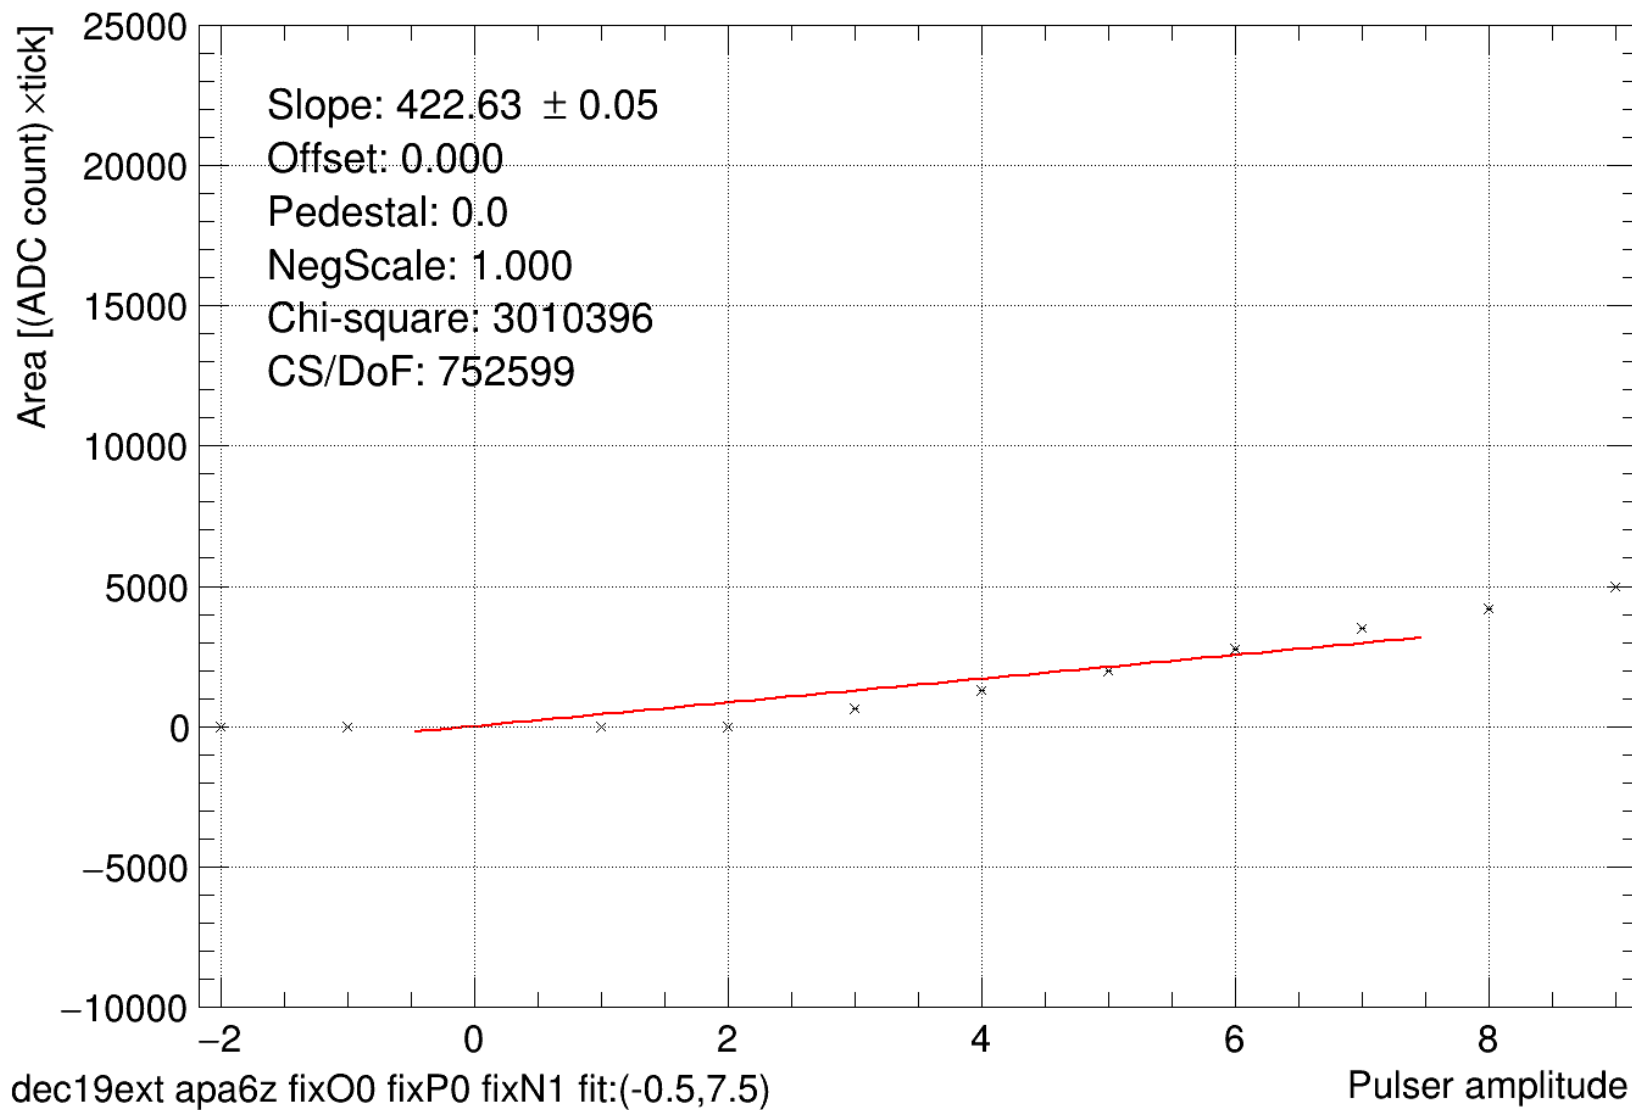
ROI area channel 9553

6z  9553 low RMS                          Big pulser offset in new data.             Recalibrate varying offset?  
6z  9555 low RMS                          Big pulser offset in new data.             Recalibrate varying offset?  
6z  9641 low tail                          Big nonlinearity in pulser response.       BAD
```

Shift

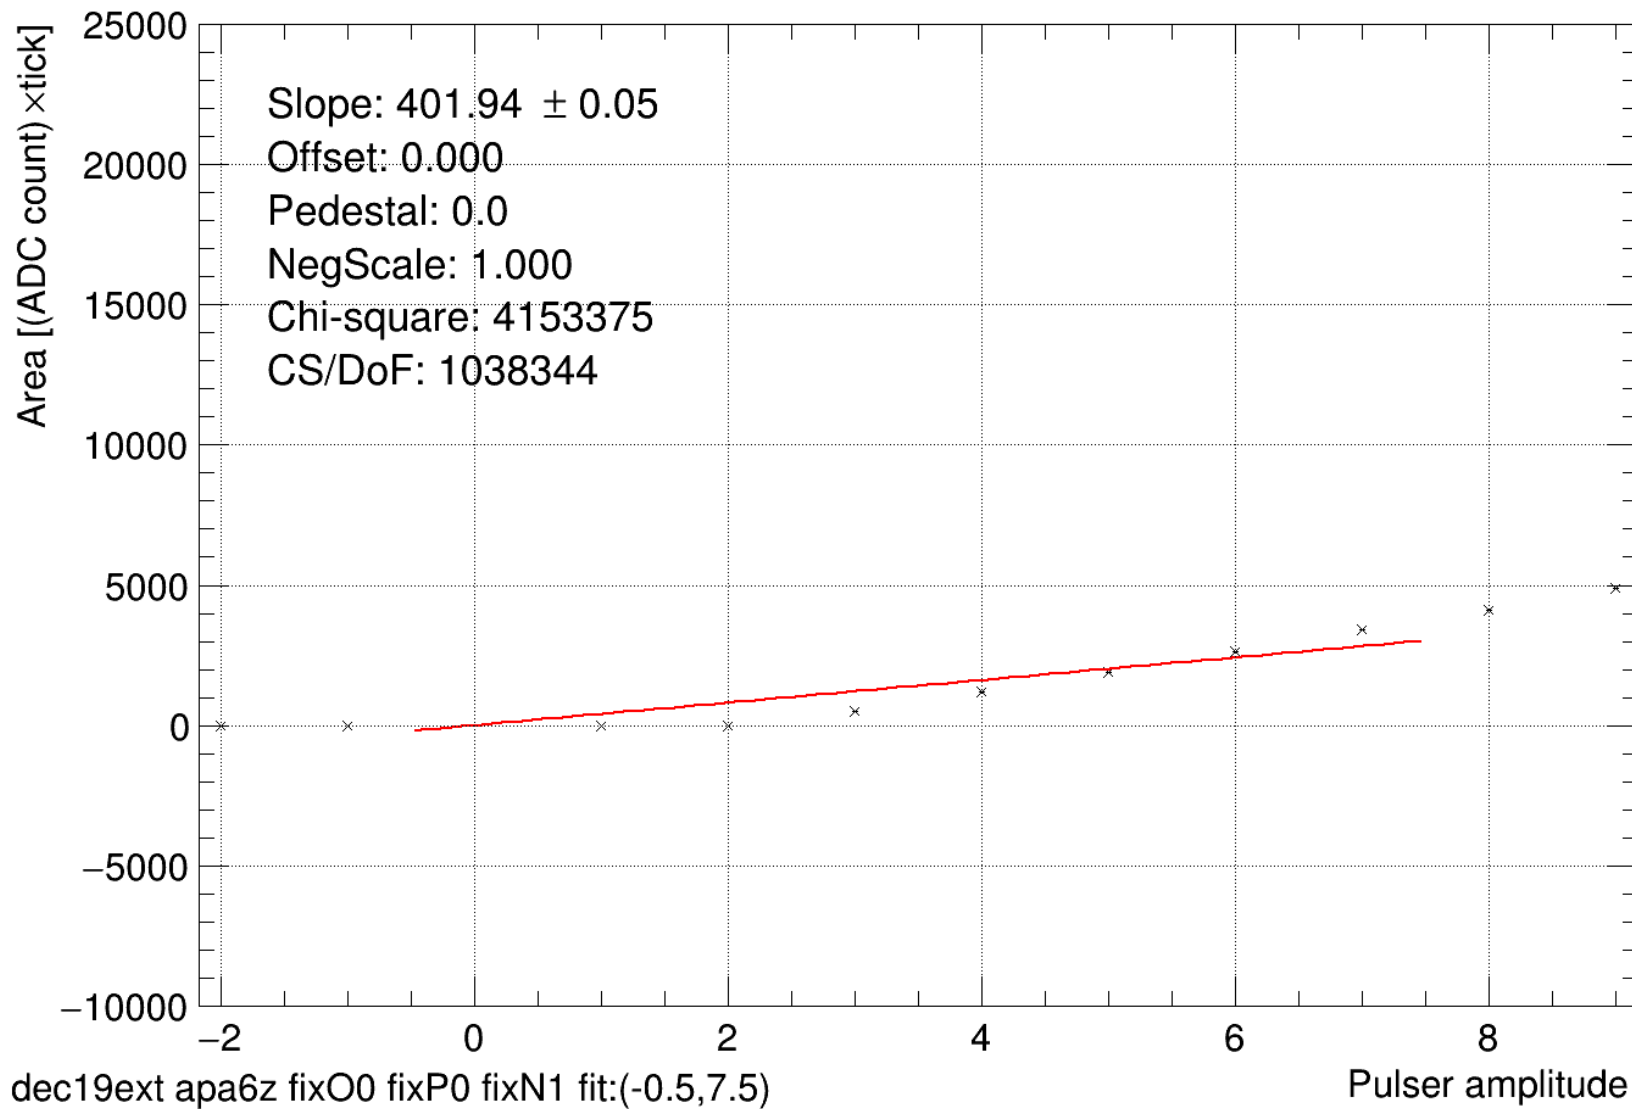
ROI area channel 9555

Shift
