Optical inspection status

Sebastian Aderhold
DESY

TTC Meeting 2010

19.04.2010 FNAL

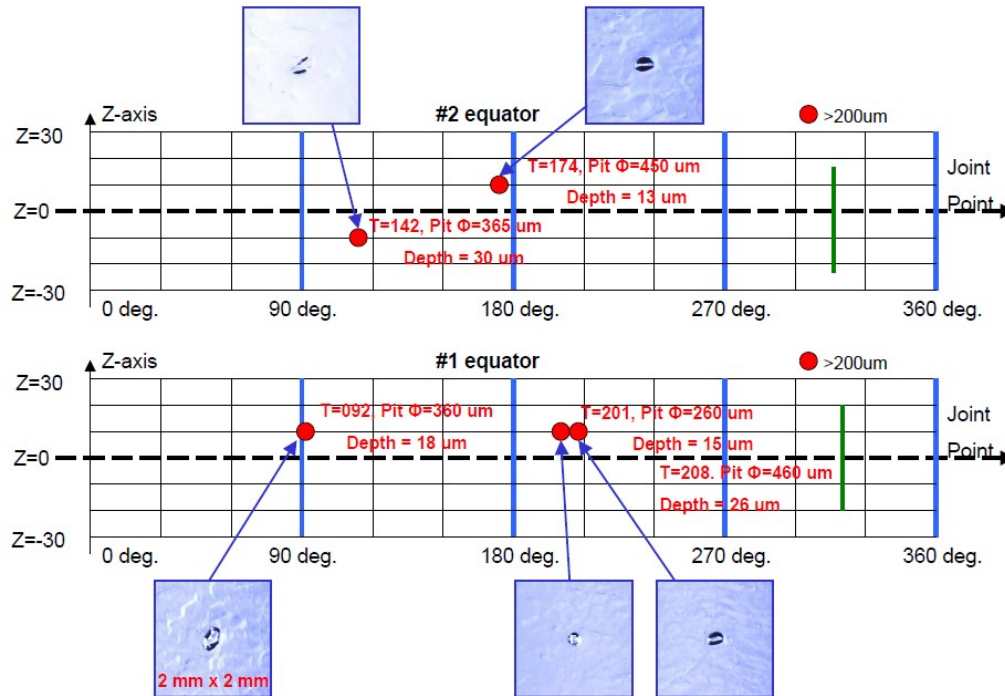
ERL injector 2-cell cavity #1

Both cavities have the suspicious spots outside the weld area.
But: these spots did not heat up to $E_{acc} = 41 \sim 43$ MV/m.

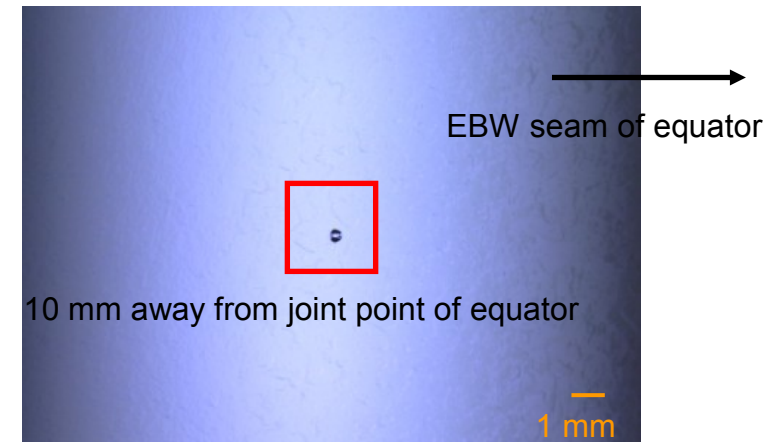
Example : #2 cavity, 1-cell equator, outside weld area, $t=076$ deg.

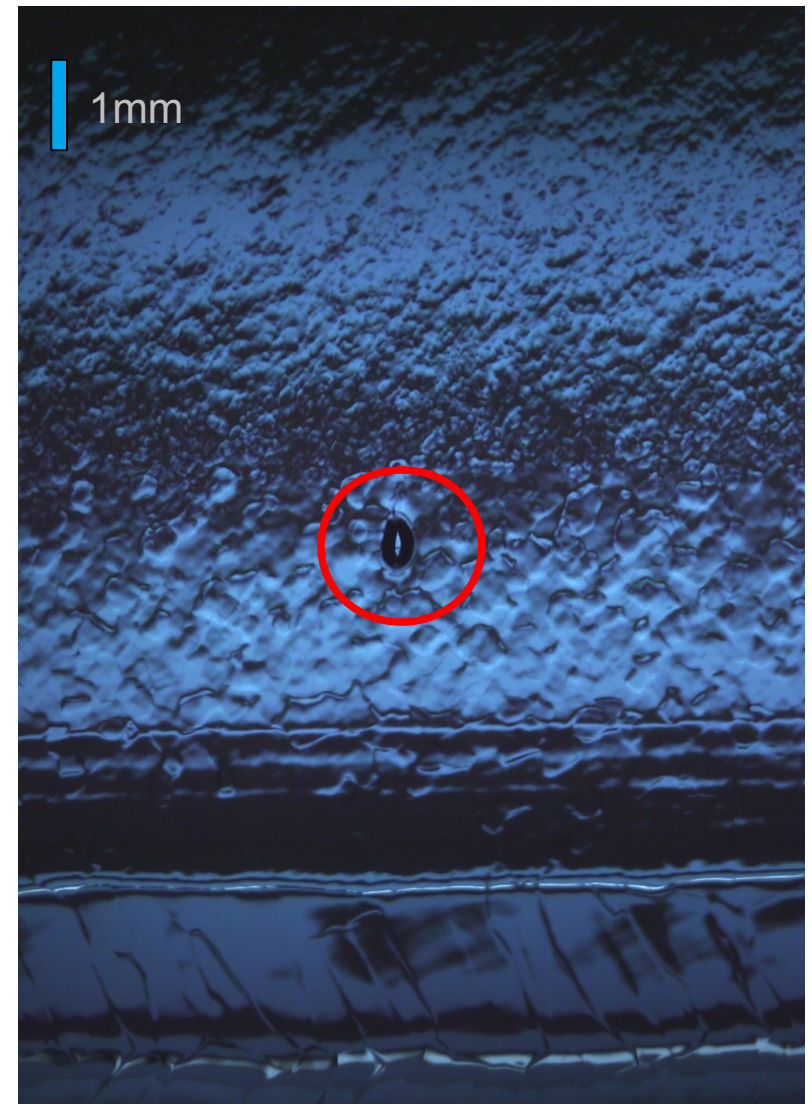
Hotspot during T-map
at equator 6 in π -mode,
Limited by quench
at 20.6 MV/m

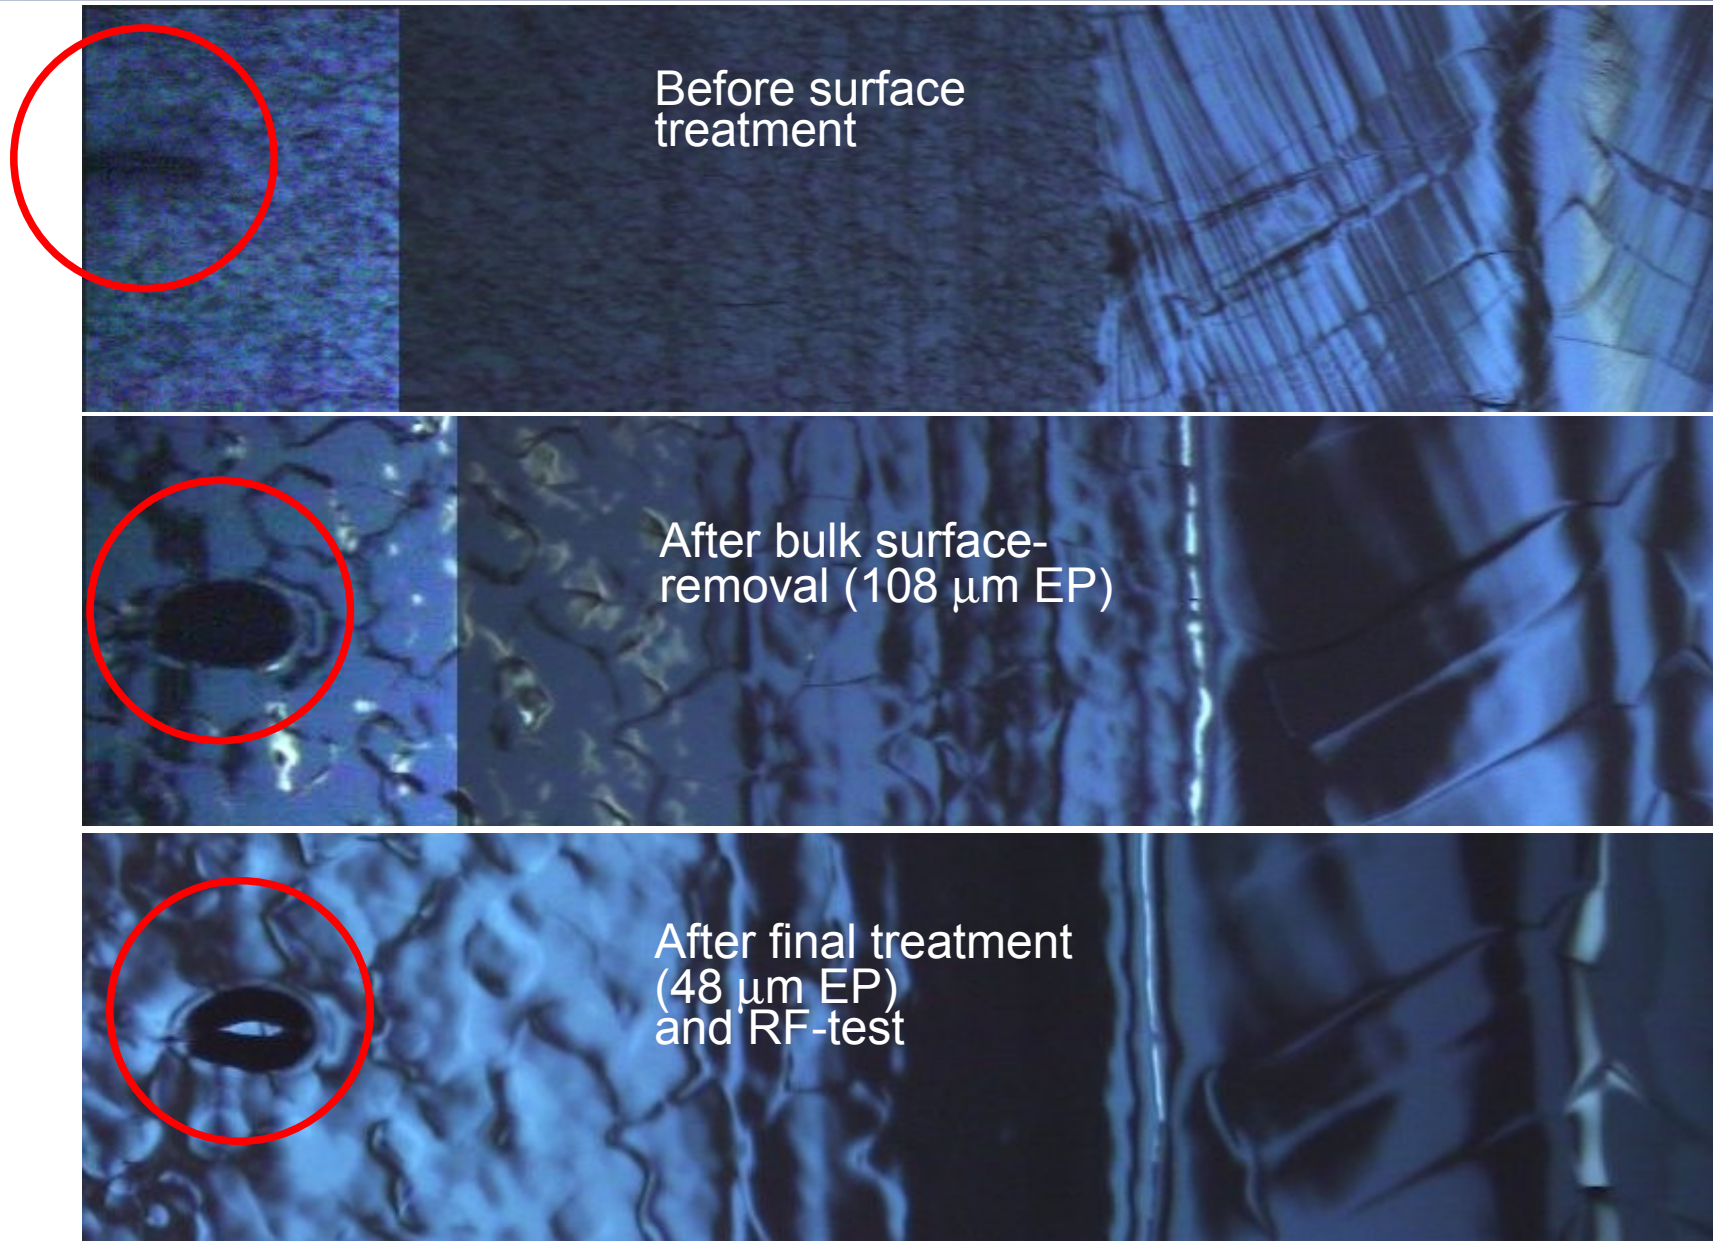
Evolution of defect in Z142

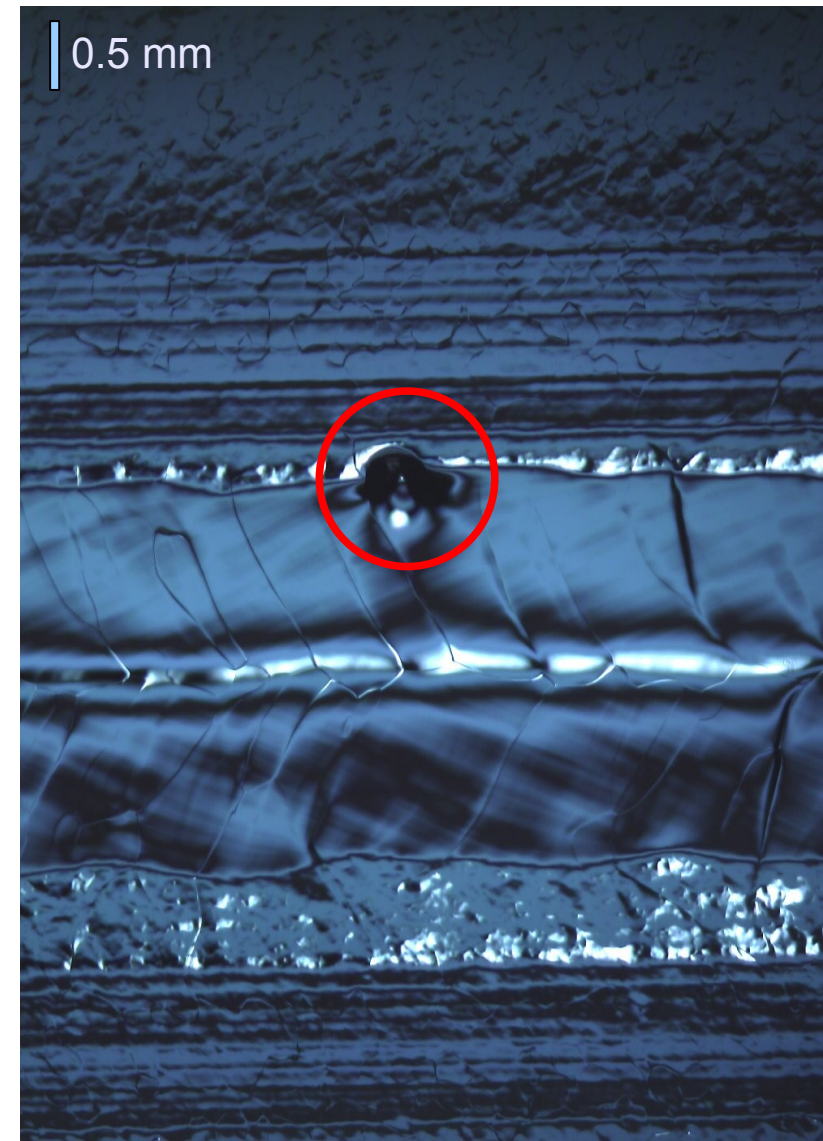
Z130: Quench in $3\pi/9$ -mode at
22 MV/m

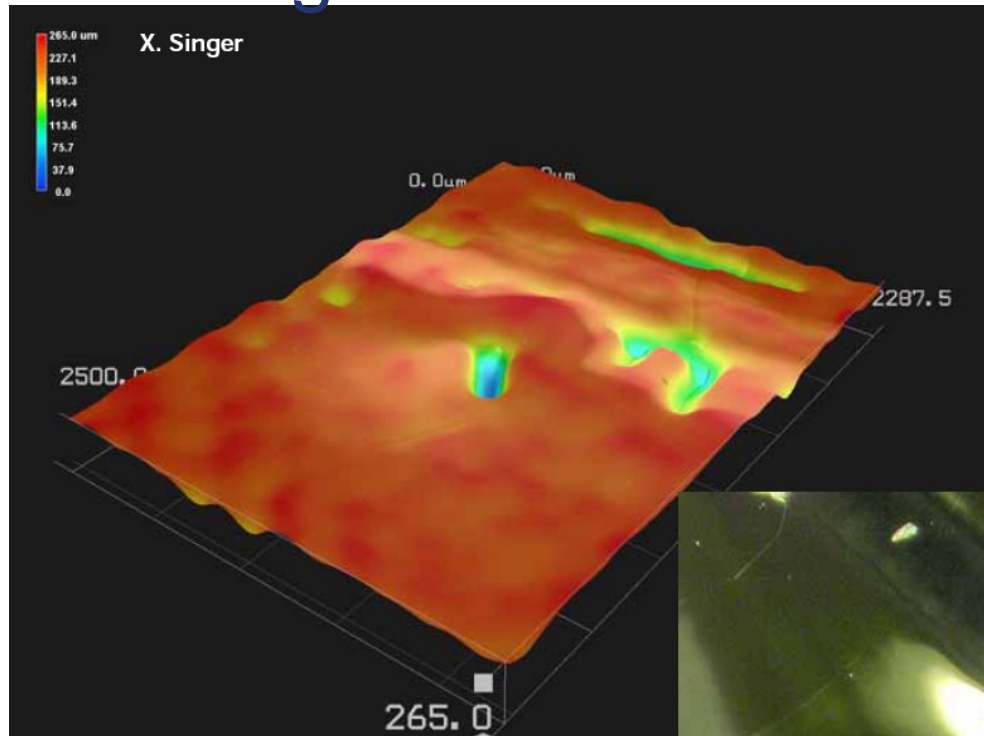
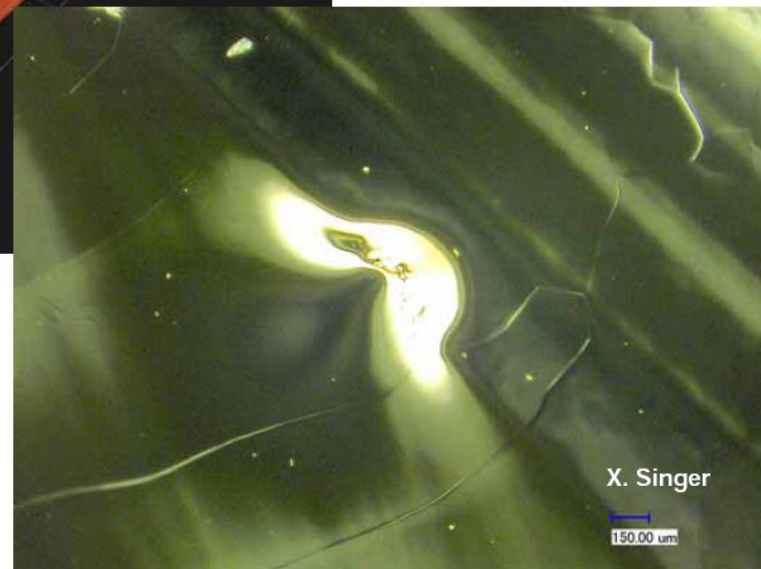
Defect in Z130

- Cavity has been cut for further investigation
- EDX: no foreign material

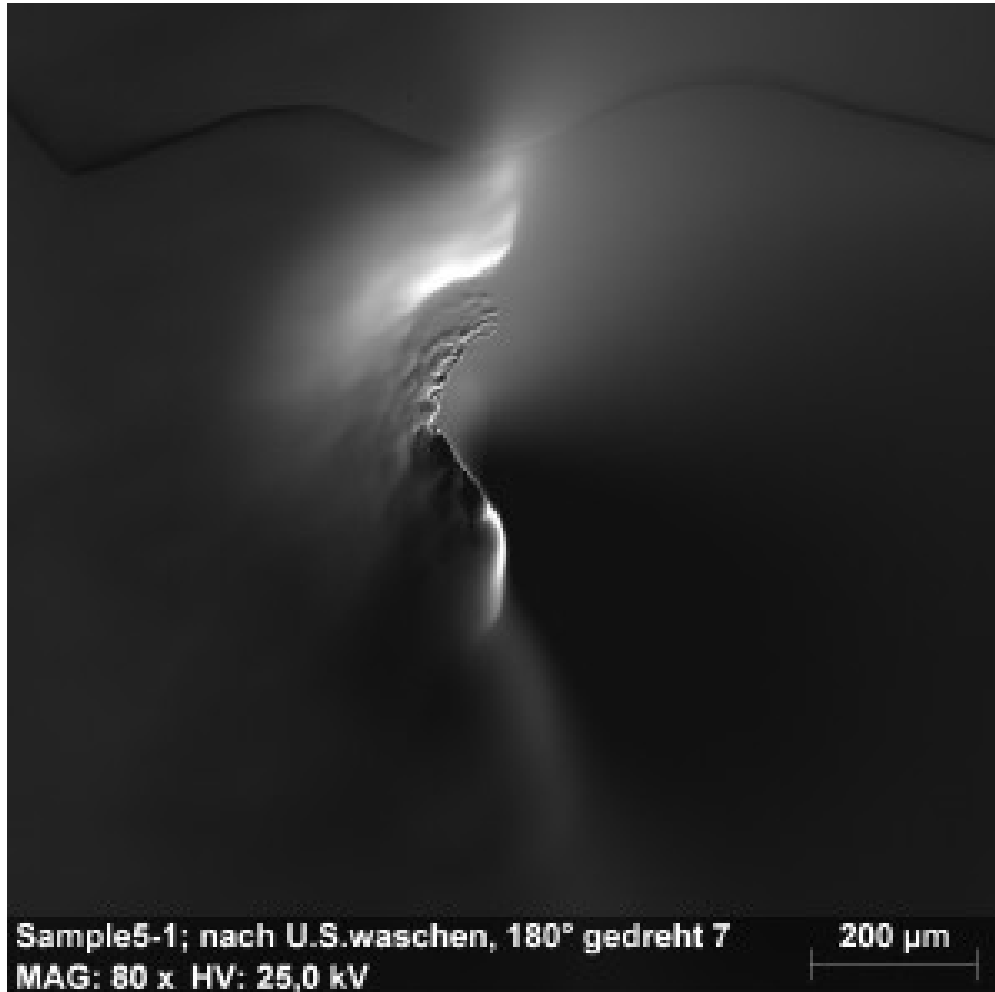
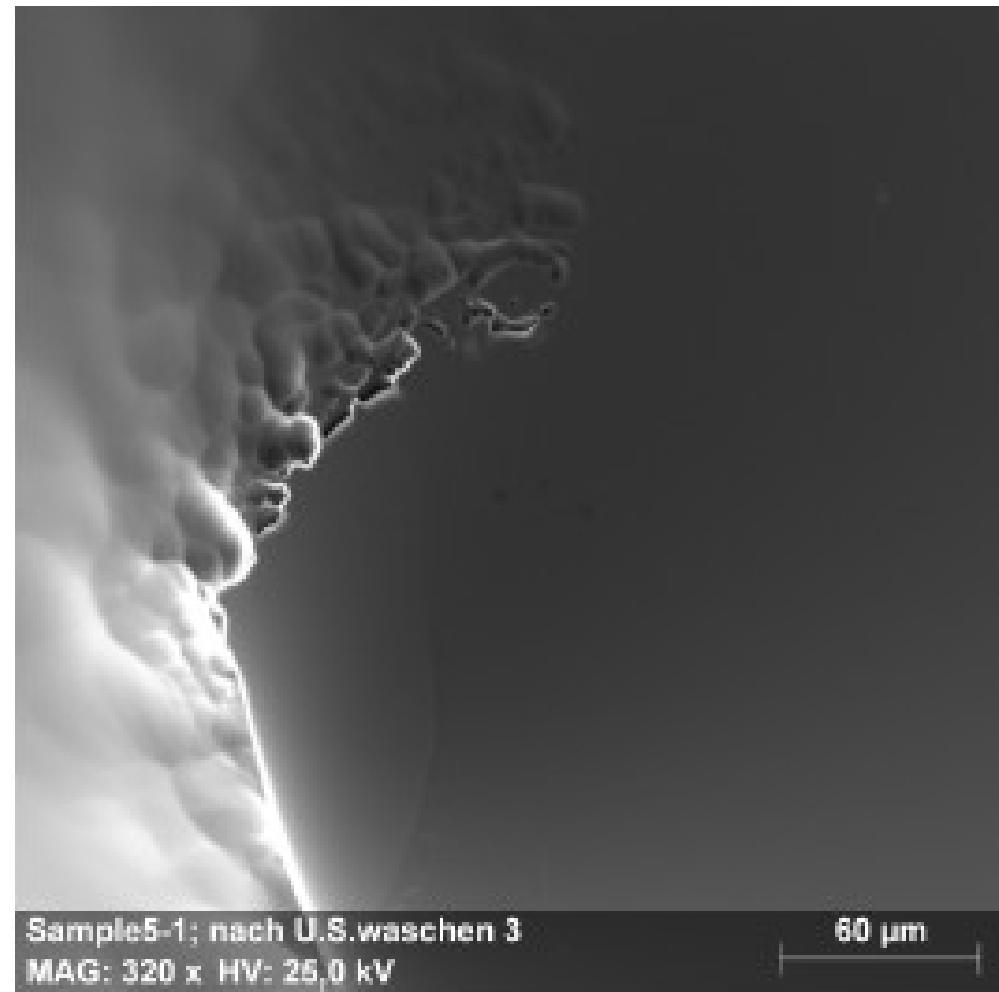
SEM-Picture of the defect

Sharp ridges at edge of defect

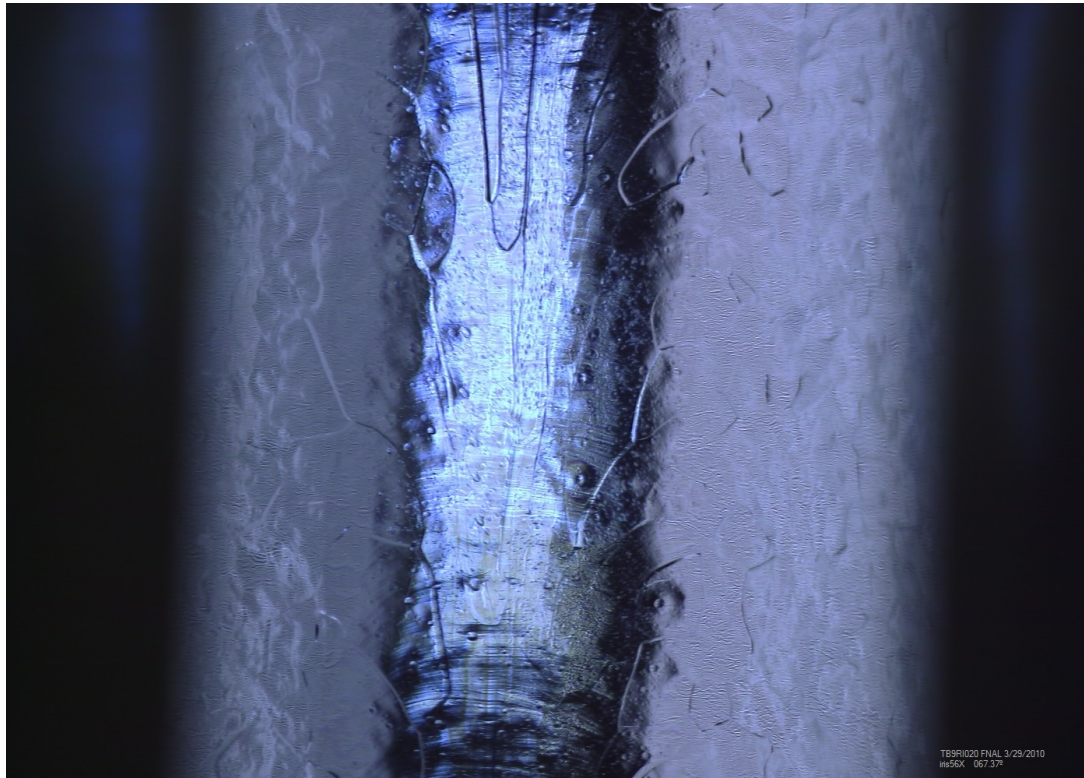
FNAL: TB9RI020, iris 5-6

Iris in „as received“ condition

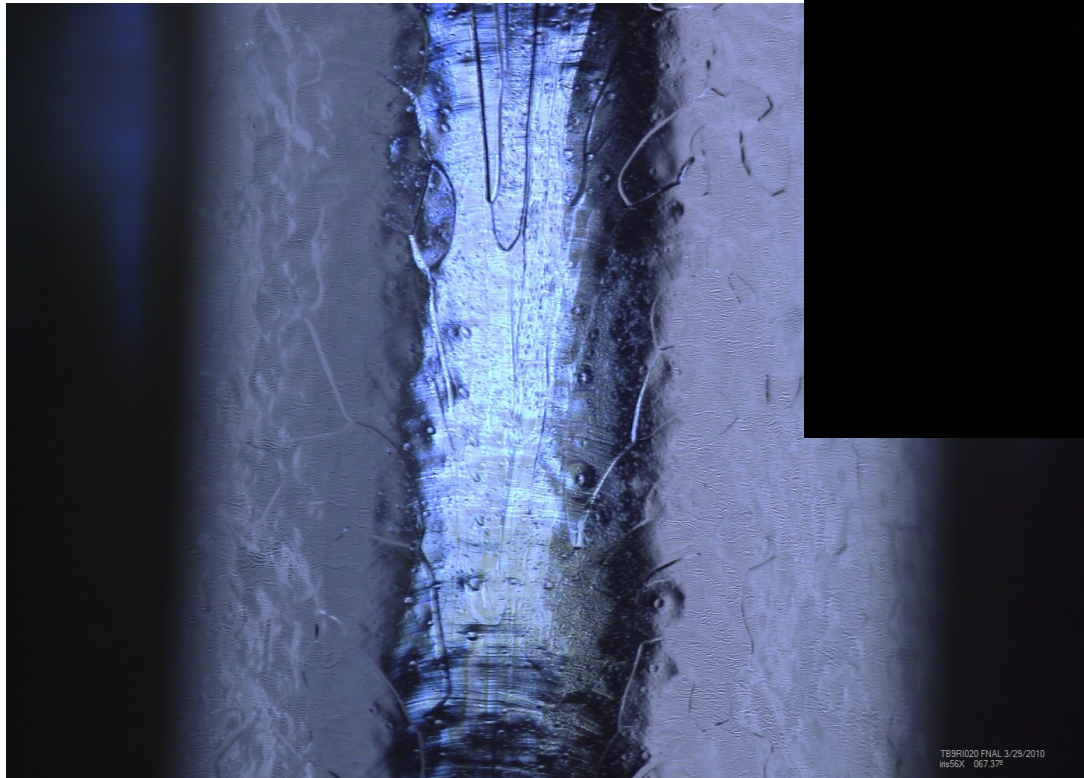
FNAL: TB9RI020, iris 5-6

Iris in „as received“ condition

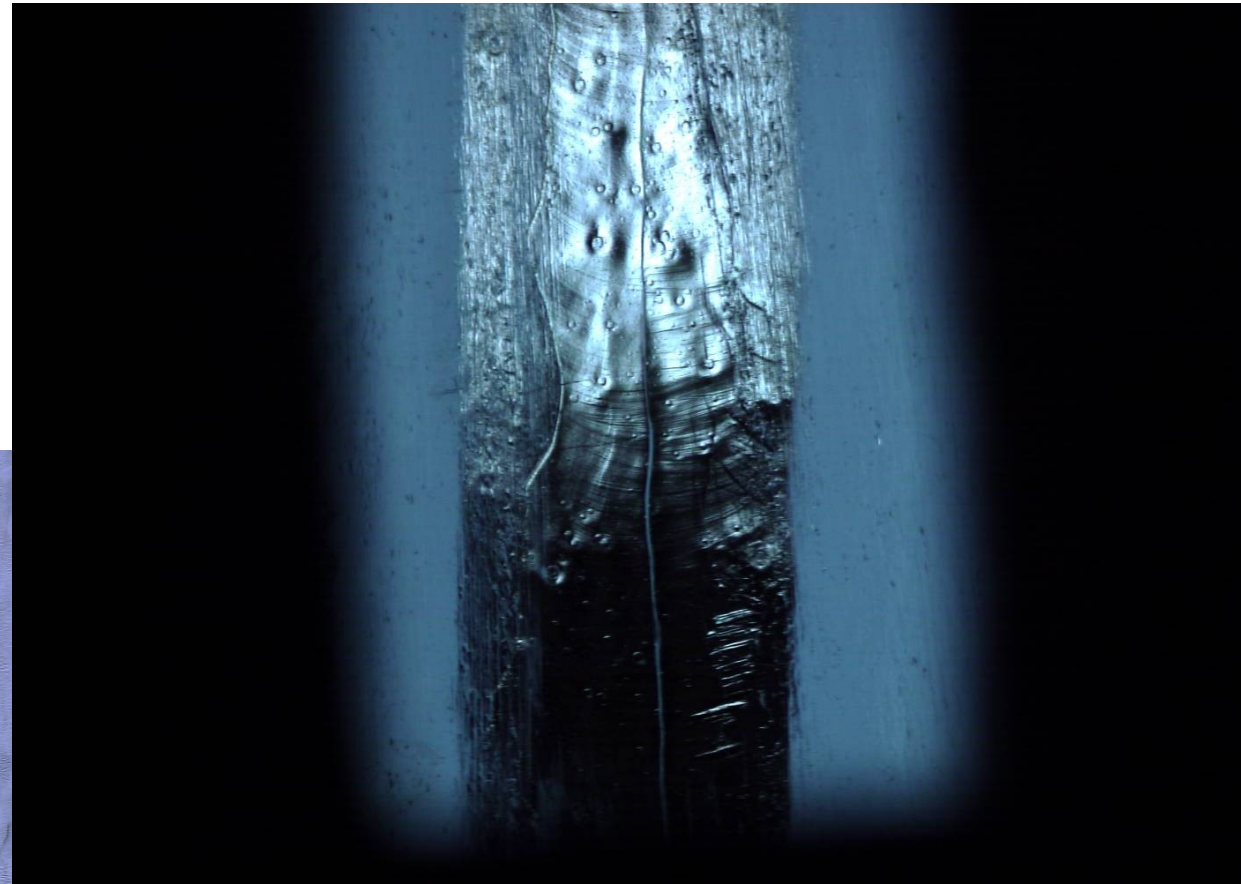
DESY: AC156, iris 3-4

„Pimples“ observed before
chemical treatment

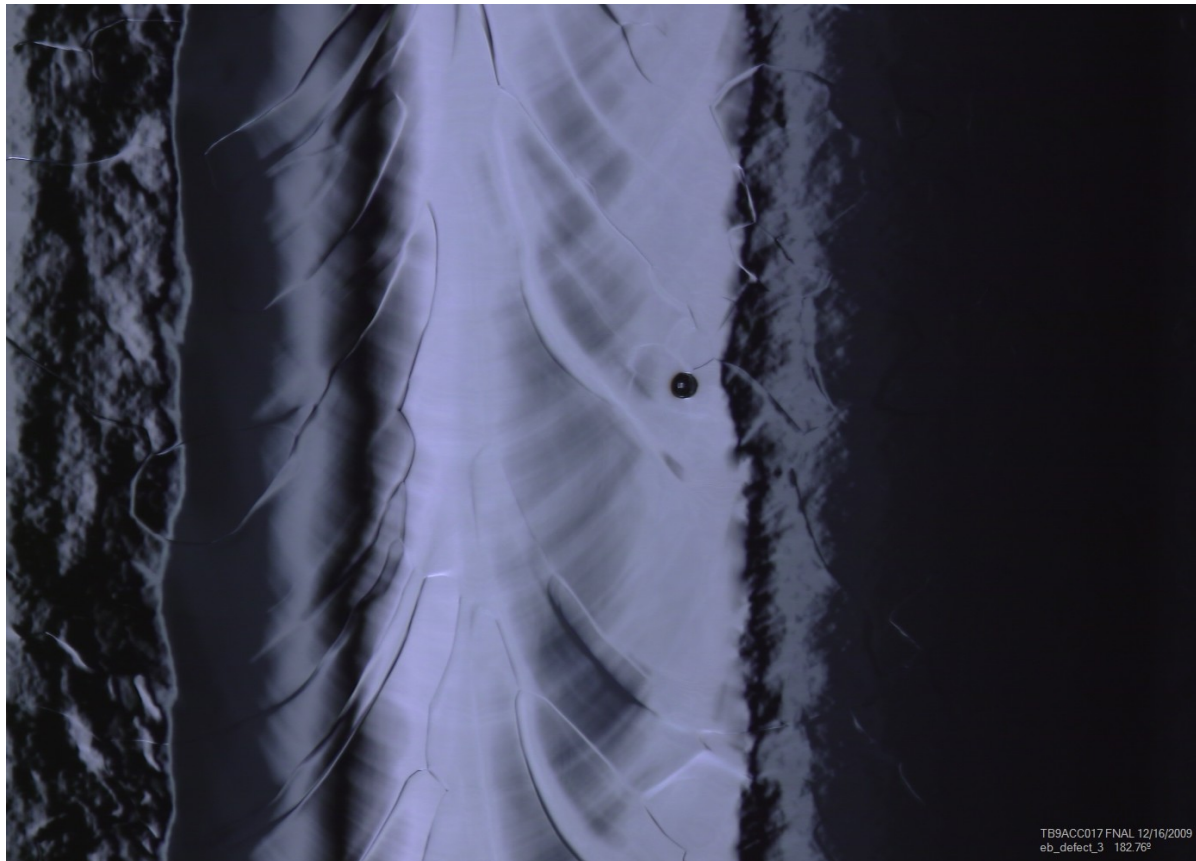
FNAL: TB9ACC017,
quench location

Defects at edge of welding seam

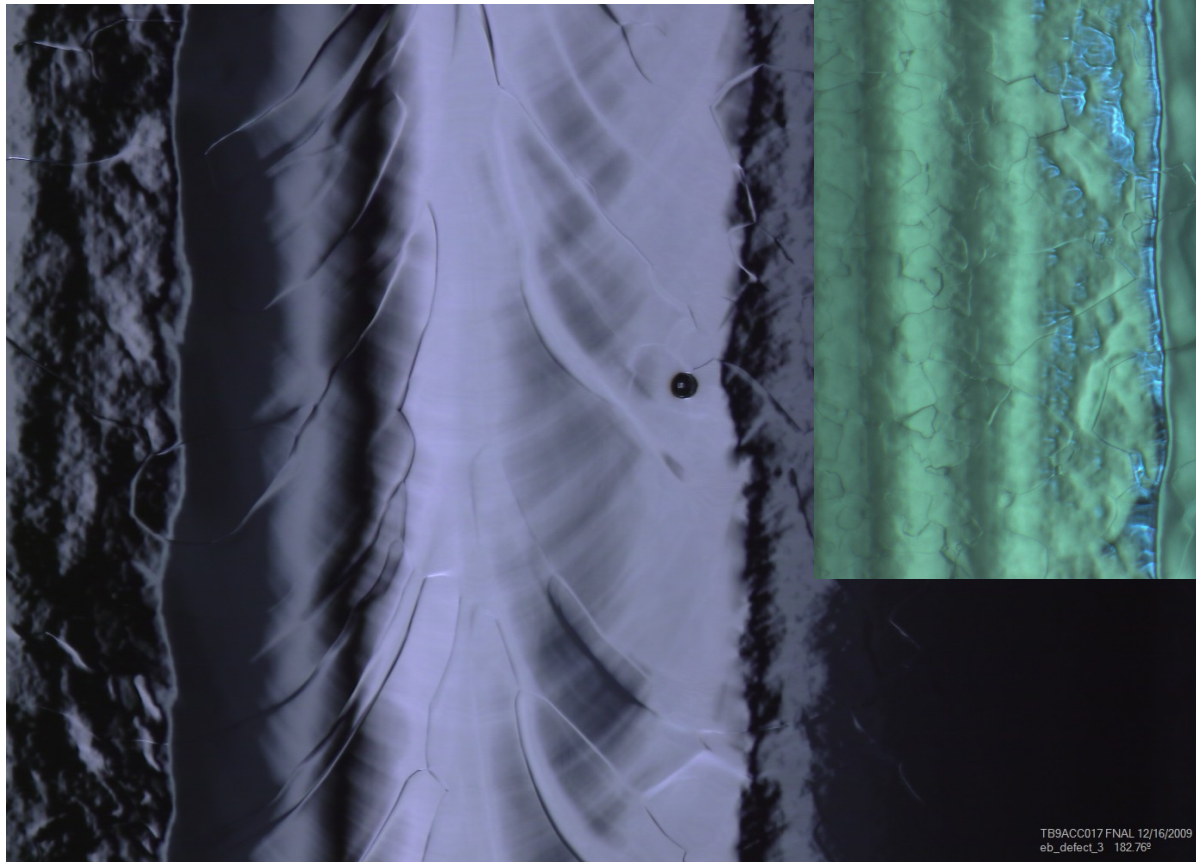
FNAL: TB9ACC017,
quench location

Defects at edge of welding seam
