TTF3 Power Coupler

Update on Operating and Fabricating Issues

TTC Meeting, FNAL, Chicago, April, 19th-22th 2010

Wolf-Dietrich Möller, DESY

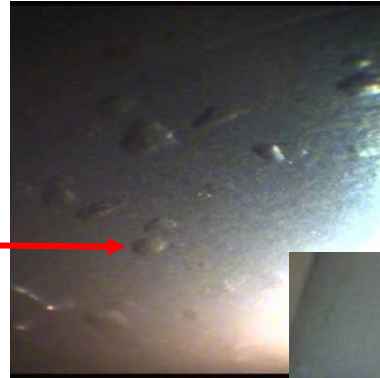
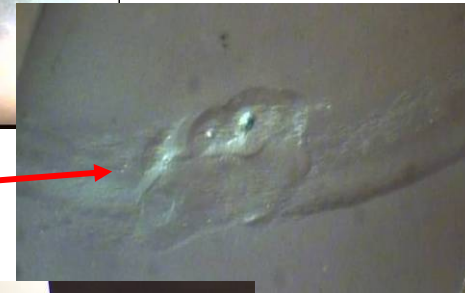
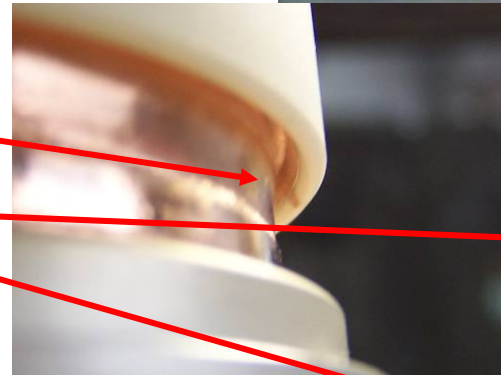
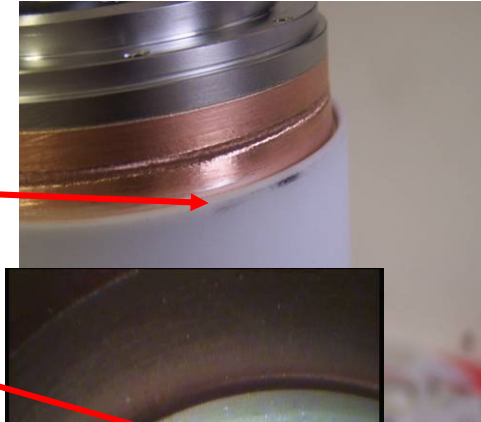
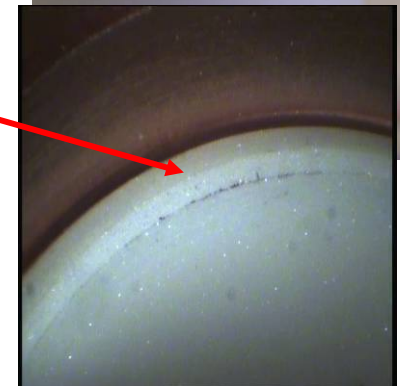
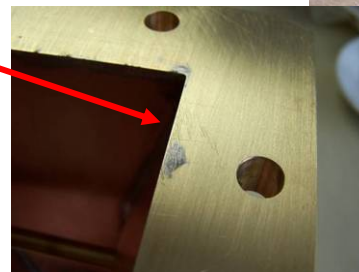
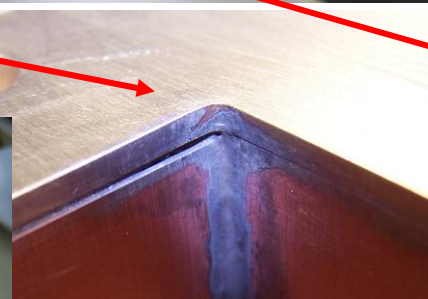
- Critical fabrication steps:
- Copper plating
 - blisters
 - adhesion
- TIG welds
 - surface irregularities
- e-beam
 - metal vapor
 - metal scratches from protective shields
- Soldering
 - insufficient fill
 - material on flange surface

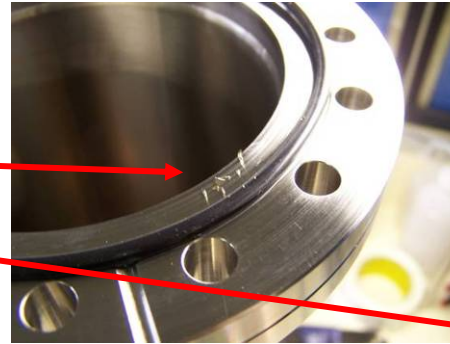
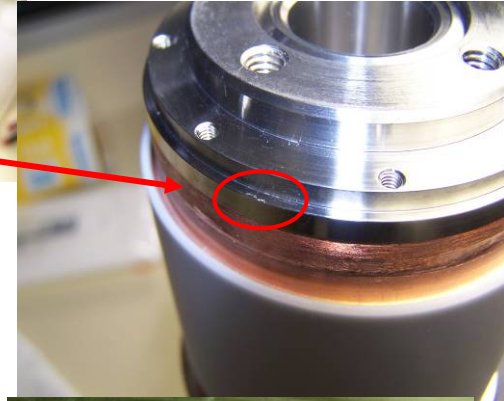
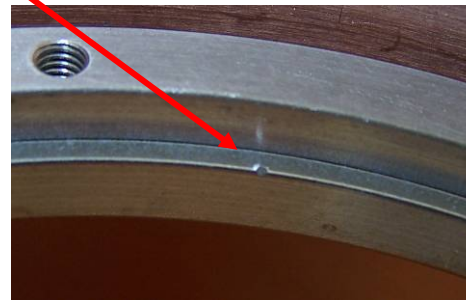
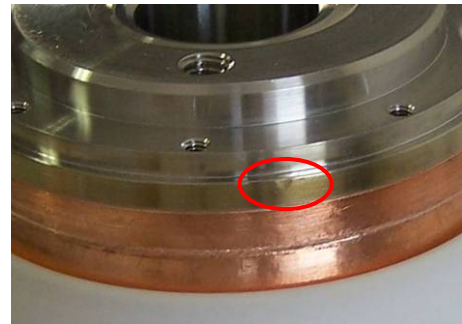
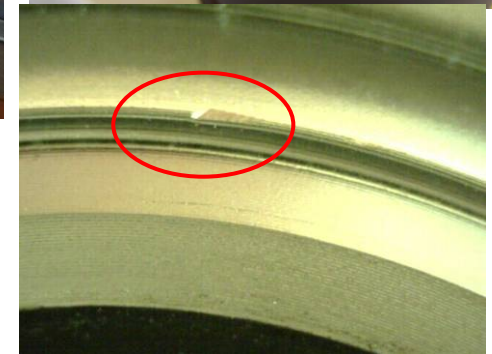
- Handling problems

- dents at Conflat knife edges
- dents at RF contacts
- scratches on RF surface
- chip at ceramic edge

It is important that the companies understand the main functions and develop an adequate handling.

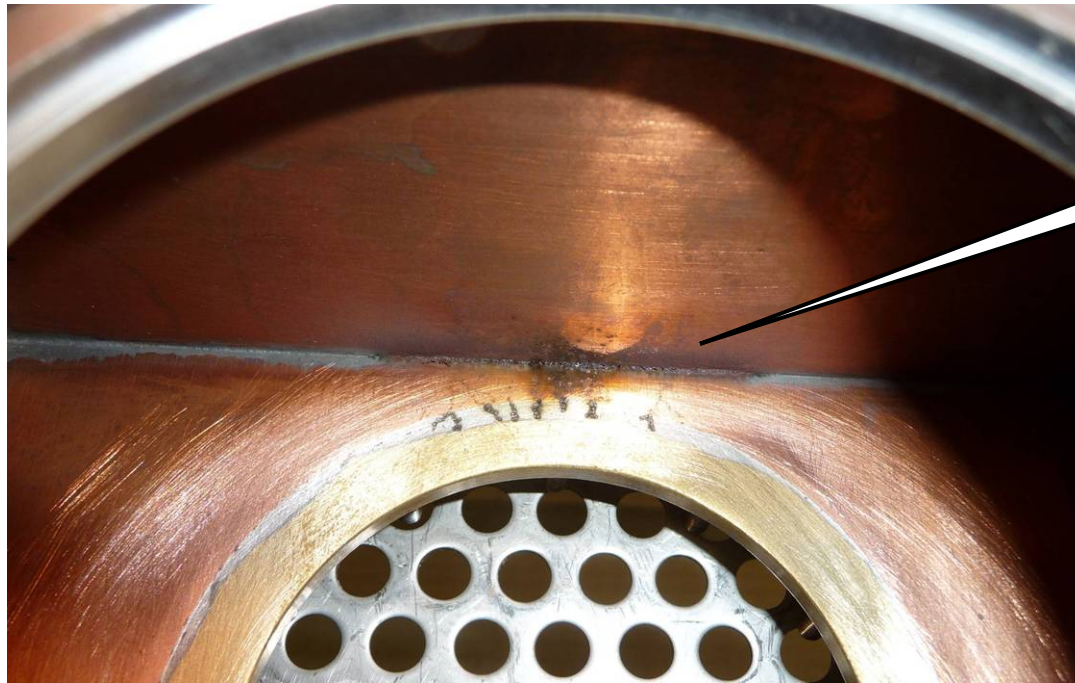
wave guide box soldering
burn marks inside

TTF3 wave guide box is a soldered design:

→ micro cracks in the soldering caused sparks

Soldering of the box is done by hand - the process is not easy to control.

1. machining from bulk Aluminium

- flexibility for fabrication tolerances not easy to apply, redesign necessary (the original design has a membrane for length compensation)
- braze wave guide
 - copper too soft
 - use copper plated stainless steel and keep the membrane part from copper (two test wave guides are under fabrication)

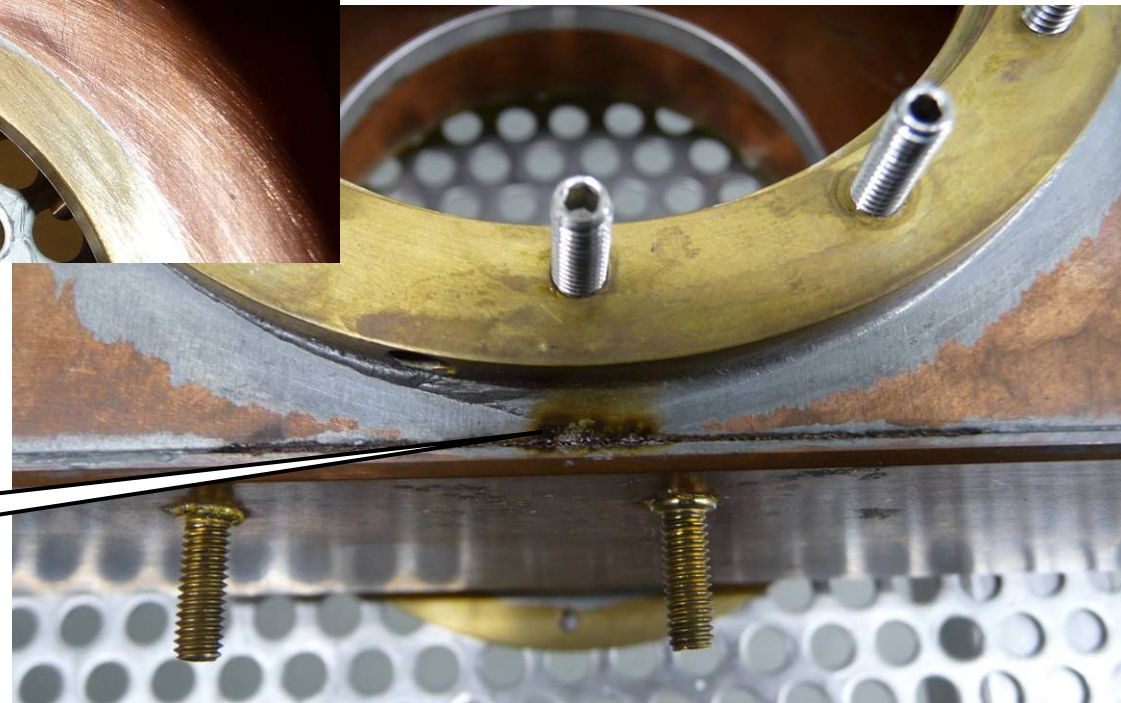
wave guide box soldering
burn marks outside

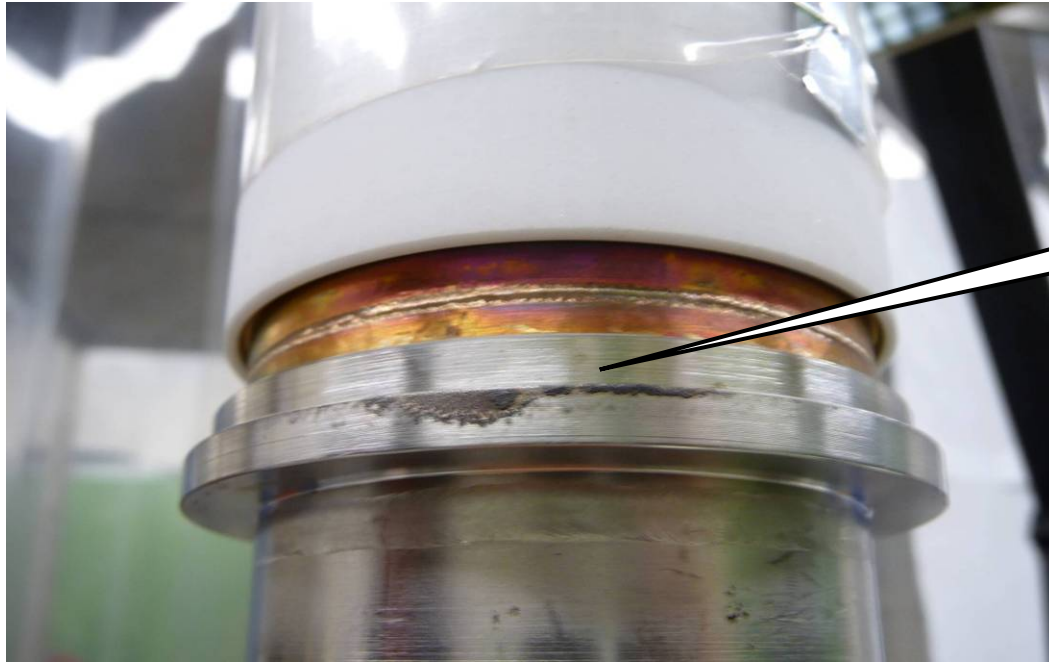
warm part outer conductor burn marks
(contact to WG)

2. TTF3 contacts are machined very precisely and have to be assembled very carefully:

→ misalignment caused sparks

1. Careful assembly

2. Change the design for RF spring or solid flange

3. Add contact seal between the flanges

4. Replace the capacitor (Chris Adolfsen, SLAC)

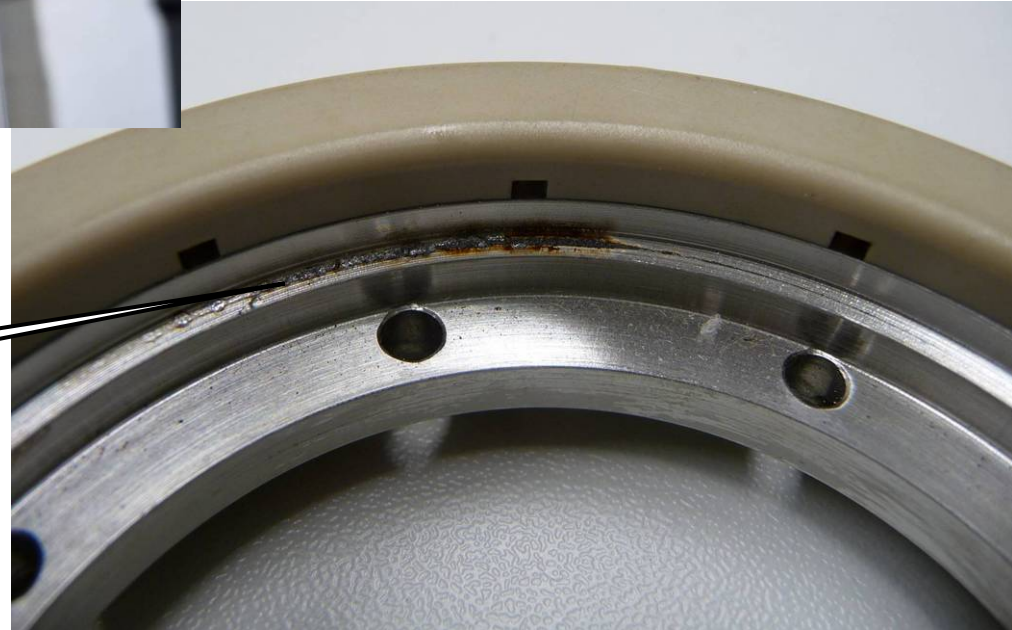
capacitor inner contact burn marks
(contact to coax)

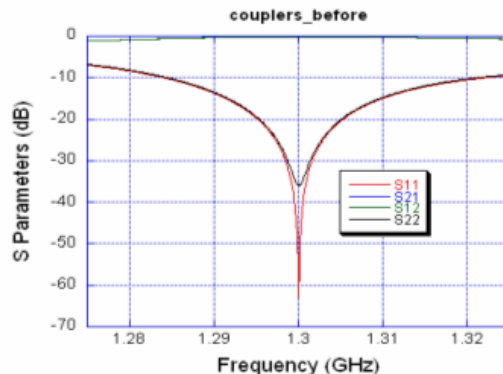
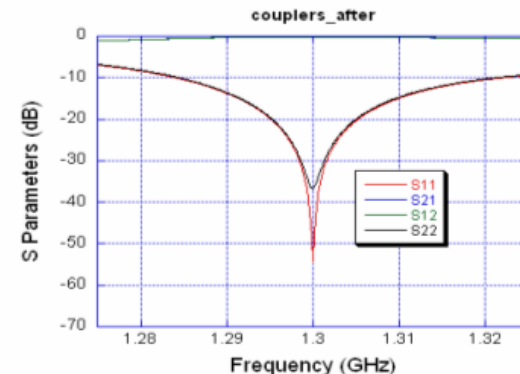
POST TEST INSPECTION SHOW NO SIGNS OF ARCING

TASK: This test was performed on build #4. FC / FH 06 – FC / FH 07
THIS TEST IS WILL MAKE AN ATTEMPT TO RESOLVE THE ISSUE OF THE COUPLERS ARCING DURING TESTING FROM THE CAPACITOR TO THE WAVEGUIDE. THE 0.050 THICK OFF COPPER GASKET, WAS ANNEALED DEAD SOFT IN A HYDROGEN FURNACE, TO BE INSTALLED ON FH06, R.F. IN WAVEGUIDE, IN THE LOCATION WHERE THE CURRENT CAPACITOR ASSY(P/N: RDES9298356F000) IS INSTALLED. BEFORE THE ORIGINAL CAPACITOR IS REMOVED A COLD TEST WILL BE PERFORMED TO ESTABLISH A BASELINE. AFTER THE ORIGINAL CAPACITOR IS REMOVED AND THE NEWLY DESIGNED COPPER GASKET IS INSTALLED IN ITS PLACE, ANOTHER COLD TEST
