HQ01d quench performance

M. Marchevsky, LBNL

HQ01d magnet configuration

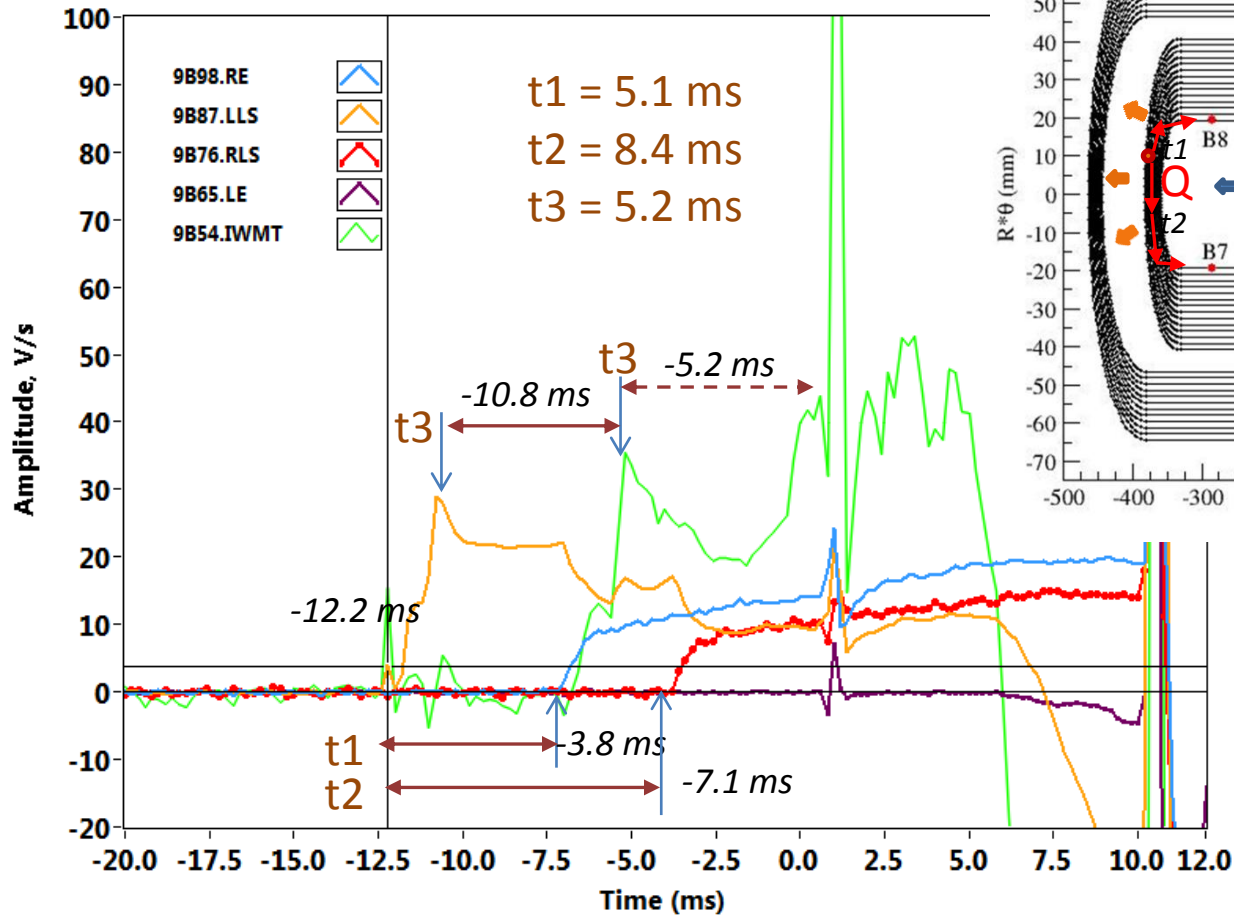
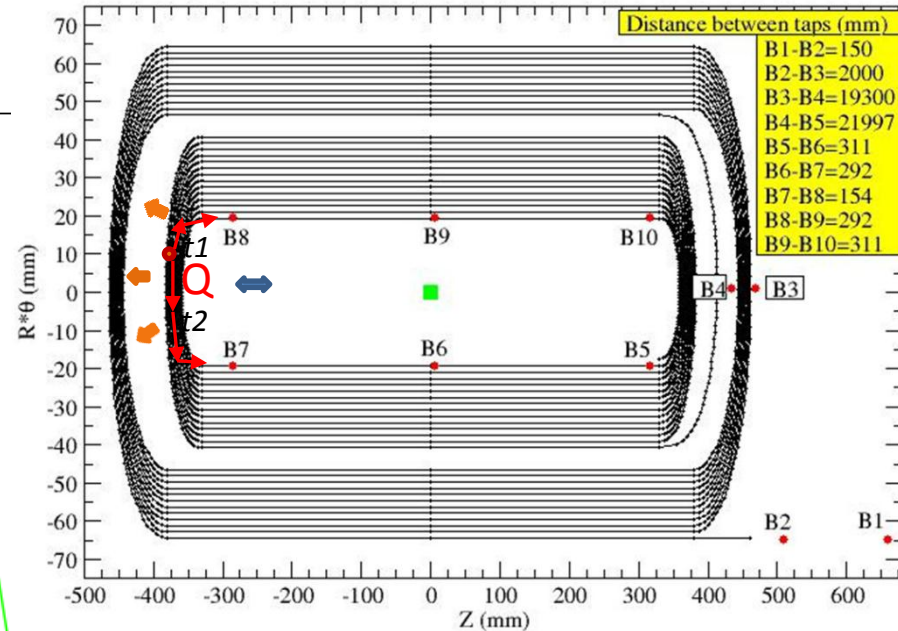
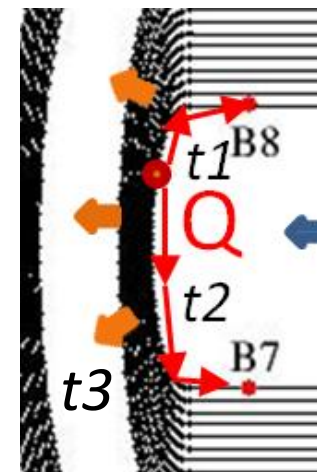
Quench propagation example (A15)

$$V_q = 154 \text{ mm} / (5.1 + 8.4) \text{ ms} = 11.4 \text{ m/s}$$

$$\tau_{t-t} = 5.2 \text{ ms}$$

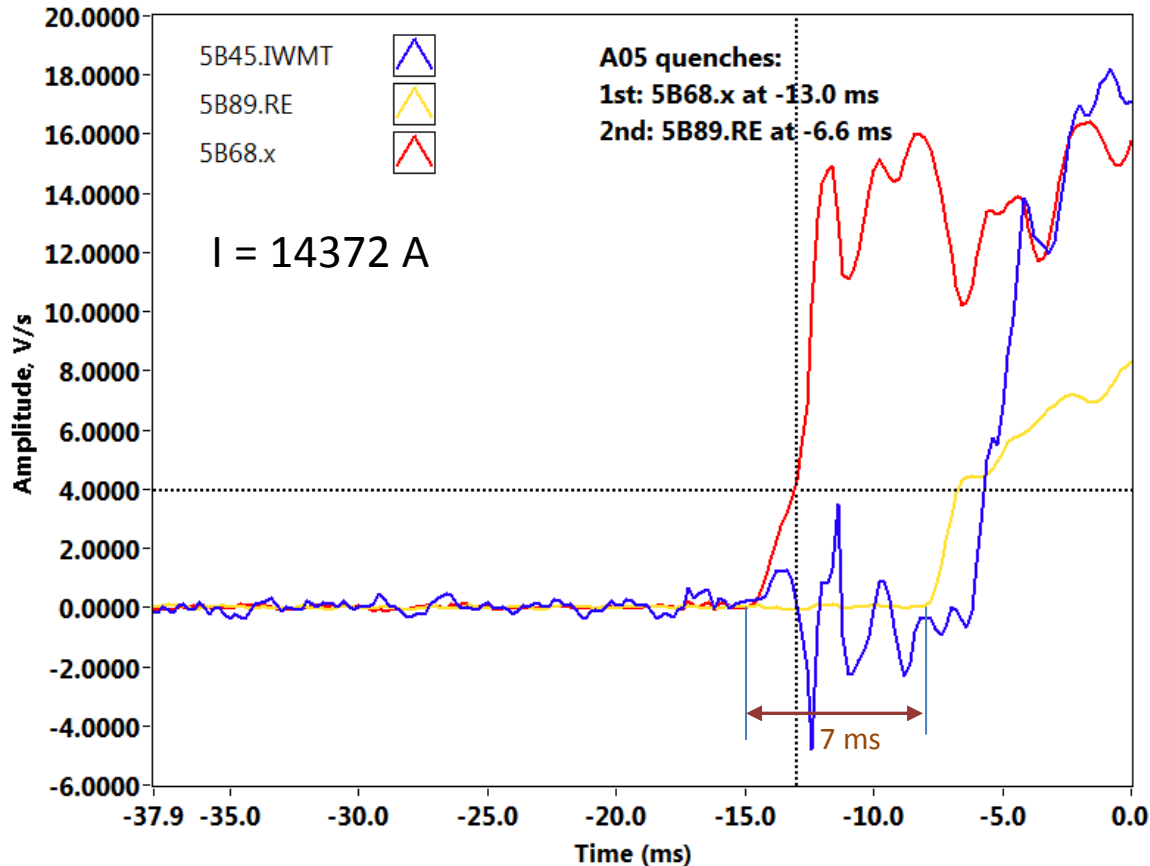
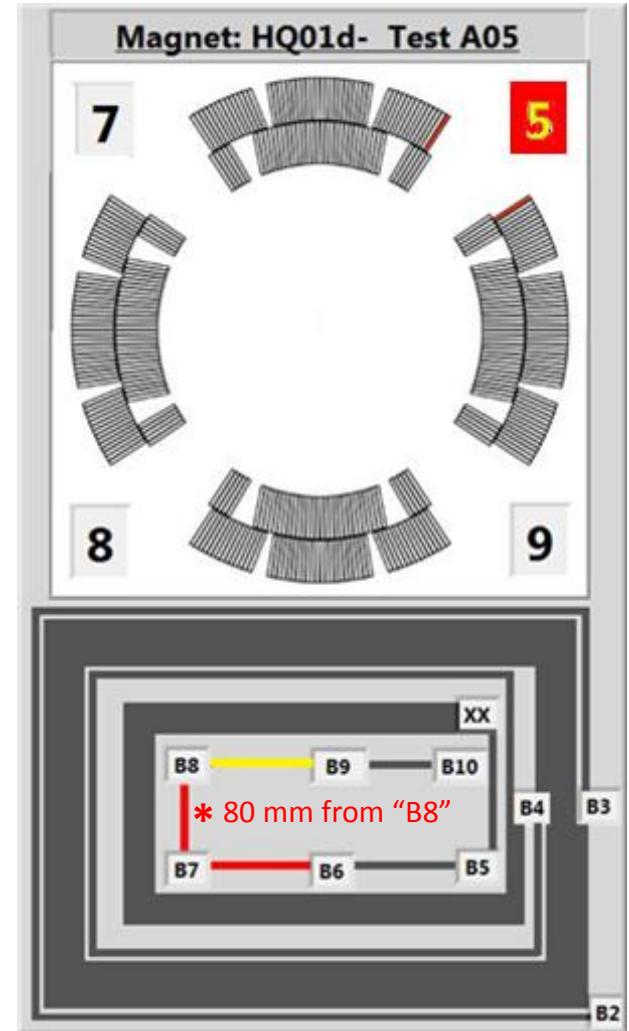
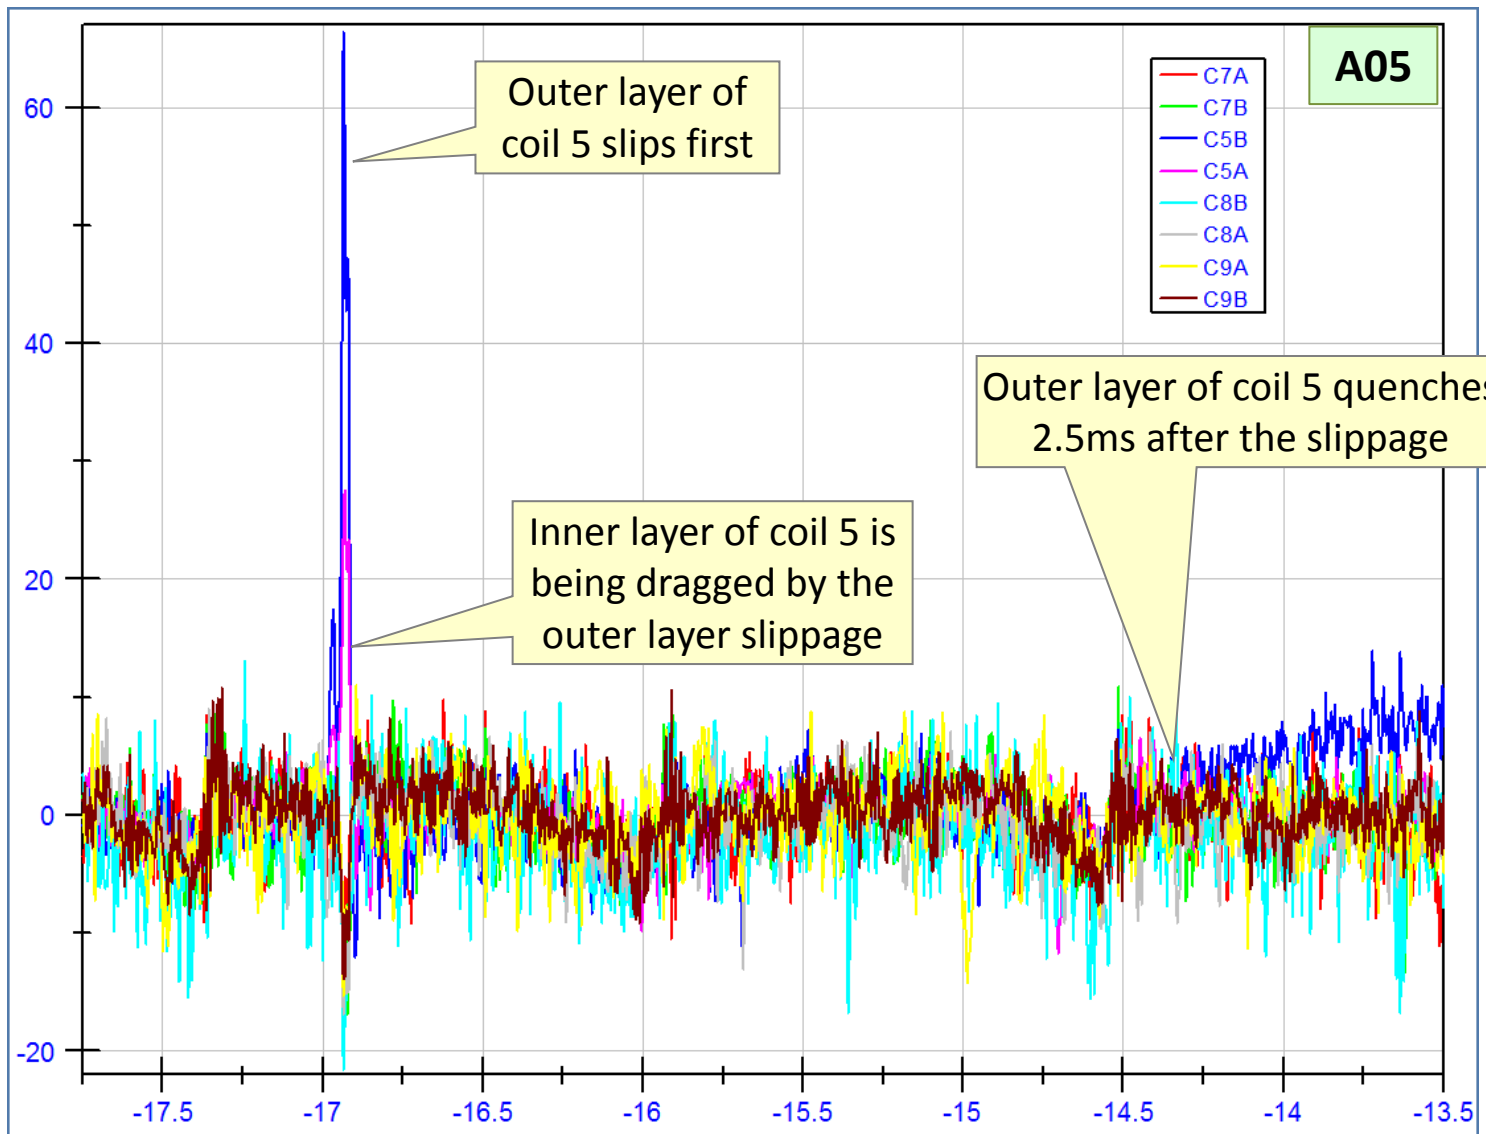
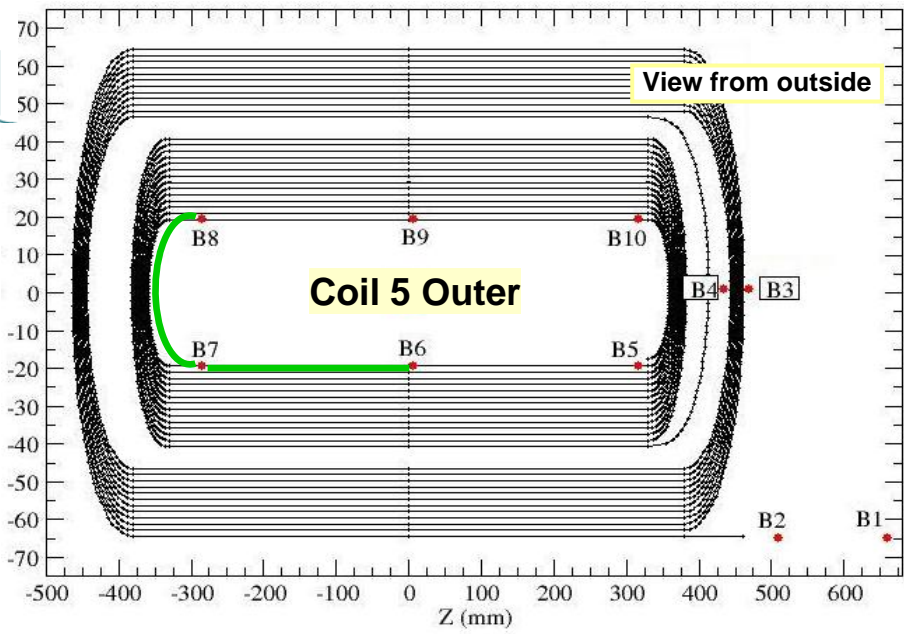
Pole, return end quench (A05)

Initial quench at the pole turn 5B68, propagating into 5B89 and 5B45 multi-turn

After normalizing by sector inductance, it becomes clear that slippage occurred on sector B68.

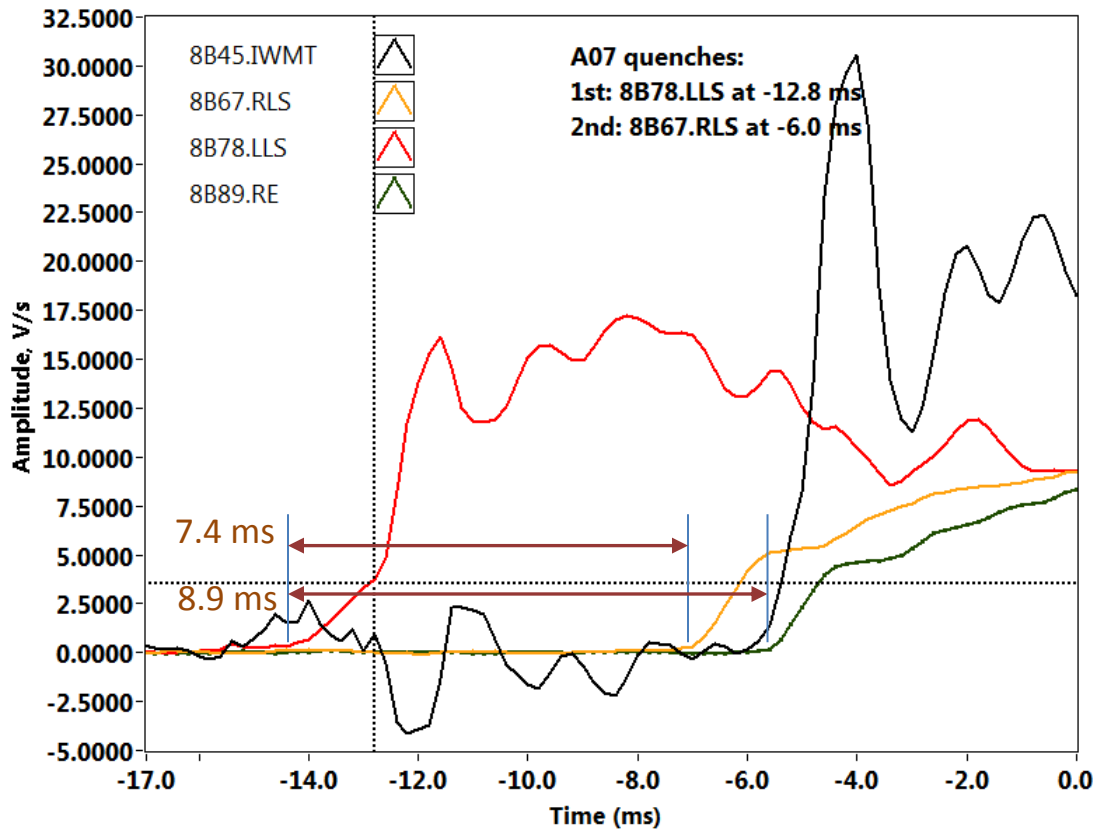
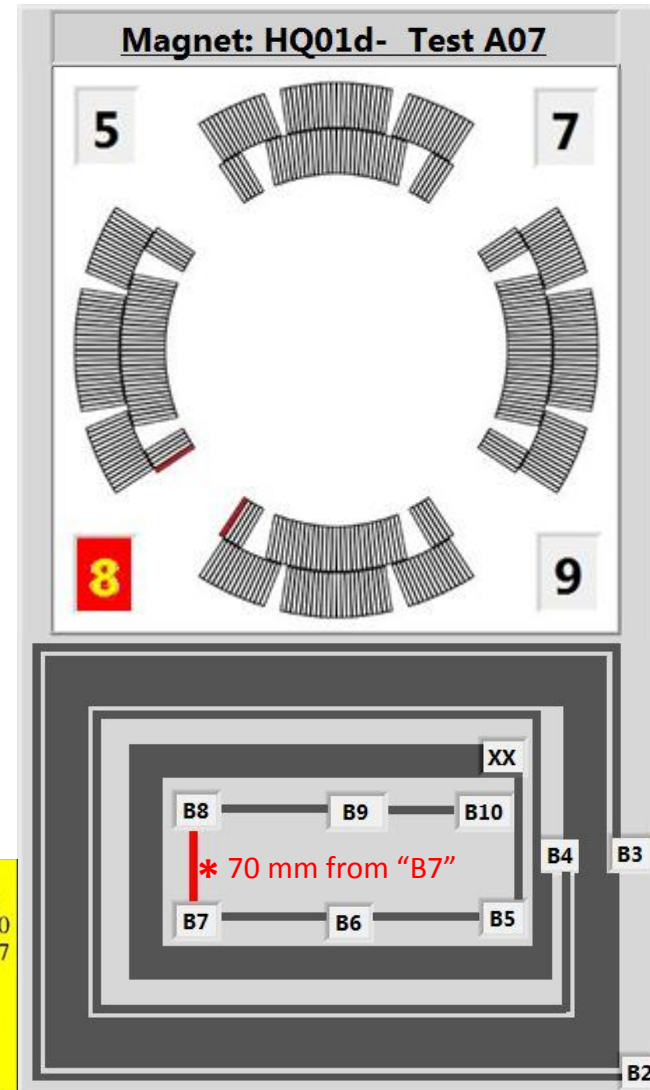
Pole, return end quench (A07)

$I = 13572 \text{ A}$

$MIITS = 12.21$

$V_1 = 154 \text{ mm} / (7.4 + 8.9) \text{ ms} = 9.4 \text{ m/s}$

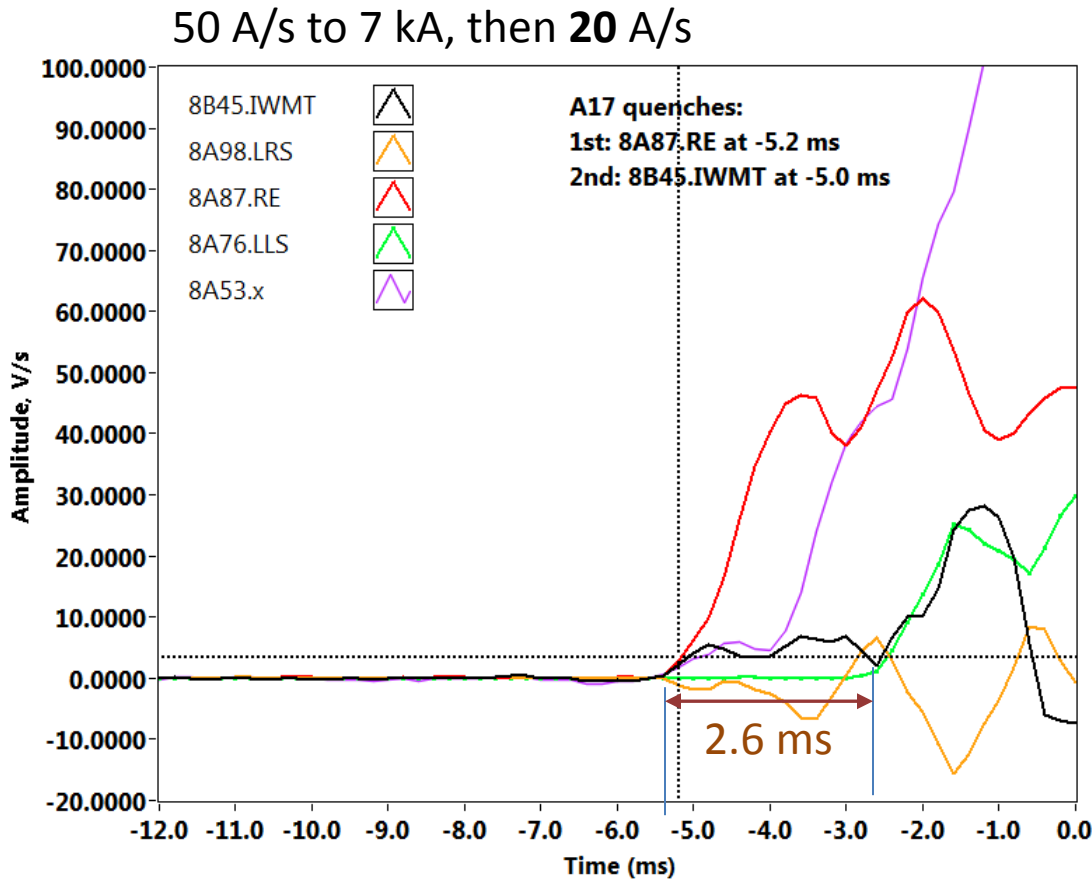
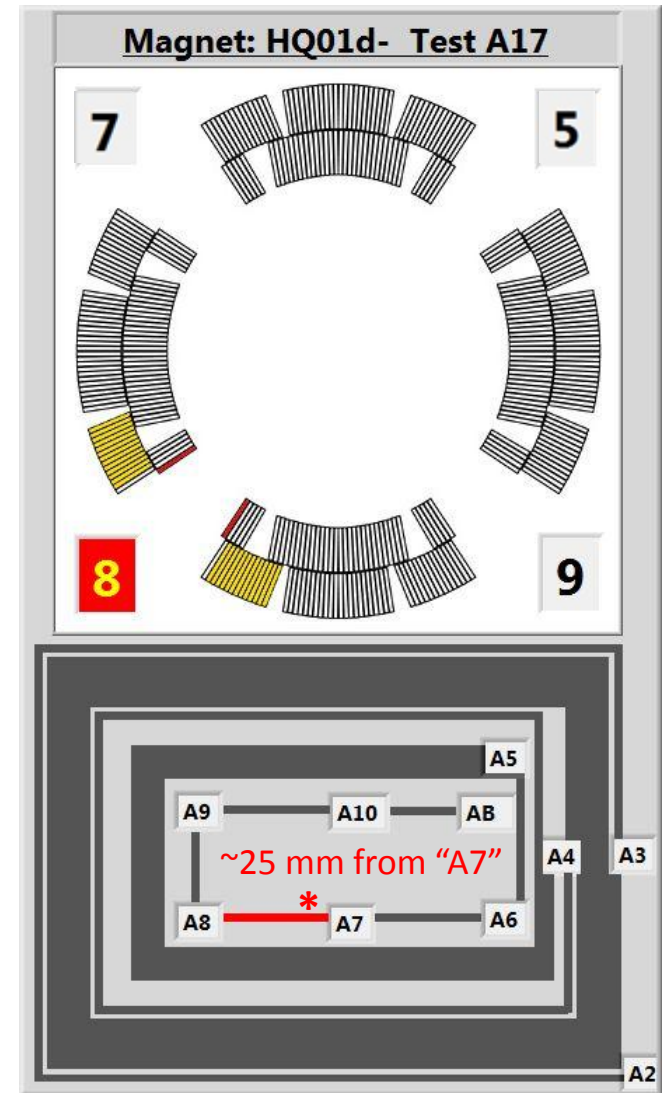
Pole, straight section quench (A17)

I = 14485 A

MIITS = 10.13

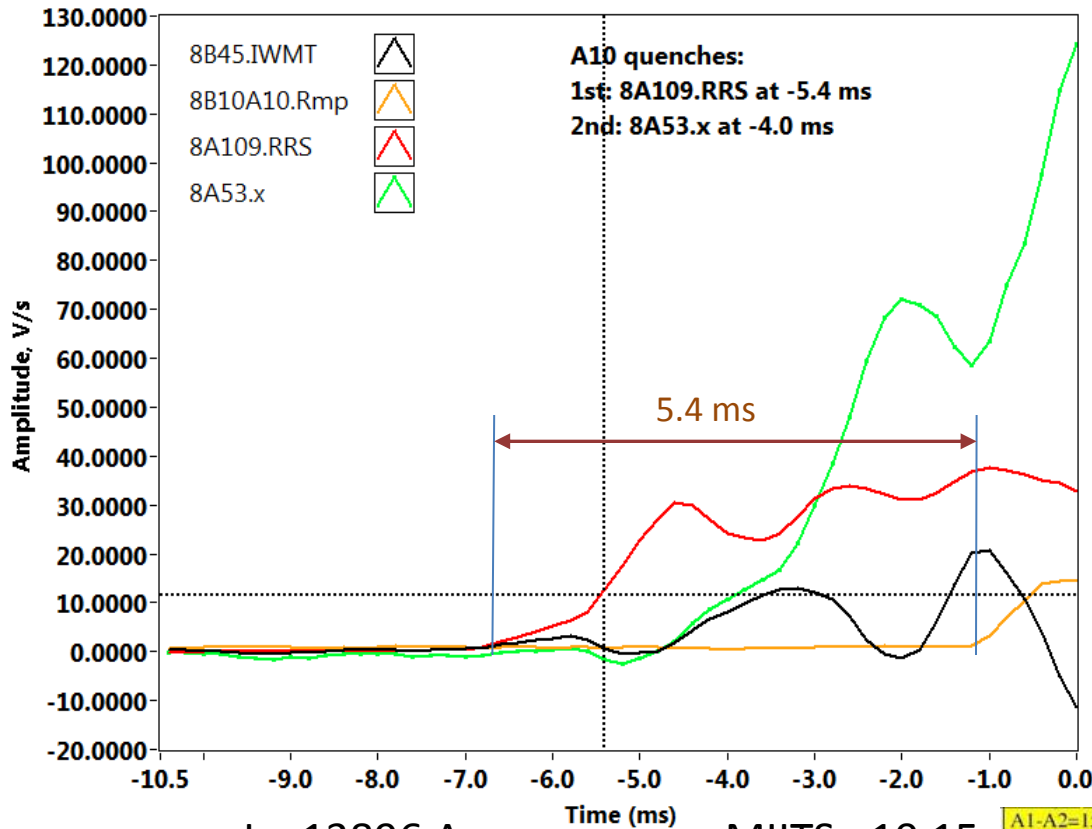
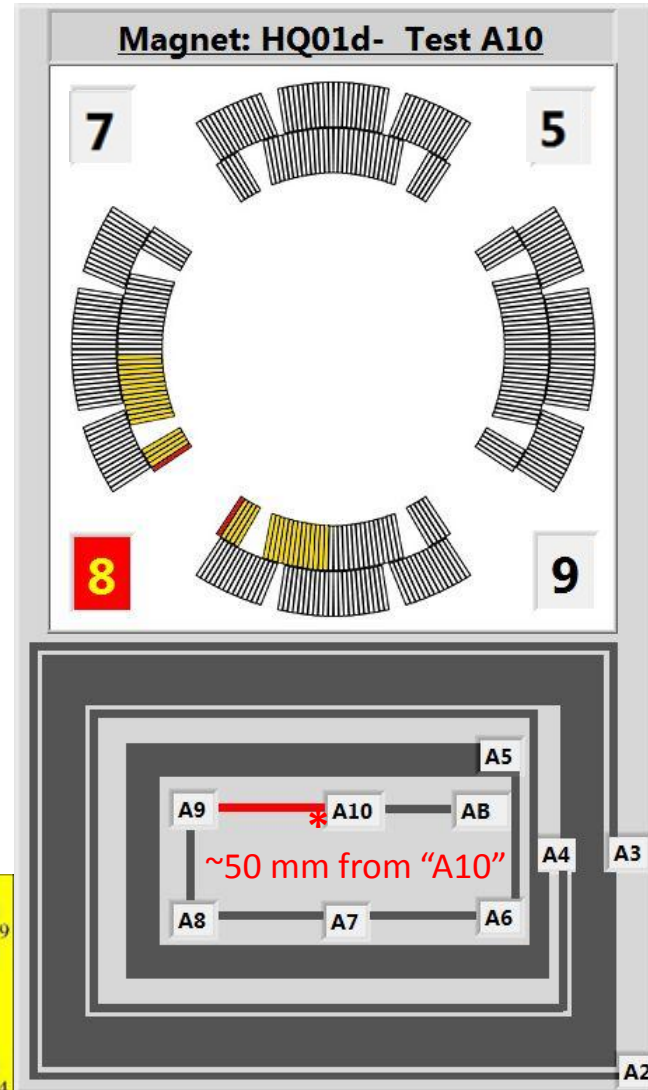
Pole-straight section quench (A10)

I = 13896 A

MIITS = 10.15

(QL based on ~ 9.4 m/s velocity)

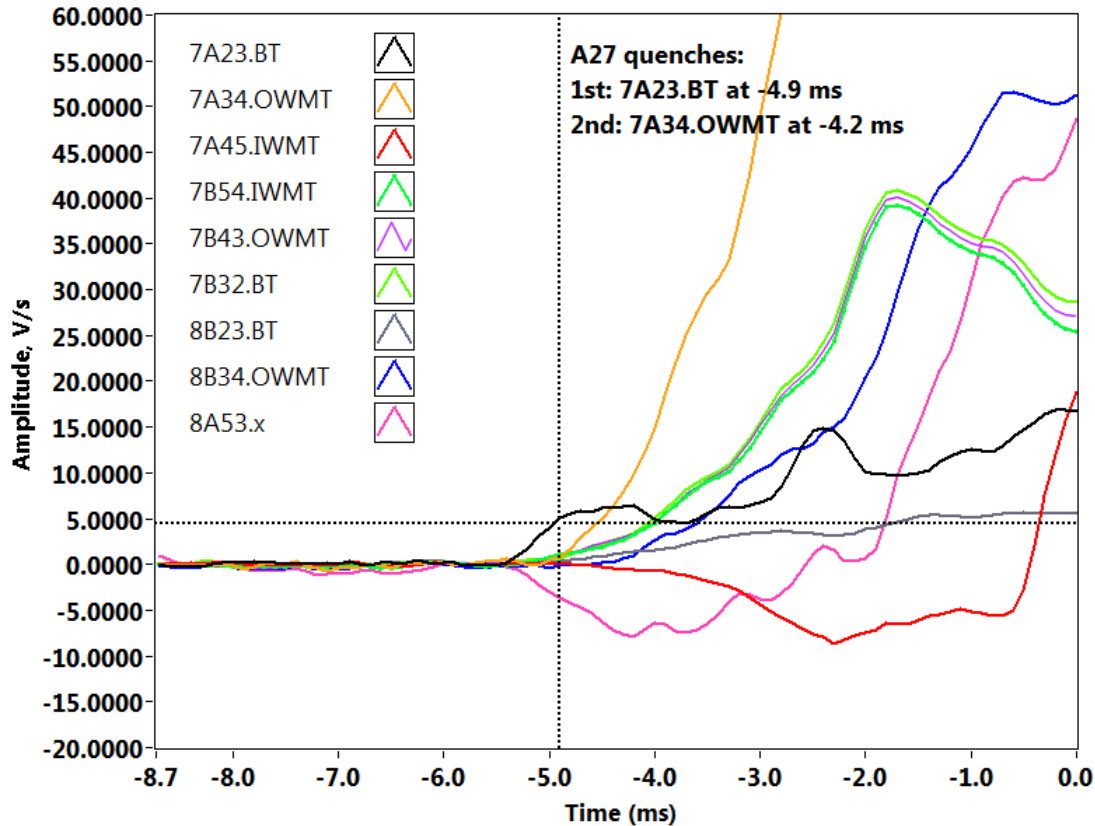
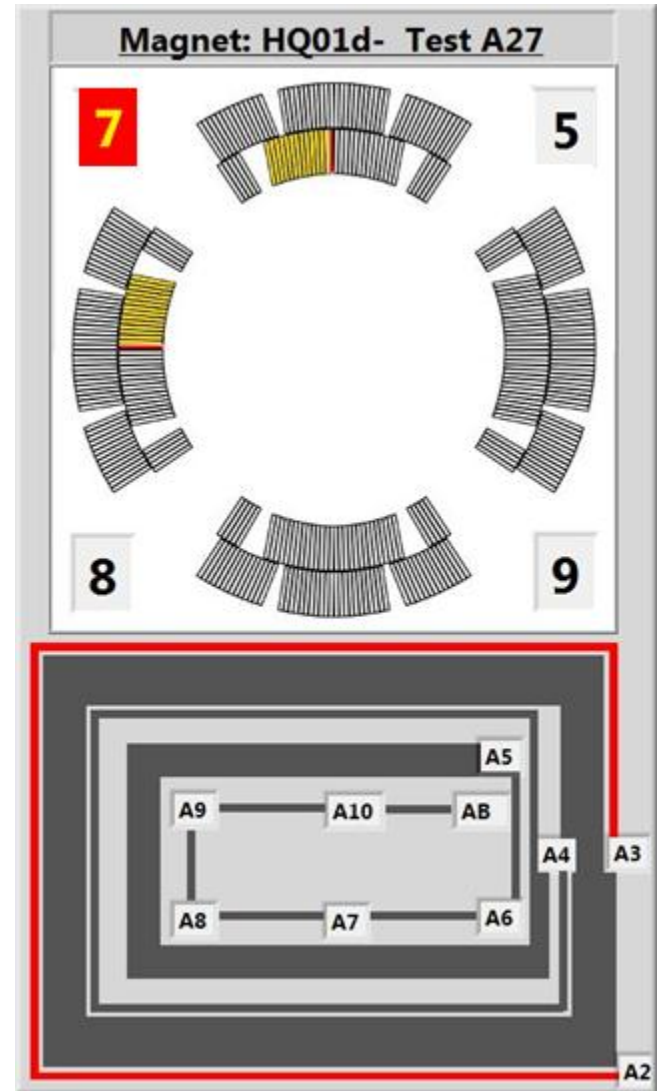
Mid-plane quench (A27)

I = 14612 A

MIITS = 10.11

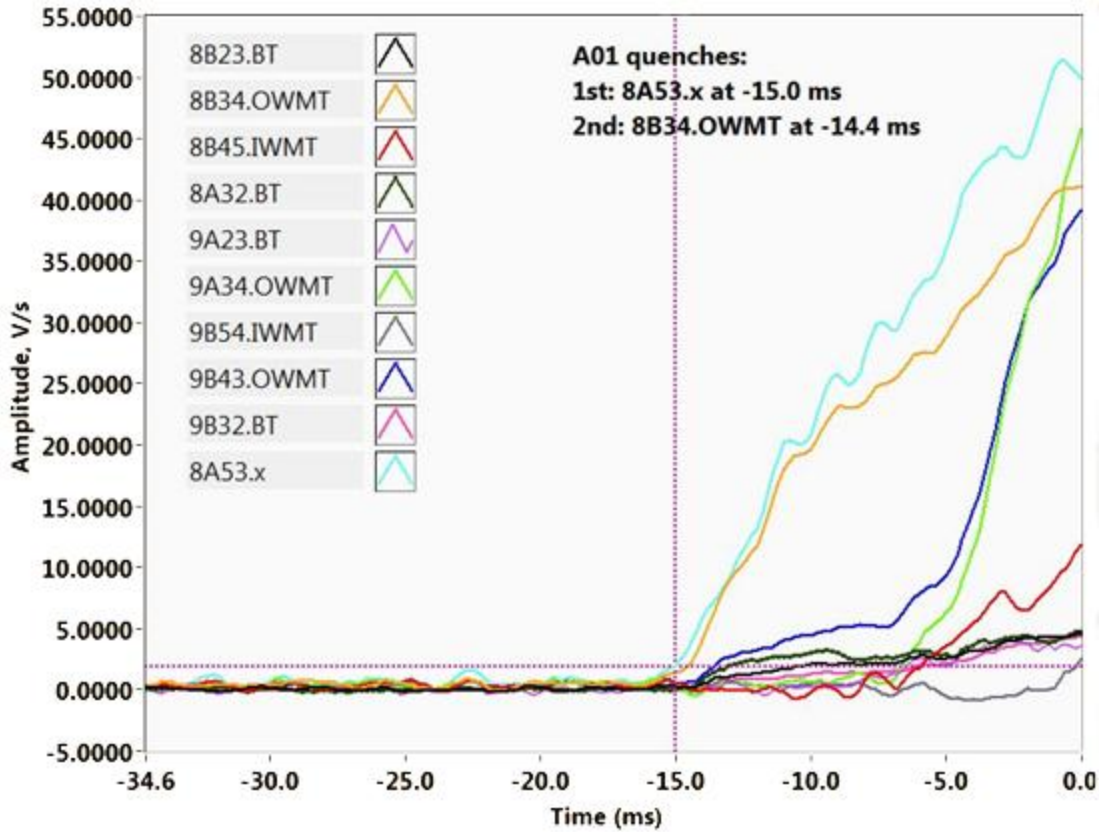
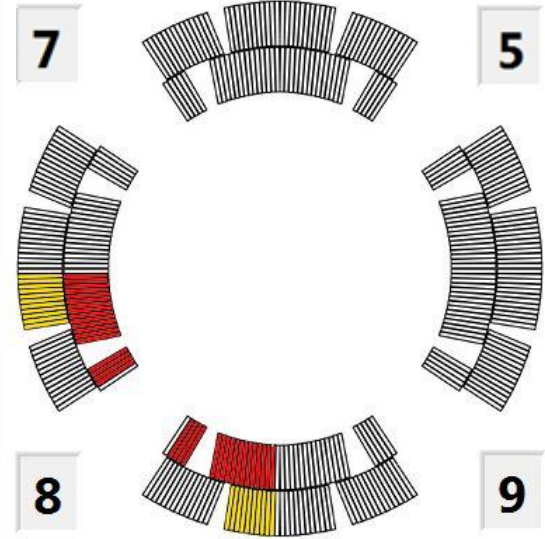
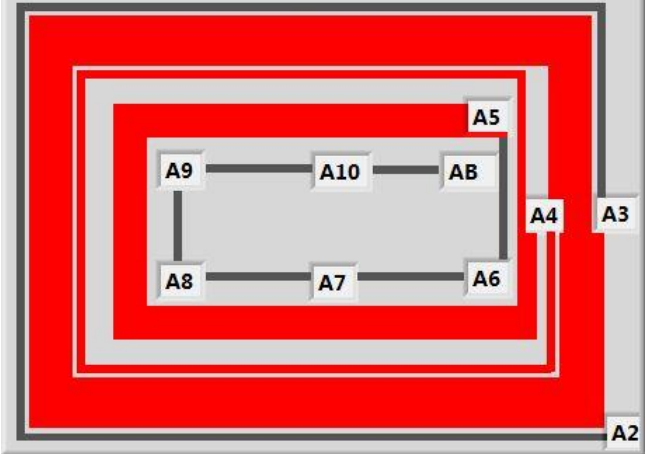
Fast ramp, mid-plane quench (A01)

I = 5719 A

MIITS = 3.19

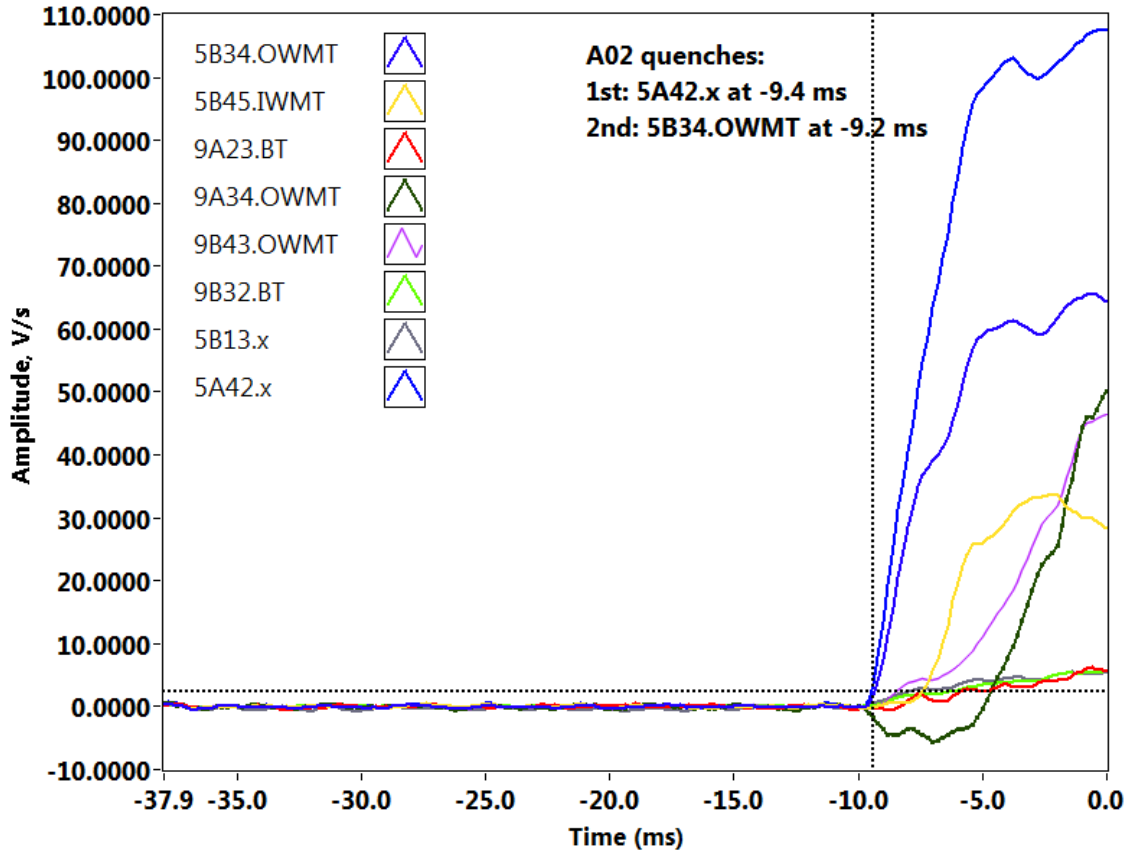
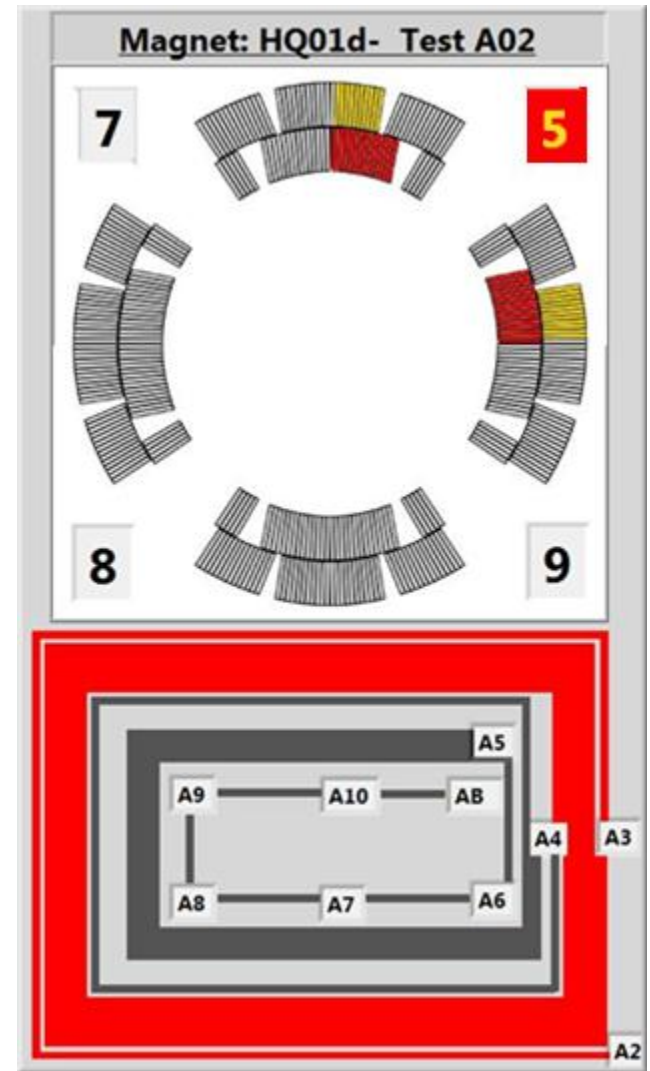
Fast ramp, mid-plane quench (A02)

$I = 8068 \text{ A}$

$MIITS = 5.12$

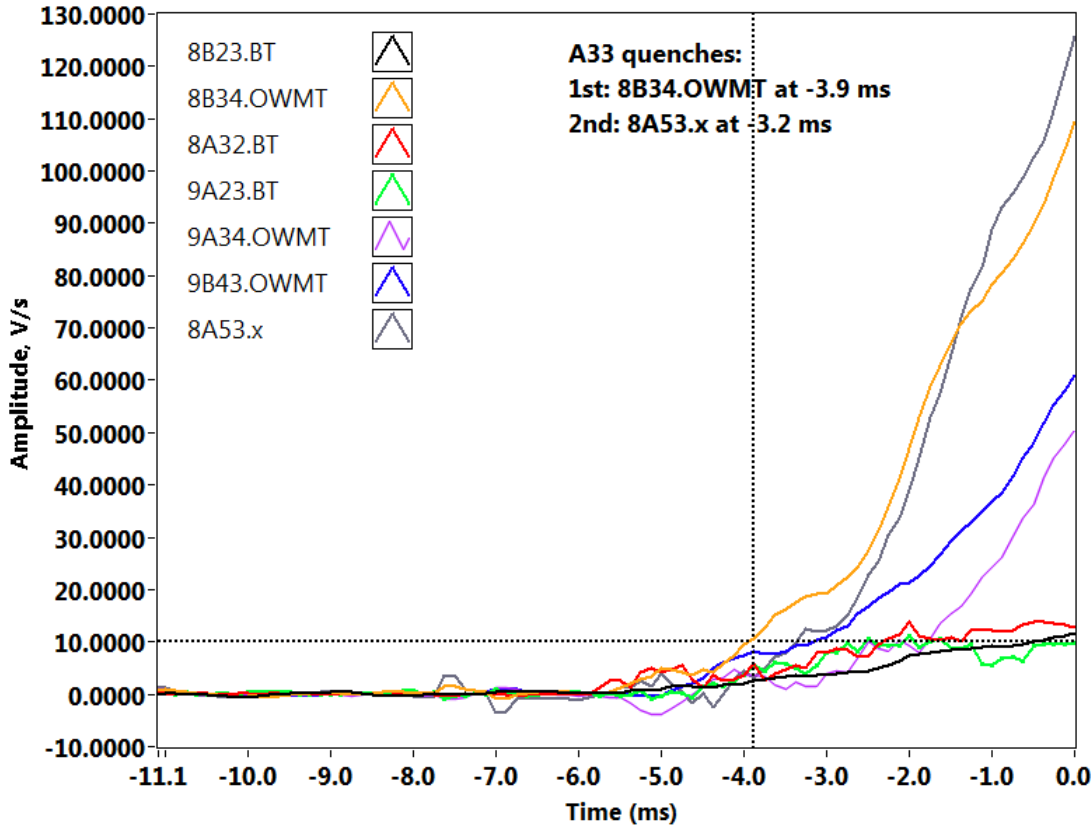
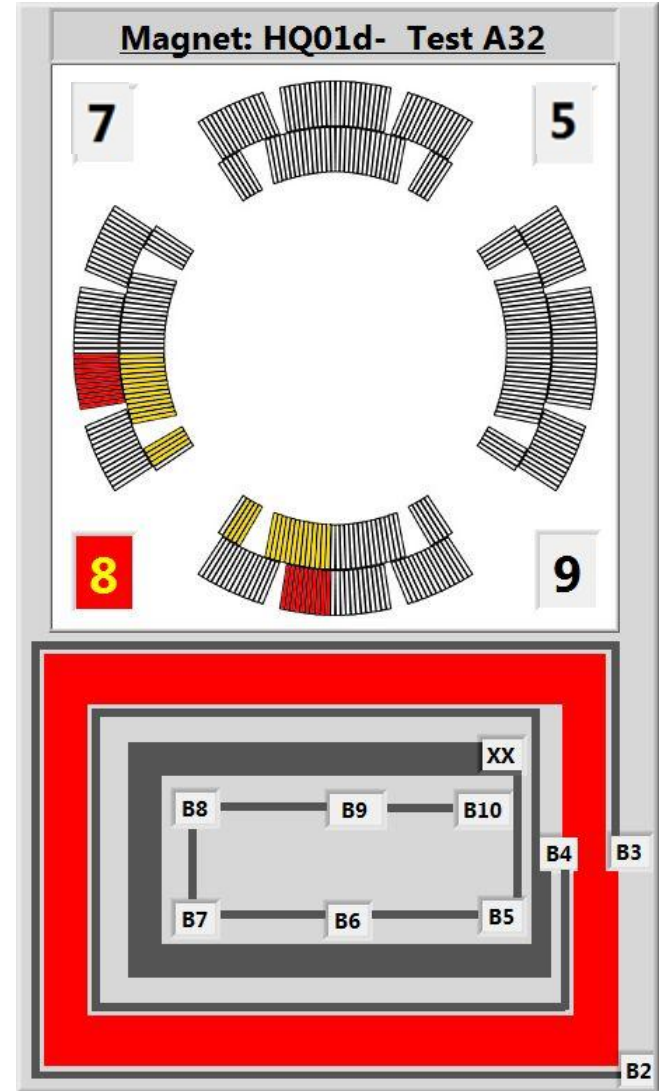
Fast ramp, mid-plane quench (A33)

I = 14318 A

MIITS = 9.63
