LARP

RC Status Report

17 May 2011

SLAC RC Design Details

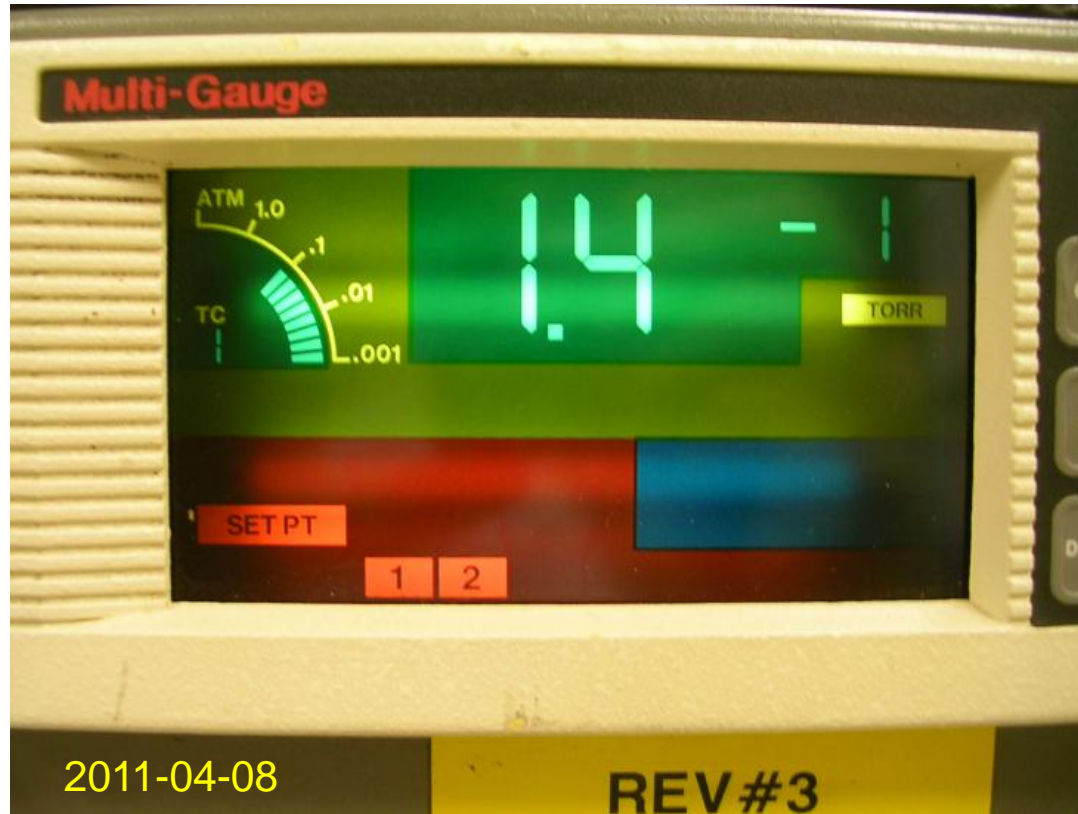
Immediate Check of Tank Vacuum on 2011-04-04 Indicates MASSIVE leak of cooling tubes to vacuum vessel

Would be a “water-to-vacuum” leak if the lines had cooling water in them

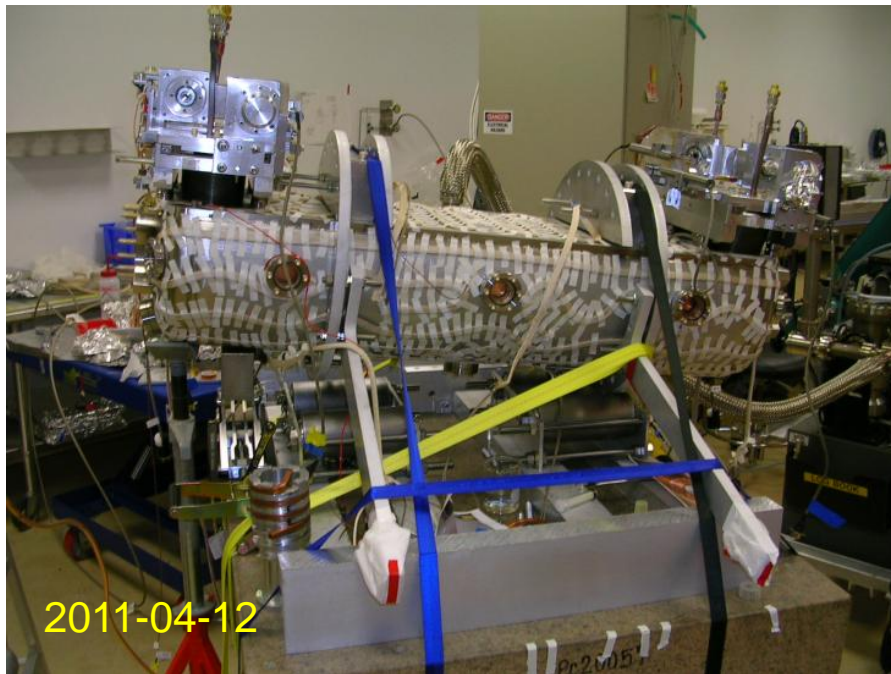
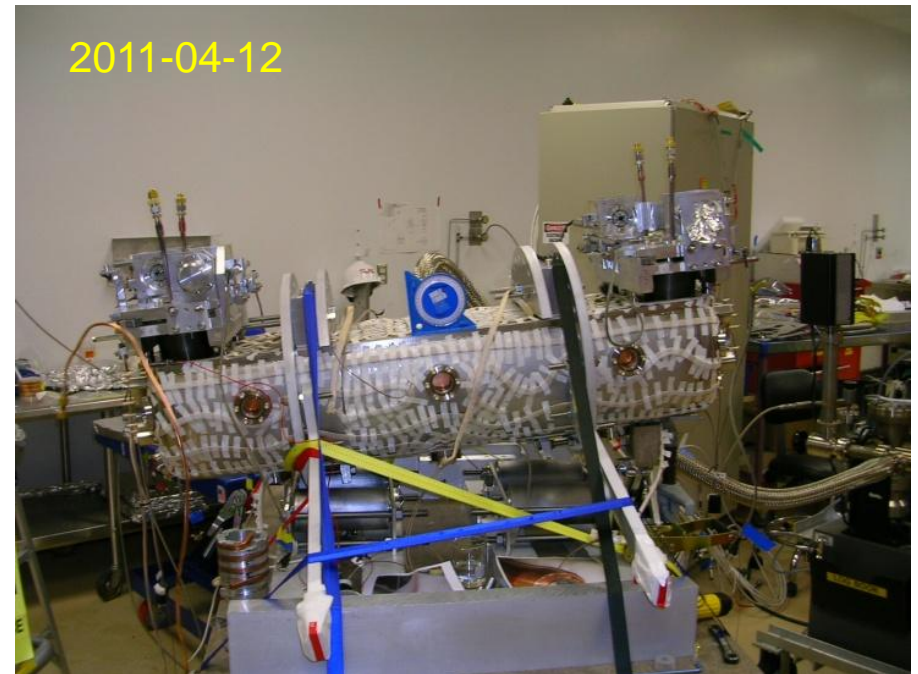
Each Jaw Is Damaged Very Near the End of the Jaw

Pour 60mL Alcohol Into Each Cooling Tube
Find that it Drains Out Cracks at the Very End of Each Jaw

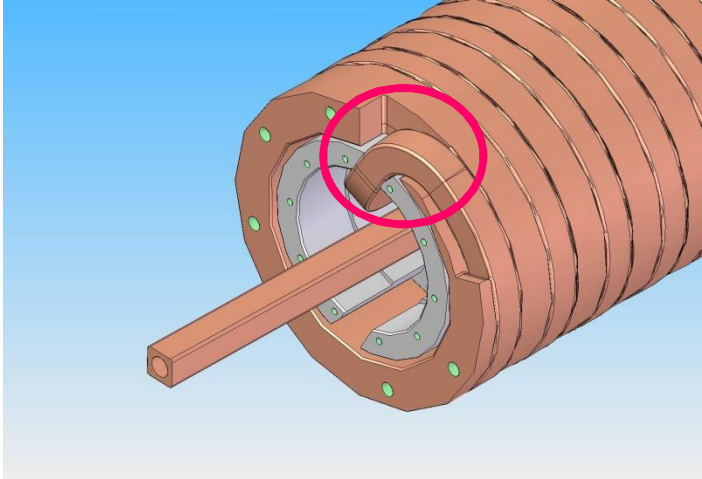
Upbeam Side of RC0 Jaw

Possible Leak Locations

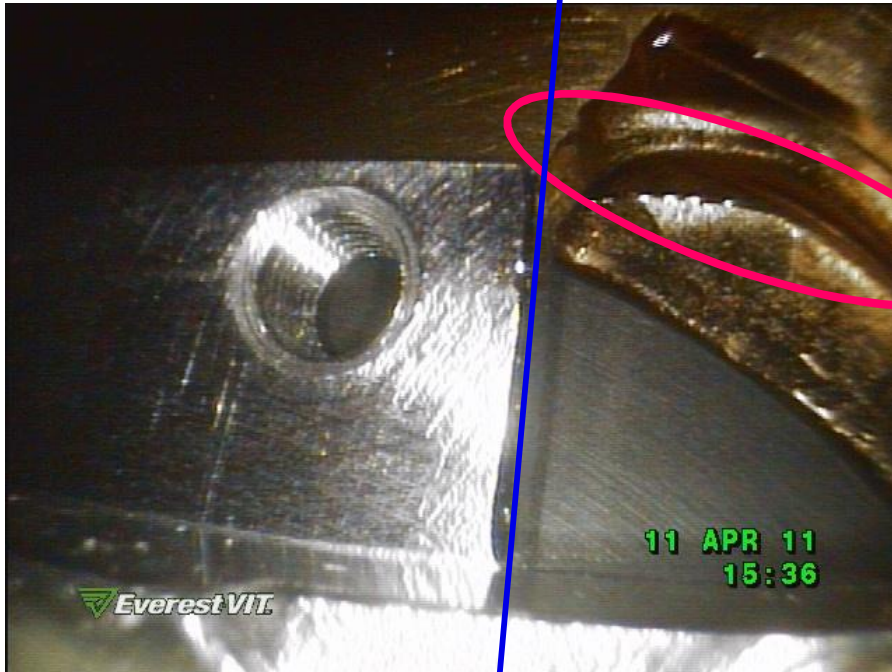
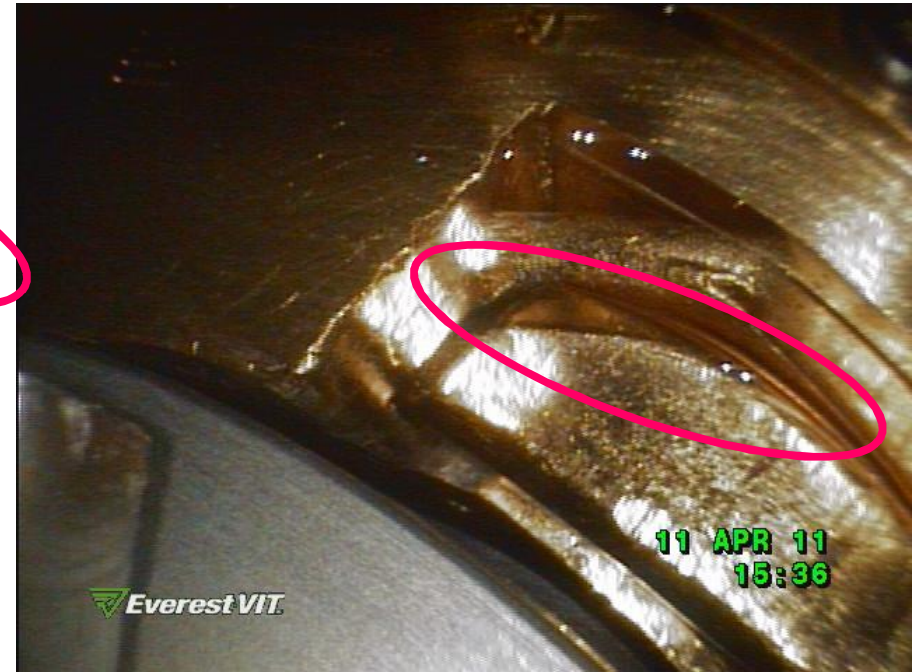
Downbeam End of RC1

Liquid seems to be on inner surface of tube
No "crack" or "hole" visible

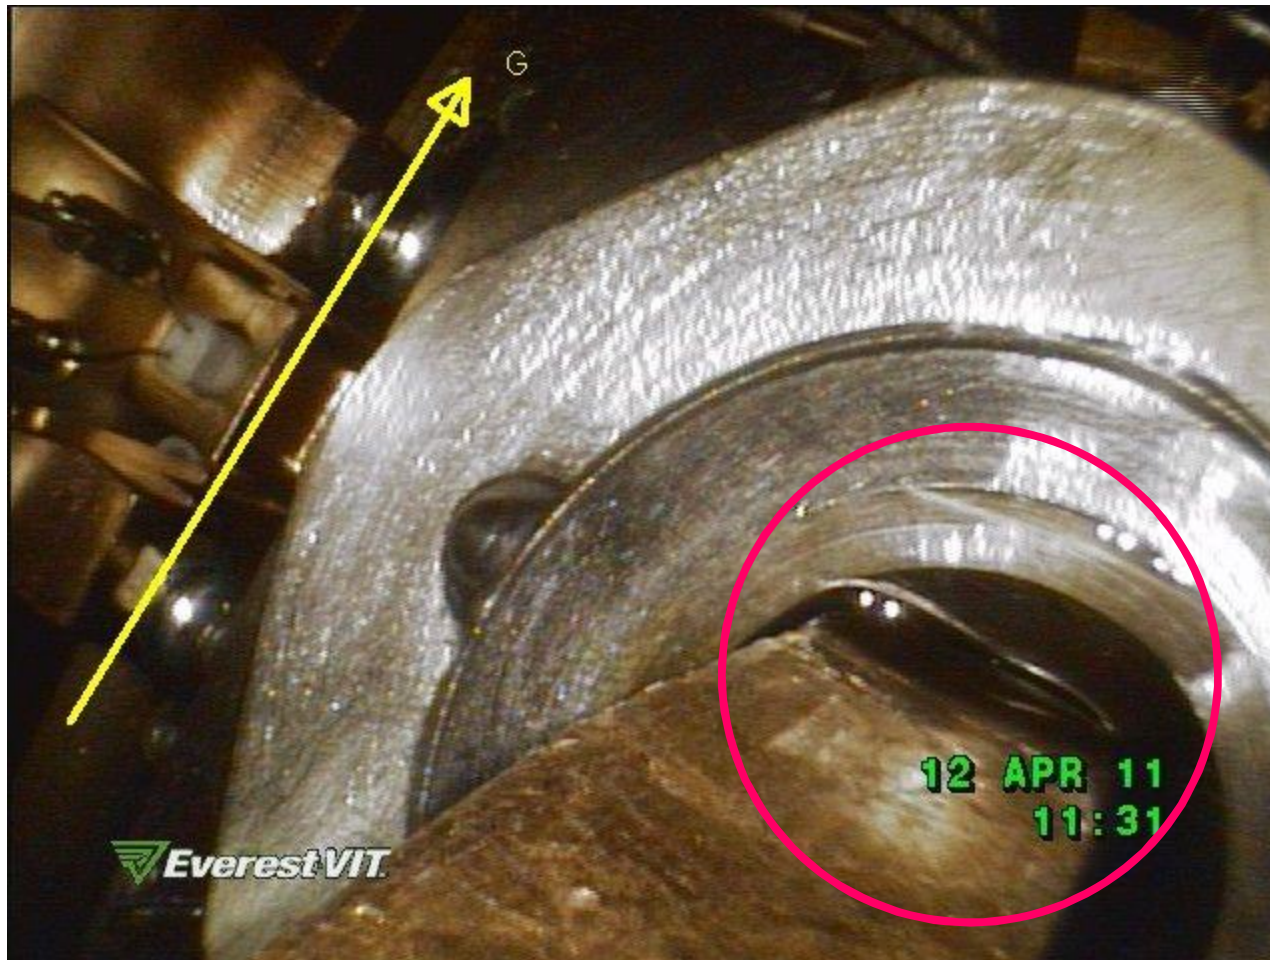
Upbeam end of RC0 Alcohol Accumulating on Tube from other end as it exits the rotation bearing housing

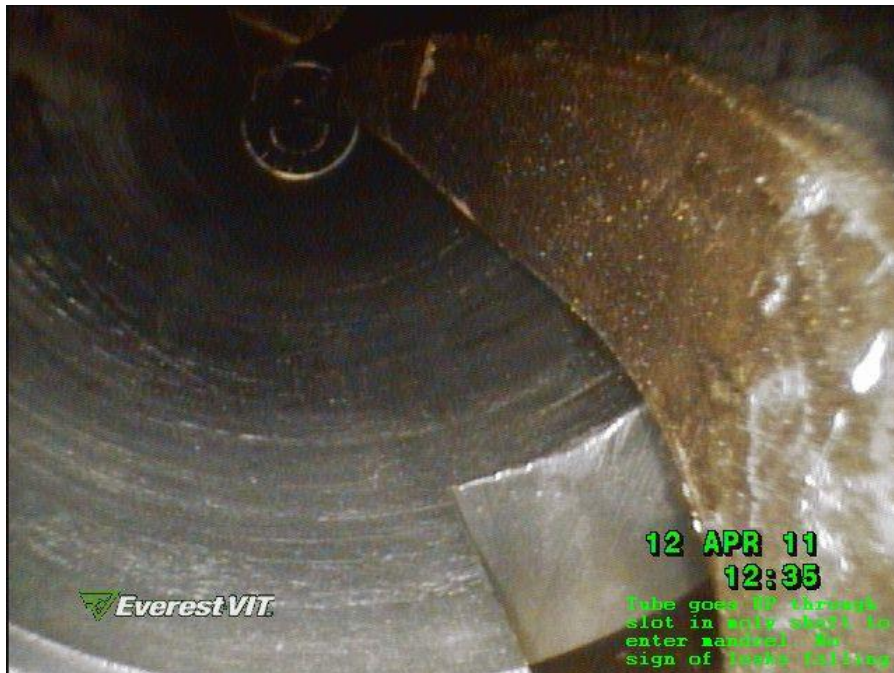
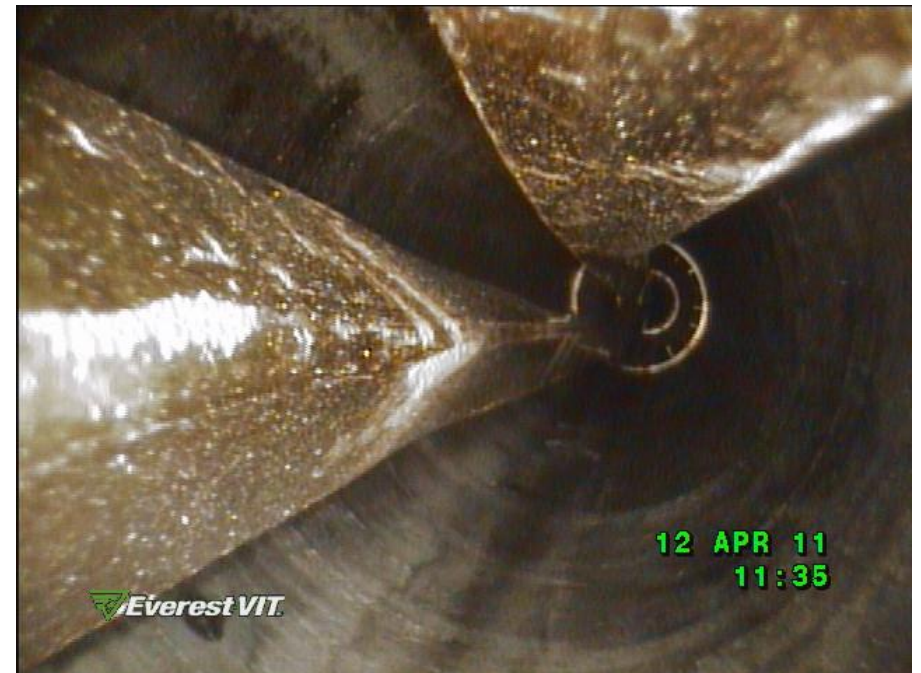
No Sign of Alcohol on Tube as it Enters Mandrel of RC0 nor on Long Runs of Tube in Center of the Mo Shaft

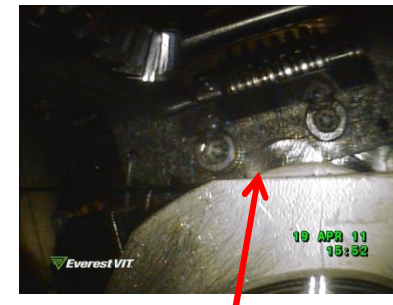
Crack in Mo Stable

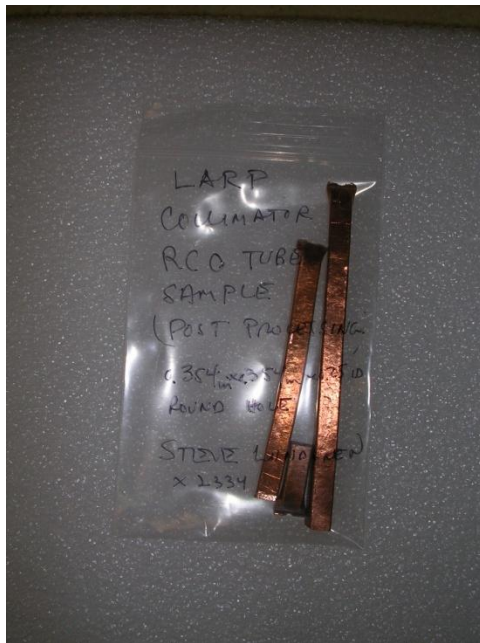
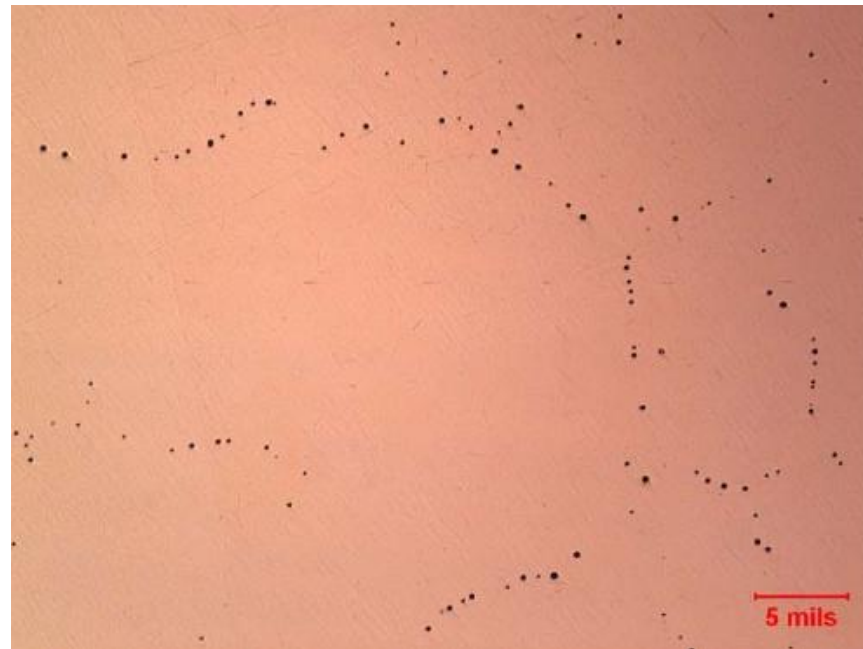
“Large non-equiaxed grains consistent with hydrogen annealed OFE copper. Porosity was rated per ASTM F 68 Plate 1. Porosity was observed within and across grains.

“The samples conform to **ASTM F68 Metallographic Class 4 for porosity** resulting from oxygen contamination.”

* Material purchased as Grade 1 OFE with test data sent by manufacturer

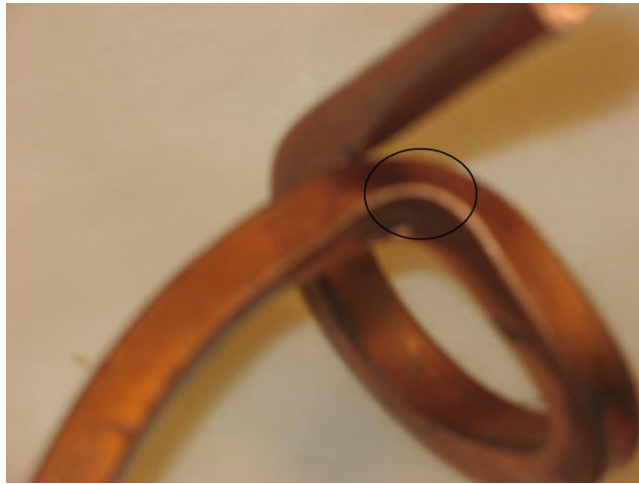
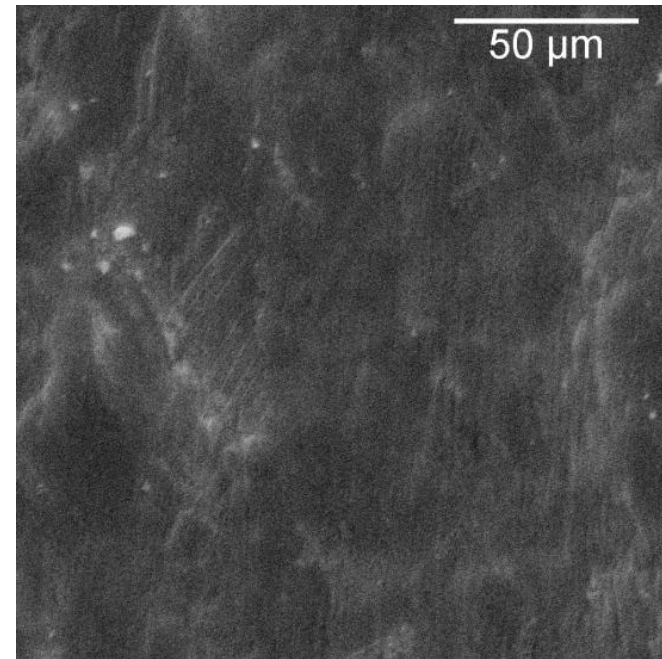
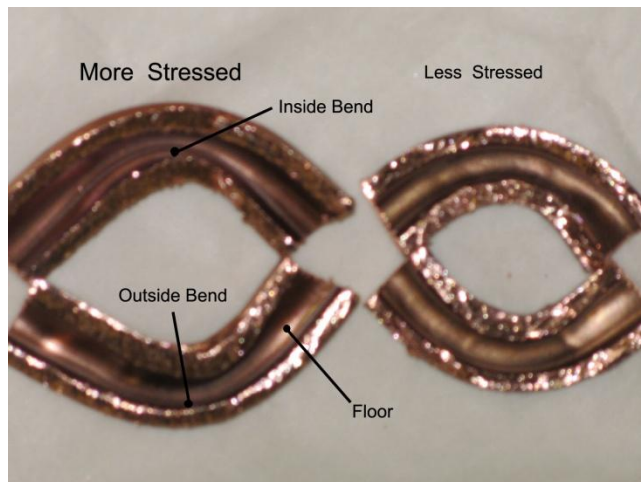
Sectioned Bends & SEM of Material Stressed by Bending

No Conclusions
