# Issue and autopsy on coil CR114

N. Lusa

18 June 2020

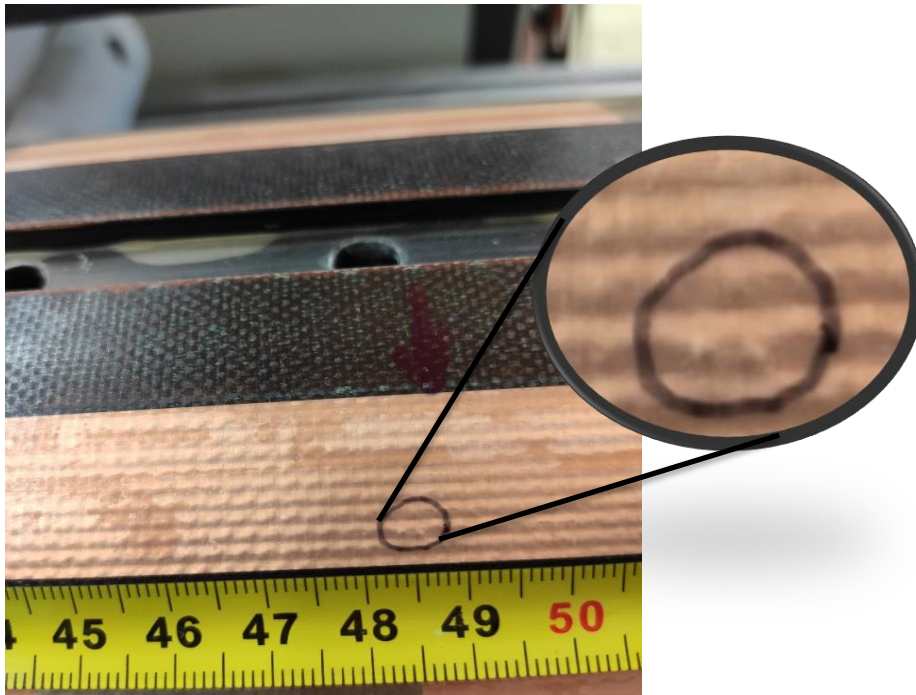
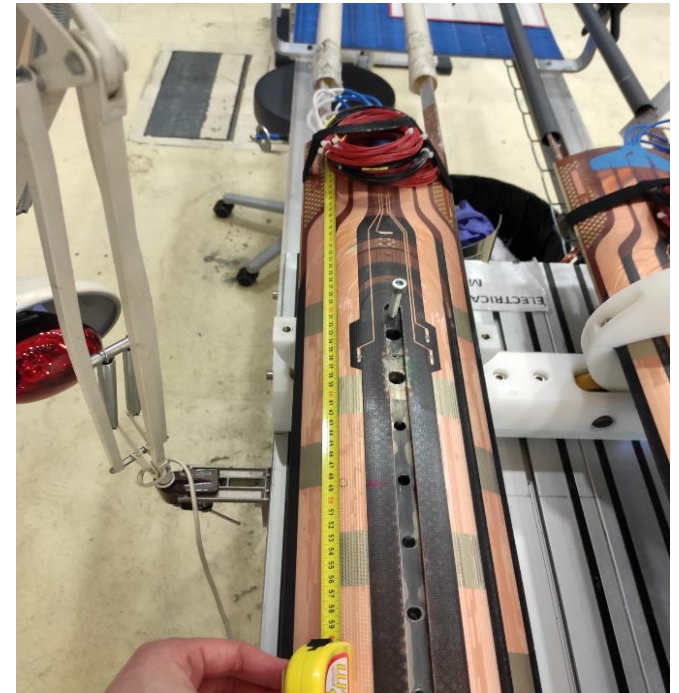
- During the acceptance electrical test of the coil, an electrical weakness was detected: low insulation resistance between quench heater circuit QH213 and MQXFB coil CR114 (all details about the non-conformity can be found on EDMS, document n° 2377455).
- The default was localized using an ohmmeter connected between the coil and QH213, and by applying a finger pressure along the QH213 strip until a change in resistance was detected (localization at 485mm from LS).

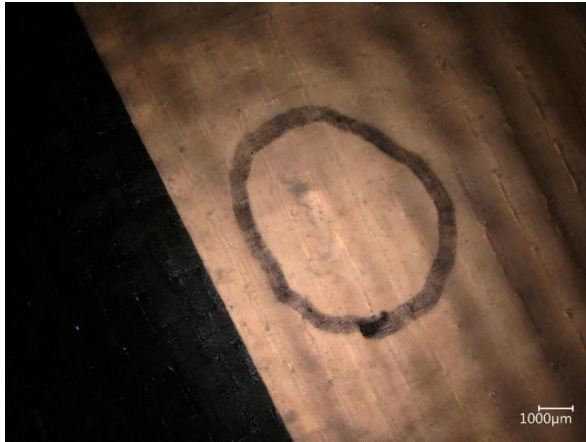
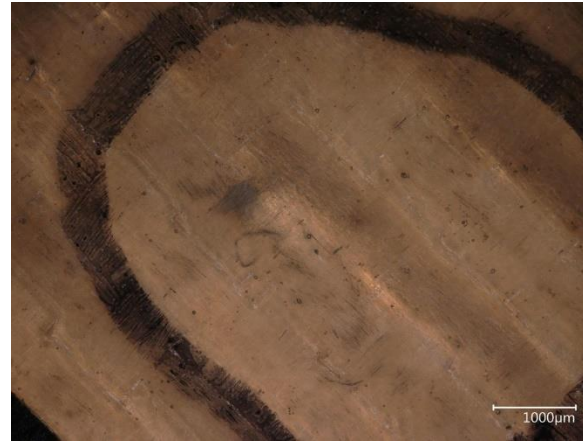
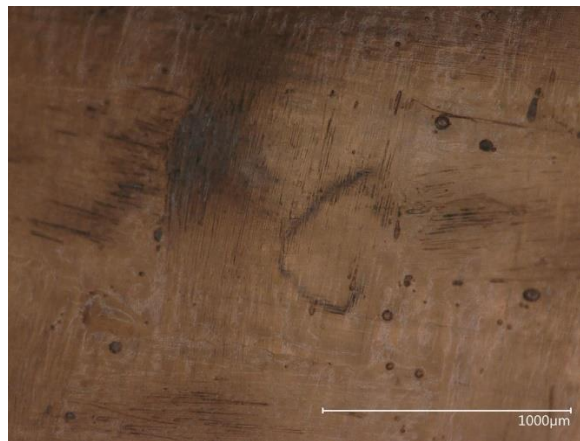
- An analysis of the quench heater area where the insulation weakness was localised with a microscope has been performed, but unfortunately the examination of the surface could not bring much more information.

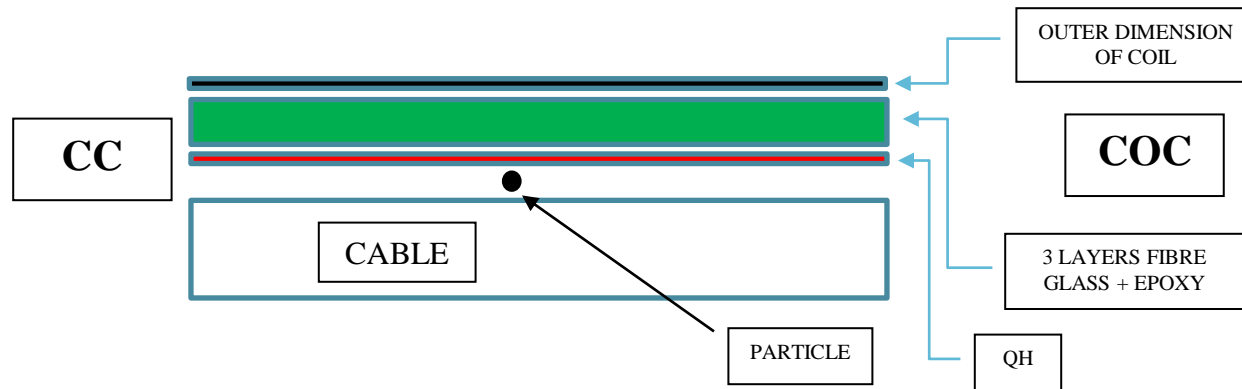
- The insulation weakness was possibly caused by a hard particle (if any) between coil and quench heater circuit that may have damaged the polyimide insulation under external pressure, so the assumption is figured here below:

- Different solutions have been tested and finally the one decided was the local chemical etching of the heater circuit around the defective area using ferric perchloride to chemically attach the metallic strip of the QH after having scratched the surface till the copper of the QH.

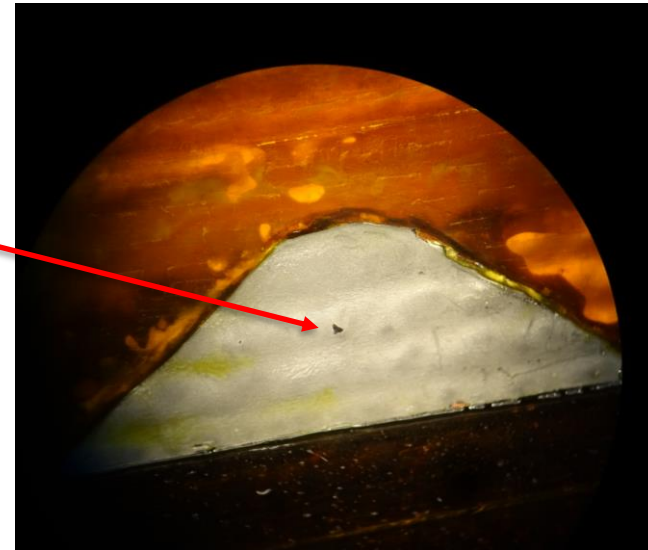
- A few minutes after the application of the chemical product, a small hole located in correspondence of the “bump” observed during preliminary control was found.
- This hole is exactly on a turn of the coil.

Revealed hole in the stainless-steel strip

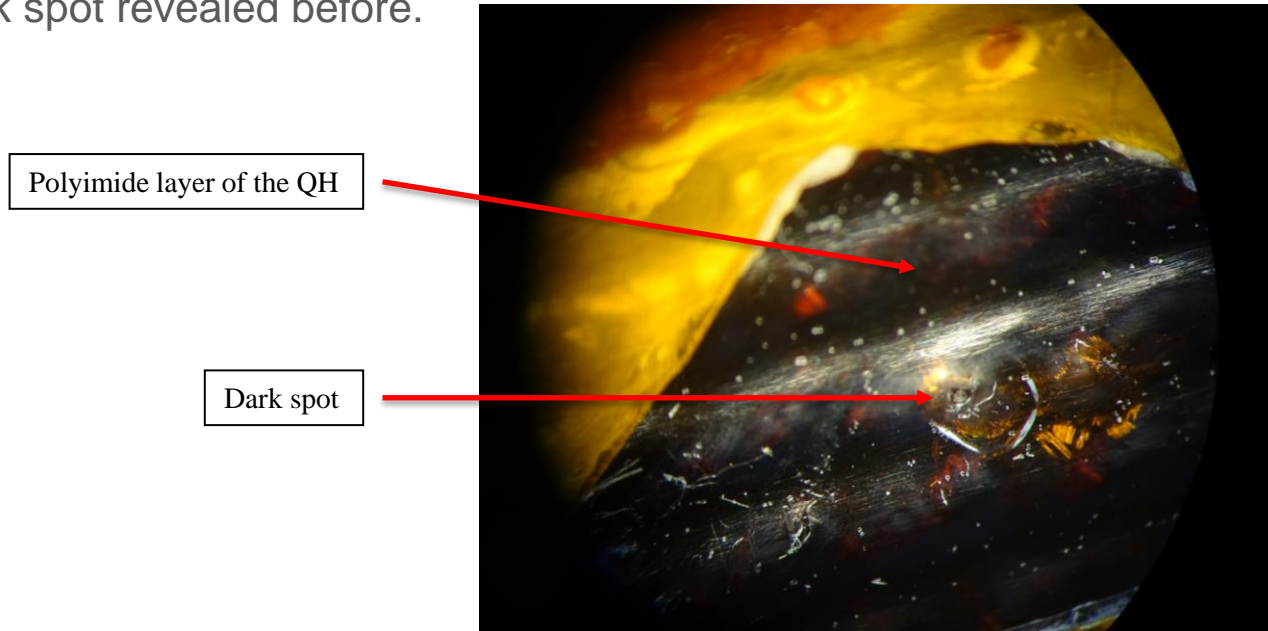
- Once the circuit area was etched away, we had the opportunity to better see the dark spot revealed before.

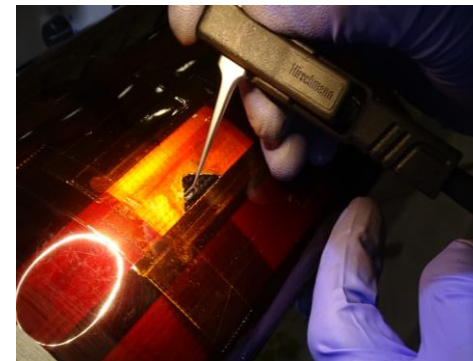
- At this point, an electrical check with a multimeter was performed connecting one wire to a lead and the other to the concerned spot and a “beep” was heard. That led us to two possible conclusions:
  - An external particle was in contact with the cable.
  - We were touching the cable.

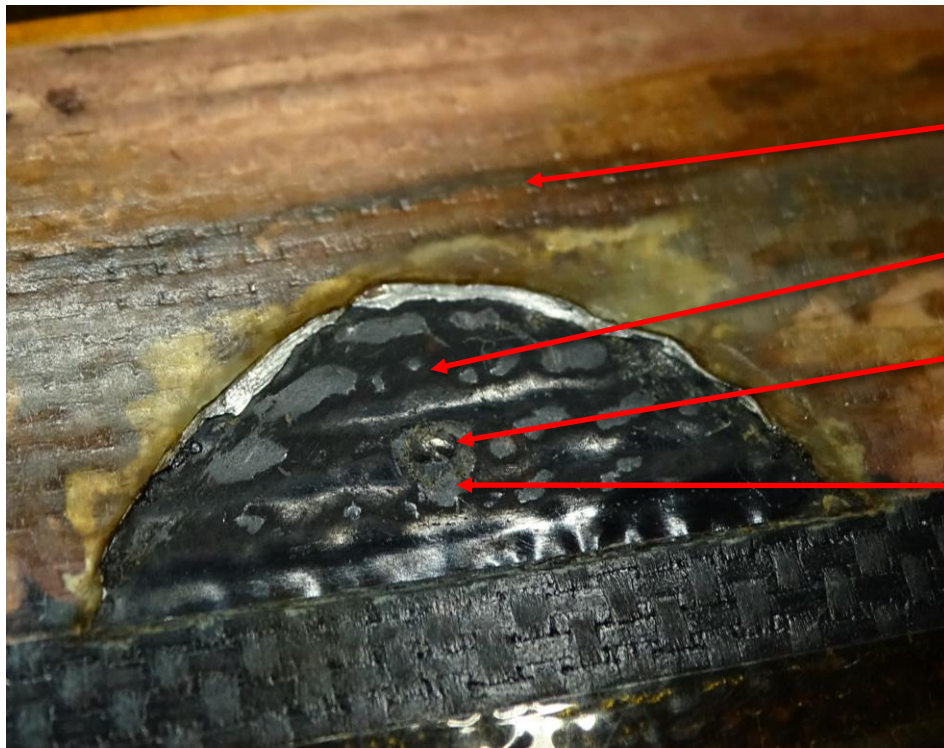
- After having completely removed the metallic layer of the QH, a Hi-Pot insulation test electrical test was performed: 500 V QH213 to coil, passed and the measured resistance was 12.8 G $\Omega$ .
- In accordance with the work package engineer, it was decided to keep going with the investigation of the defect.

Limited area of intervention where polyimide insulation of the QH has been removed

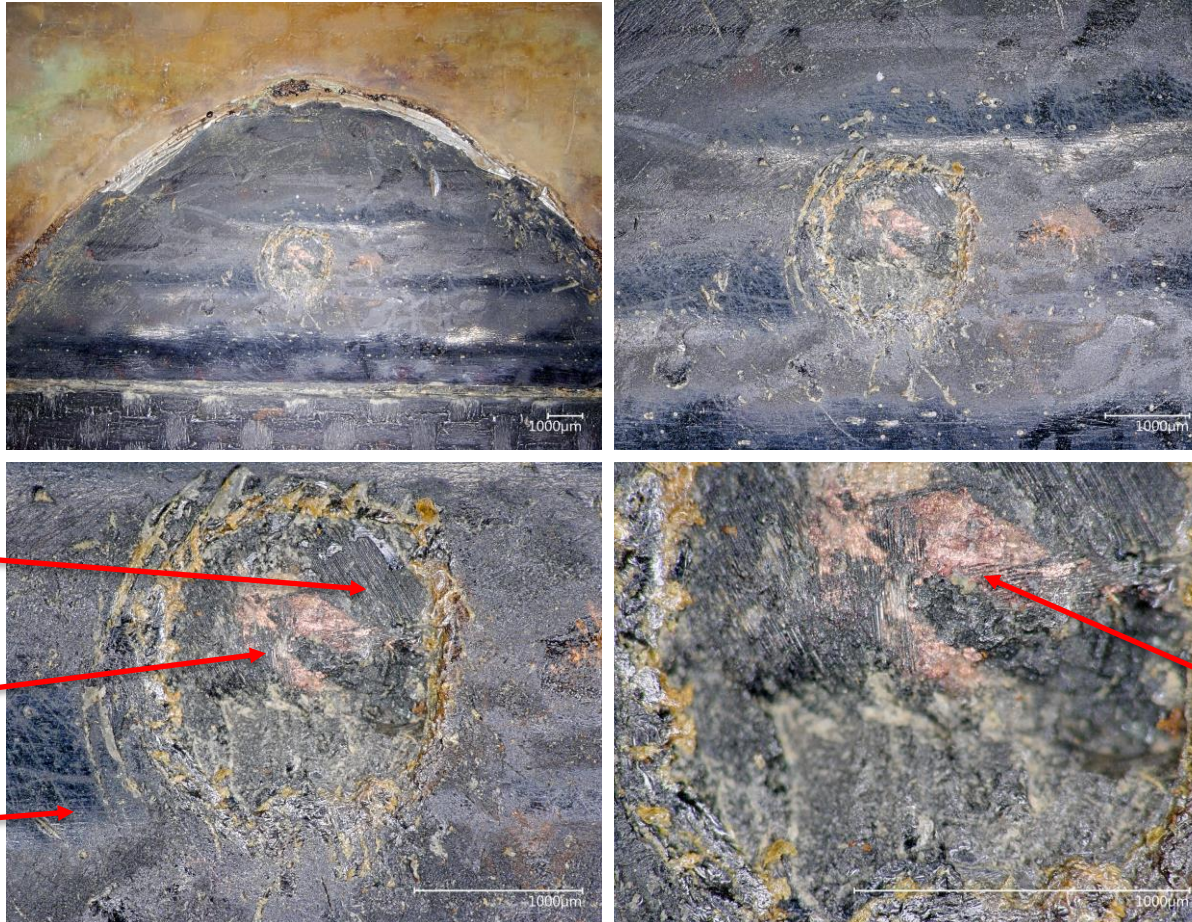
- During the delicate scraping of the polyimide film, no external particle has been observed. In order to verify the hypothesis that it was the cable and to check its status, a microscopy analysis was performed.

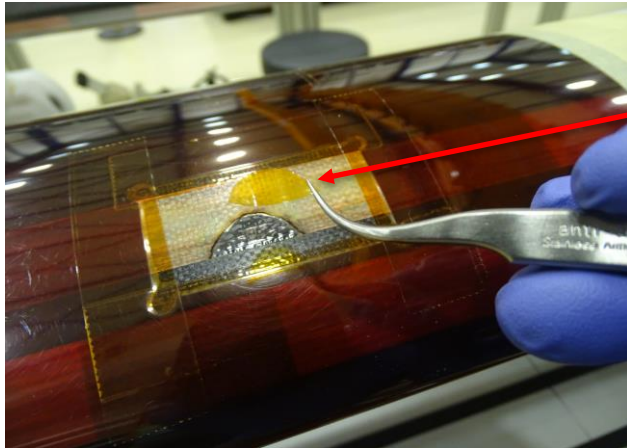
Polyimide tape to protect and insulate the cable

- In order to better clean ferric perchloride that migrated between fiber glass + epoxy and metallic strip of the quench heater, it was decided to scrape a bigger area at the surface of the coil.

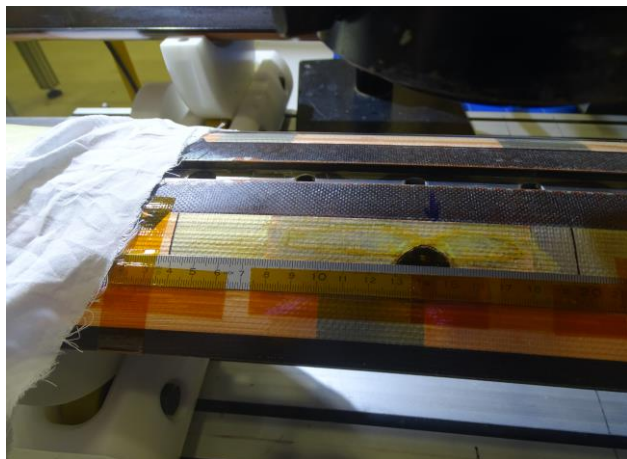
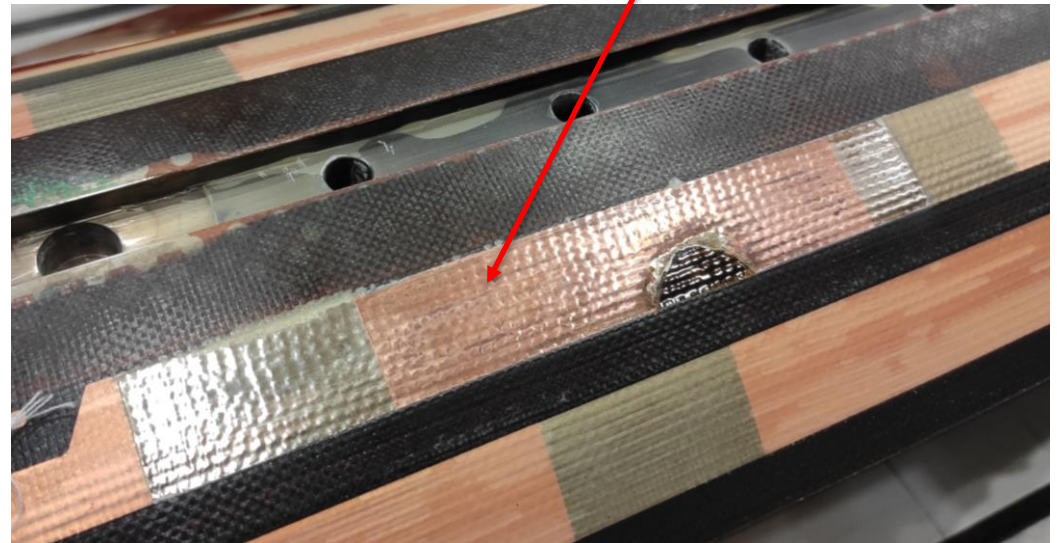
Metallic strip of the QH cleaned with distilled water and iso-propylic alcohol

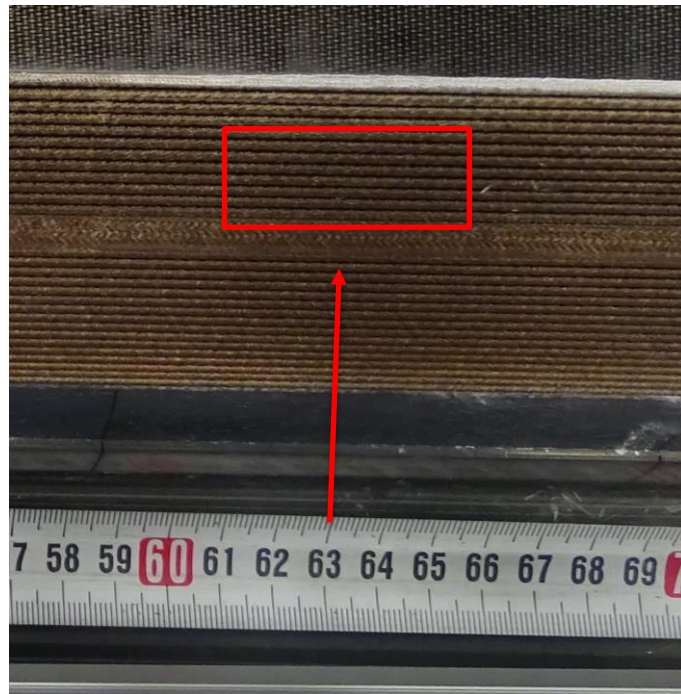
After reaction

- Checking the pictures taken by QA team after reaction and after impregnation with the coil on the base plate, the evidence is that any defect was observed.

The beginning of the measure after reaction does not match with the beginning of the measure taken after impregnation as the reference isn't the same so the defect (if any) is located at about 630mm.
