**Report of the MQXFA06
Coil Acceptance Review**

**Report of the MQXFA06 Coils Acceptance Review
November 17, 2020**

S. Izquierdo Bermudez, A. Ghosh, G. Sabbi

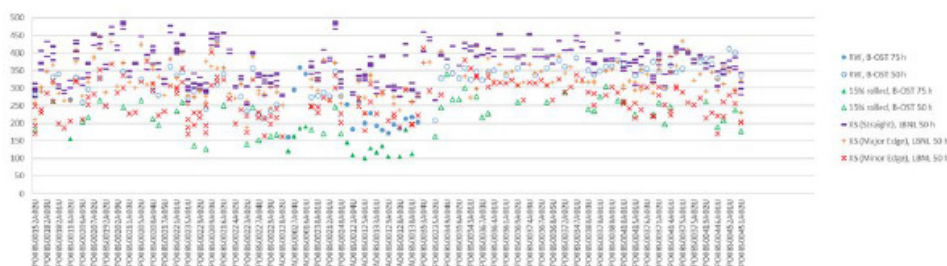
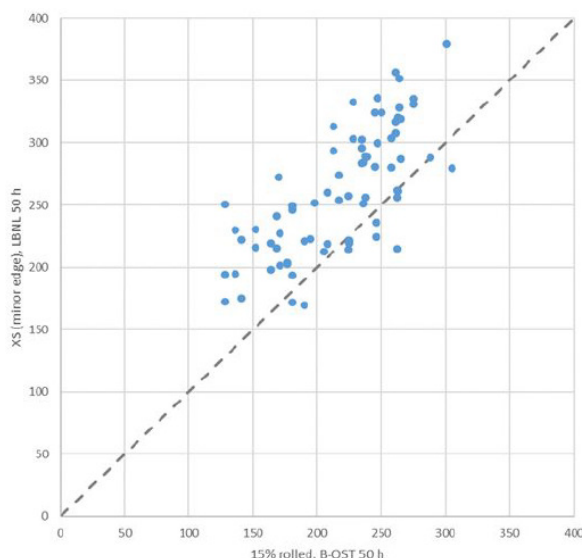
- LBNL RRR measurements still appear to give consistently higher results than those from witness samples, rolled strands, and magnet cold test. Please comment on this. There was some discussion during the presentation, but no convincing argument was made to show that we understand this difference and how to improve.

- The committee appears to imply that the measurement technique is at fault. Let's be clear: the LBNL measurements are accurate and are not biased based on the outcome of numerous inter-comparisons. The differences are actual differences in the samples based on HT and sample preparation or state. We understand the difference fully and it is related to (a) coil reacted over temperature, which affects the witness samples; (b) pedigree of the billet material and the billet manufacturing; (c) agreement between rolled strand data and the data for segments incorporating cable edges

- RRR depends on the HT and sample preparation
 - Coil 211, for example, showed excellent agreement between witness and XS RRR.
 - Coil 119 HT overcooked the coil, so witness RRR is low. LBNL RRR has been consistently with BOST 15% rolled data.

- See below presentation at the 2020 06 03 Conductor Status with CERN

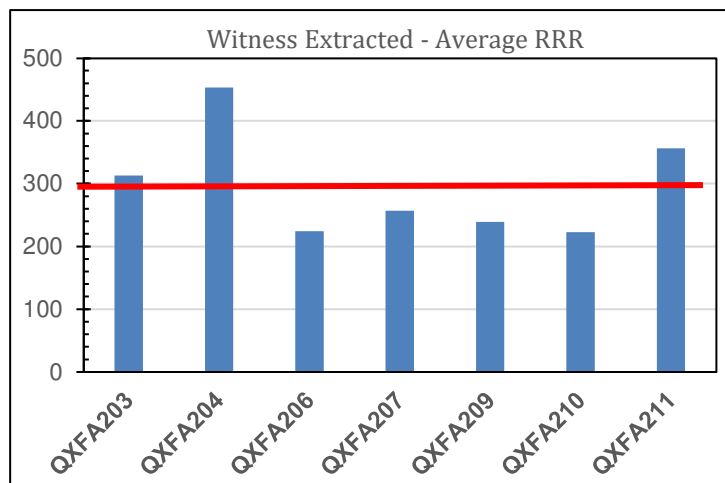
- The coil reaction at FNAL was modified after coil 122 as it was observed that the plateau temperature at 665 C was high (DR 12014). The plateau temperature for Coil 123 was reduced by 4°C. As expected, the RRR of extracted strands for 123 show a higher value as compared to previous coils (see Table).
- We estimate that the coil reaction at 665C at FNAL is at a higher temperature than that at BNL. This observation is based on witness sample measurements at FNAL of the RRR for these and earlier coils that were reviewed previously. This is shown below for BNL and FNAL coils:
