A Plan to Refurbish the 805 MHz Pillbox Cavity

Daniel Bowring

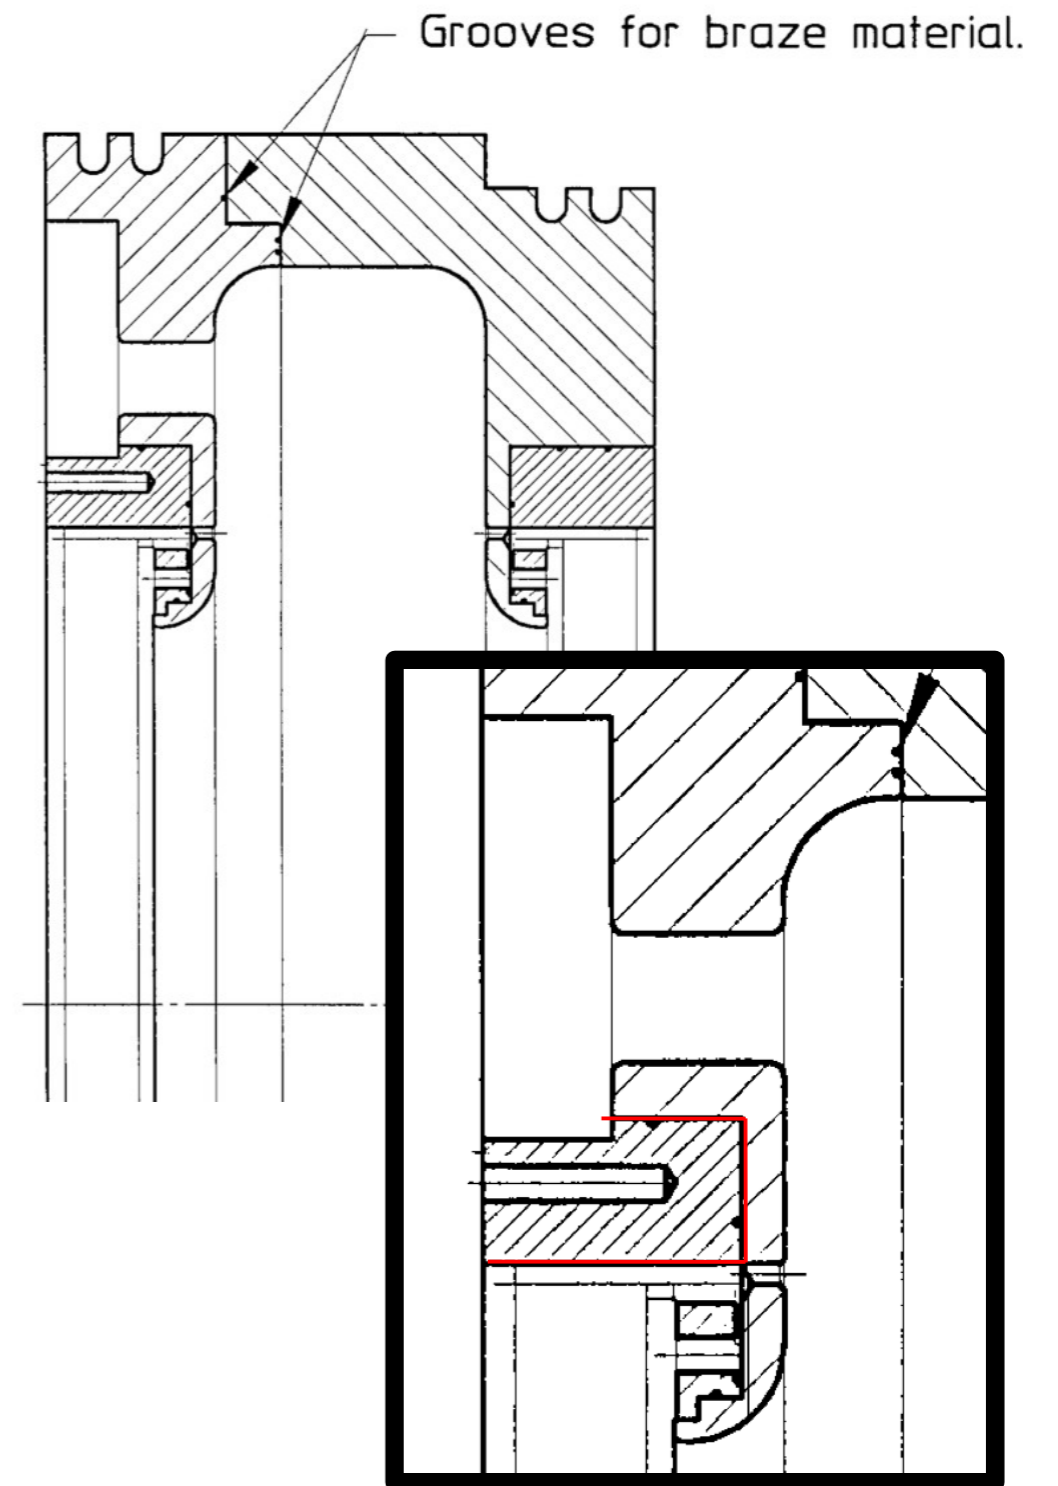
Braze problems

- Leaks after machining into original braze joint.
- Difficult to achieve vacuum (ideally $\sim 10^{-8}$ Torr).
- Has complicated plans for surface treatment.

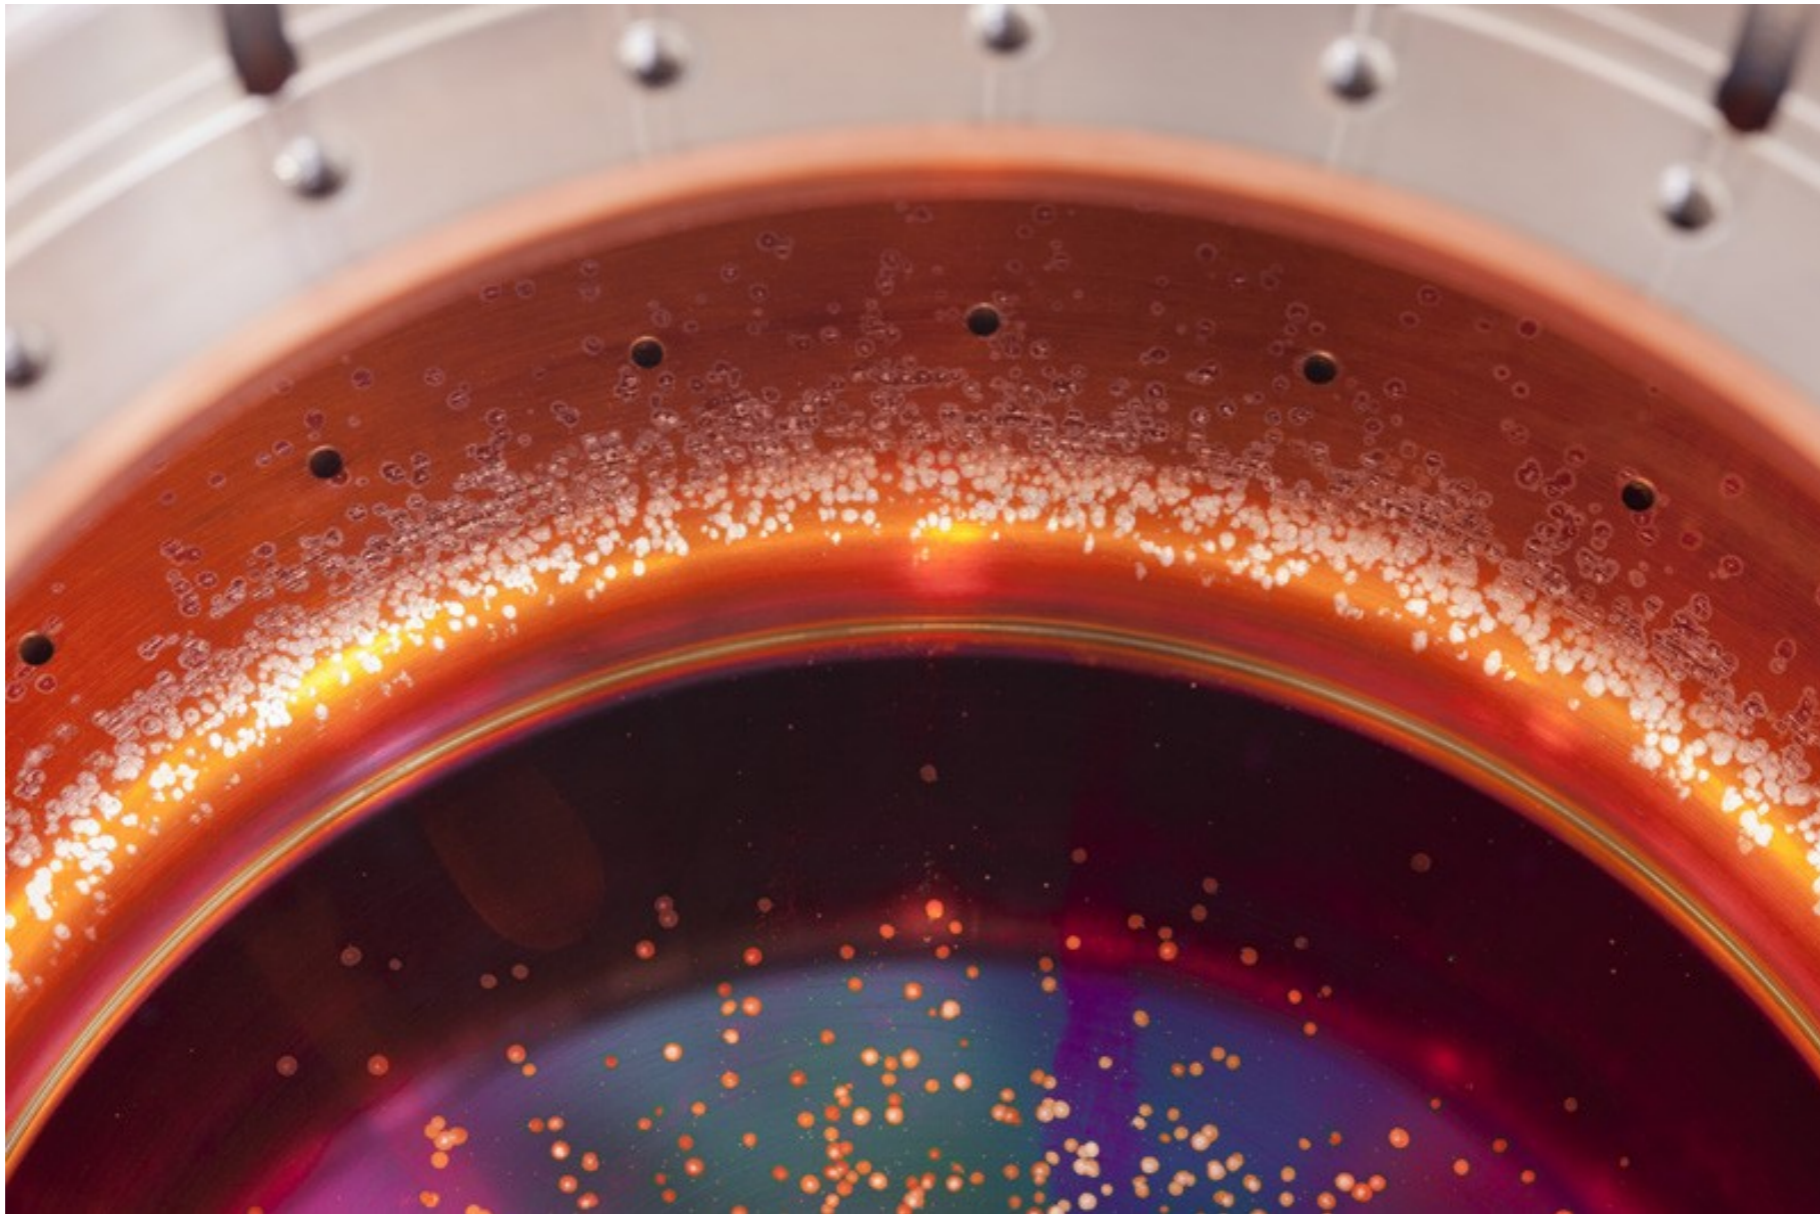
Damage

- Cavity did not perform – even with $B=0$ – after refurbishment.
- You've already seen some of the erratic breakdown data.
- **Significant damage.**
- Possibility now of **contamination.**
- New button tests in the pipeline w/ greater field enhancement.

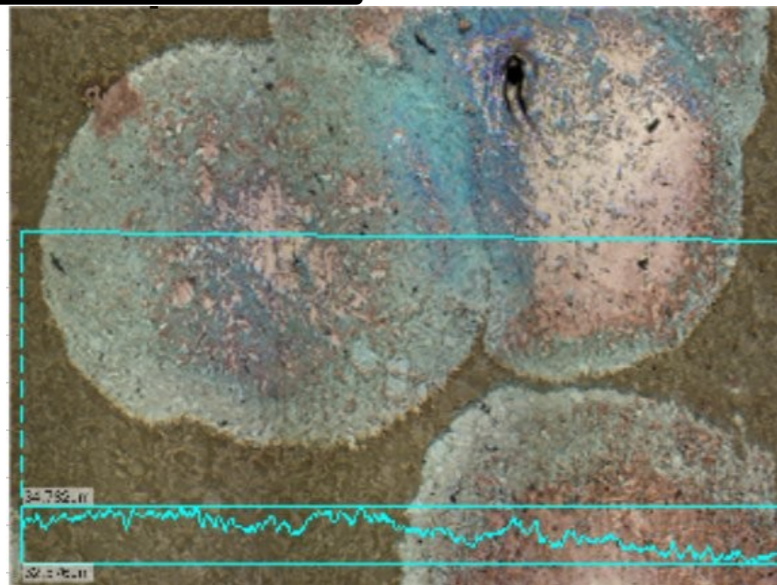
1.90 mm scan
 $\Delta h=0.804 \text{ } \mu\text{m}$

Laser confocal microscopy (LCM) from A. Romanenko, A. Dyzuba @ FNAL. Nonuniform craters with no clear center peaks. This suggests low-energy crater events with partial melting. EBSD would help here.

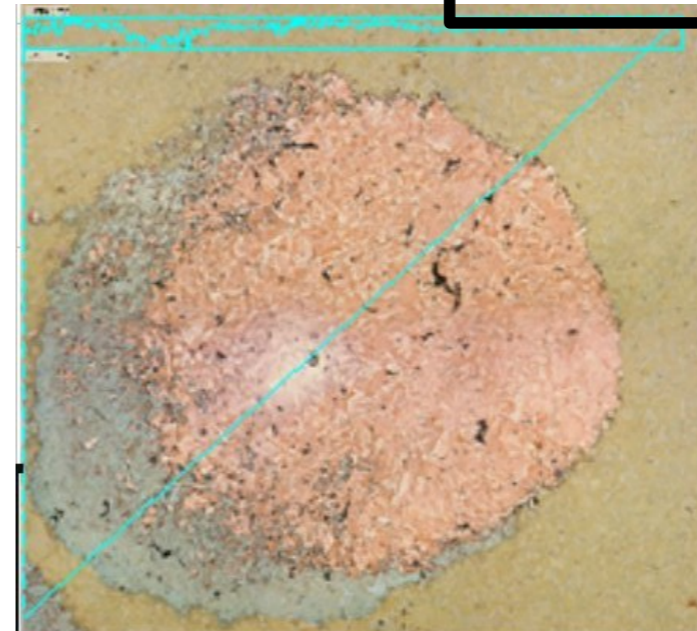
1.83 mm scan
 $\Delta h=0.208 \text{ } \mu\text{m}$

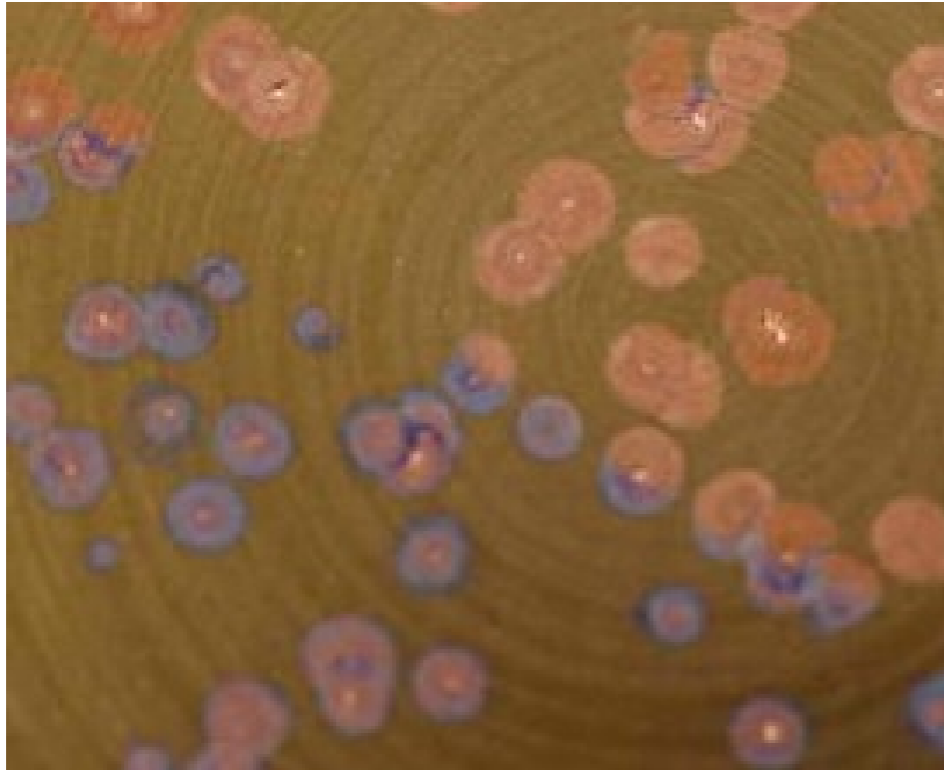
Macro Photograph

Bi-colored damage spots imply chemical flow across window.

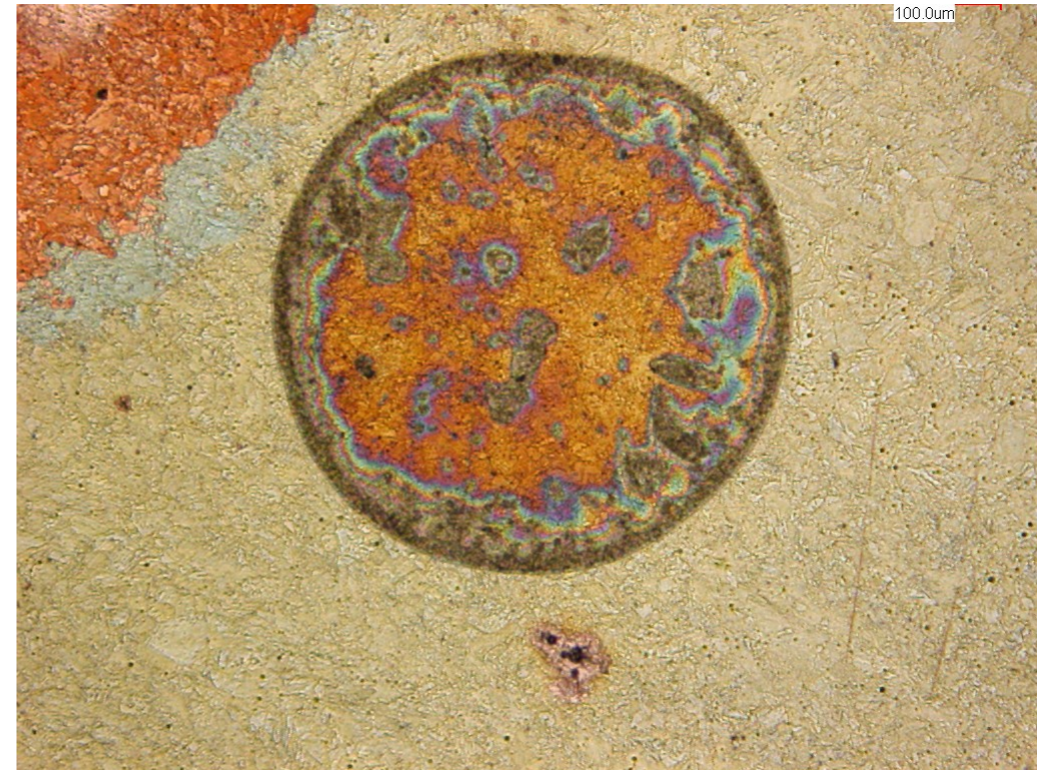
Laser Confocal Microscopy

Rainbow pattern: oxide or nitride contamination?
