Subject: Deviation request and/or DCR proposal
Date: September 8, 2020 at 4:03 PM

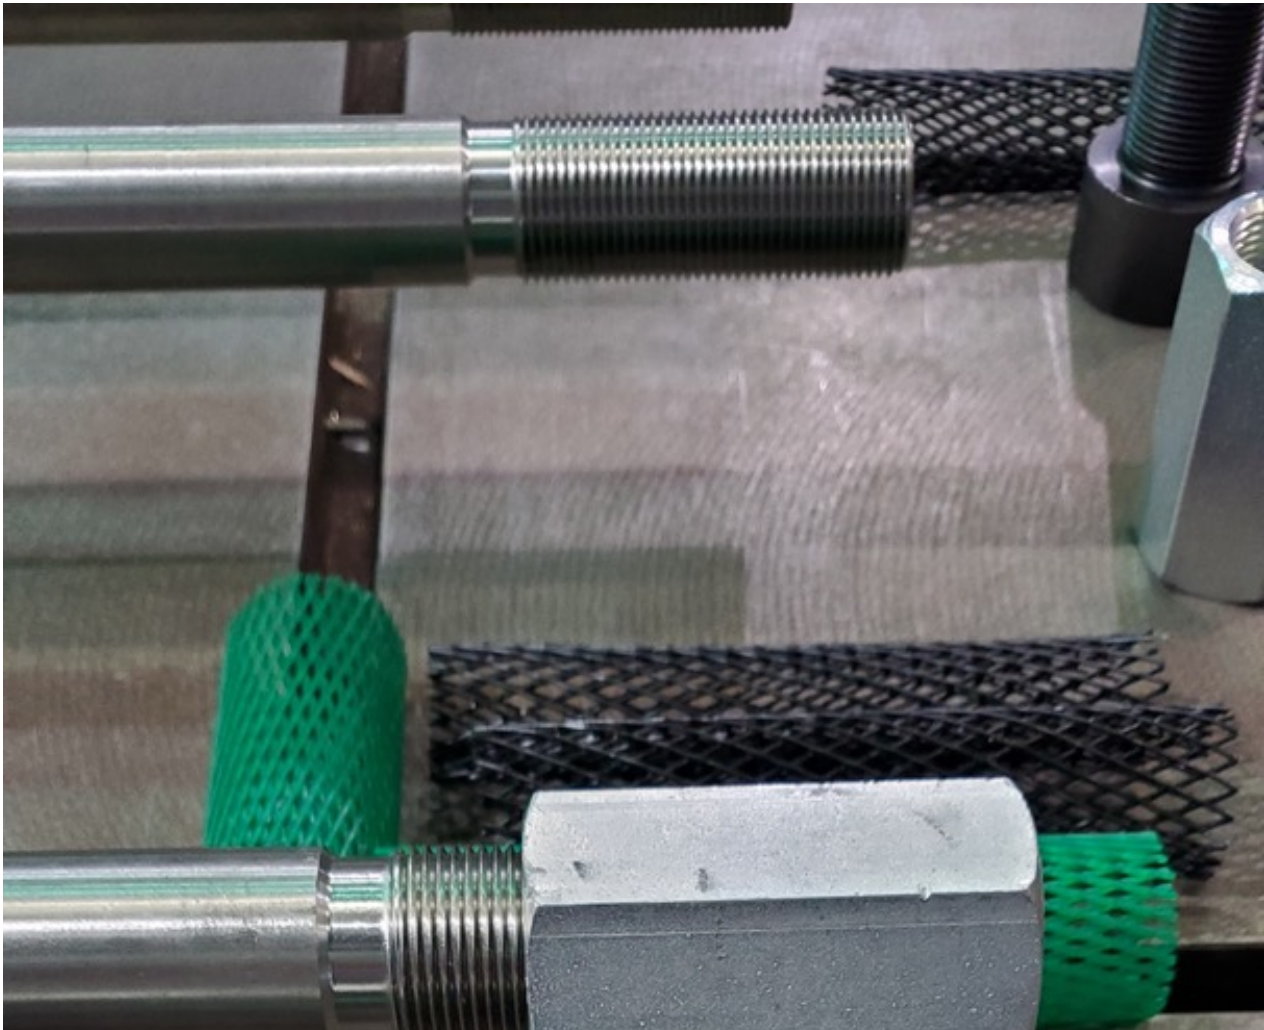
The vendor who machined the rods has apparently been having an issue with the thread pitch, which is ever-so-slightly off, to the effect that ~2" or less of rod engagement into the Nitronic end plate is okay, but any more thread engagement begins to bind up. We had noticed this with earlier magnets, but we finally tracked it down to it being the pitch issue; we even had the vendor come on site to observe the issues we were having with the batch of rods for A05-A08 orders, after which we sent these rods back for rework. After getting them back we are finding this issue still persists.

The enclosed picture shows a 3" long threaded coupler nut at the point where it begins to bind. The attached PDF redline is the fix that we are proposing.

This redline proposal (for either a DR or DCR) is to remove the last ~1" of the thread so that we can fully screw the axial rods into the Nitronic endplate without binding, but still maintain the same loading on the threaded contact area as before. It's only the first part of the threads that take up the full load, so removing the "backend" of the threads doesn't change the loading condition on the threads or plate.
