# Production of a MQXFB practice coil without ceramic binder on the OL

N. Lusa

11 November 2020

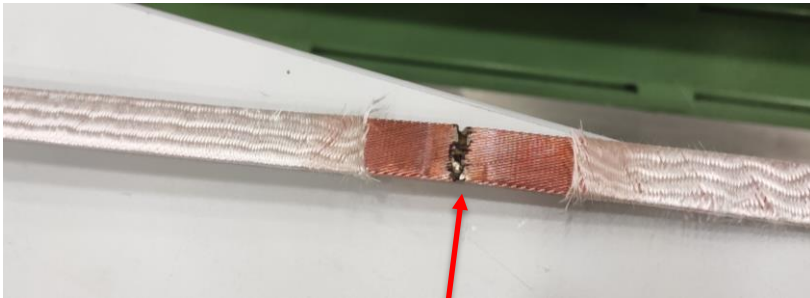
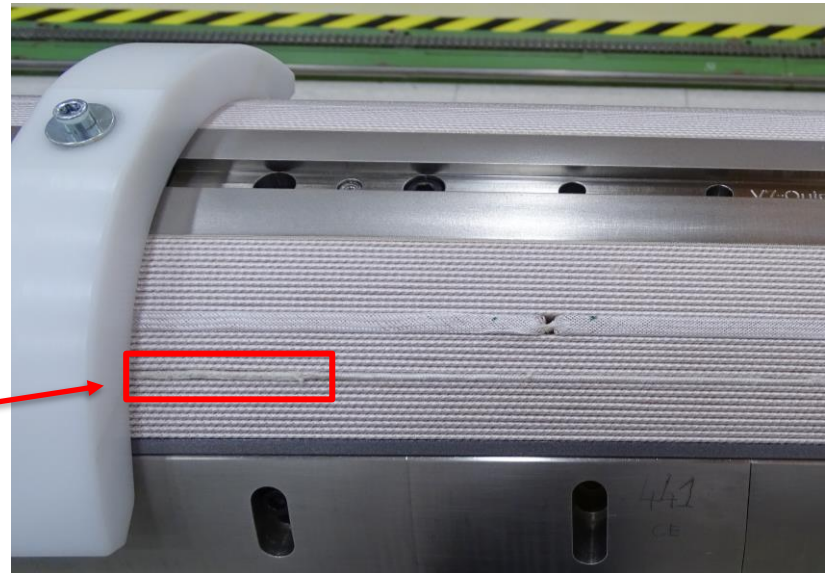
- During the outer layer winding of MQXFB coil CR120, there was a critical non-conformity (EDMS [2421749](#)).
- The coil was degraded to practice coil and, once the winding completed, it was decided to:
  - Not apply ceramic binder on the outer layer;
  - Perform anyway a dry curing (entire thermal cycle).

Cable needed to be cut and welded then a repair of the insulation was performed (binder was applied to keep the insulation in place)

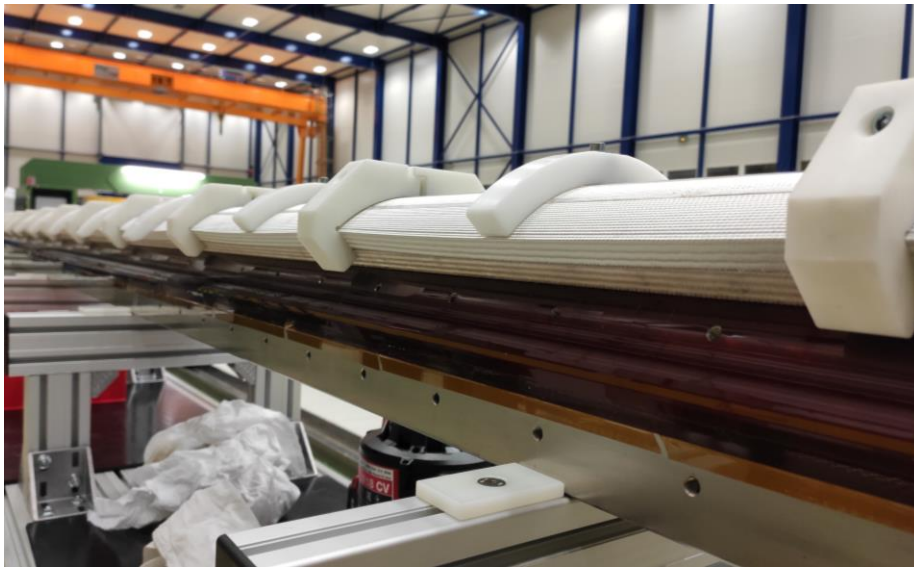
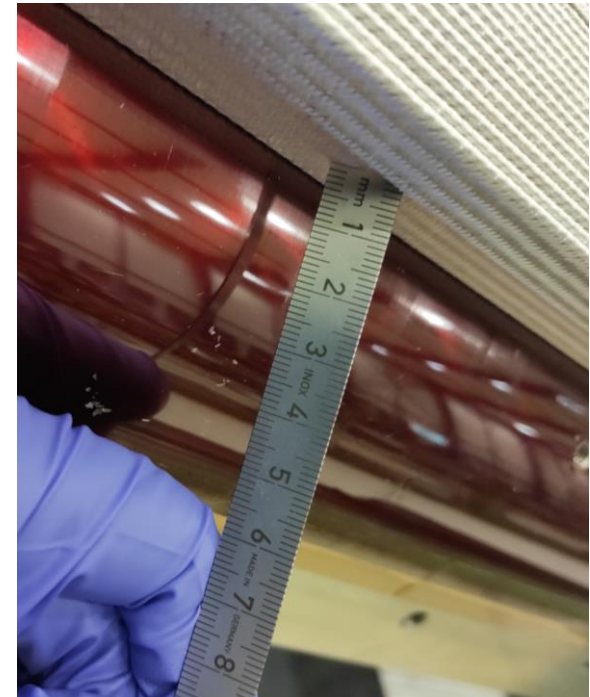
- Once the curing finished, starting from CS the side bars and the curing shims were removed showing a difference in the stiffness of the coil:
  - The IL was more rigid than the OL
  - A gap of about 2mm was measured between the cable on the OL and the IL along the whole length of the coil

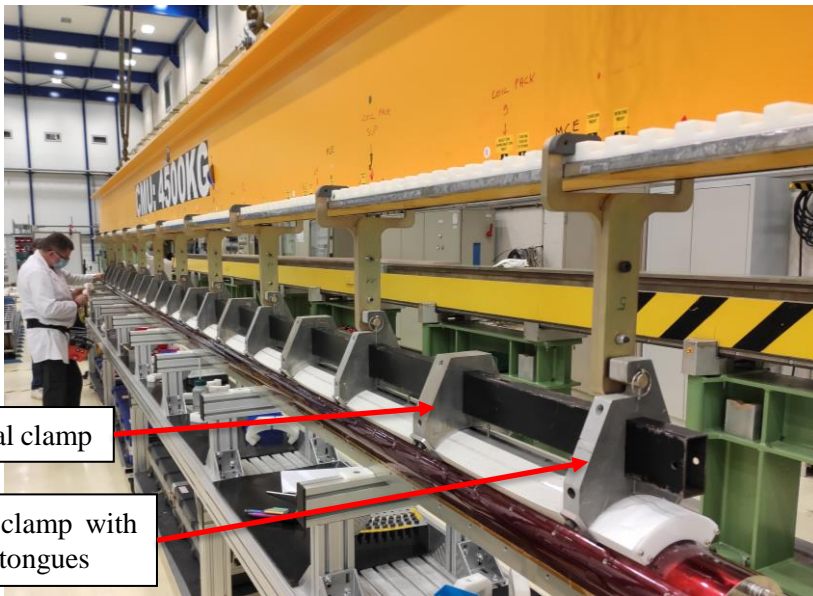
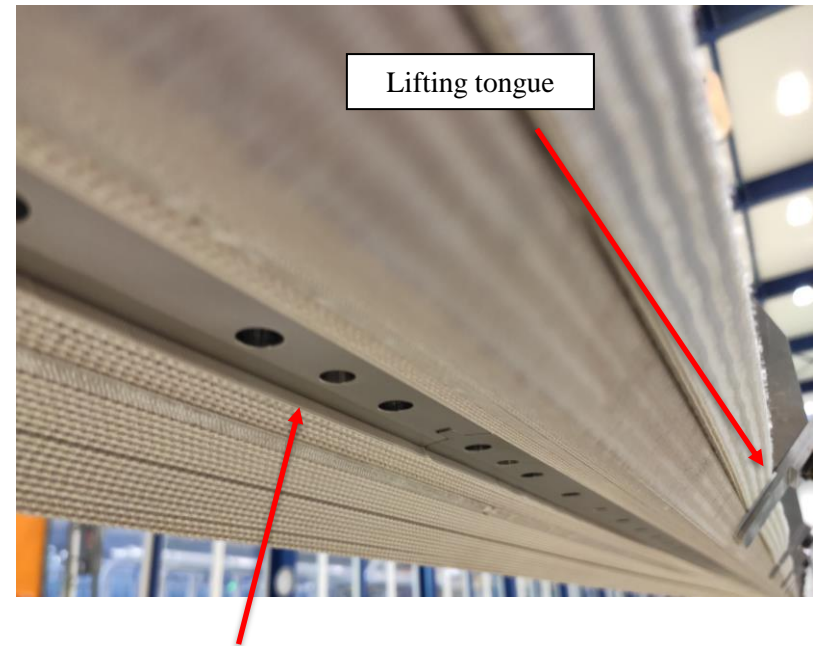
- Lifting beam with additional and modified clamps was used.
- The turns in the IL close to the poles were below by almost 4mm with respect to the poles along the length:
  - Probably due to a not uniform pression given by the lifting tongue during the screwing.

Turns below by almost 4mm with respect to the poles

- As a remainder, here below the modifications implemented to the lifting tongues:
  - The number of pieces was increased from 10 to 18;
  - The width of the additional pieces was increased from 30mm to 50mm;
  - The thickness of the lifting tongues was decreased from 8mm to 4mm (1mm of PTFE in contact with the coil) and the material was changed to high strength steel (15 NiCr 13);
  - The screwing system was changed passing from M6 rods + wing nuts to threaded hole in the lifting pieces + M8 screws.

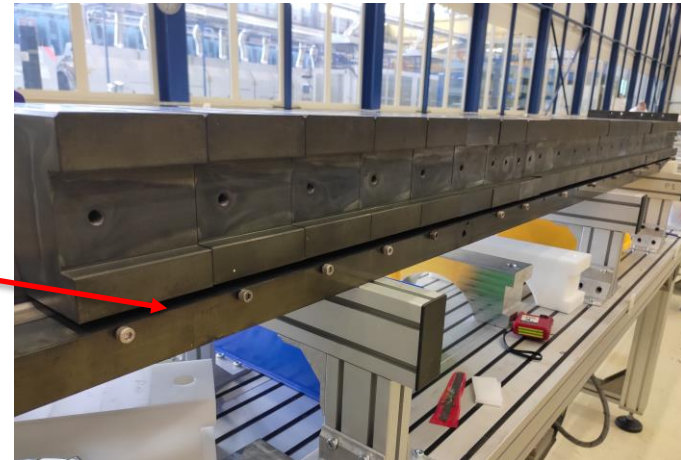
- Once the coil in the reaction cavity, two differences were noticed:
  - The coil was bigger than the cavity along the whole length, indicating that the dry curing cycle was not efficient enough to guarantee the compression of the OL ;
  - A kind of spring effect was experienced trying to put back in place the turns.

A gap of 5mm was measured between the reaction blocks and the base plate indicating an over dimension of the coil due to its elastic behaviour (normally a gap of 2mm is measured)

- Due to the overgap, additional steps were added to the closing procedure to gently guide the coil in the reaction cavity.

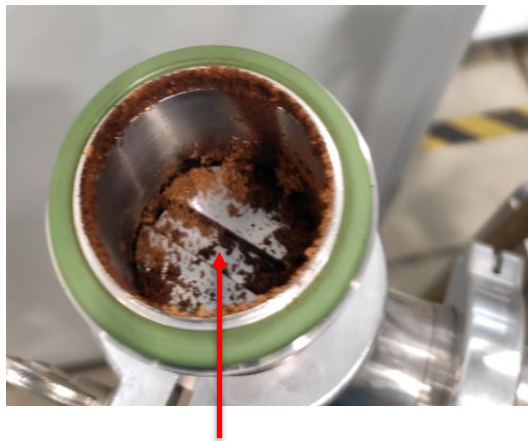
Dirtiness normally observed in the overpressure valve

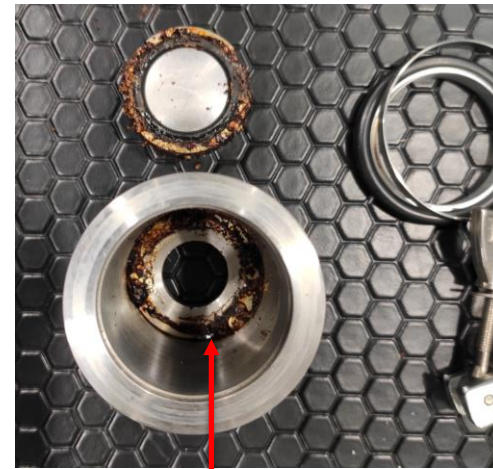
Dirtiness in the overpressure valve for practice coil CR120

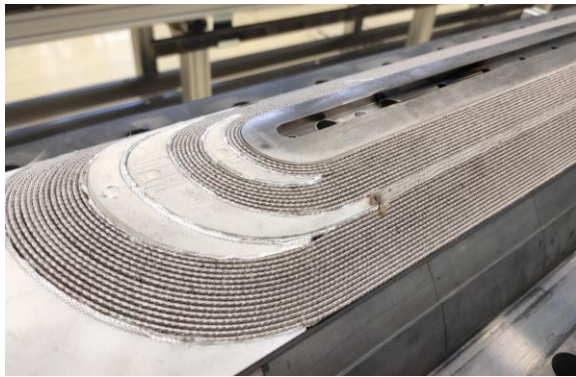
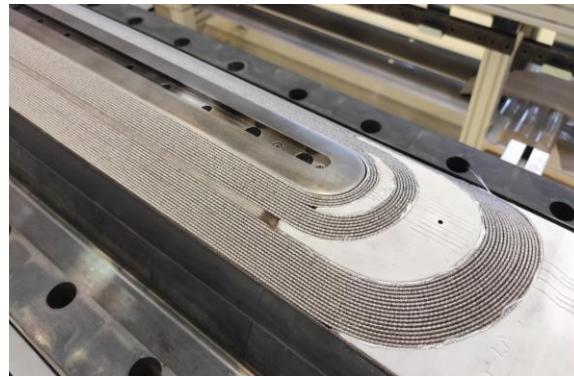
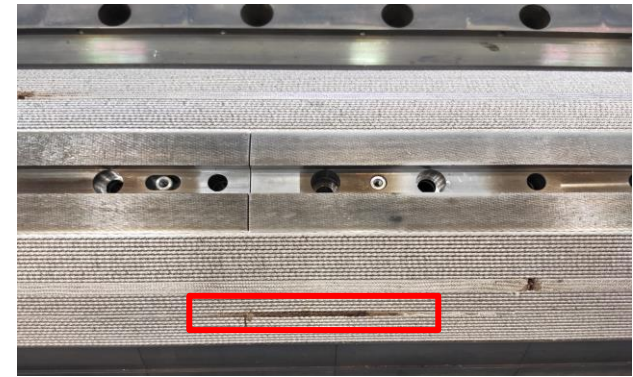
2. The color of the fiberglass insulation once the OL exposed: silverish aspect of the fiberglass with darker regions where binder was applied (repair area and wedges extremities);

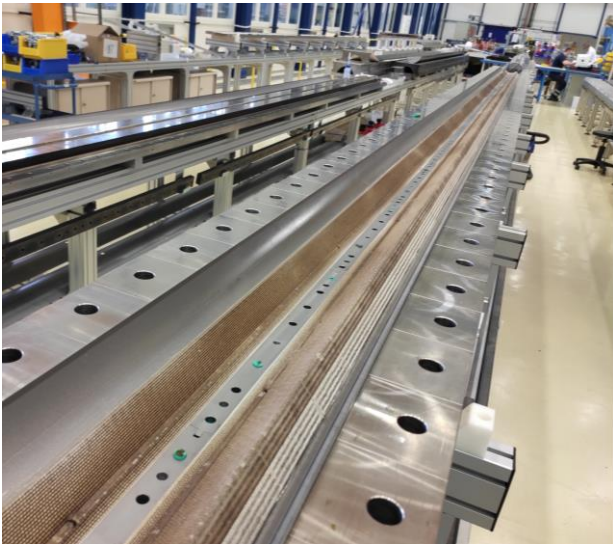
5. With the IL exposed, a difference in the colour between the two layers could be easily detected (all the pictures can be found on [EDMS 2431174](#)) .
6. The robustness observed on the OL does not extend to the midplane (same fragile behaviour observed in the two layers).

OL were ceramic binder was not applied

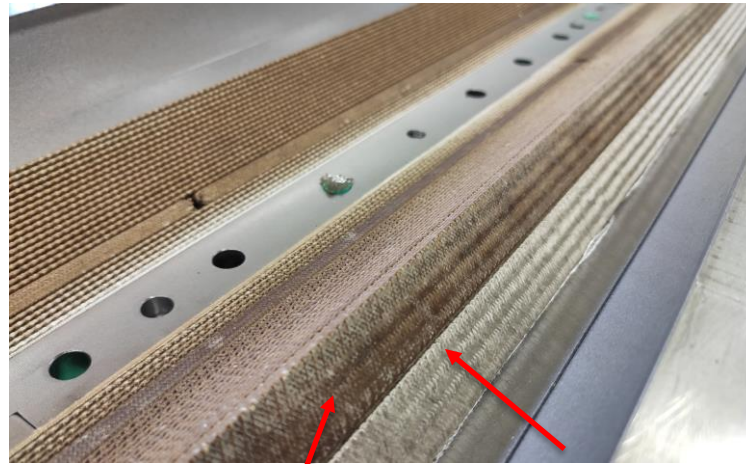
IL were ceramic binder was applied

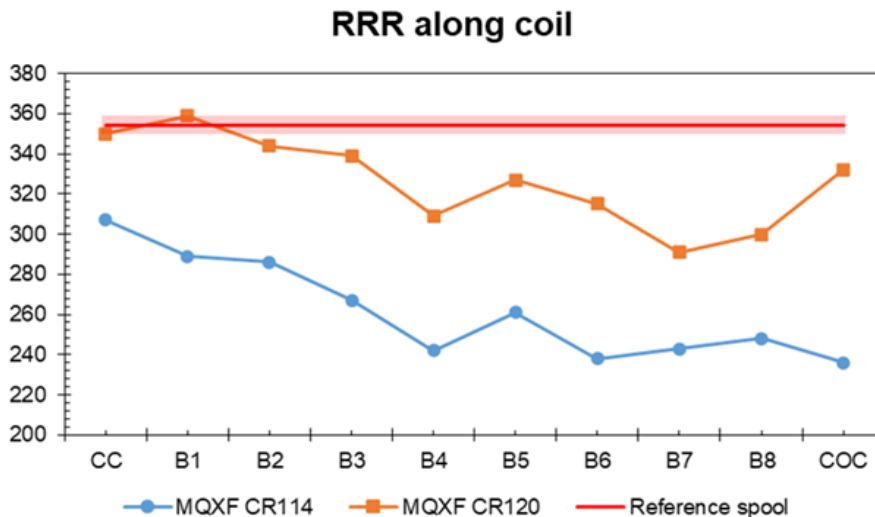
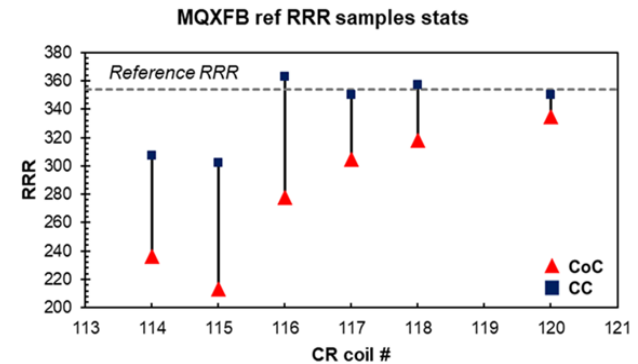
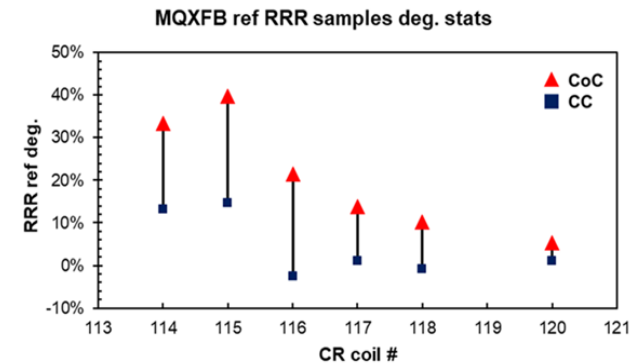
- Increased RRR along the coil with respect to CR114 (last coil where additional samples were placed) that accounts for all the improvements implemented in terms of mould sealing.
- Combined effect of increased Ar flow and no ceramic binder on OL has reduced ref. degradation to 5% in NCS.
