# Z142

# Z161

# LG cavities AC151-AC158

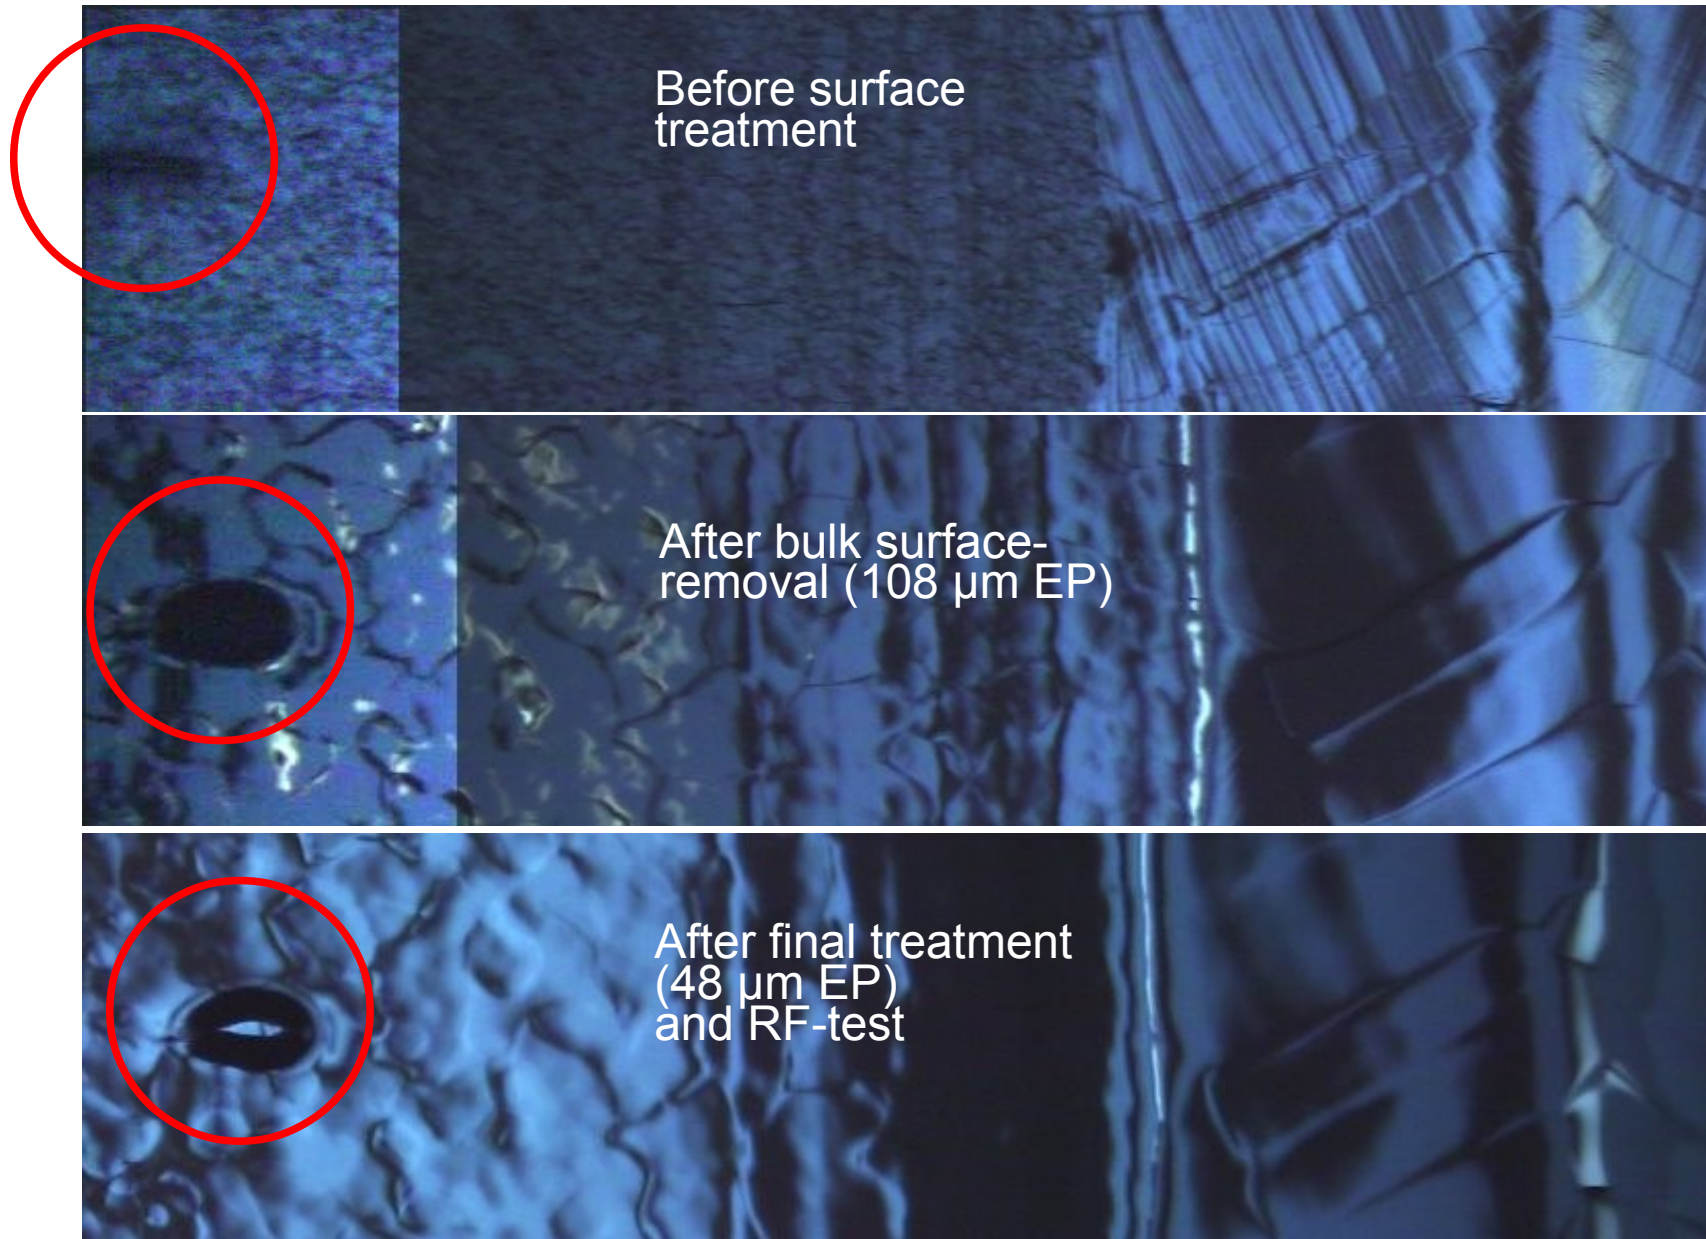
- Defect identified as quench location in vertical test by T-map
- Quench in pi-mode at 20.6 MV/m with  $Q_0=1.6E10$

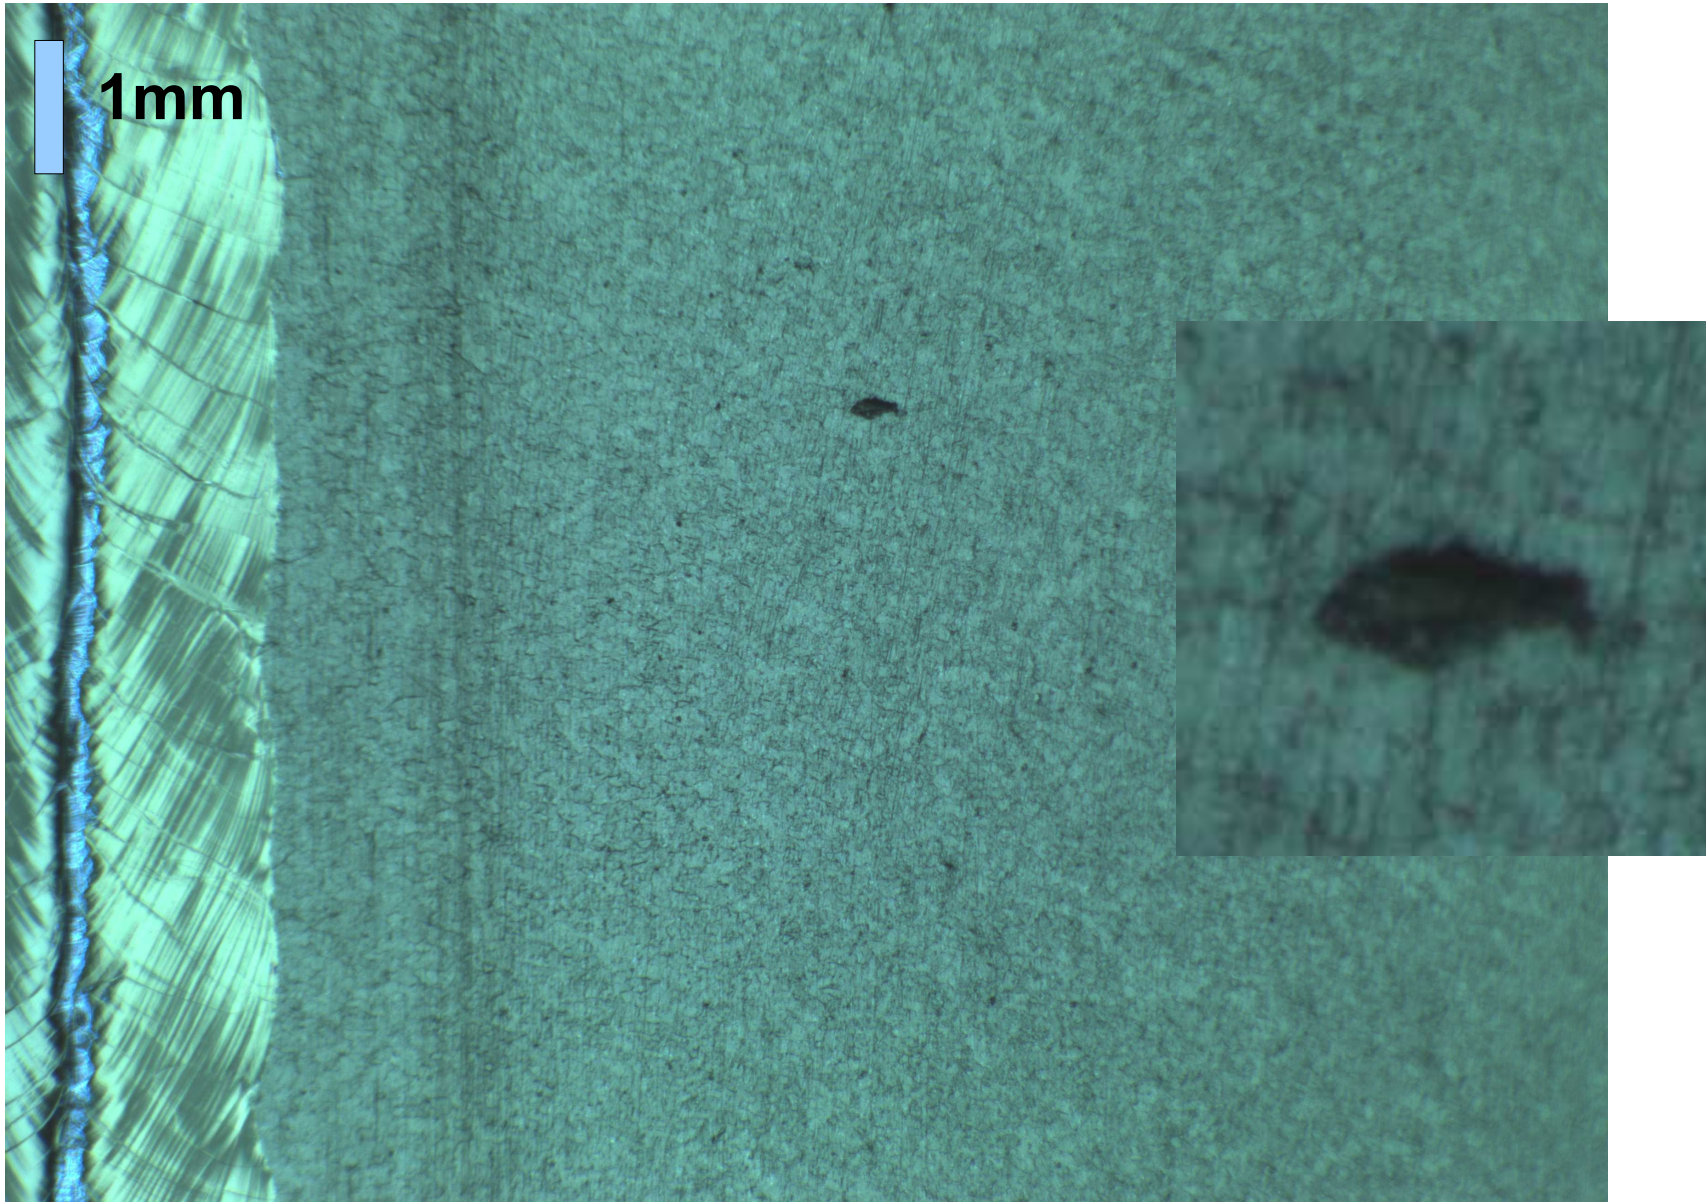
# Z161: Initial surface condition

- Big (several 100 um) dark spots were observed in Z161
- They were not removed by ultrasonic rinsing
- EP (100 um surface removal) did not remove the spots, only the surface around the spots was affected, „pre-EP surface“ is still visible
- Still visible after final EP and vertical test, partially correlated to quench position

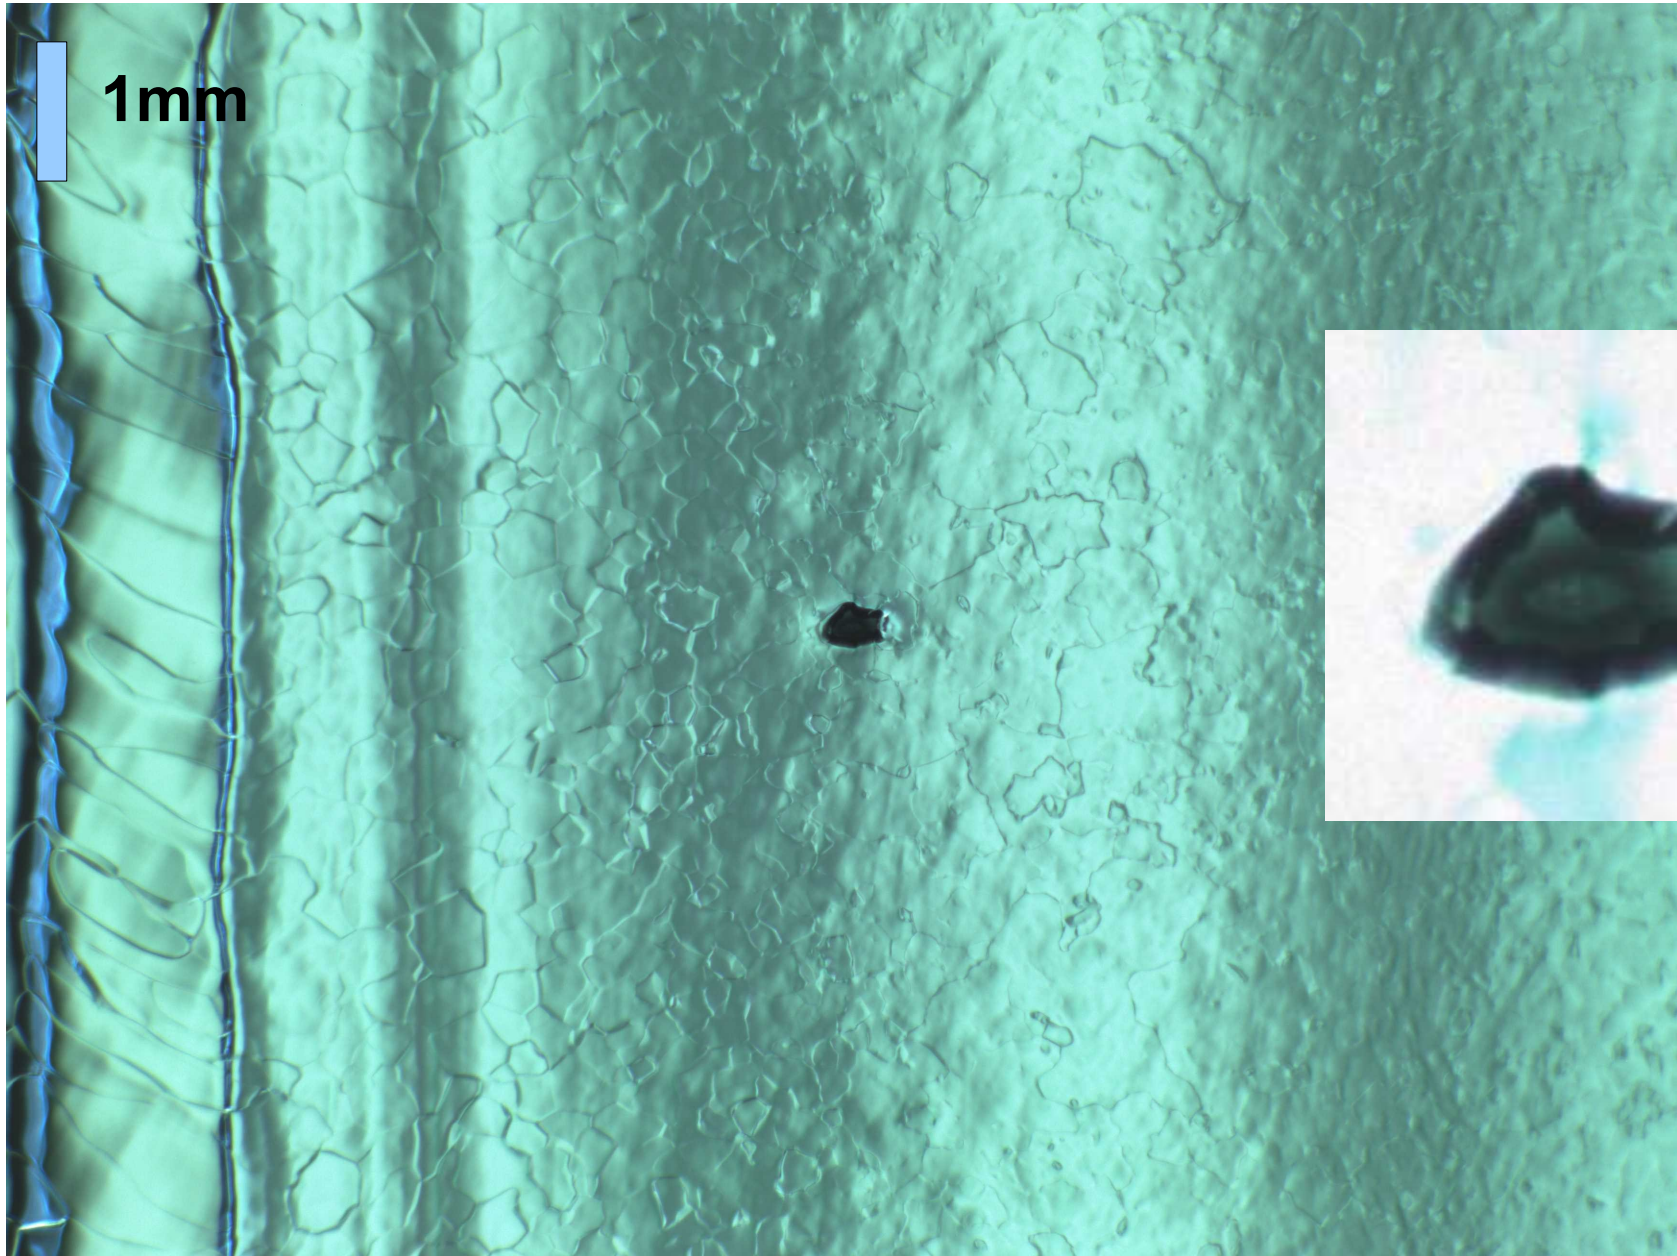
# Z161: after vertical test

- Quench at 13.6 MV/m
- Several of the defects identified as quench-location by T-map and 2nd sound
- Cavity dissected for detailed analysis
- EDX-analysis: Aluminum detected on defect
- The source of the Al-contamination is thought to be understood and eliminated
- Details: Poster by X. Singer et al., THPO055

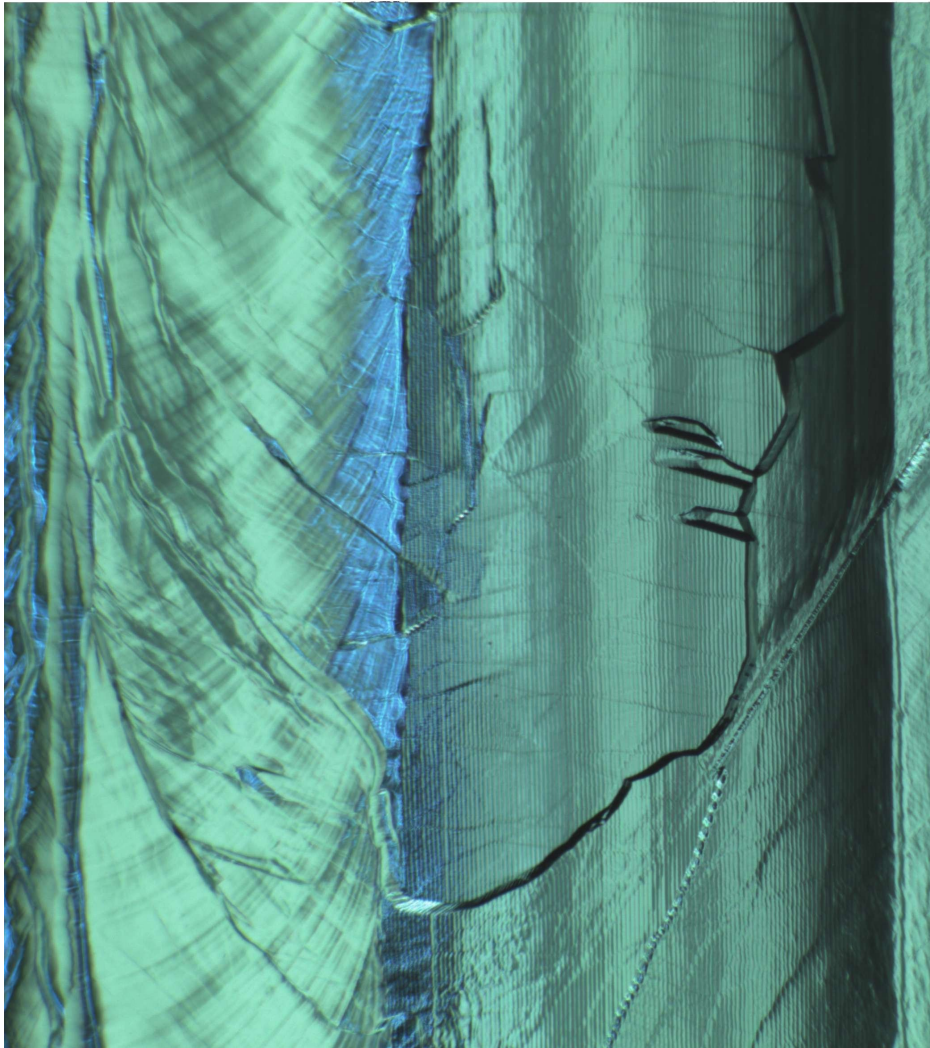
After BCP

- Optical inspection of quench-locations identified by Tmap and 2nd sound so far:
  - No „obvious defects“ at quench location
  - Just etching-pits (all over the cavity as well) and grain-boundaries

# Example: Grain boundary in AC158
