## *DR's for Serial # QXFA212*

# MAGNET DISREPARANCY REPORT

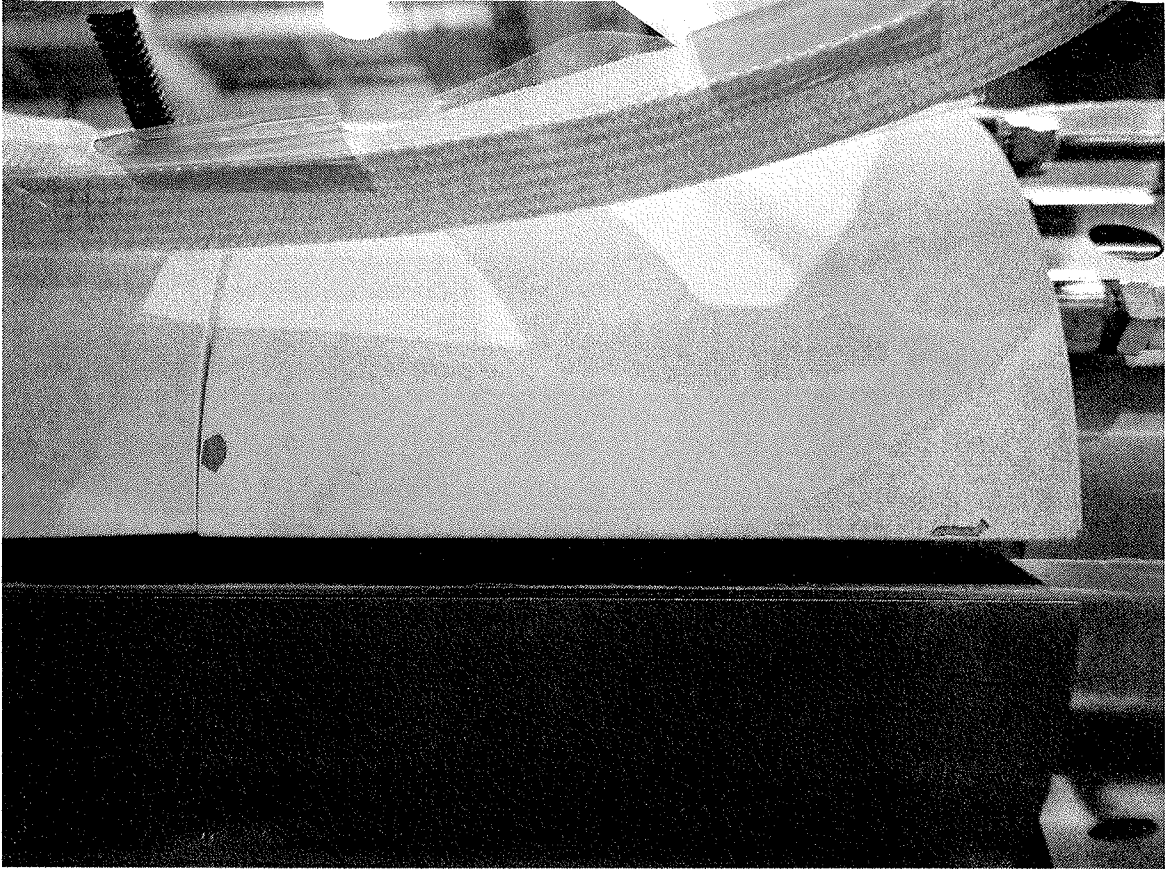
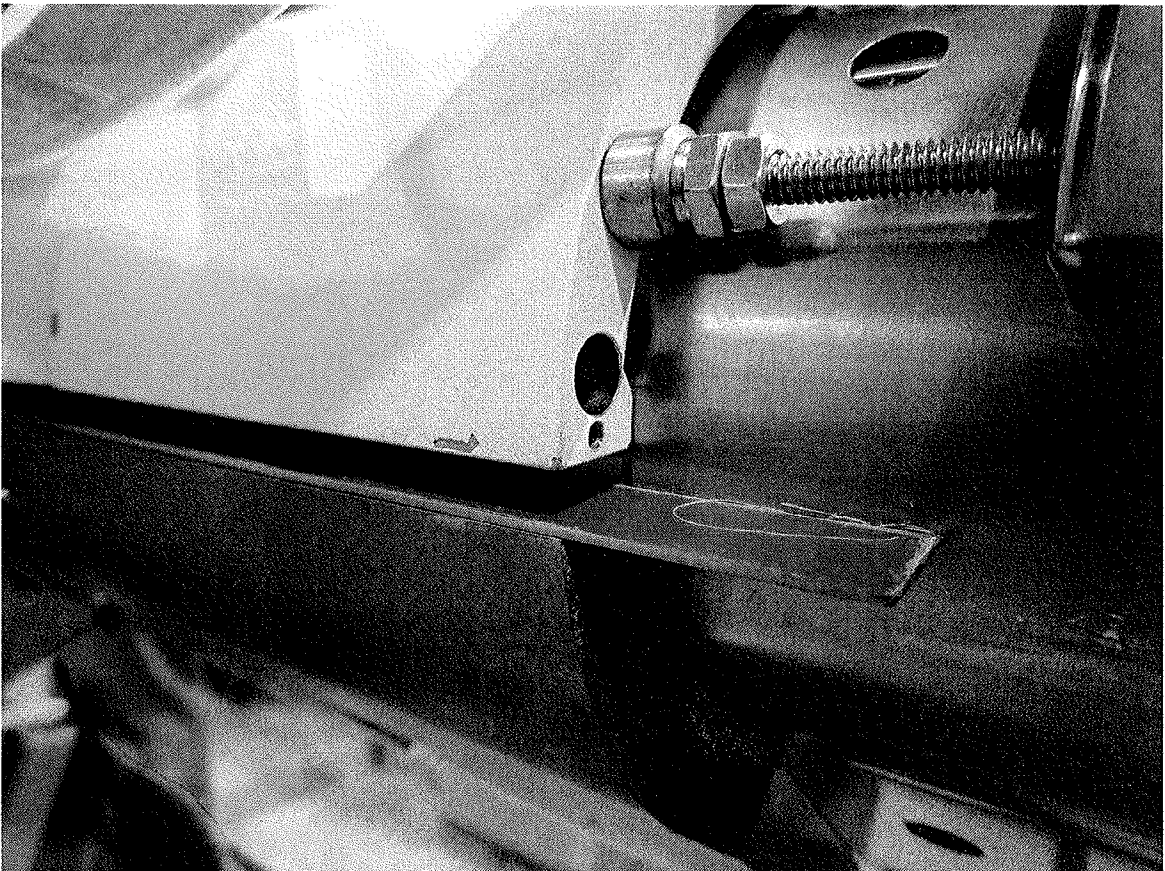
<i>DR</i>	<i>Description</i>	<i>Status</i>	<i>Disp.</i>	<i>Action Req</i>	<i>Closed Date</i>
AM-157	LE splice block F10042599 chipped when dropped	F	UAI		2/5/2020
AM-158	End spacer B2-IC3 has short to conductor	F	UAI		2/5/2020
AM-168	Chip in ceramic on NLE spacer. Chips on inner LE saddle and saddle extension	F	RPR	8/3/2020	8/3/2020
AM-172	Cure control system reset post cure	F	RWK	9/1/2020	9/1/2020
AM-173	Length should be 4524-4534, is 4523.3	F	UAI		9/1/2020
AM-174	Voltage Tap B6 is open	F	UAI		9/21/2020
AM-175	Voltage drops out of range	F	UAI		9/21/2020
