Author(s): **Steve Virostek**

**TECHNICAL NOTE**

**ERNEST ORLANDO LAWRENCE  
BERKELEY NATIONAL LABORATORY**

## **MICE Spectrometer Solenoid: Overview and History**

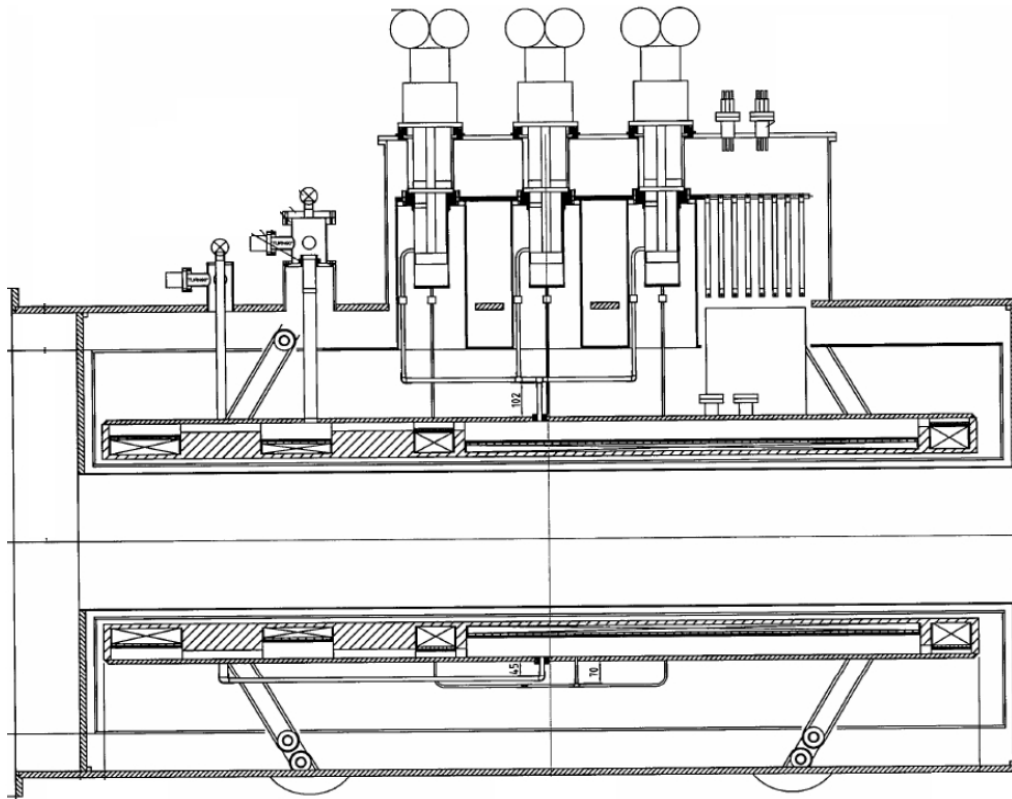
Figure 1: Cross section of Magnet 1.

The first magnet assembled and tested (Magnet 1) was built per the specifications of the original Wang NMR design report titled "Final Engineering Design for MICE Spectrometer Solenoid Magnets" and dated 9/6/06. The LHe cooling and recondensation circuit for this magnet consisted of a series of small diameter tubes that fed the recondensed LHe to the bottom of the cold mass and directed helium vapor from the top of the cold mass to the cryocooler recondenser cans. A cross section of the magnet showing this configuration is provided in Figure 1.

Upon cooldown of Magnet 1 to 4.2K, it was discovered that the cryocoolers were not recondensing helium due to blocked liquid and vapor return lines. It appears likely that the lines were blocked by frozen nitrogen. Prior to cooling down with LHe, the system is pre-cooled using LN. If the system is not fully purged of nitrogen using a thorough pump/purge procedure, then the remaining nitrogen can be frozen by the LHe and cause blockage of the cooling lines, as likely occurred in this case.

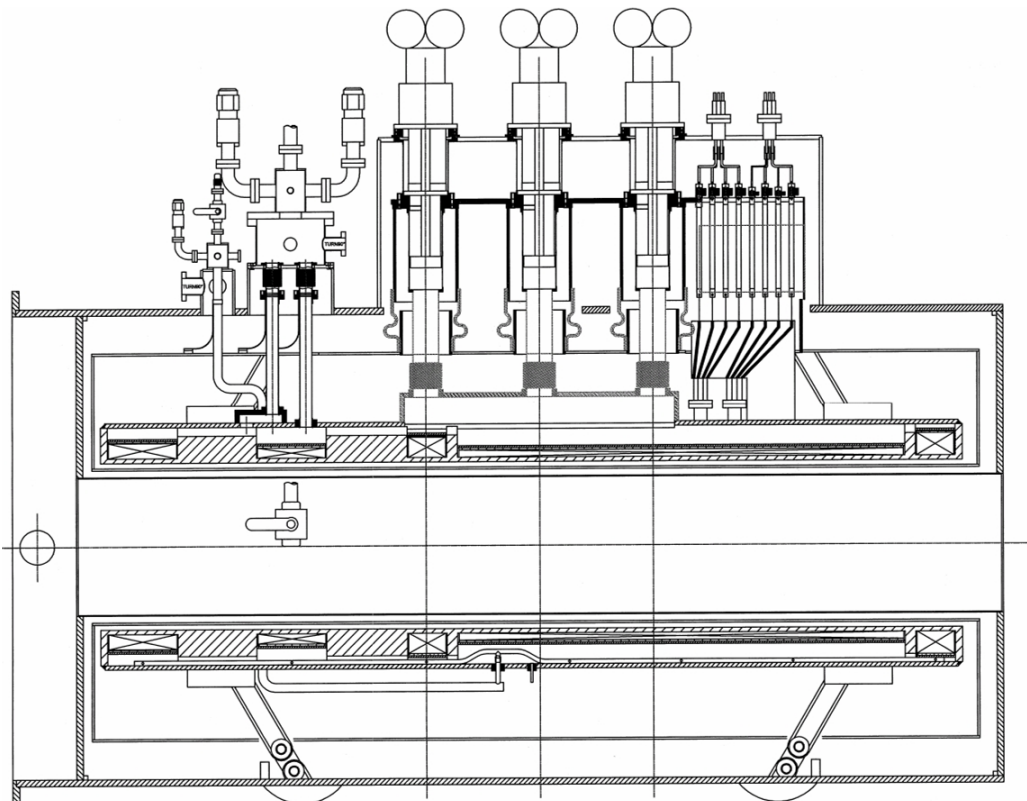
A cross section drawing of Magnet 2A showing this modified configuration is provided in Figure 2.

Magnet 2A was cooled down, and the cryocoolers appeared to be recondensing helium; however, the magnet did not reach an equilibrium condition where there was no LHe boil-off. The training of the magnet commenced, and a current of 238 amps was reached at which point an open circuit was detected. After warm-up, the magnet tower was opened, and a burned out HTS lead was discovered (see Figure 3). Subsequent investigation and review of the temperature sensor logs indicated that the upper end of the HTS leads were inadequately cooled at their connection to the 1st stage copper plate.

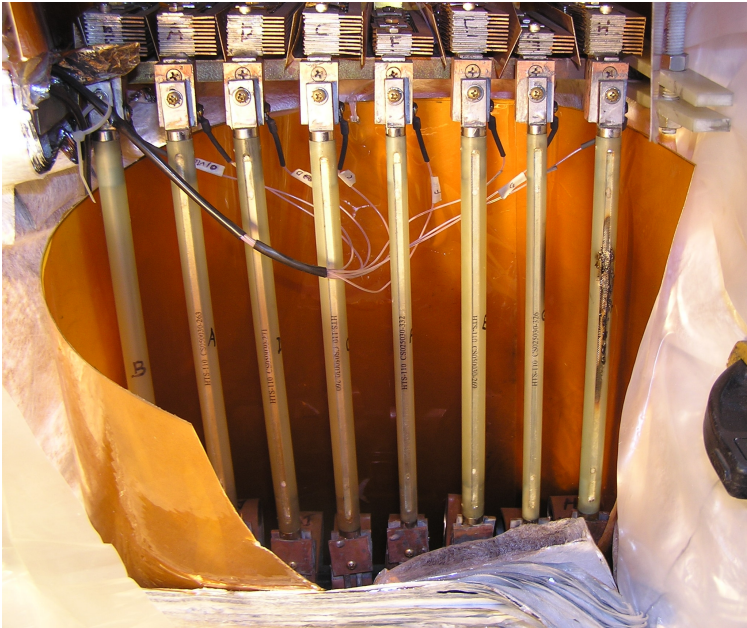
Figure 3: Burned out HTS lead in Magnet 2A (right).

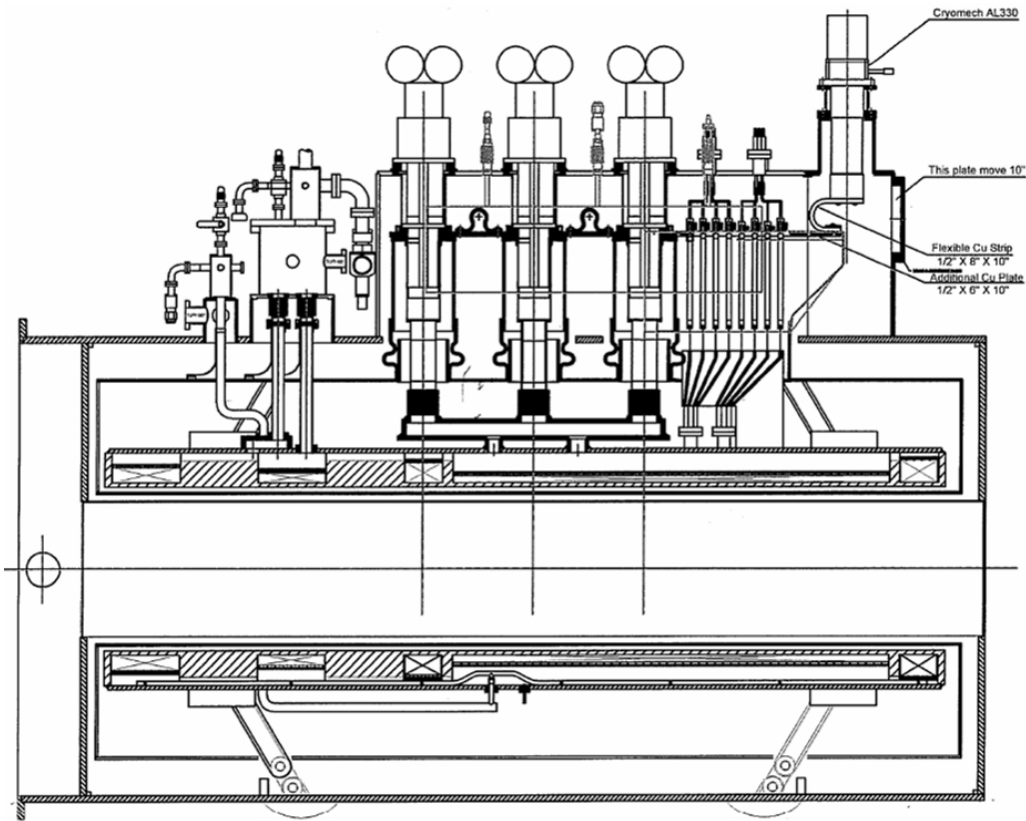
A review committee was convened by MICE management in 11/09 in order to assess the magnet design and to recommend modifications. Per the committee's recommendation, a single-stage cooler capable of removing 170 watts at 55K was added to increase the cooling power at the upper end of the HTS leads and to help reduce the shield temperatures. A cross section of the magnet showing this configuration is provided in Figure 4, and the single stage cooler details are shown in Figure 5.

Figure 4: Cross section of Magnet 2B.

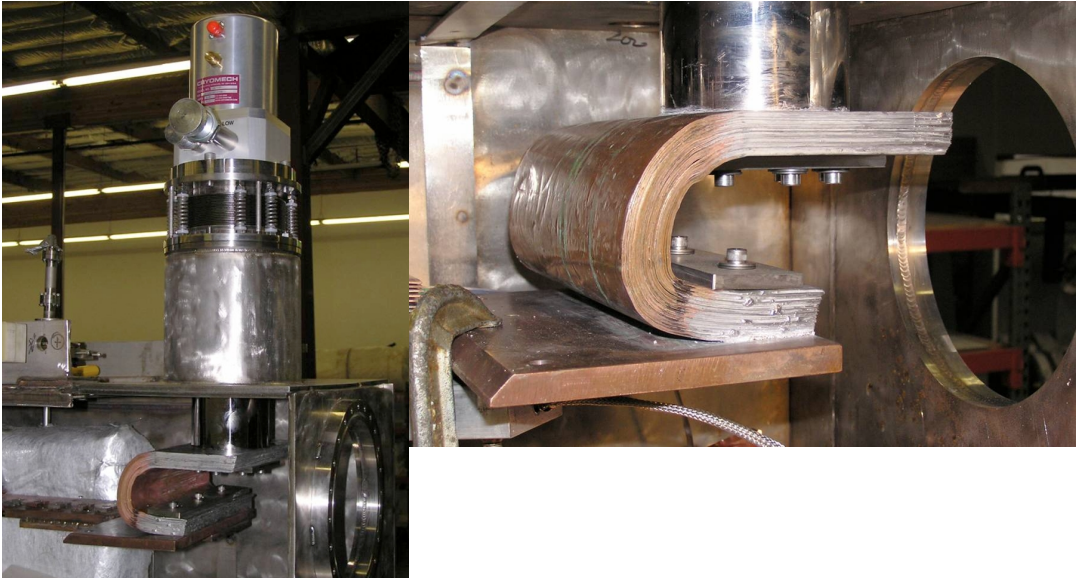
Figure 5: Magnet 2B single stage cryocooler (left), and the cooler connection (right).

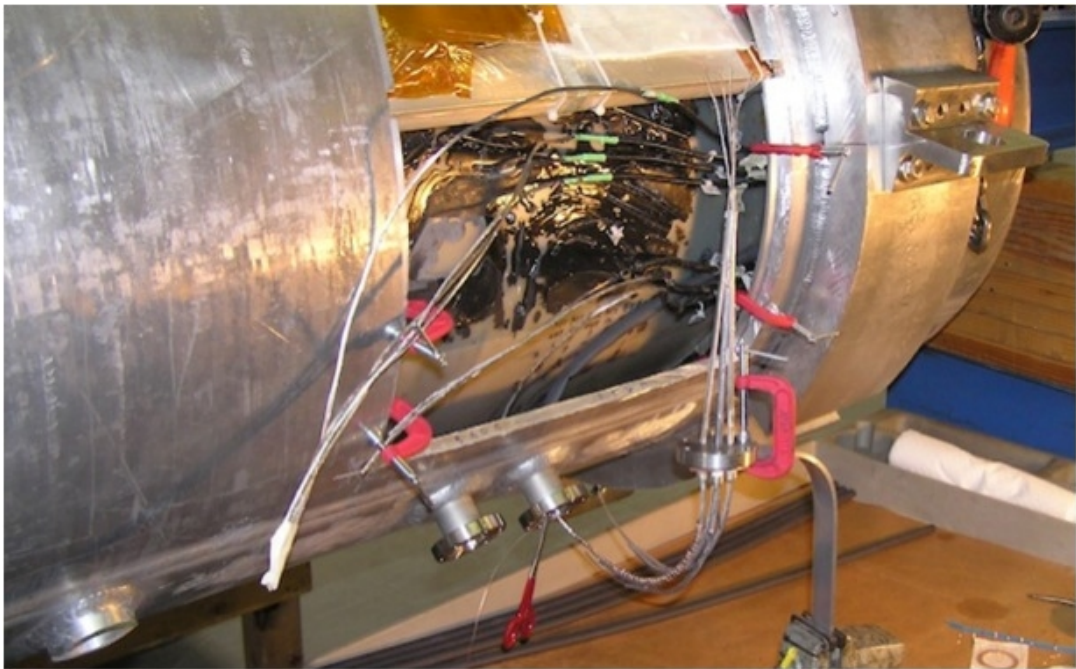
After warm-up, Magnet 2 was disassembled and the cold mass opened; the failed lead was located just inside the cold mass feedthrough. Analysis of the failure area indicated

that the conductor adjacent to the feedthrough will require the addition of extra copper to stabilize it against movement and to enhance conductive cooling. This improvement was carried out on Magnet 2B during the repair of the failed lead (Figure 6).

Figure 6: Repair and stabilization of the Magnet 2B cold leads.
