Spectrometer Solenoid Overview & History

MAP Tech Board Meeting

September 13, 2011

Lawrence Berkeley National Lab

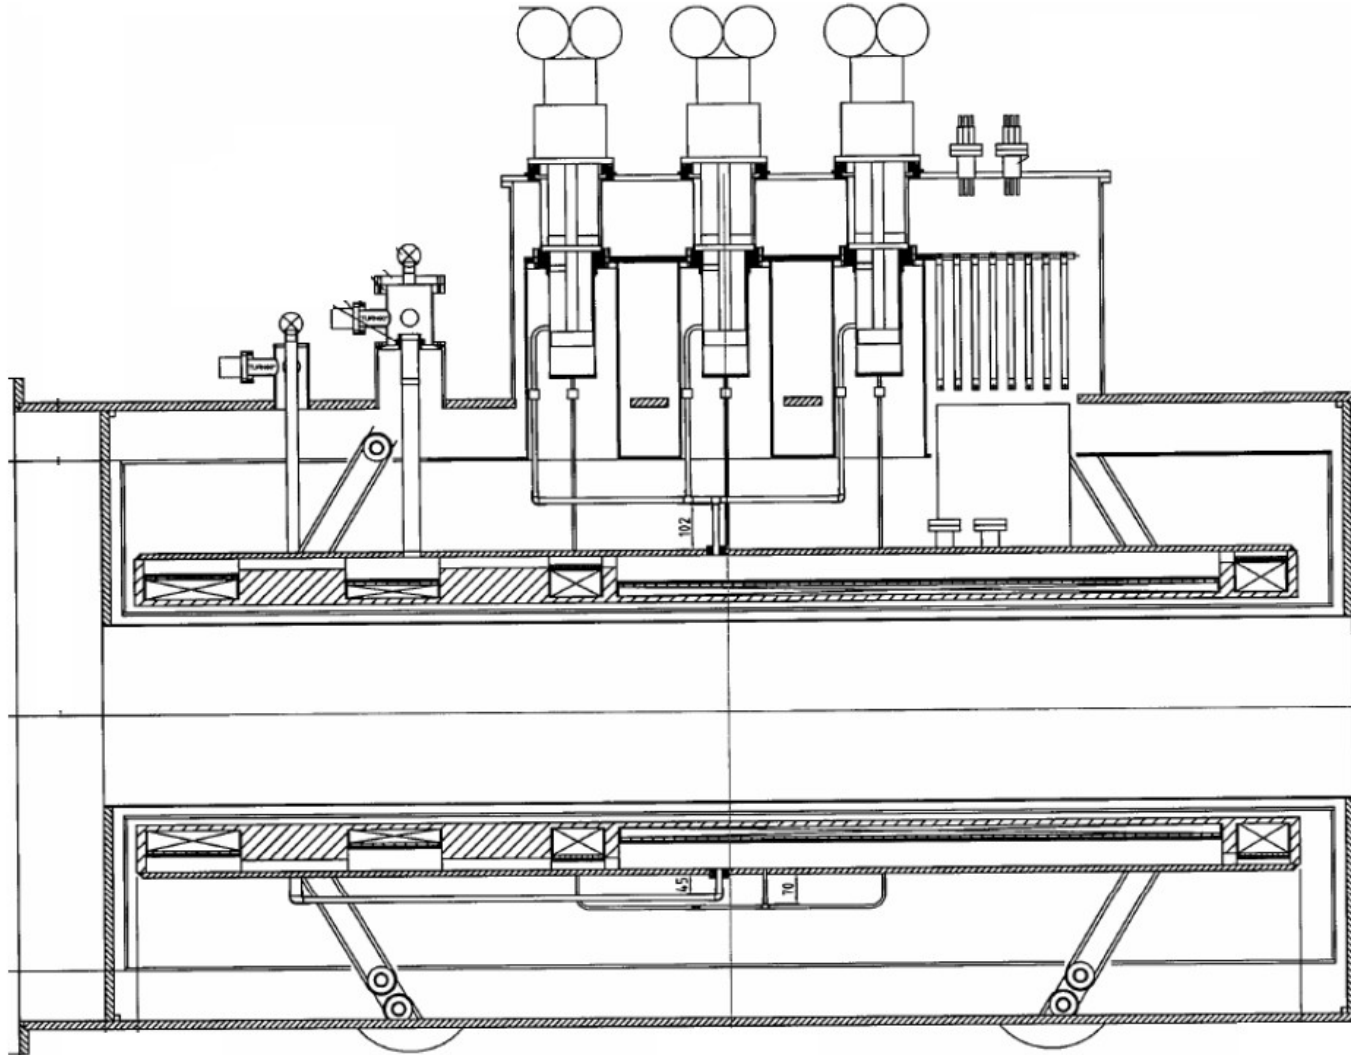
Magnet 1 Cross Section

- Magnet 1 was built per the specifications of the original Wang NMR design report dated 9/6/06
- The cooling circuit consisted of small diameter tubes that fed recondensed LHe to the bottom of the cold mass and directed helium vapor from the top of the cold mass to the cryocooler recondenser cans
- Upon cooldown, the cryocoolers were not recondensing helium due to the liquid and vapor return lines being blocked by frozen
- While cold, the magnet was trained with all five coils running in series to a peak current of 196 amps was reached
- The training was discontinued when the available LHe ran out
- Magnet 1 was disassembled in order to allow modification of the recondensing circuit

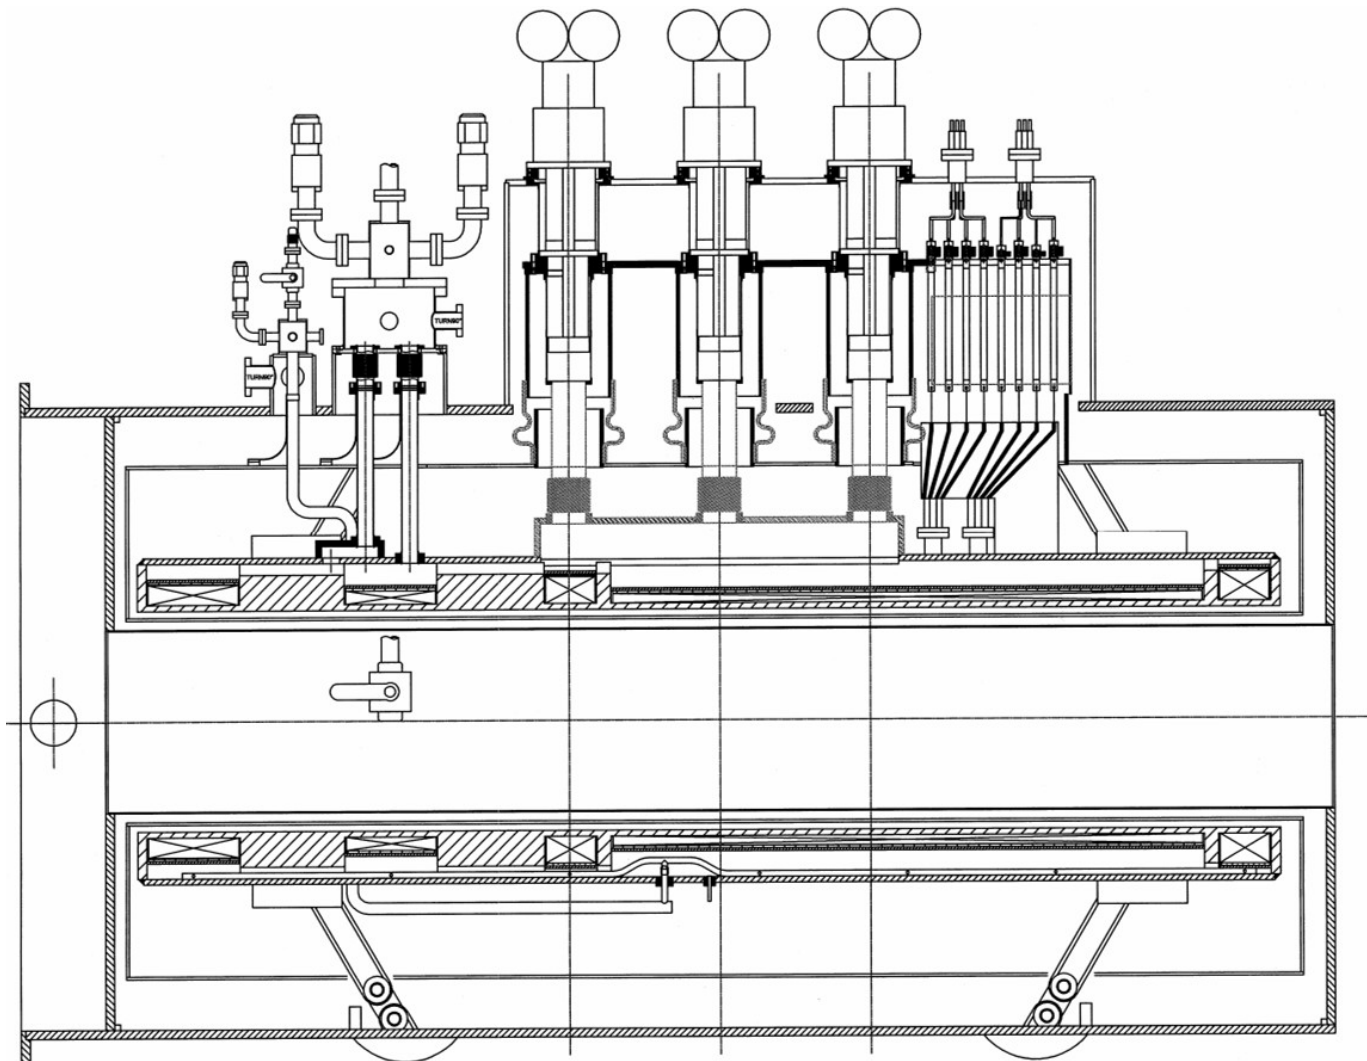
Magnet 2A Cross Section

- The second magnet was assembled with a series of design changes
 - replacement of the cooling circuit with large diameter tubes connecting the condensing cans directly to the top of the cold mass
 - addition of an LN reservoir connected to the shield
 - replacement of the thin, flexible copper straps that connected the shield to the 1st stage copper plate with thicker 1100 aluminum straps
- Upon cooldown, the cryocoolers appeared to be recondensing helium, but the magnet did not reach an equilibrium with no LHe boil-off
- The training of the magnet commenced, and a current of 238 amps was reached at which point an open circuit was detected
- After warm-up, the magnet tower was opened, and a burned out HTS lead was discovered; the failure was caused by inadequate cooling of the HTS lead upper ends at their connection to the 1st stage Cu plate

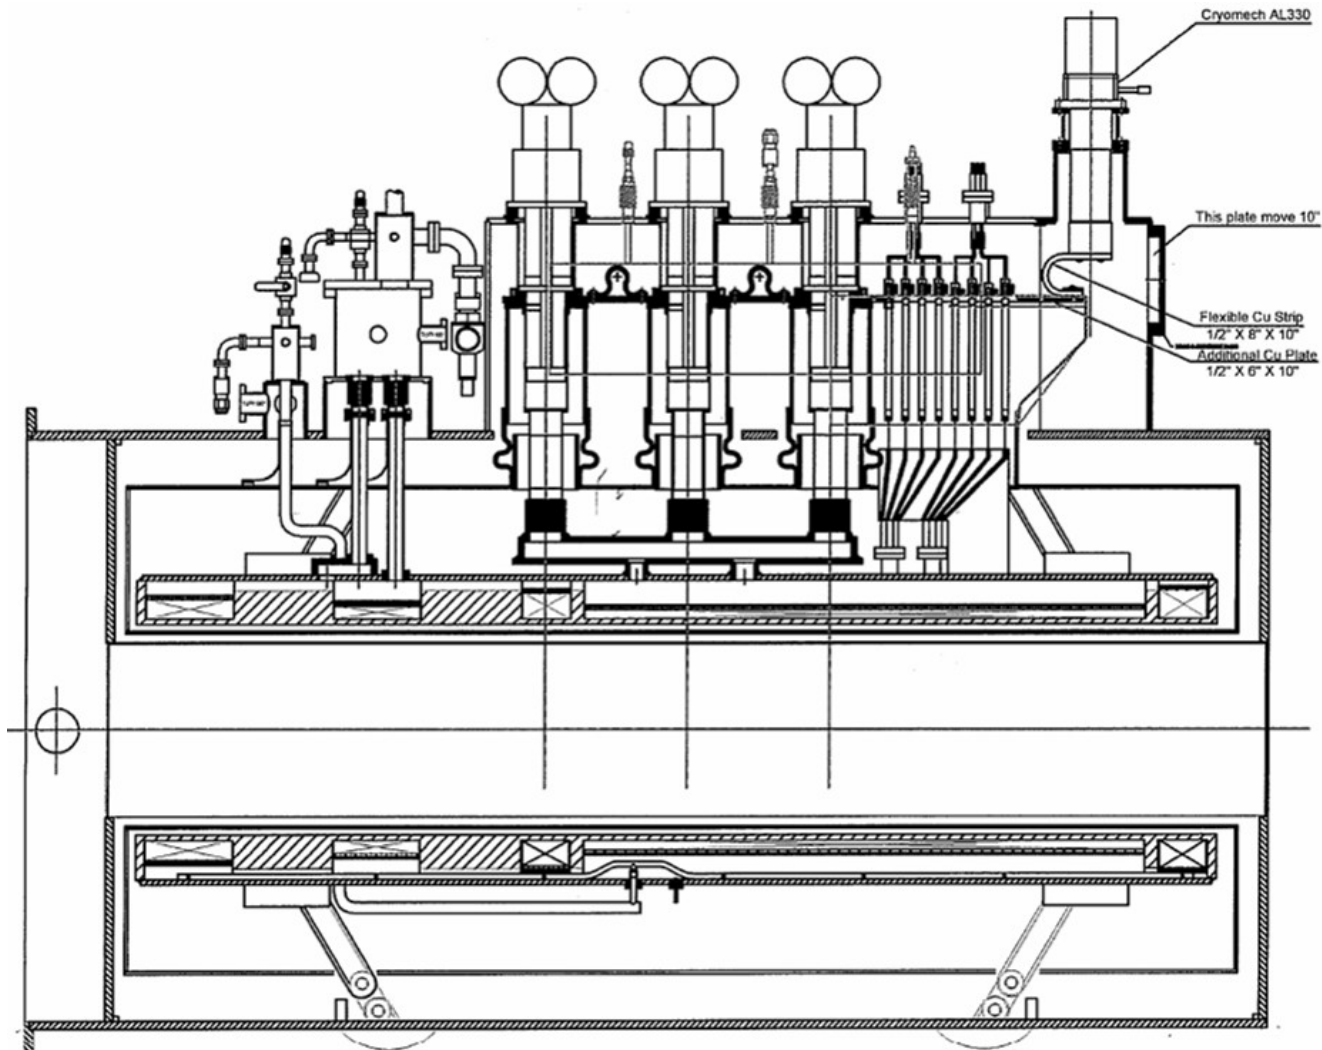
Magnet 2B Cross Section

- A review committee was convened by MICE management in 11/09 in order to assess the magnet design and to recommend modifications
- Per the committee, a single-stage cooler was added to increase cooling at the HTS lead upper ends and to help reduce the shield temperature
- With the HTS lead issue solved, Magnet 2B was trained in series to 258 amps when a coil lead was again found to contain an open circuit
- The failure was traced to the M2 coil close to the He/vacuum feedthru
- Training on the Center, E1 and E2 coils in series continued and reached a current of 270 amps
- Also noted was the fact that the three 2-stage coolers plus the single-stage cooler could not maintain a closed LHe system
