Liners & Seals

The SNO⁽⁺⁾ Experience

Doug Hallman
Laurentian U.

ANT-11

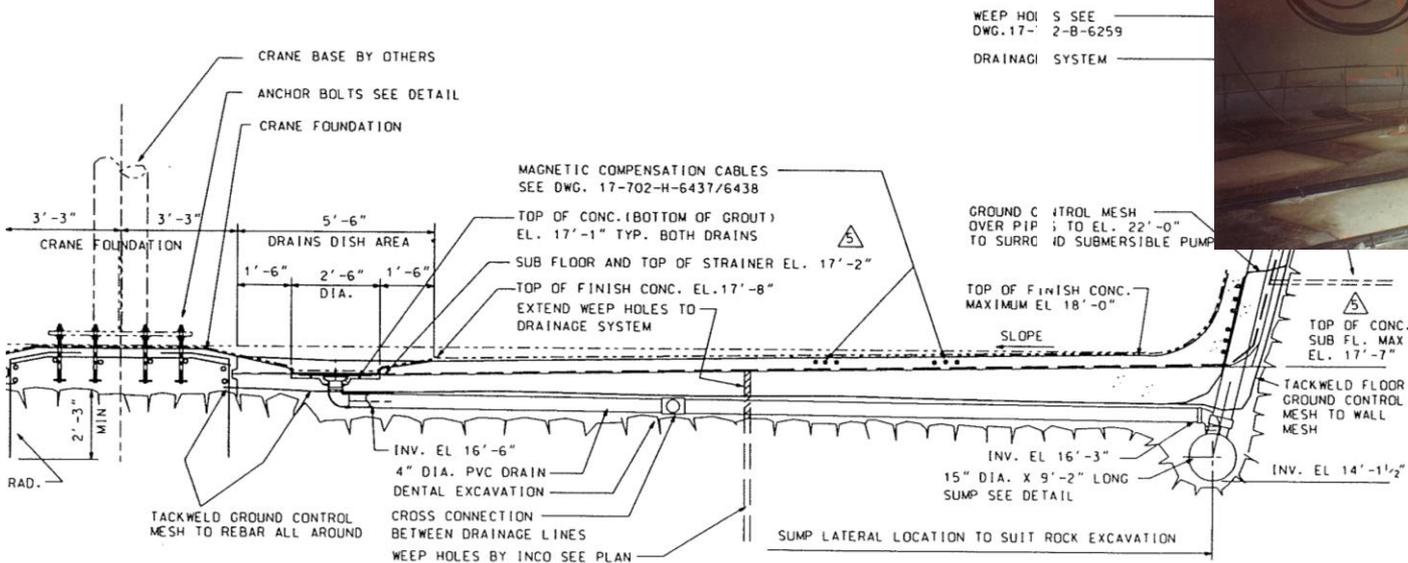
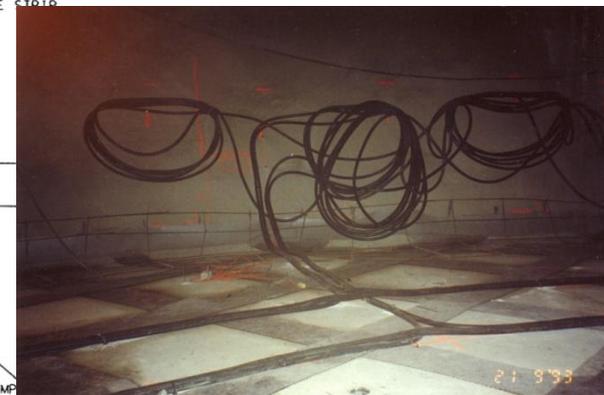
SNO+ Cavity Layout

4 TYP. DELAMINATED SECTIONS. LINER TO BE REMOVED ON WALL WHEREVER IT IS DELAMINATED.

10 TYP. EXPOSED SS PLATES AND CABLE BOLT ENDS TO BE COATED WITH 0.3" THICK Five Star POLYUREA FOLLOWED BY A 3" DIA CYLINDRICAL CASTING OF VersaFlex SL-85 SEALANT OVER THE BOLT END. CABLE BOLTS LOCATION AT 6.5 m RADIUS (256.0") FROM THE CENTER OF CAVITY

THE EXISTING URYLON FLOOR LINER TO BE REMOVED (CUT IN 2FT.x2FT. SQUARES). ALL CAST SEALS ON FLOOR PSUP ANCHOR BOLTS TO BE REMOVED PRIOR TO FLOOR REPLACEMENT AND SEAL WORK. CONCRETE FLOOR TO BE CLEANED AND PRIMED (BY OTHERS).

EXISTING LINER AND SEALS AT CENTRAL CRANE BOLTS TO BE REMOVED AND FLOOR/BOLTS CLEANED.

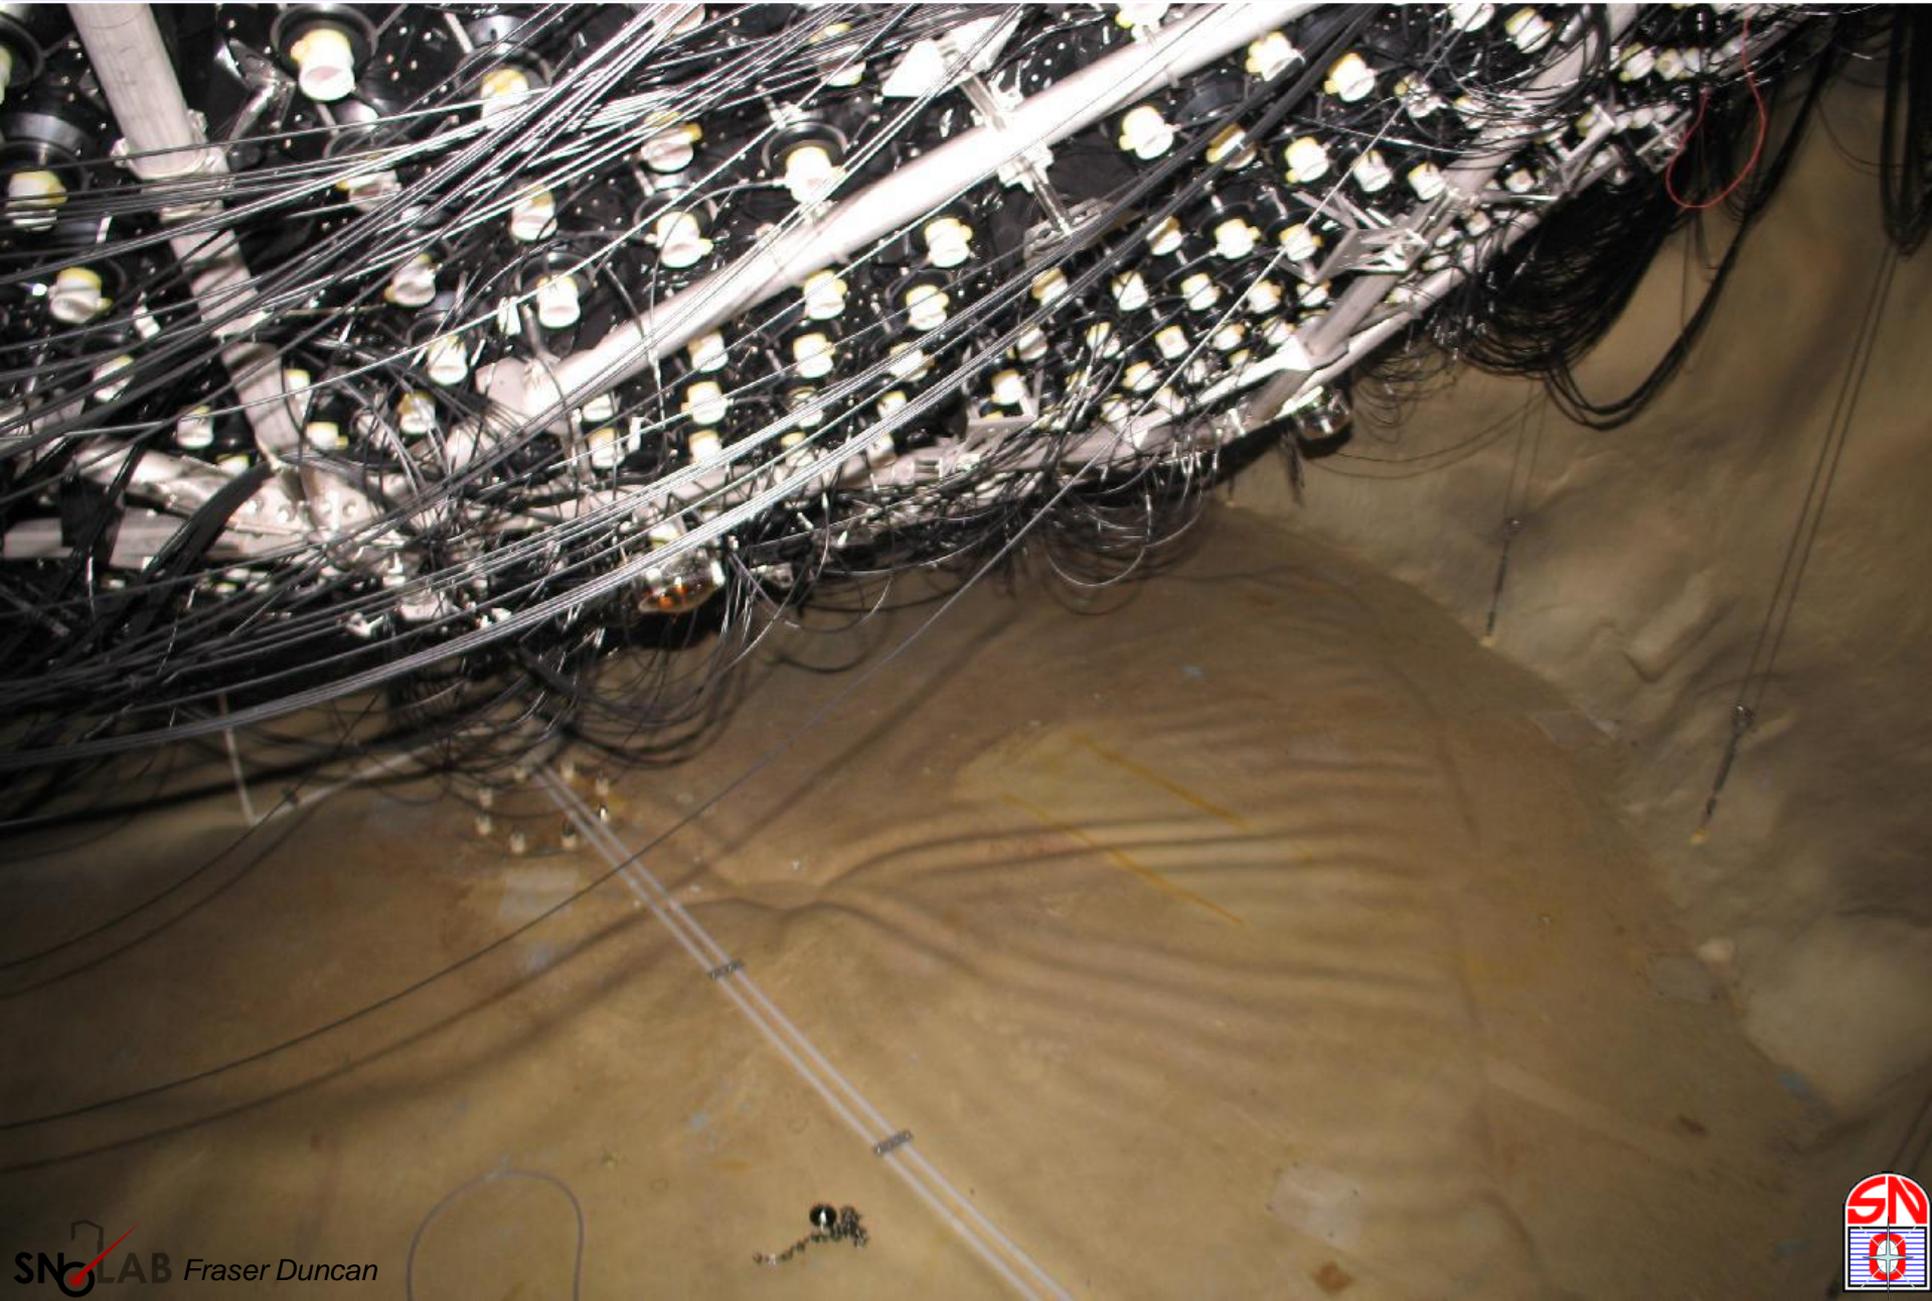
Cavity Floor - wrinkles

- When the cavity was drained at the end of the SNO experiment in 2006, insufficient time was allowed for the sump pumps to relieve backpressure from water in surrounding rock and the liner lifted from the floor. A set of wrinkles also developed in the floor liner.
- The remaining water was pumped out through several 1.5” diameter holes made in the floor liner.
- These holes were sealed prior to a refill of the cavity (for data taking with light water in the acrylic vessel).
- Camera images revealed that the wrinkles did not flatten out but formed tighter folds, ultimately resulting in several cracks through the liner, and a larger leak rate.

- A decision to replace the SNO floor liner was made, given uncertainties of repairing the damaged existing floor liner and the need to install and seal additional floor anchors for the acrylic vessel (required since the liquid scintillator placed in the AV has a 0.85 specific gravity).
- anchor installation – drilling of anchor bolt holes required isolation tent in bottom of cavity – frame plus tarp plus exhaust system to create negative air pressure differential with rest of cavity.
- Floor prep. and wall joint feathering was completed
- A two component polyurea primer (roller-applied liquid) was used to enhance adhesion with concrete.
- Liner - 6 alternating gray/white layers each 1.5 mm thick.
