Tests Status

Chimneys

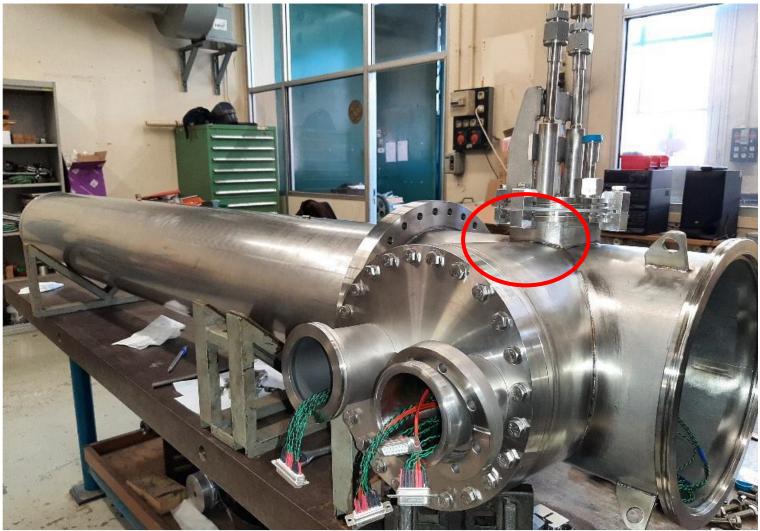
- **Sealing not correct:** one welding (done in the industry) at the top which cannot be fixed easily
- \Rightarrow remaining leak (~10⁻⁴ mbar l⁻¹ s⁻¹)
- \Rightarrow few 10⁻² mbar obtained
- (reminder at CERN (10⁻³ mbar))

Not critical for cold tests

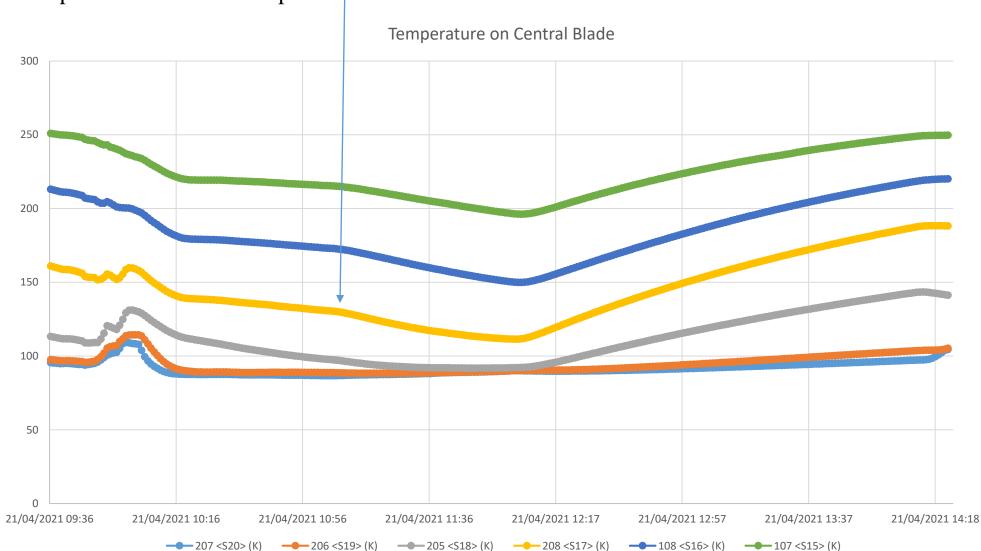
- 9h35 : Nitrogen flushing
- 10h : blade removal and tests of all slots
- 10h05 : cooling : Nitrogen injection in thermalisation circuit
- 10h20-11h10: heating with 2x5W (change of slope in cooling)
- 12h00-14h: tries to adjust temperature in the bottom part

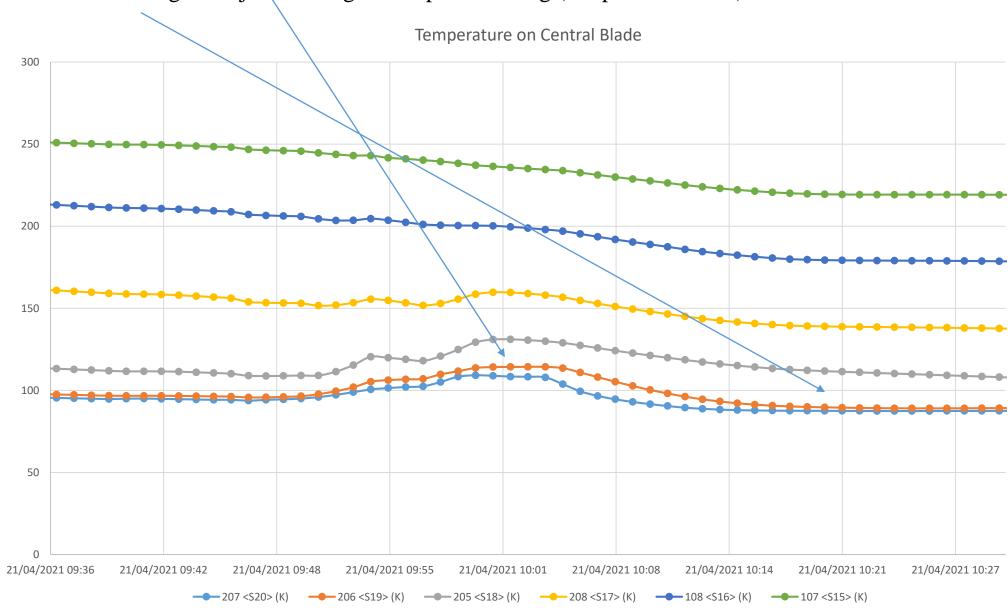
- Effect of blade removal and introduction
- No increase due to heating start: just a change of slope in cooling (see previous slide)
