DUNE ColdADC FDR

Carl Grace, on behalf of ColdADC Design Team – July 21, 2021

Lawrence Berkeley National Laboratory

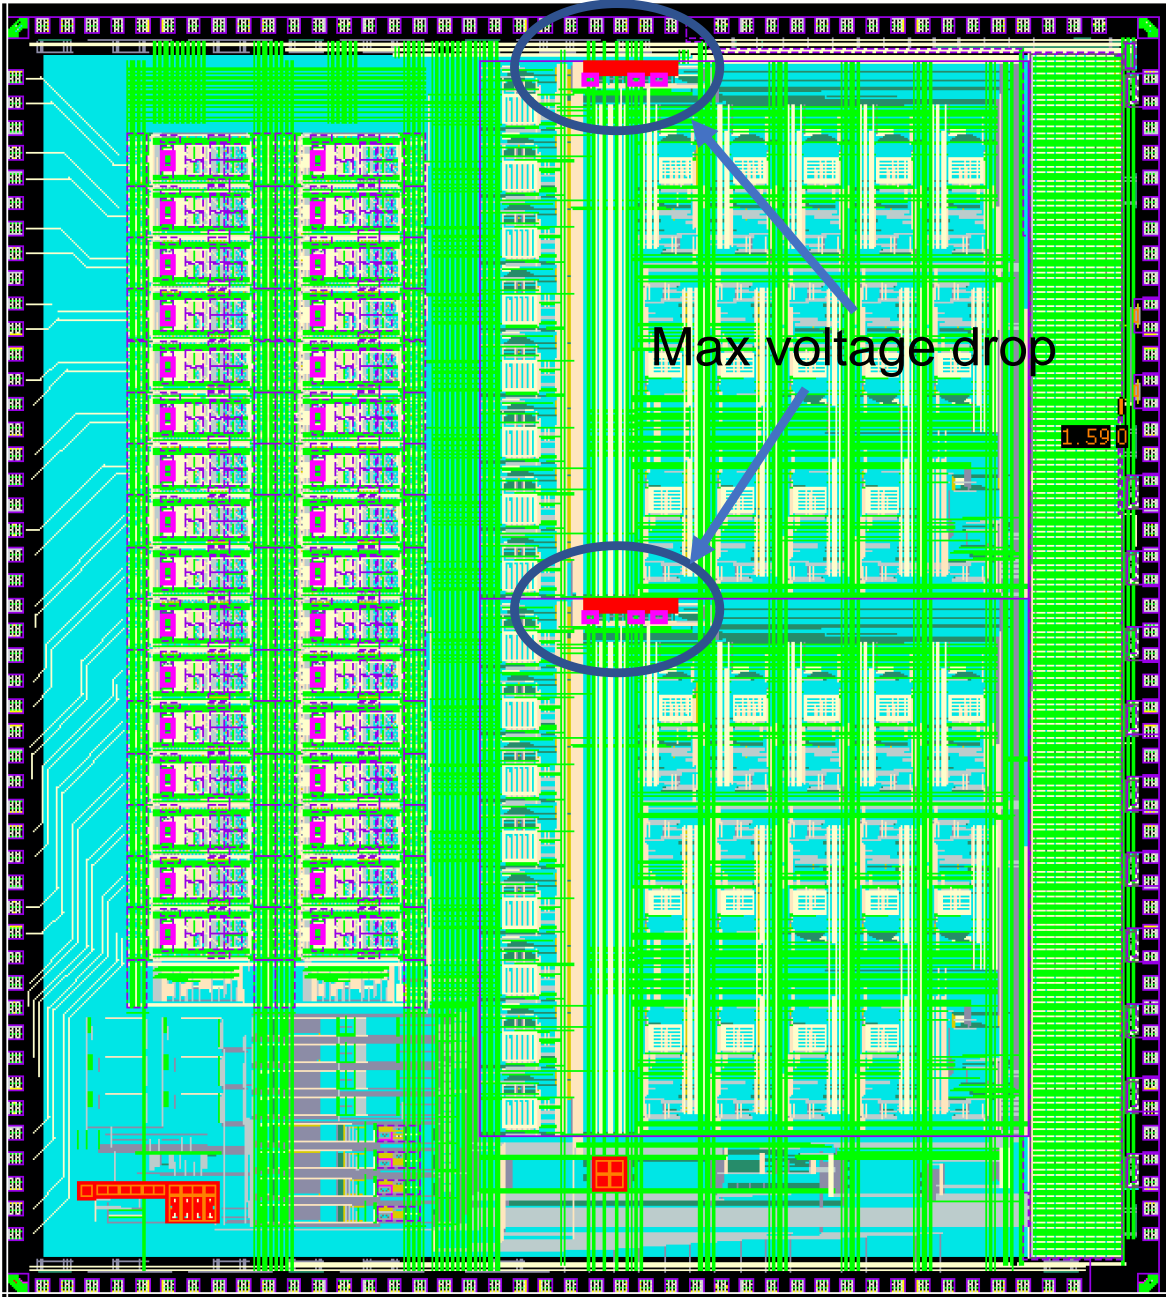
IR Drop

- Issue: Significant current draw caused IR drop at room temperature that caused significant voltage drop at ADCs
- Effect: ADC nonlinearity at room temperature unless ADC operated at elevated supply (no problem at cold).
- Root cause: Insufficient routing metal in power/ground (PG) network
- Fix: A specialized CAD tool called Volta was used to analyze the PG network in P1 and this allowed up to add sufficient routing metal to avoid IR drop issues in P2
- Result: No IR drop issues observed in P2 (max warm IR drop of 80 mV)

Additional metal limited IR to 80 mV worst case at room temperature

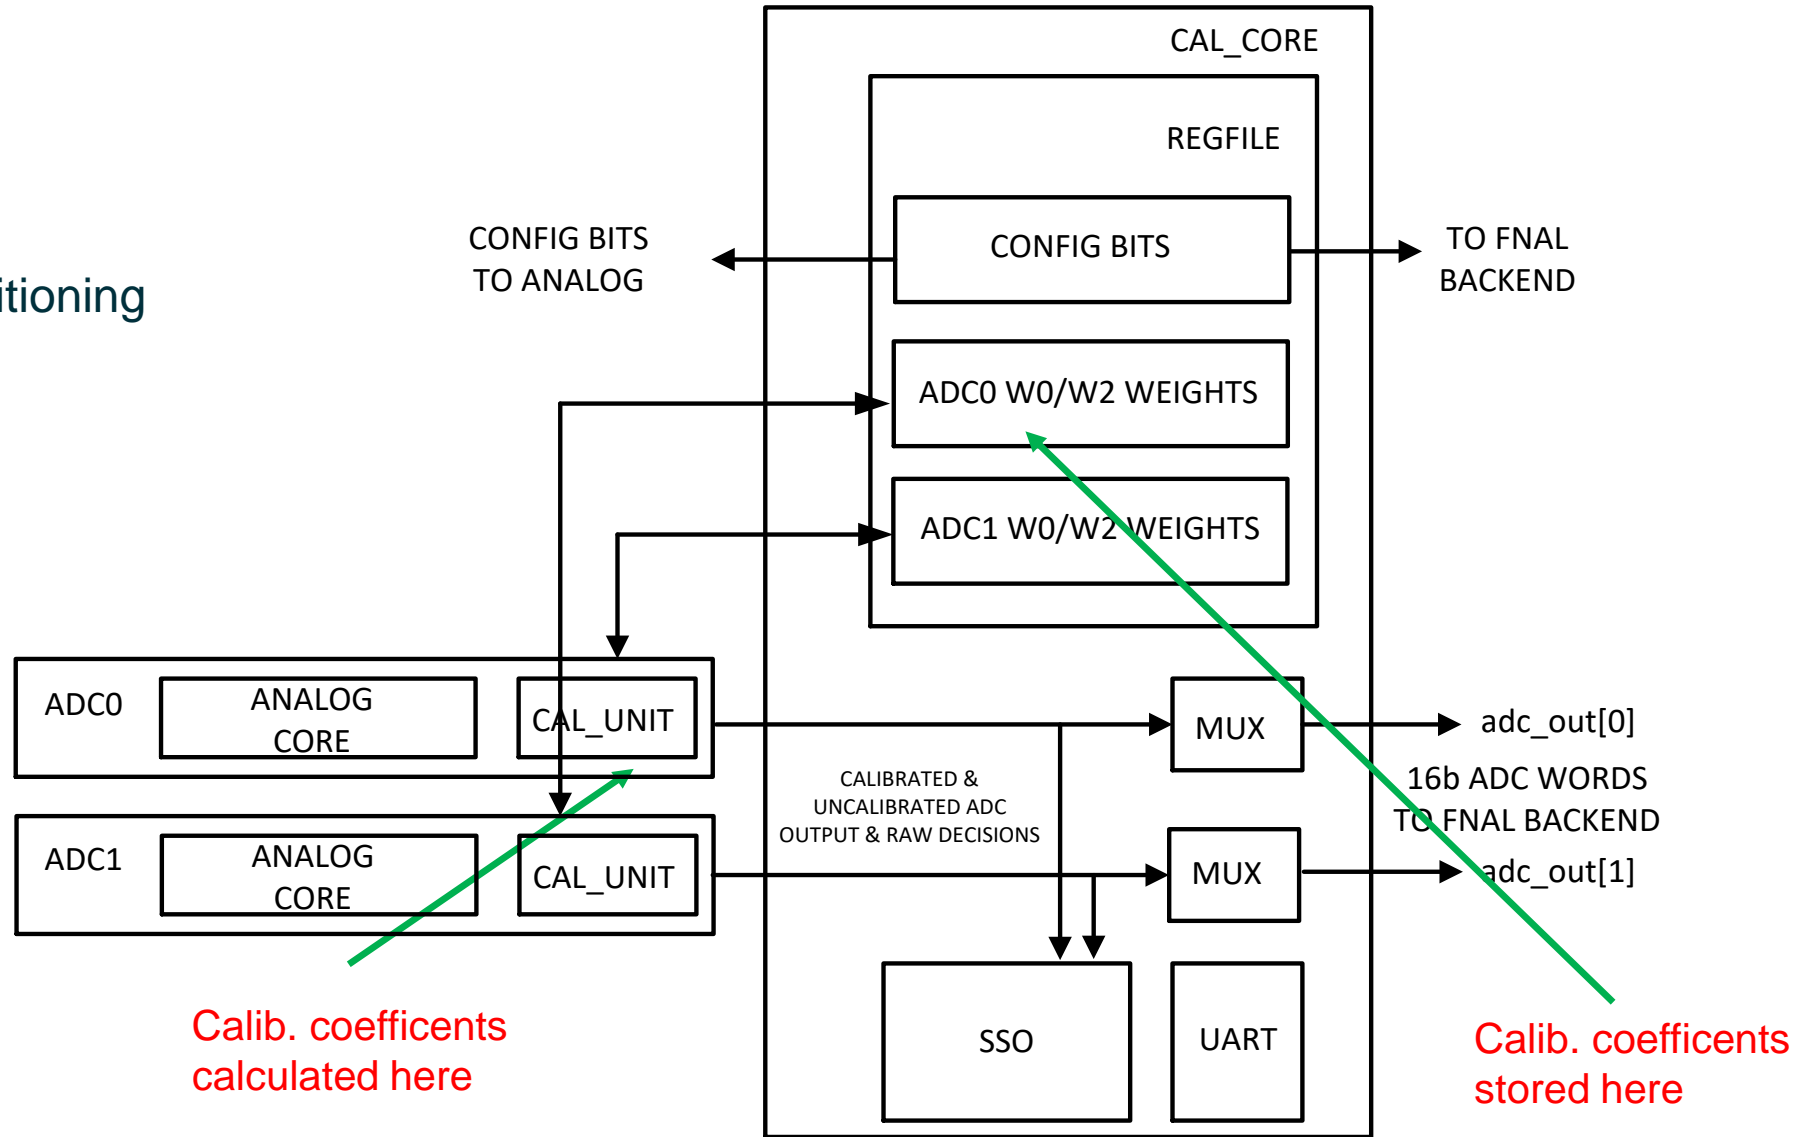
P1 Partitioning

- Issue: The automatic calibration function in P1 failed to operate correctly
- Effect: While evaluation of the calibration algorithm was still possible, required calculating calibration correction data off-chip and then reloading the calibration weights on chip (not suitable for fielding in practical detector)
- Root cause: Miscommunication between design teams, and separation of different functional unit in separate synthesized blocks
- Fix: Repartitioned design to use a single, monolithic digital block. Implementing more extensive verification, improved communication through use of shared documents and meetings
- Result: Autocalibration fully functional in P2 without problems

Calib. coefficients
calculated here

Calib. coefficients
stored here

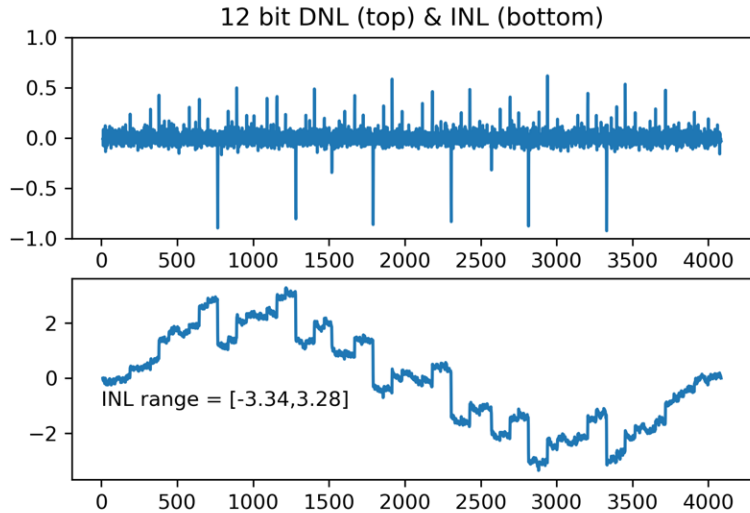
Uncalibrated

- Issue: The ADC linearity was not as good as expected (based on simulation)
- Effect: Additional nonlinearity in P1 above expectations
- Root cause: Several issues, including insufficient opamp gain and insufficient swing across corners
- Fix: Op amps were redesigned to improve swing and increase gain
- Result: Linearity was improved relative to P1. Residual nonlinearity consistent with dielectric absorption in the capacitors used to implement the ADC stages (stable correction possible)

X-axis: ADC code
Y-axis: nonlinearity in LSBs (12 bit)

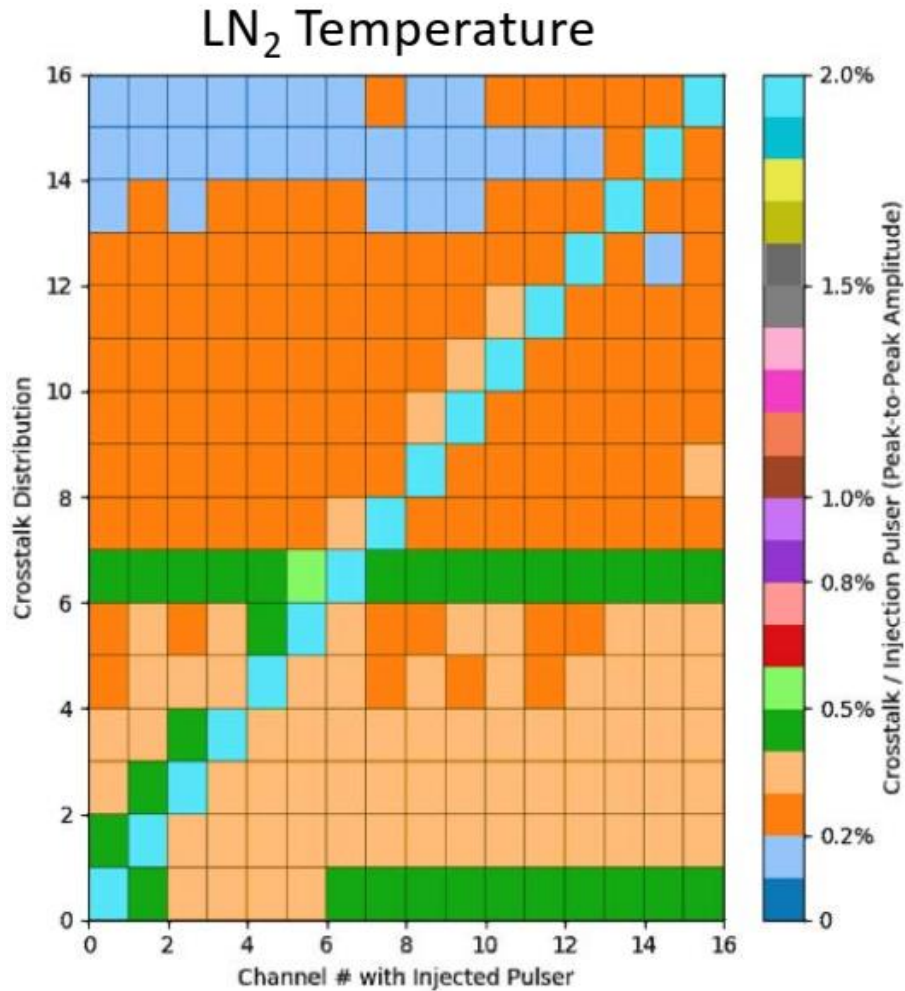
- Issue: While not critical, there was evidence of a low level of crosstalk ($\sim 0.5\%$) between channels.
- Effect: Limited performance of some channels
- Root cause: Insufficient bandwidth in the mux (too high on-resistance in switches) leading to kickback and mutual capacitive coupling between channels
- Fix: Improve BW to mitigate memory effect (kickback) and reduce channel-to-channel coupling via layout optimization
- Result: Crosstalk improved to 0.06% (almost order-of-magnitude improvement)

P1 Crosstalk (0.5% worst case)

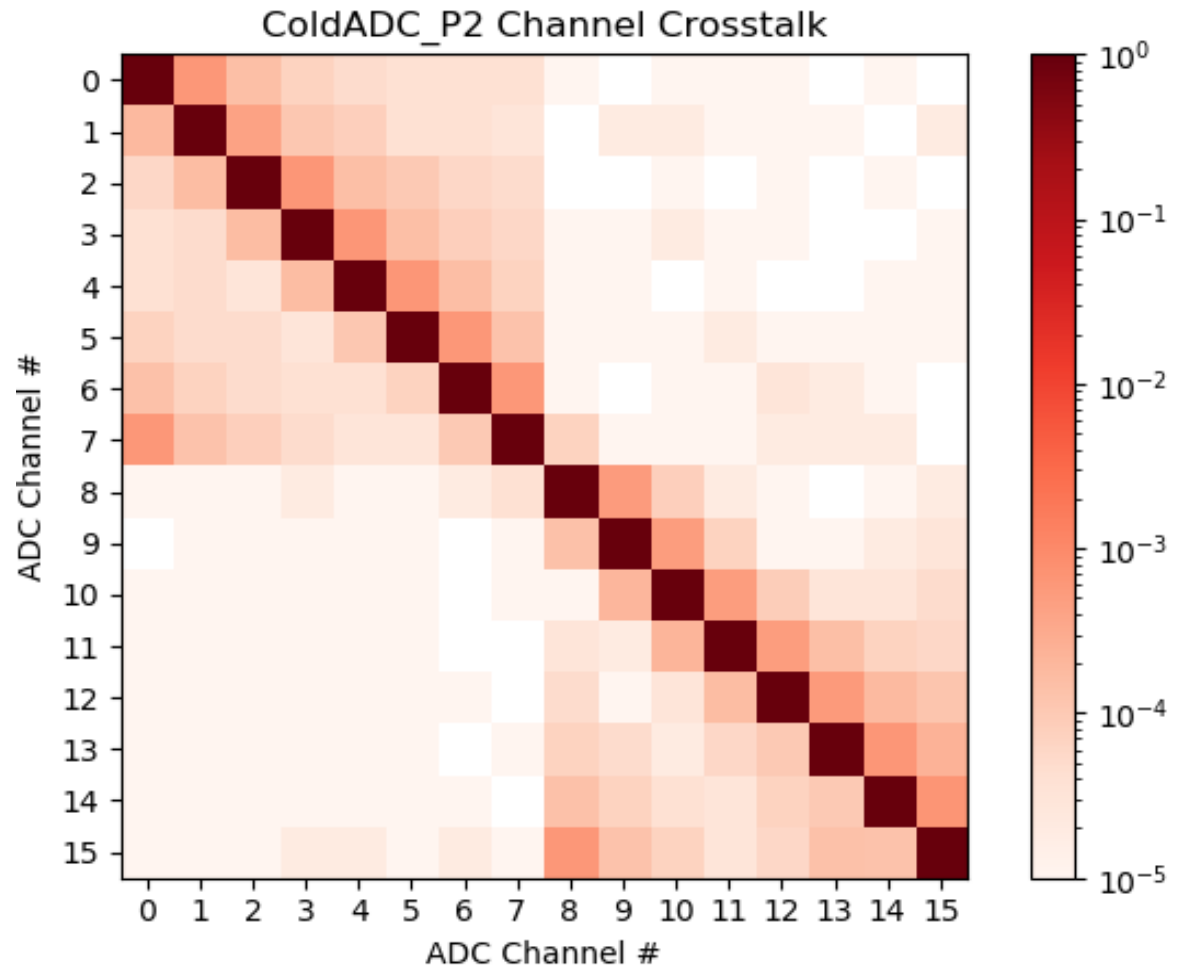
P2 Crosstalk (0.06% worst case)

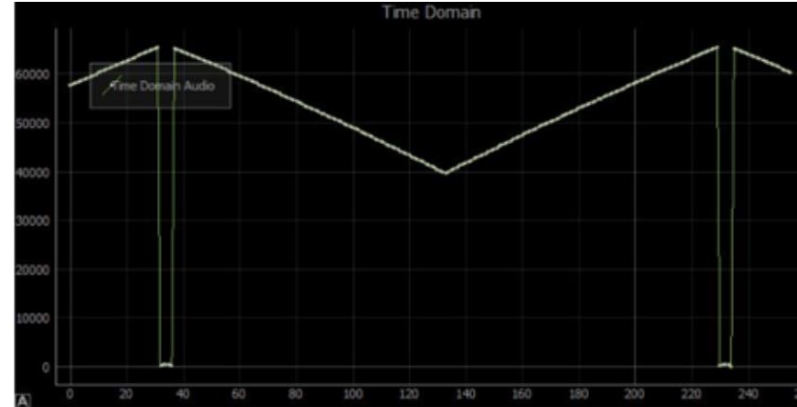
ADC With Overflow

- Issue: If the sum of all ADC stages gains $> 2^{15}$, overflow (or underflow) possible
- Effect: Overflow observed in testing of P1
- Root cause: Capacitor mismatch can cause some ADC stages to have gain > 2 .
- Fix: Implement digital overflow monitor to detect overflow condition and pin the ADC output to appropriate value
- Result: Overflow monitor demonstrated to work as expected

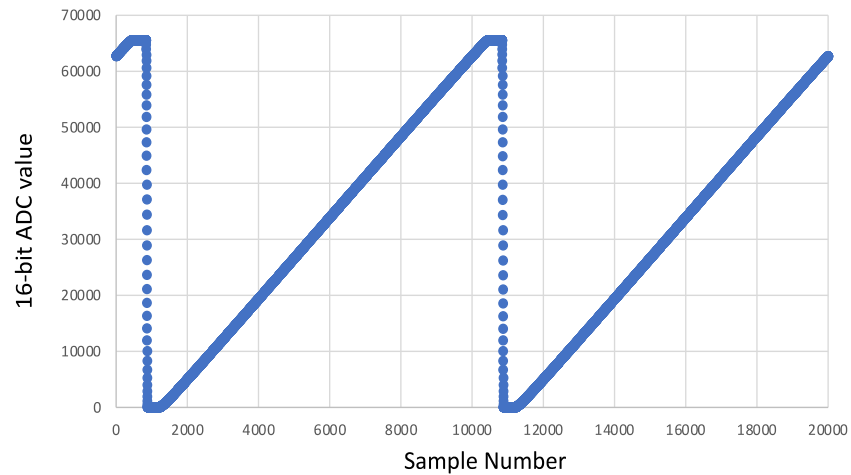
Overdriven: Calibrated, Overflow Protection ON

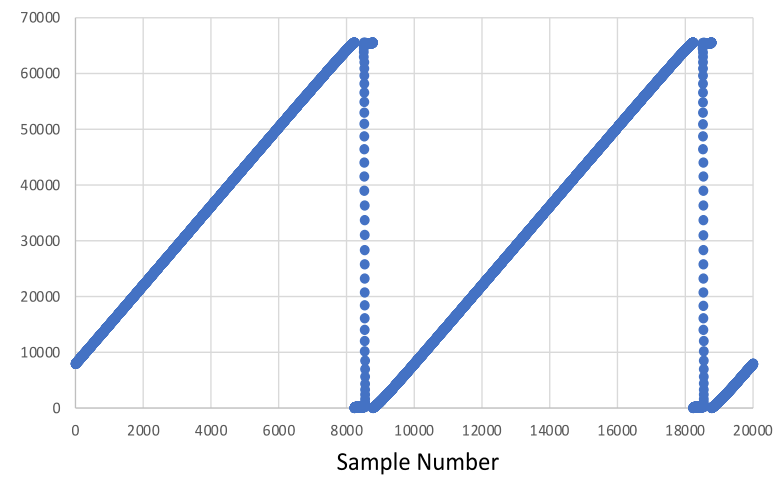
Overdriven: Calibrated, Overflow Protection OFF

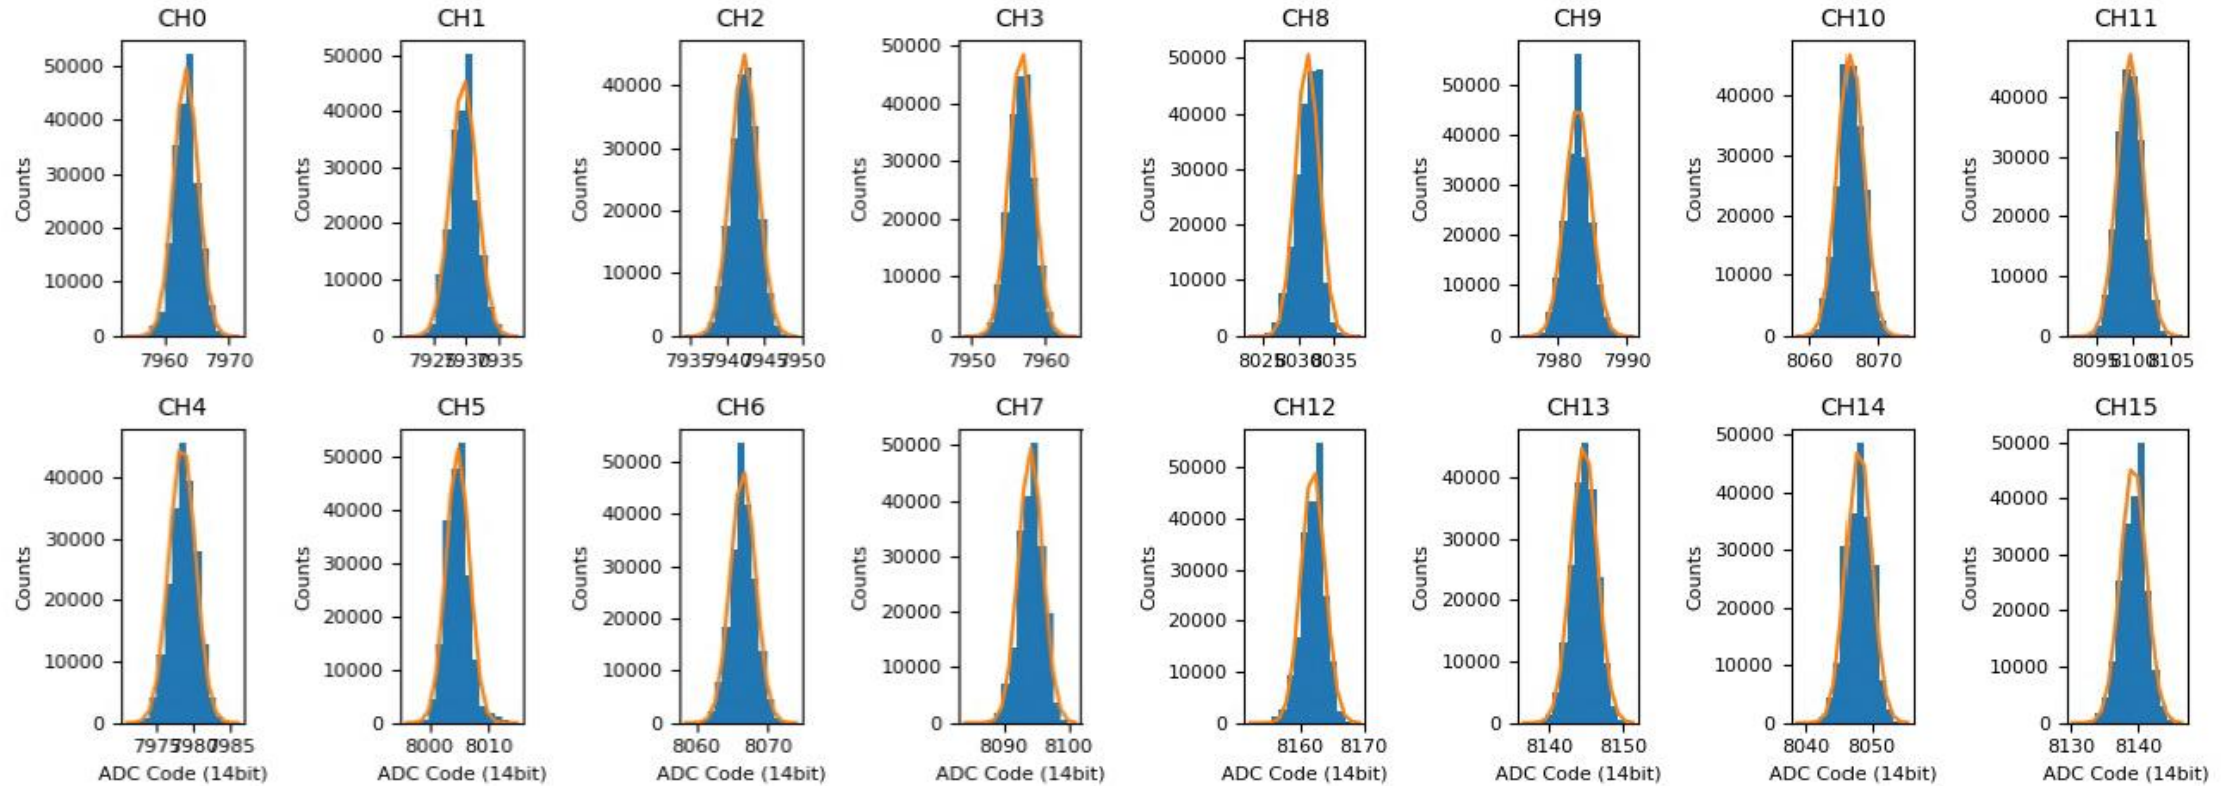
Noise Across Channels

Highly stable noise characteristic → about 140 $\mu\text{V-rms}$ at LN_2
