The Search for Air Overpressure During Blasting Operations

Phil Nesbitt, LBNF/DUNE – US, Mining Engineer Intern

FERMILAB-POSTER-21-030-LBNF

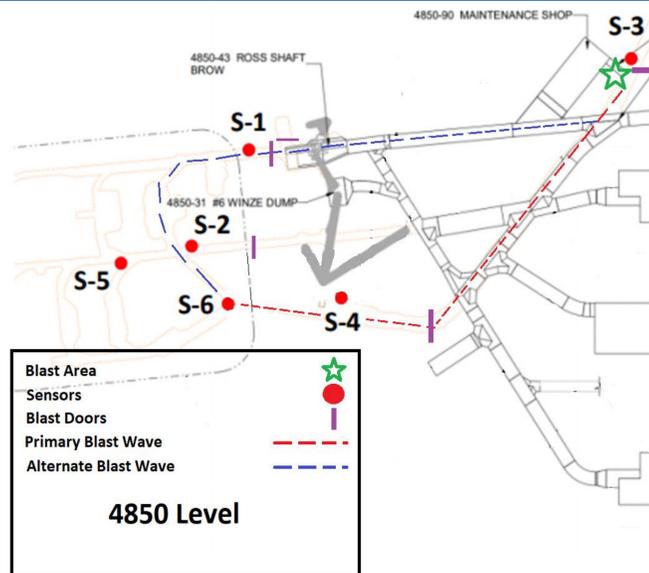
Seismic Sensor Layout on 4850 level

During blasting of the machine shop egress (4850-90A) which is located right next to sensor 3, air overpressure readings were recorded on sensor 6 which is located directly outside of CASPAR. These readings were not duplicated on any other sensor causing some confusion. Several sensors are positioned such that the soundwave would pass them before arriving at sensor 6 meaning energy should dissipate by arrival at sensor 6, not increase. Another consideration is the location of blast doors in relation to the various sensors.

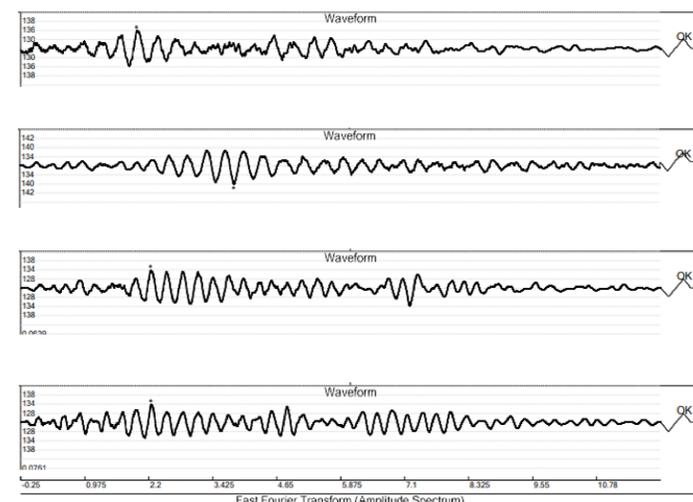
Acoustic Comparison for over-pressure readings on Sensor 6

Analyzing the data, the overpressure acoustic range was between 1.5 and 7.2 Hz with most overpressures falling near the 3.5 Hz range. The average time the overpressure was recorded was 3.23 seconds. Acoustically speaking, a soundwave travelling in air from the blast, taking the most direct route, should arrive at sensor 6 within 1.9 seconds. That this time was almost doubled was a clue that multi-path sound propagation was occurring. Also, the possibility that different waveforms were reinforcing each other was tantalizing.

Another data point analyzed was the waveforms appeared sinusoidal. This is an indication that a resonance was present. In taking both the resonance and the multipath sound propagation as primary data points, an experiment was conducted where-by a video was recorded of airflow indicators which were installed in the vicinity of sensor 6 to determine the direction and intensity of the airflow after the blast. The next step was moving the sensor from the metal post it had been mounted to and attach it to the concrete wall for measurement during a subsequent blast.

Once the sensor was removed from the metal post, the sinusoidal nature of the soundwaves disappeared indicating that the post was likely resonating with the frequency of the soundwave causing a false overpressure reading. The airflow video showed a large volume of air was moving rapidly through the area indicating that air travel was likely flowing through several adjacent levels and returning through the #6 winze during the blast. This helped to explain why the sound took longer than expected to arrive at the sensor. It was determined that resonance was the most likely culprit. The microphone was replaced and remains mounted to the concrete wall. In all subsequent blasts, no overpressure has been recorded that was not attributed to the type and weight of explosives being used.
