## *DR's for Serial # QXFA202*

# MAGNET DISREPAANCY REPORT

Part No: F10030927		Rev	Traveler No.: AUP-100	Rev: A
Part Name: QXFA Coil Winding & Curing			Traveler OP No.: 230	
Qty: 1	Ser. No./Lot No.: QXFA202		Operation: Respooling	
Initiator: H. Hocker		Life No.: 22131	Date: 9-11-18	
Type of Problem: (Check) Mechanical      Electrical      Other <input checked="" type="checkbox"/>				
Description			Disposition	CE
Continue on reverse side if required			RWK, RPR, UAI, SCP	DQAR
During respooling, a raised strands were detected on the side facing down (the side which would face the coil island). The raised strands continued for most of the length of the conductor.			UAI	<i>[Signature]</i>
Instructions: Continue on additional sheets if required			Name	Life #
USE AS IS - MONITOR AND NOTE CABLE STABILITY DURING COIL WINDING				
Reason for Discrepancy:				
UNSTABLE CABLE				
Corrective Action:				
REPORT ISSUE TO CABLE FAB GROUP - DONE 10/15/18				
Report reviewed by CE <i>[Signature]</i>			Date	<u>9/28/18</u>

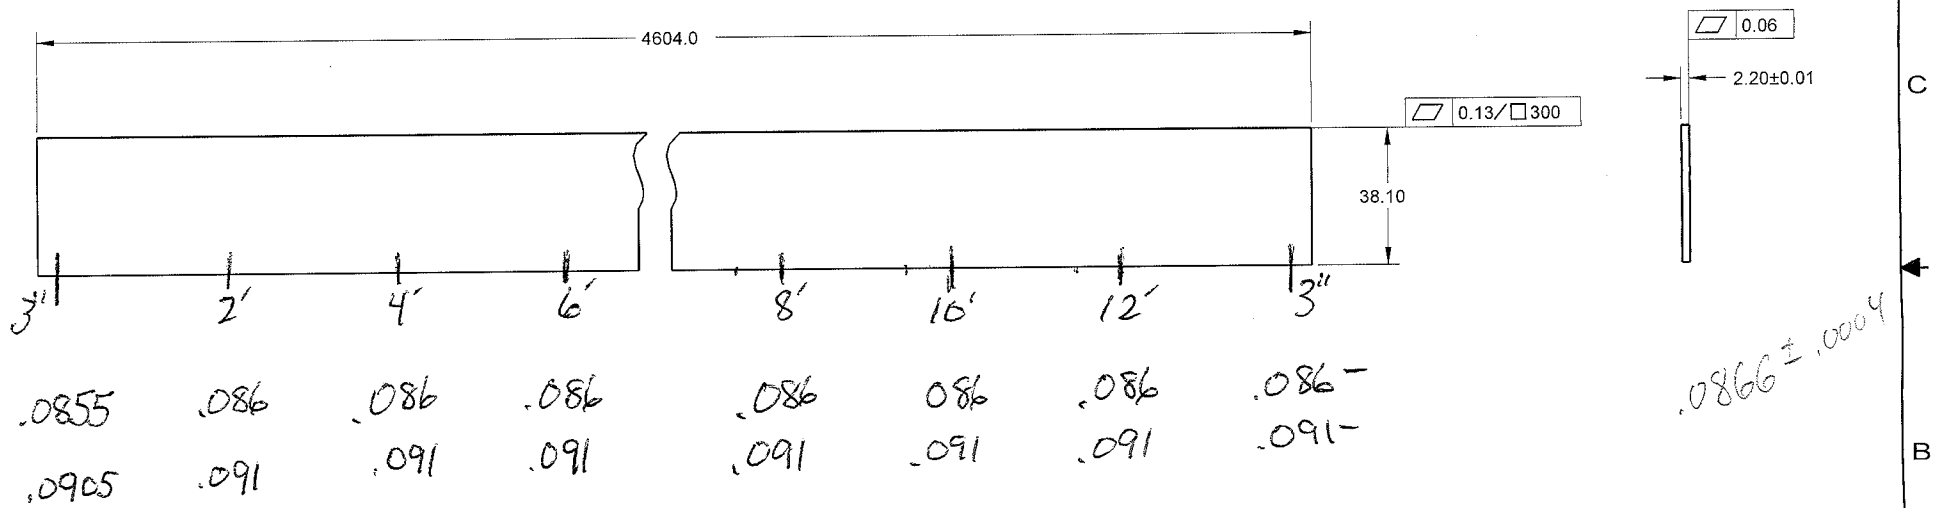
DR AM-113  
2/2

Description <small>Continue on reverse side if required</small>	Disposition	CE	DQAR
	<small>RWK, RPR, UAI, SCP</small>		
<u>One midplane shim was found to be .005 thicker than the other one. .091 vs. .086.</u>			
<u>Discrepancy was found to be consistent down the full length of shim, as shown on attached sheet.</u>	<u>RWK</u>	<u>JA</u>	<u>CB</u>

.0866 ± .0004

Instructions: <small>Continue on additional sheets if required</small>	Name	Life #	Date
<u>MARK EACH SHIM WITH ACTUAL THICKNESS.</u>			
<u>OMIT THE LAYER OF .005" MYLAR FROM THE MIDPLANE WHERE THE OVERSIZE SHIM IS INSTALLED.</u>	<u>T. Levine</u>	<u>21627</u>	<u>12/7/18</u>

Corrective Action: FERMI TO PROVIDE UPDATED SHIMS
