DR's for Serial # **QXFA206**

MAGNET DISCREPANCY REPORT

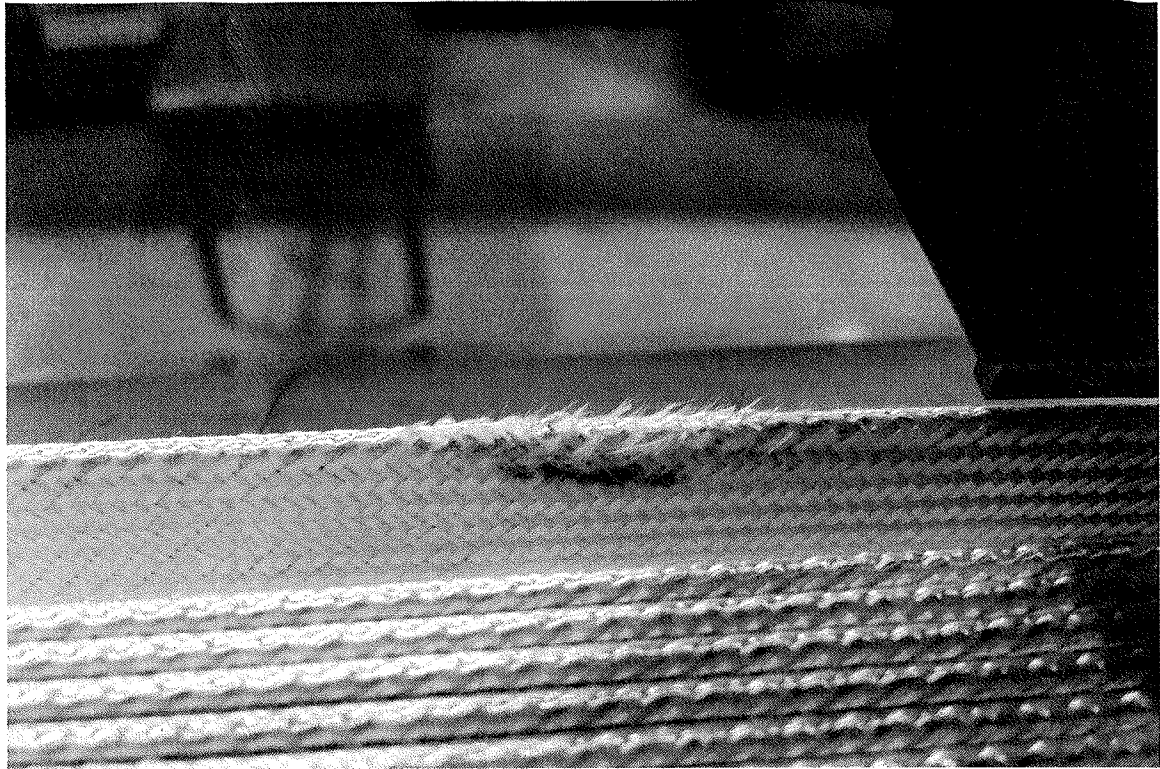
Description	Disposition <small>RWK, RPR, UAI, SCP</small>	CE	DQAR
Continue on reverse side if required			
Scuffed insulation on turn 28, transition side, located 48" from the lead end straight section			
<i>AND STAINED</i>	<i>UAI</i>	<i>JS</i>	<i>[Signature]</i>
<i>ATTEMPT TO CLEAN WITH ALCOHOL</i>			
<i>UNSUCCESSFUL</i>

Instructions: Continue on additional sheets if required	Name	Life #	Date
<i>USE AS IS</i>
