## *DR's for Serial #*    **QXFA220**

# MAGNET DISREPAANCY REPORT

Part No: F10115641	Rev B	Traveler No.: AUP - 110	Rev: E
Part Name: QXFA COIL ASSEMBLY		Traveler OP No.: 1240	
Qty: 1	Ser. No./Lot No.: QXFA 220	Operation: Layer 1 Winding	
Initiator: Glenn Jochen		Life No.: 15764	Date: 12/09/2020
Type of Problem: (Check) Mechanical <input checked="" type="checkbox"/> Electrical <input type="checkbox"/> Other <input type="checkbox"/>

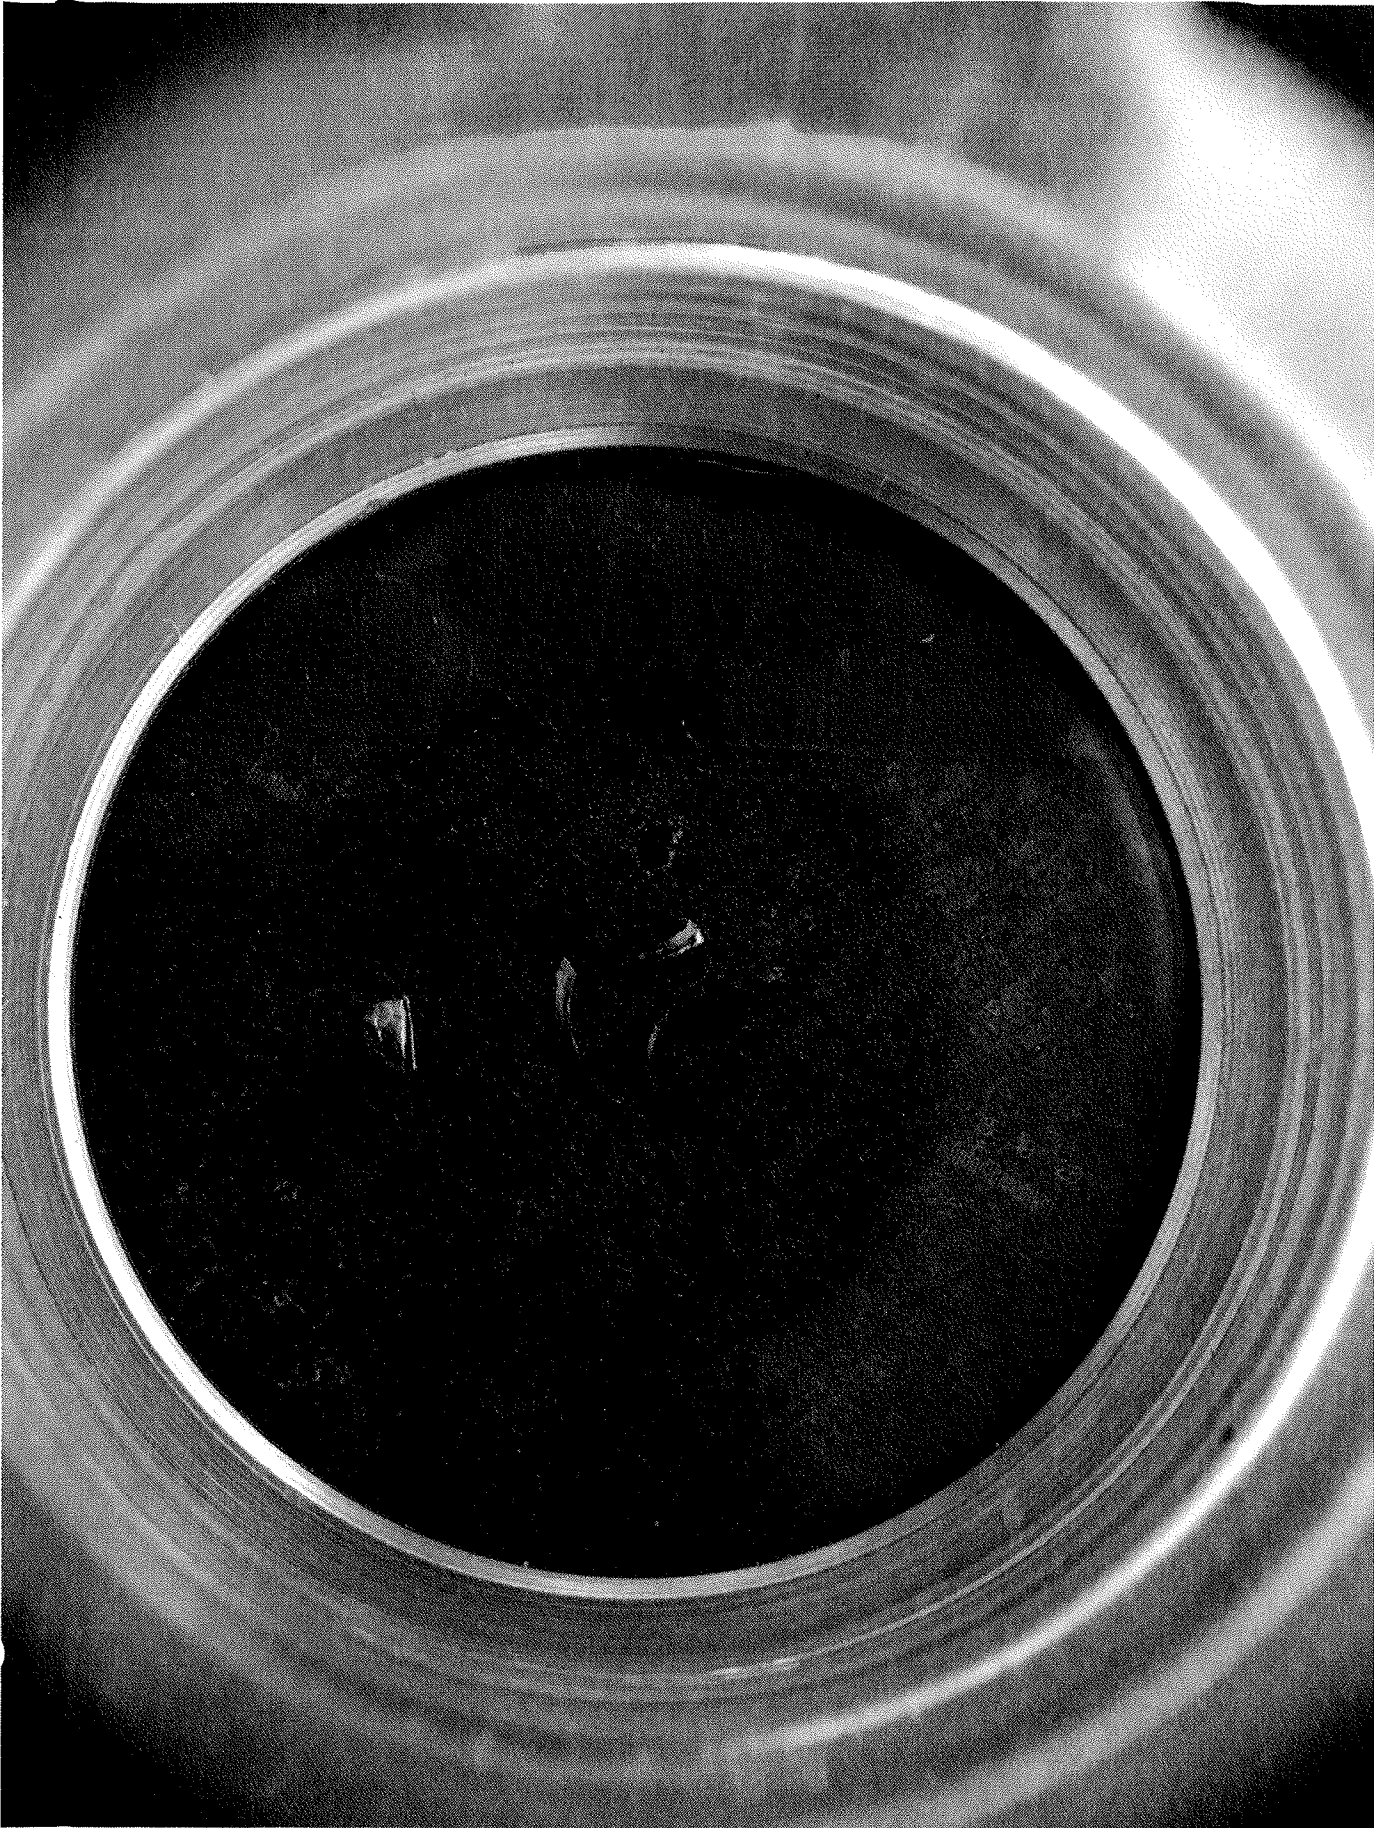
Description	Disposition <small>RWK, RPR, UAI, SCP</small>	CE	DQAR
Continue on reverse side if required			
Discovered metal chip protruding from a metric threaded hole in the L1 centerpost second from the lead end. The threaded hole is ~31-1/4" from the lead end splice block. One of the chips (long & thin) are ferrous.	RWK	<i>[Signature]</i>	<i>[Signature]</i>
The other two are not affected by the magnet.

Instructions: Continue on additional sheets if required	Name	Life #	Date
Taped off surrounding coil turns and carefully removed the chip from the threaded hole. Captured the chip pieces with adhesive side of masking tape	<i>[Signature]</i>	15764

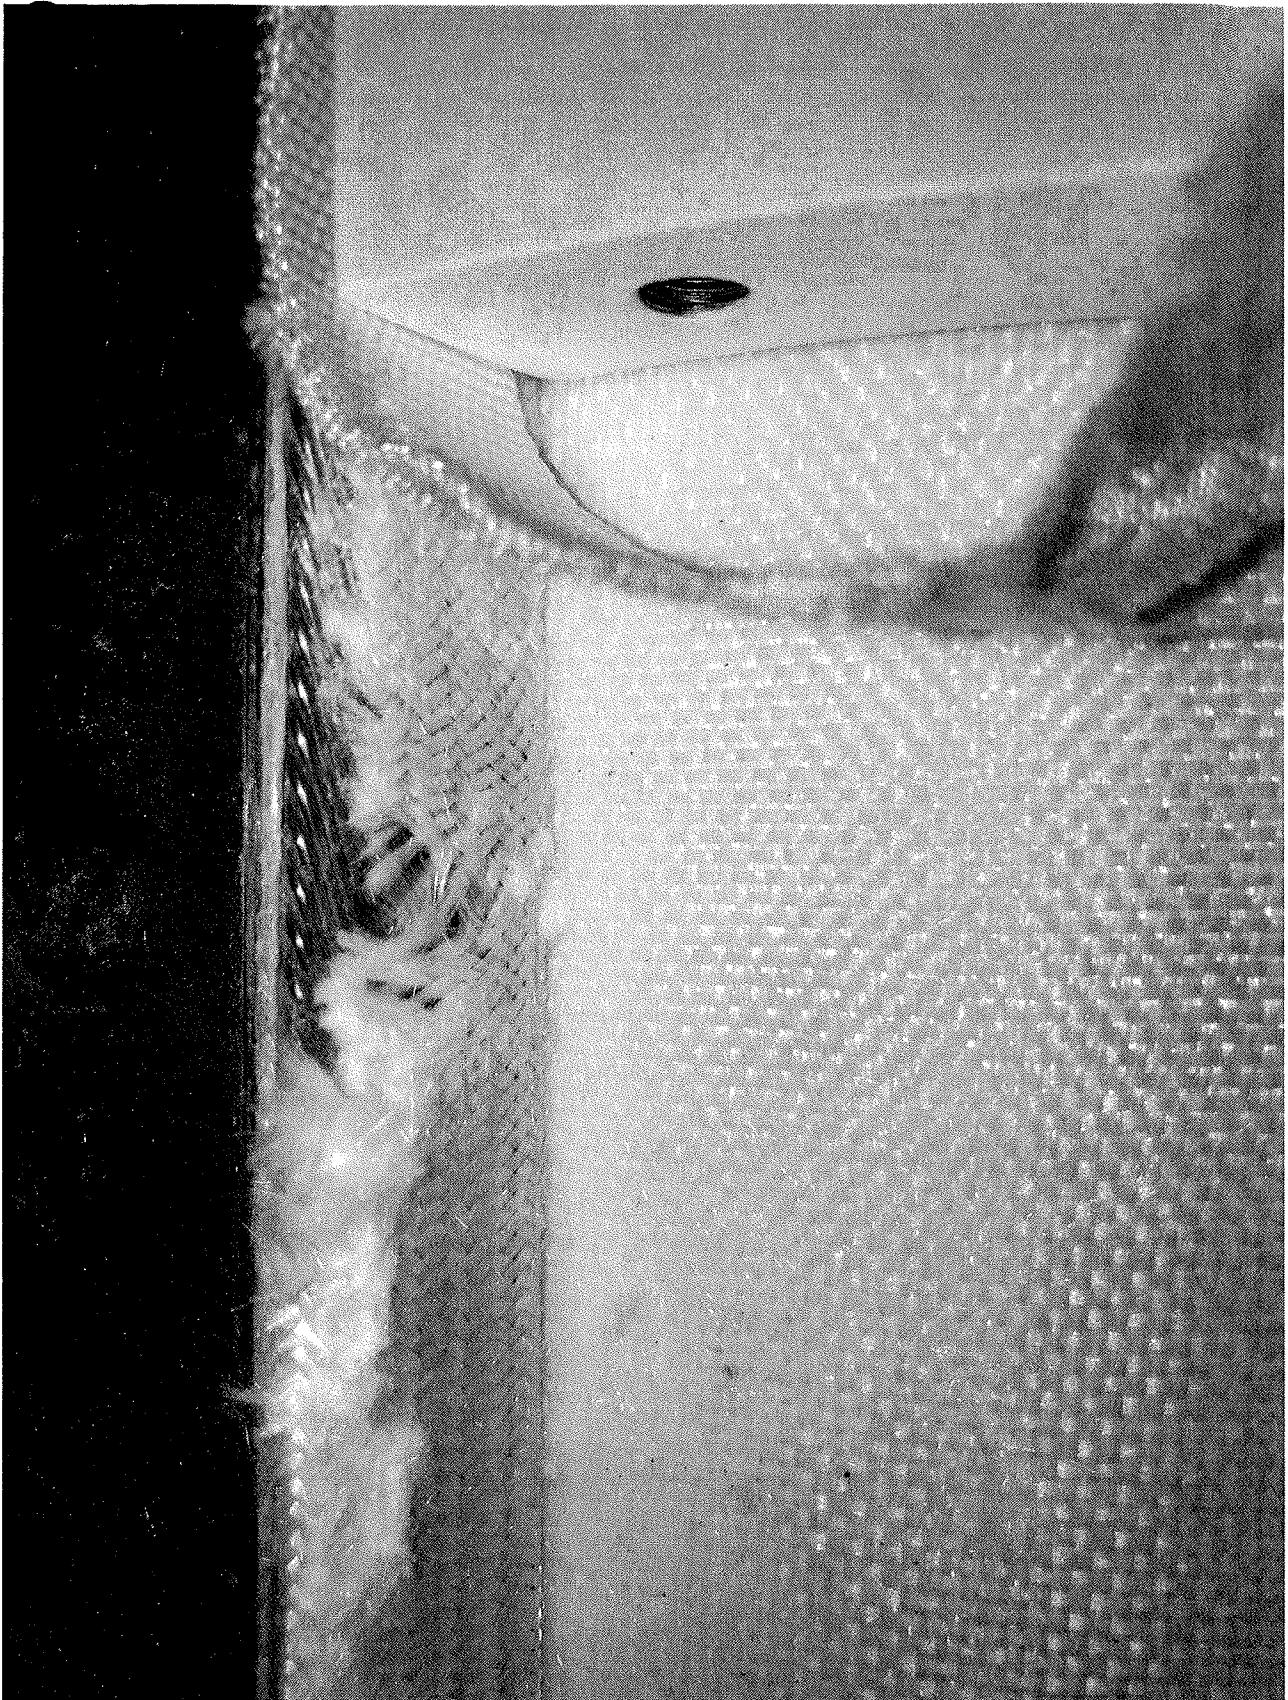
Description	Disposition <small>RWK, RPR, UAT, SCP</small>	CE	DQAR
Continue on reverse side if required			
Layer 2 coil lead insulation is chaffed along the major edge for ~ 1" adjacent to the lead end splice block. See sheet 2	RWK	<i>JS</i>	<i>[Signature]</i>

Instructions: Continue on additional sheets if required	Name	Life #	Date
SMOOTH OUT DISPLACED FIBERGLASS PRIOR TO REACTION.	<i>[Signature]</i>	15764
