Module 0 lessons learnt

Justin Evans

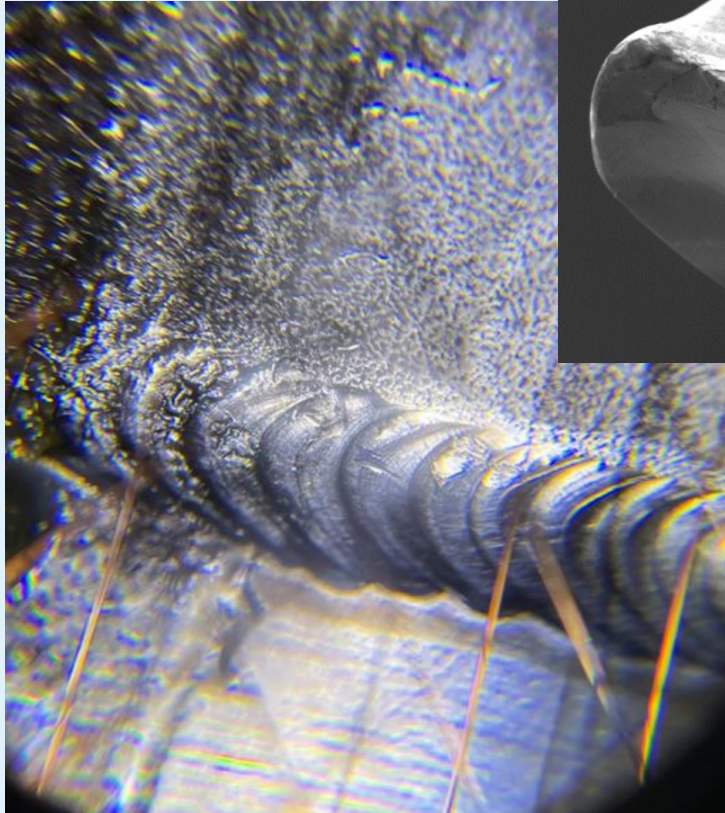
ProtoDUNE 1: Broken X-wire

Broken X-wire was caused by pre-existing damage

- Scratch on frame indicates contact by a sharp object, which also damaged the wire

Improvements to procedures

- Culture of always reporting any inadvertent APA contacts, or other incidents that could cause damage to production manager
- Any wires with any suspicion of damage are removed from the APA

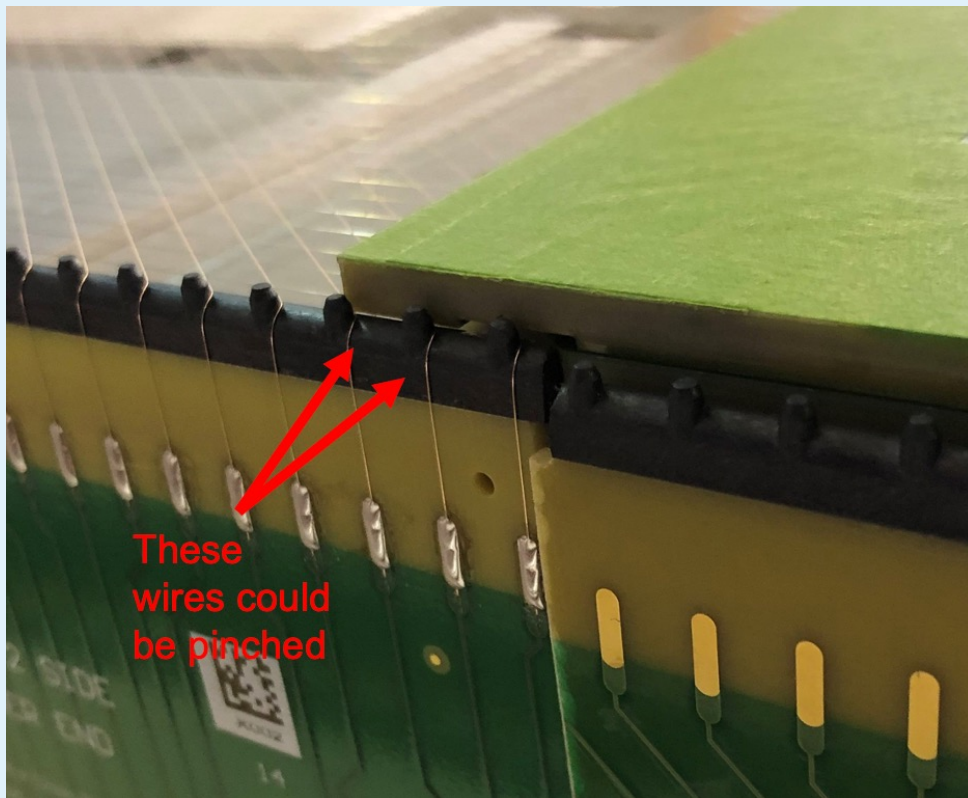
ProtoDUNE 1: Broken V wires

- Corner V-wires were bonded to the U-head board above, creating a short wire length

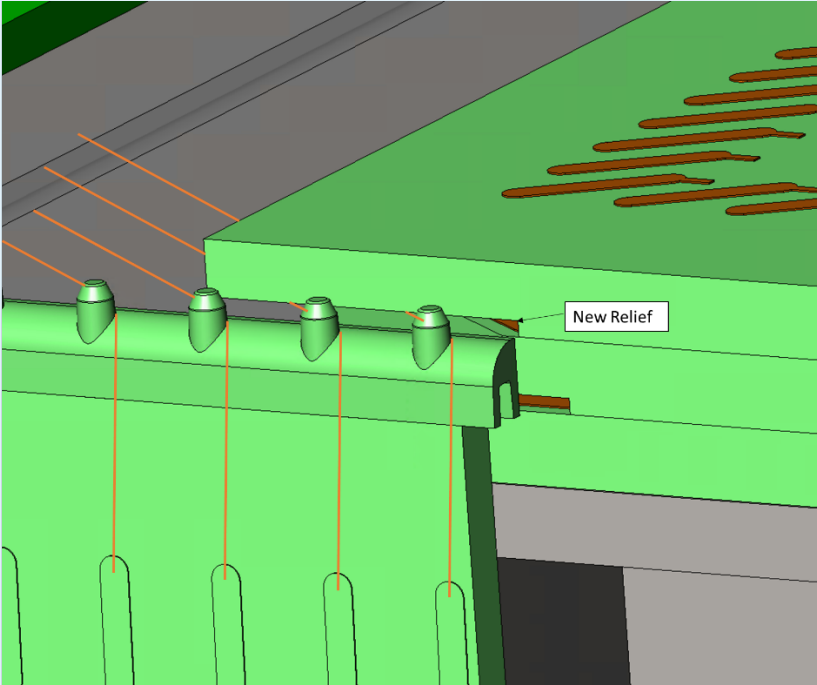
ProtoDUNE 1: Broken V wires

- Corner V-wires were bonded to the U-head board above, creating a short wire length
- New wire relief added to U- and G-head boards to prevent this bonding

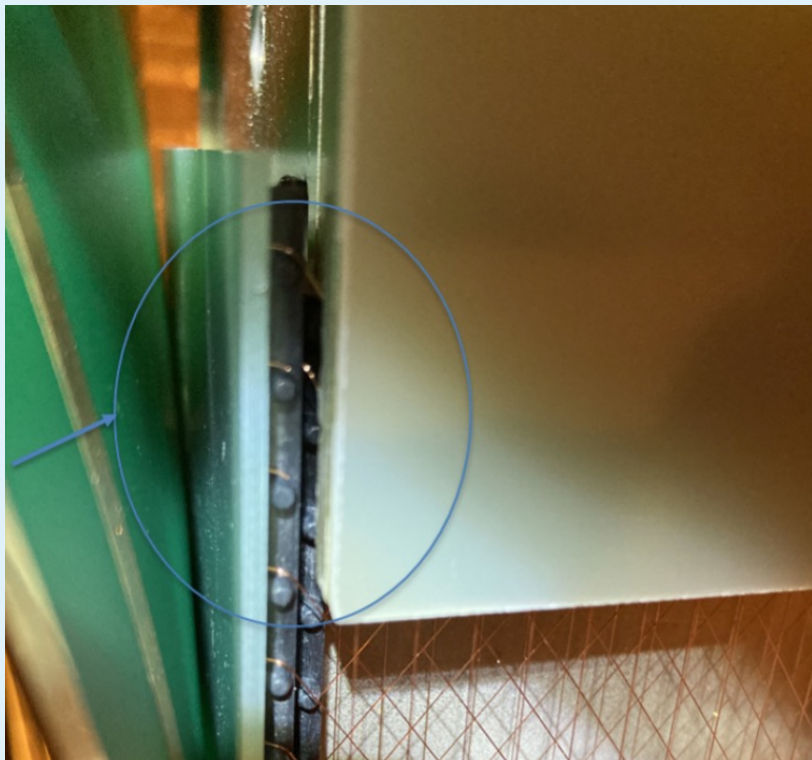
ProtoDUNE 1: Broken U-wires

Short U-wires are broken

- Due to short wire lengths between boards

Short corner wires will be soldered at zero tension

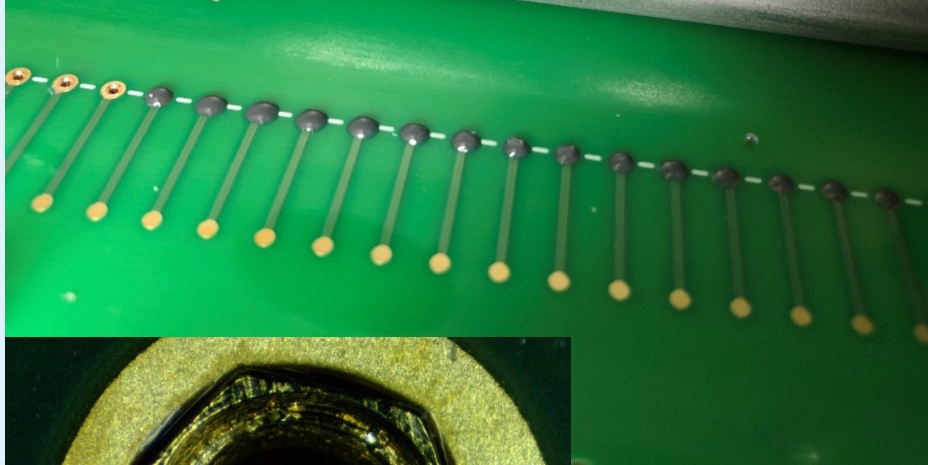
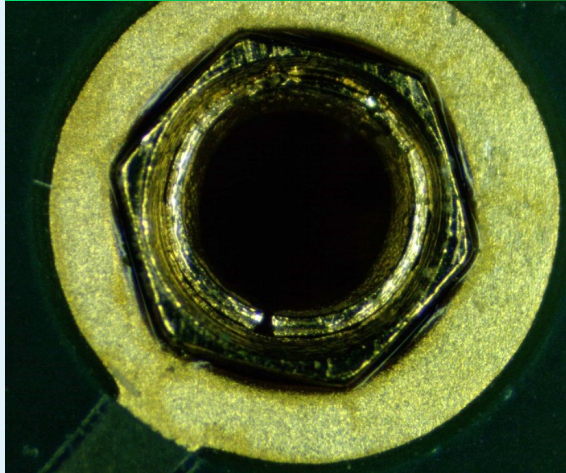
New Mill-Max pins

Epoxy flowed through new Mill-Max pins

- New hexagonal shape creates a gap in the pin

A new groove has been added in the back of the V-head boards to prevent epoxy flowing to the Mill-Max pins

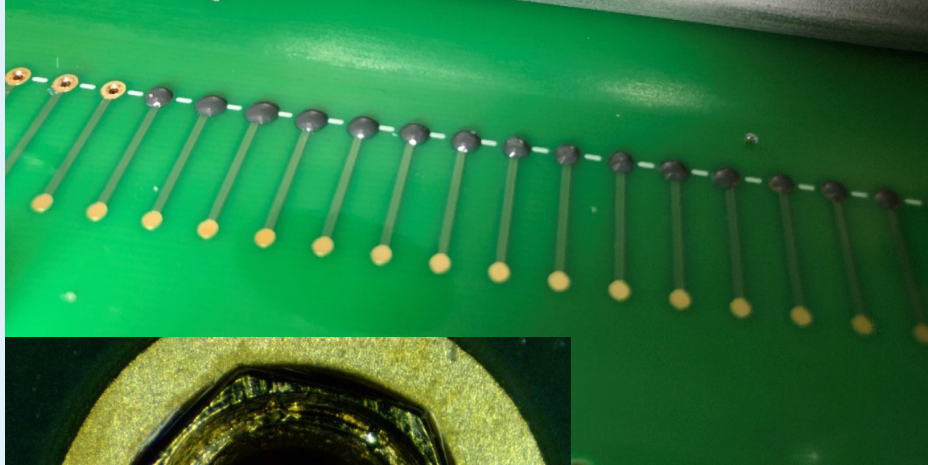
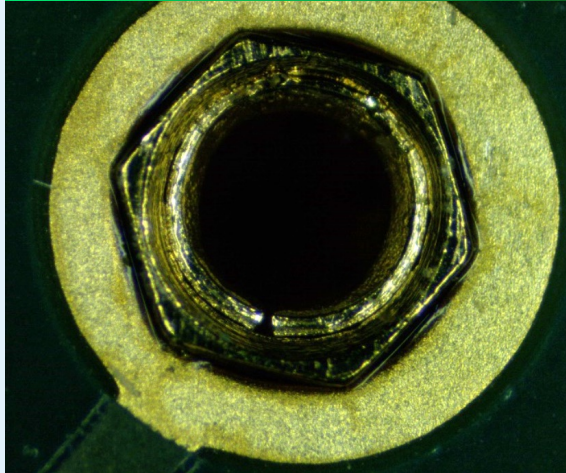
New Mill-Max pins

Epoxy flowed through new Mill-Max pins

- New hexagonal shape creates a gap in the pin

A new groove has been added in the back of the V-head boards to prevent epoxy flowing to the Mill-Max pins

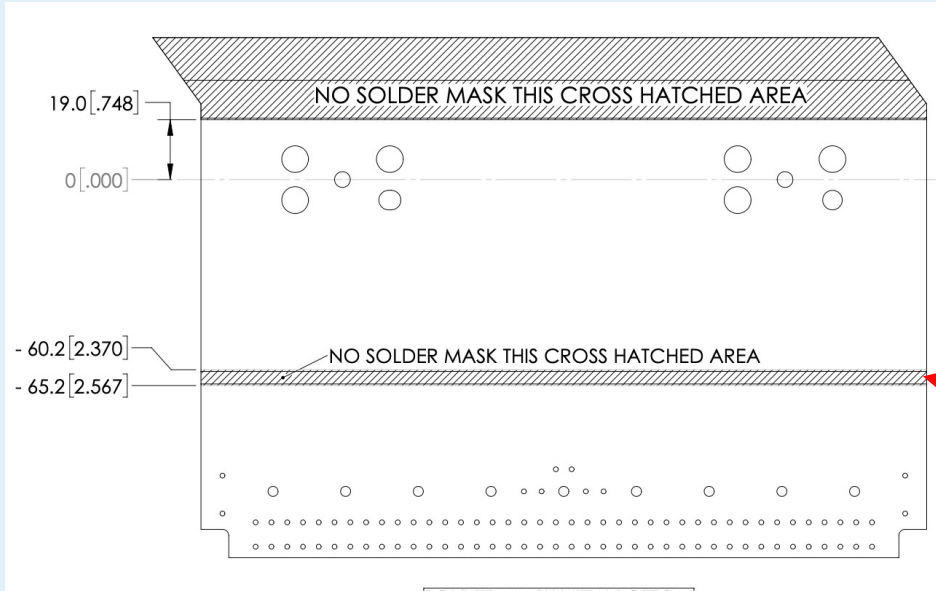
New Mill-Max pins

Epoxy flowed through new Mill-Max pins

- New hexagonal shape creates a gap in the pin

A new groove has been added in the back of the V-head boards to prevent epoxy flowing to the Mill-Max pins

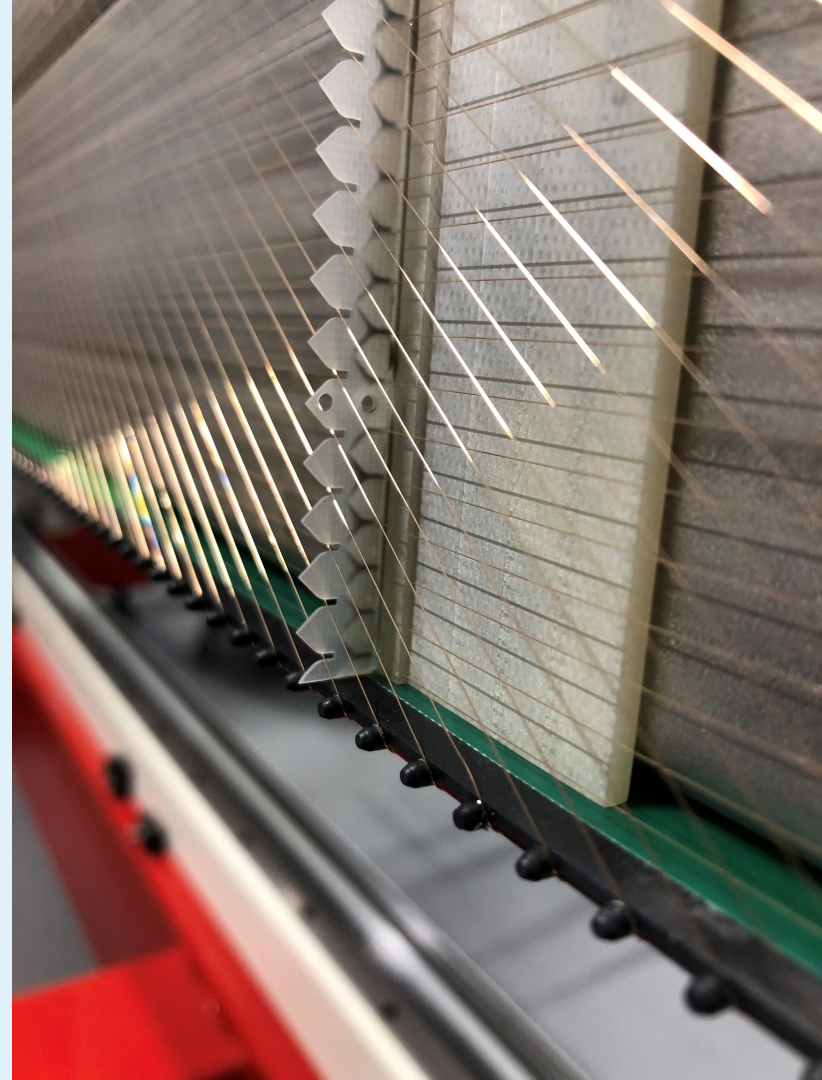
APA 2 V-layer: misaligned holes

The V-layer, when first wound, was not planar with the X-layer

- The boards along the high-slot edge are just under 1 mm offset from the centre of the tube, due to the holes drilled in the tube being offset
- In the picture, you're looking for the fact that the wires do not sit at the bottom of the gaps in the combs

- V-layer is being re-wound
- Board-locator dowels have been remade with off-centre holes
- These new dowels shift the high-slot V-wrap boards by enough to bring them back into alignment
- Screw holes marginally reamed out (fraction of mm) to ensure no collision with screws

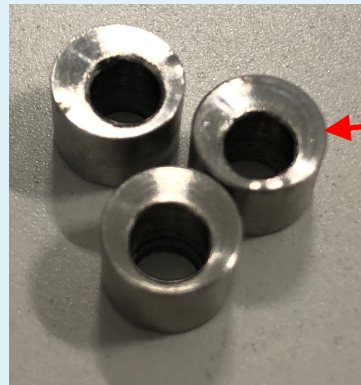
Dowel with off-centre hole

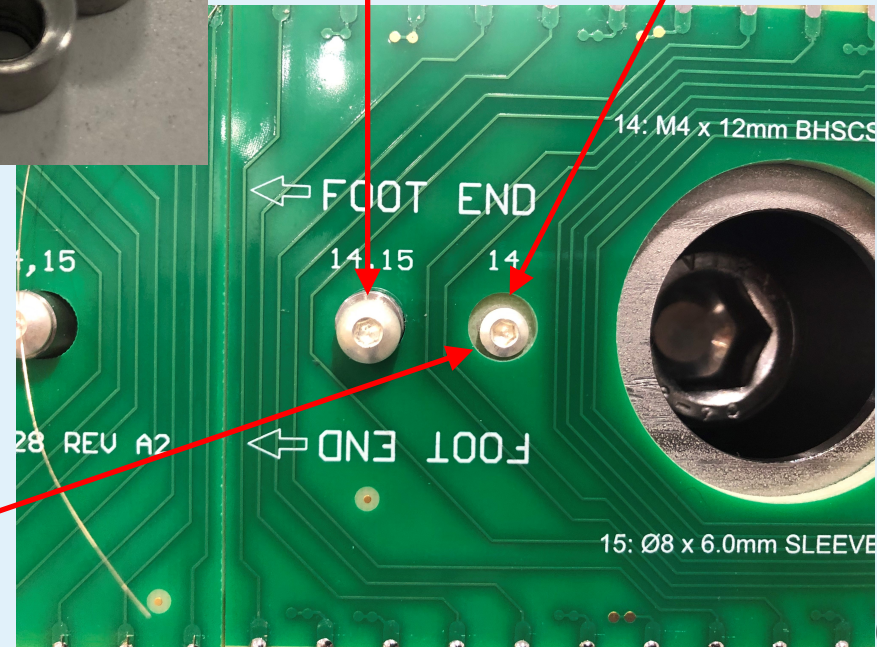
You can see the board has shifted up

This hole is slightly reamed out to ensure no collision with screw

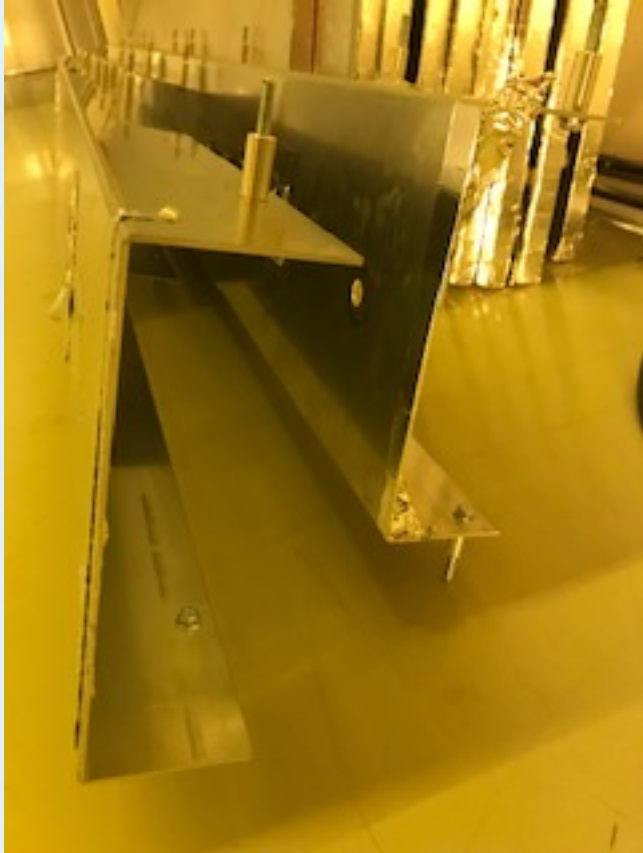
Sharp edges on protection channels

- Aluminium protection channels have sharp edges that could damage APAs during removal
- Padding will be added to the edges of future channels

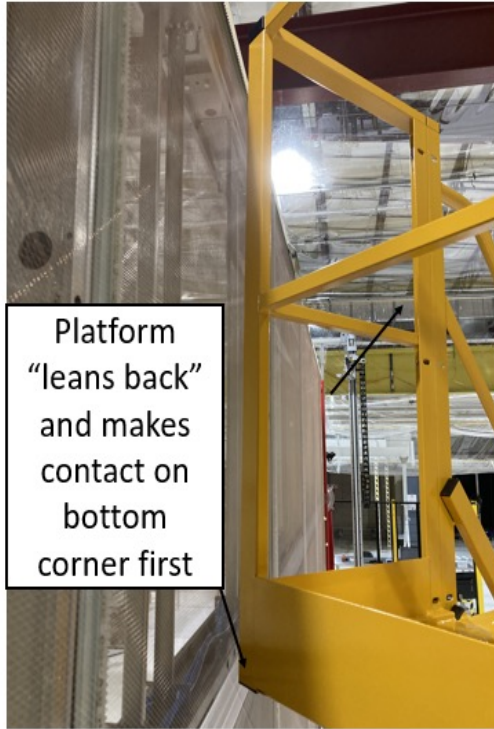
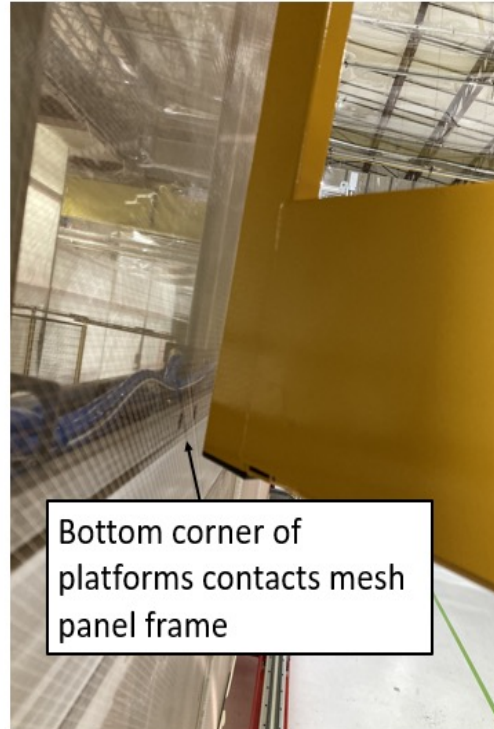
Ladder contact

Ladder made contact with
APA 4

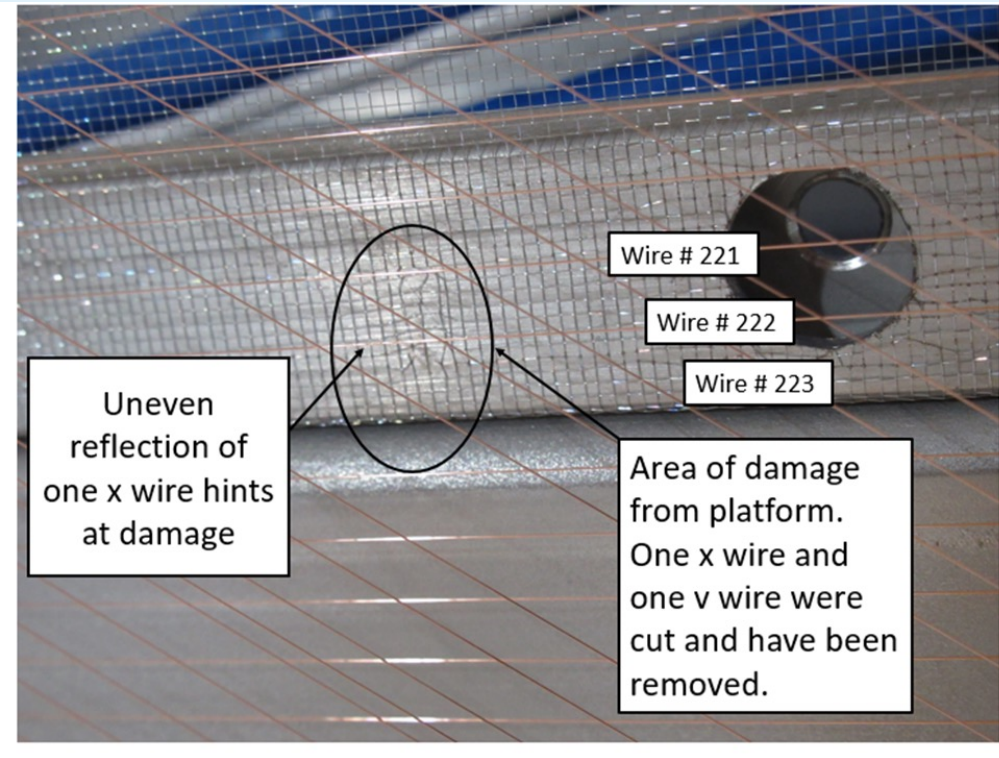
Ladder contact

Ladder made contact with
APA 4

Damage to mesh

2 damaged X-wires

2 damaged V-wires

➤ Removed

➤ Replaced

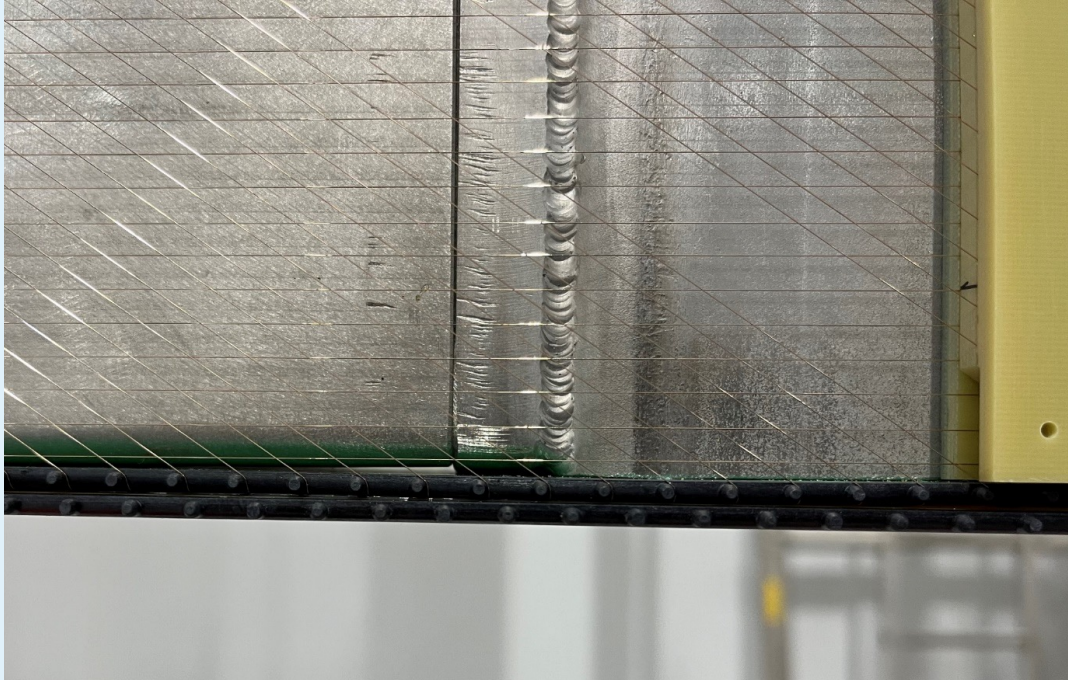
Broken wires APA 2

- Two broken V-wires on APA 2

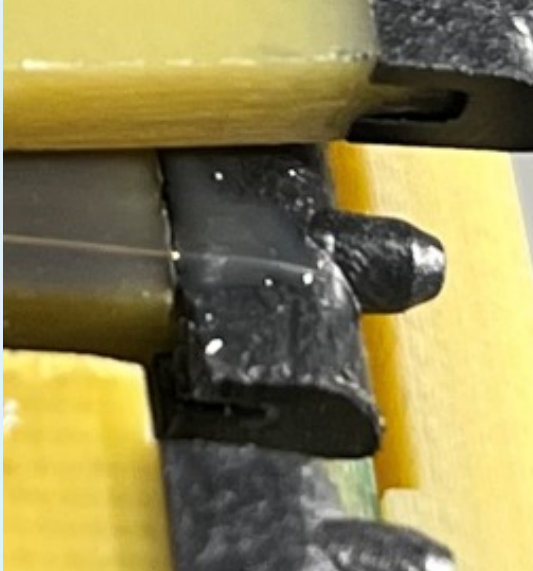
Broken wires APA 2

- Two broken V-wires on APA 2
- Occurred due to insufficient glue on teeth of one V-board
- Teeth were knocked when installing U-board
- In future, board assembly to ensure teeth are glued all the way to the end, and technicians will be more vigilant, and masking tape will be used to prevent wires being epoxied to the teeth

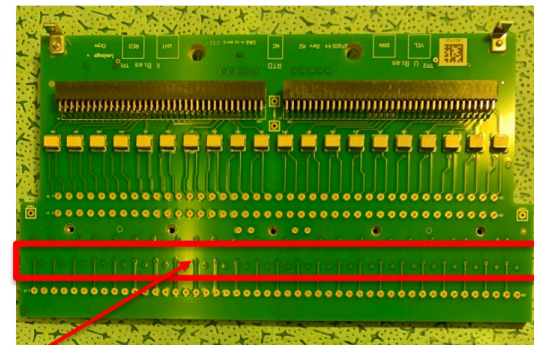
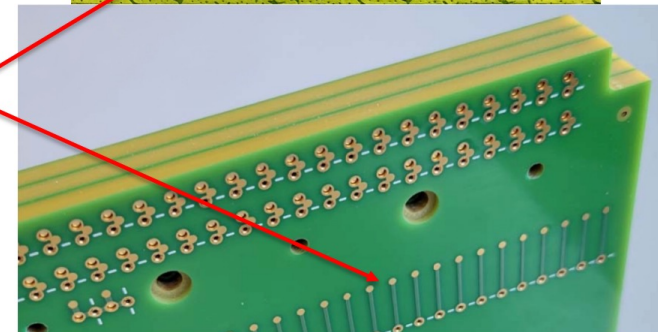
- Overlapping vias and contacts on the X layer headboards and the CR boards (shown by the arrows) caused current leak when bias voltage was applied to the X layer wires.
- Inconsistent card set produced by mistake; found during the APA 1 test.
- The error was on the CR boards, the headboard stack is correct.
- Mitigated temporarily with a strip of Kapton (area in the red box) to allow the APA 1 test to proceed while the correct set of CR boards is being made.

Headboard stack, exposed side of the X layer board
