# Challenges and Lessons Learned from fabrication, test and analysis of ~10 MQXFA Low Beta Quadrupoles for HL-LHC

Giorgio Ambrosio and the MQXFA team

# MQXFA07 Training Quenches

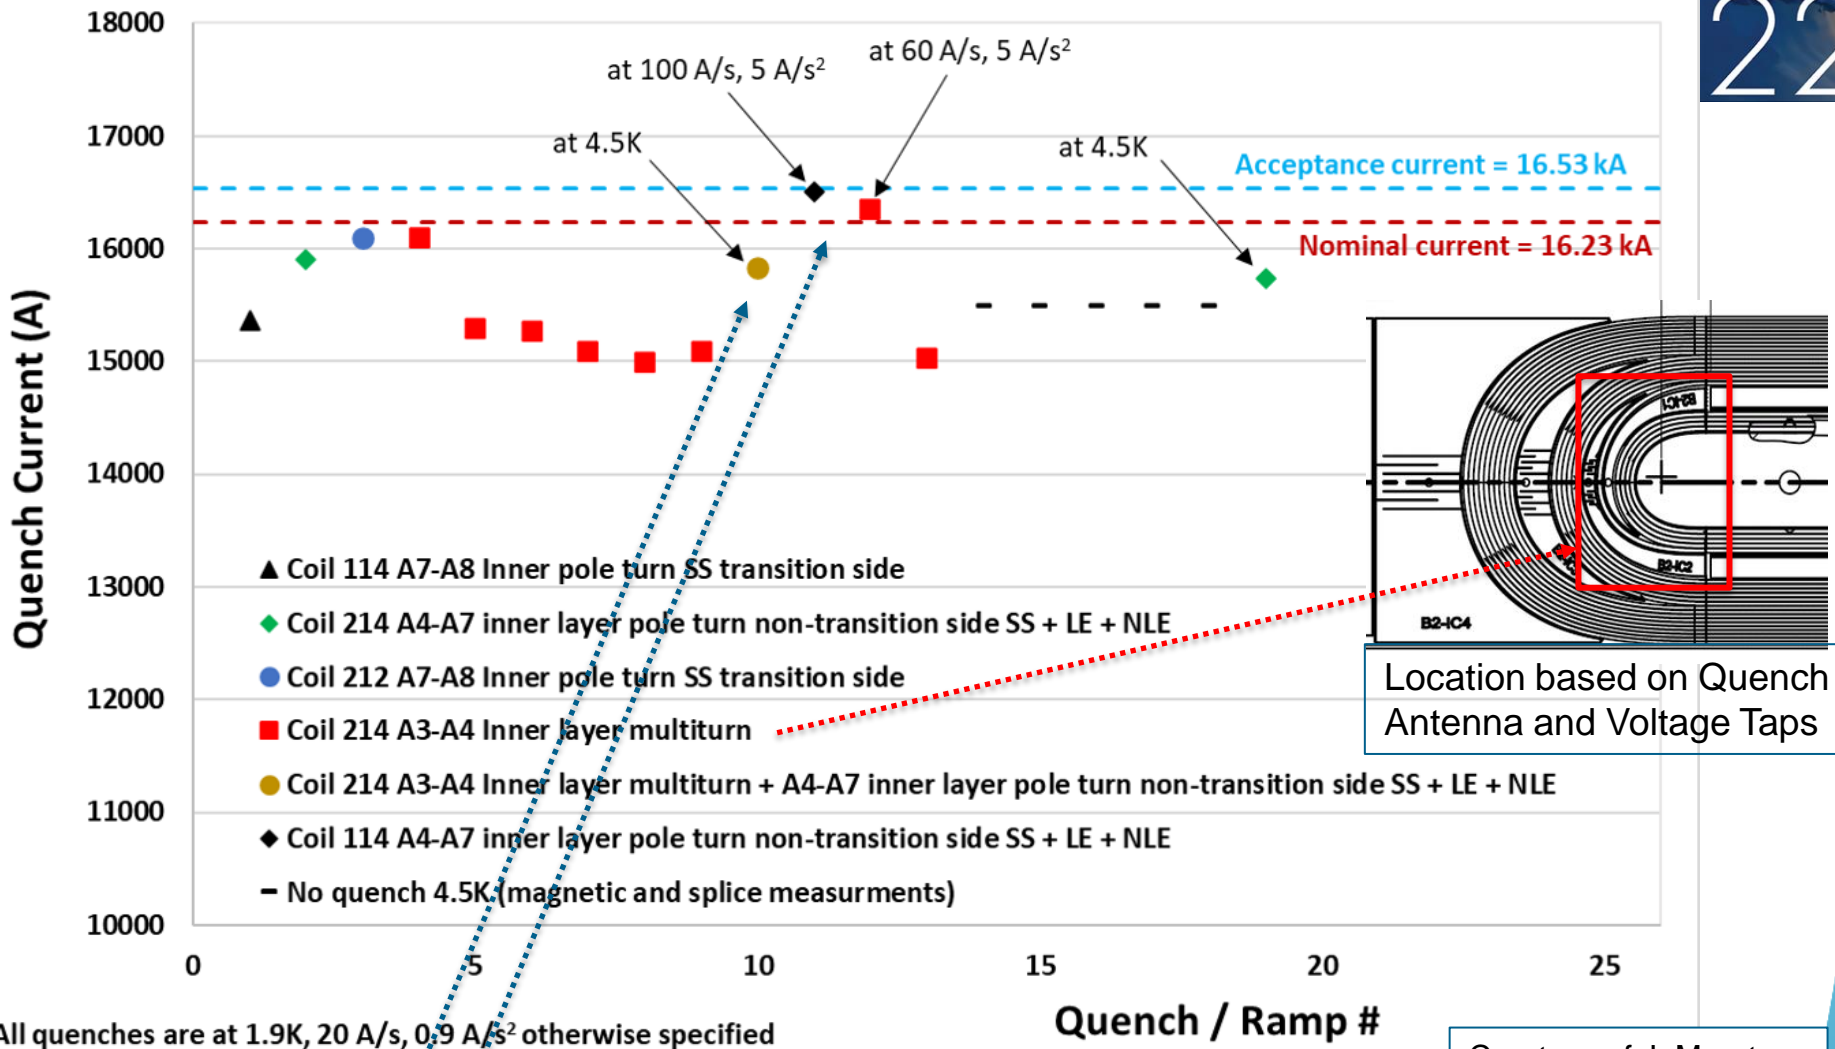
- Reverse temperature dependence
- Reverse ramp-rate dependence
- Same features and location in MQXFA08

- Self-field **instability** triggered by a **local issue**, likely affecting only some strands, that pushes more current in adjacent strand(s)
  - Field in quenching turn is between 6 and 9 T

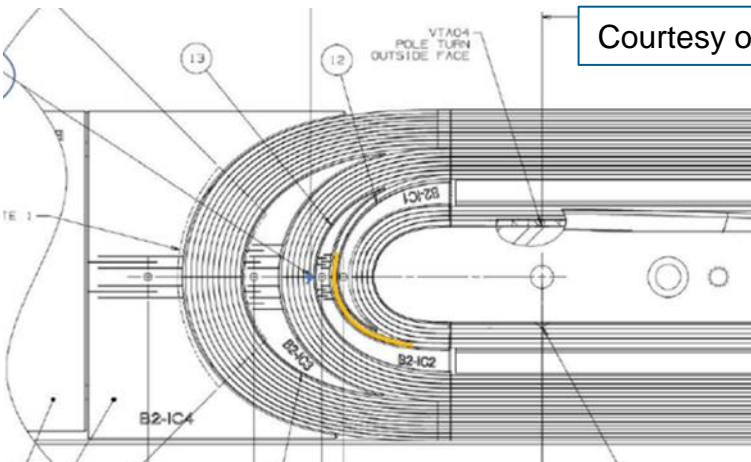
coil 214 as it was setup for the lab shutdown

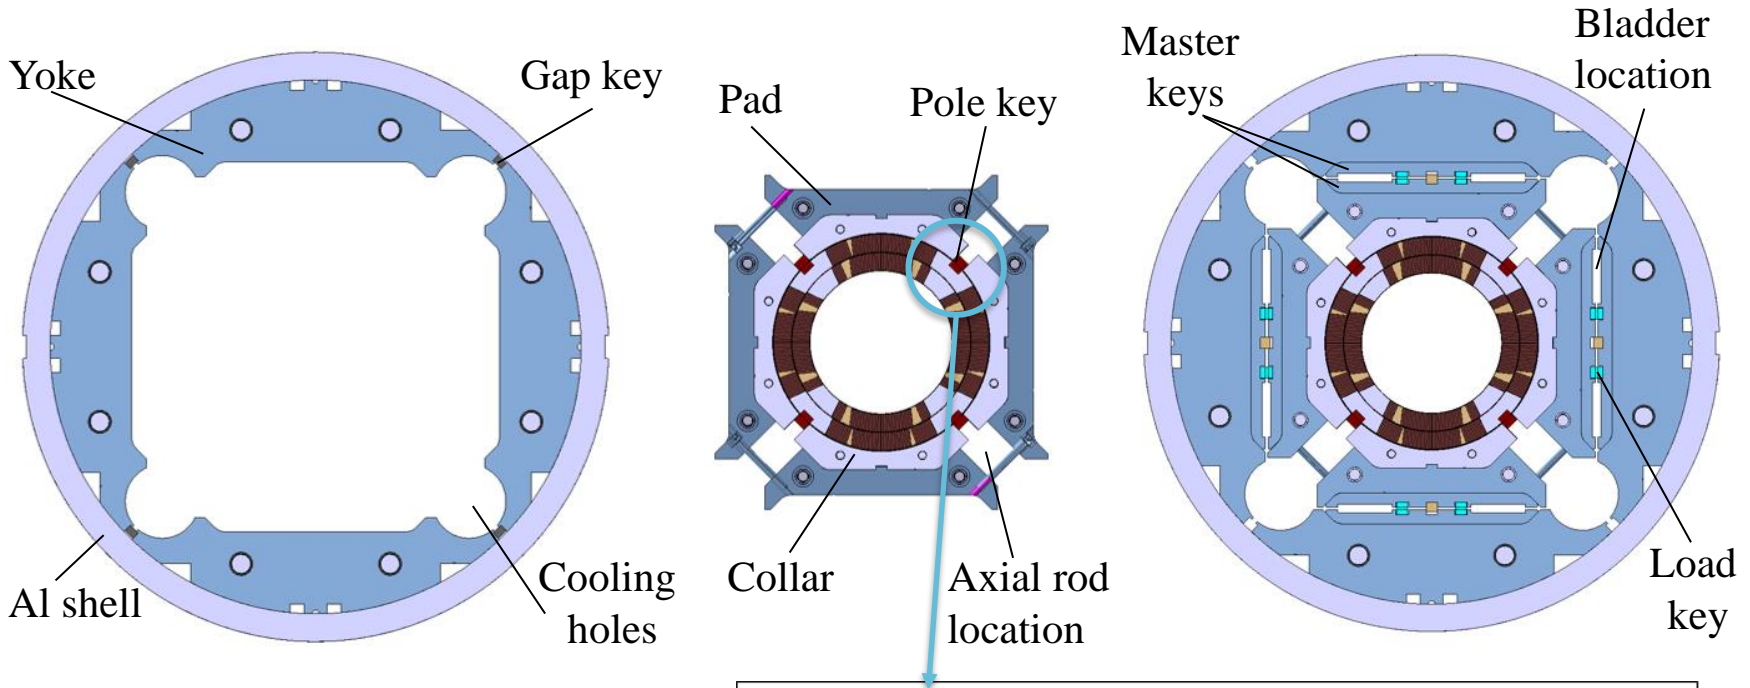
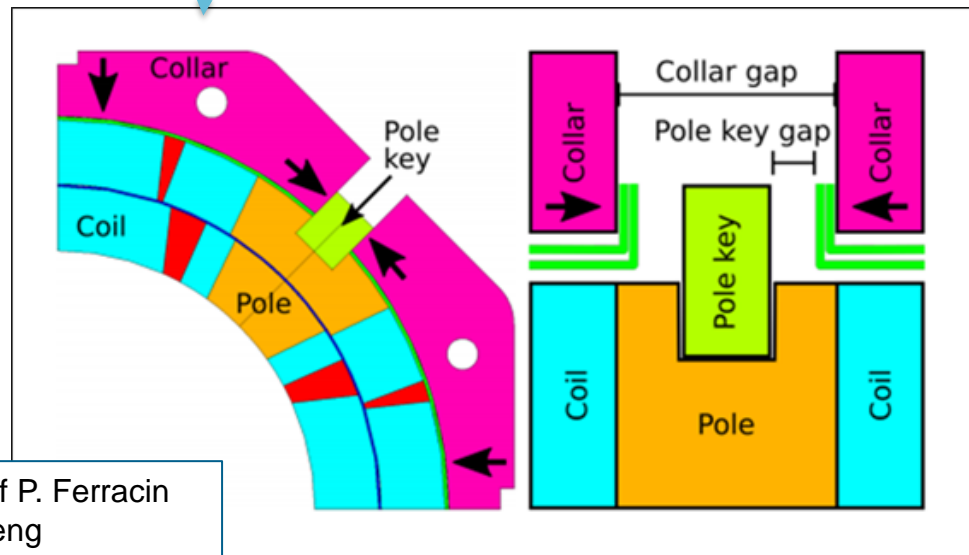
A pole-key gap asymmetry was found during MQXFA07 and MQXFA08 disassembly:

- Gaps closed in quadrant 3
- Gaps open in other quadrants

- Design change for larger pole-key gaps:
  - From 200  $\mu\text{m}$  to 400  $\mu\text{m}$  - average pole key gap per side
- Revised MQXFA Series Magnet Production Specification:
  - Added spec for minimum gap on each coil at each longitudinal location: 300  $\mu\text{m}$  per side

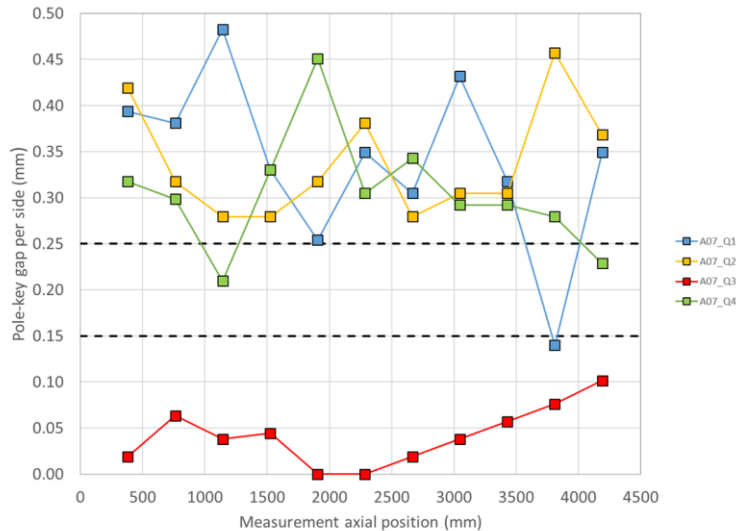
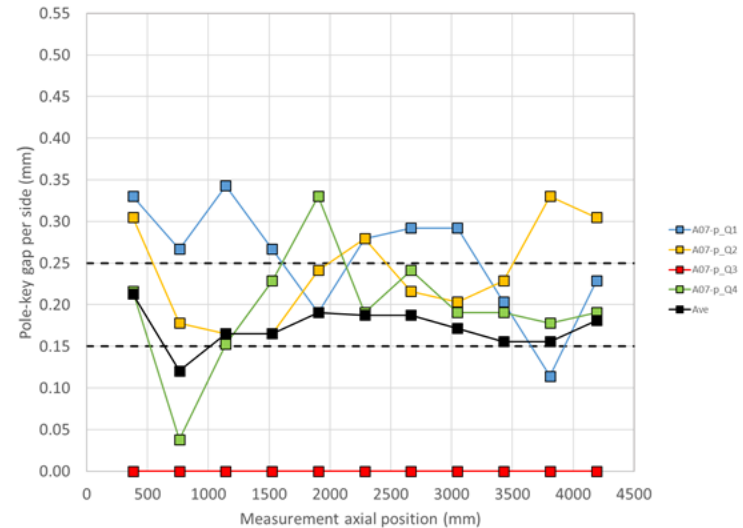
- The measured **pole-key gaps** were not as **uniform** in MQXFA07 and MQXFA08 as in past magnets; this is particularly apparent on the **limiting coils (Q3 for both magnets)**
- Only the **total average** (on the 4 keys) was targeted in the **specification**. The underlying assumption was that the **gaps** would be **redistributed** across coils during **loading**.
- **Investigation** of the effect of this non-uniformity on the mechanical performances with **2D** and **3D FE models**
  - **2D effect: preload variation within acceptable range**

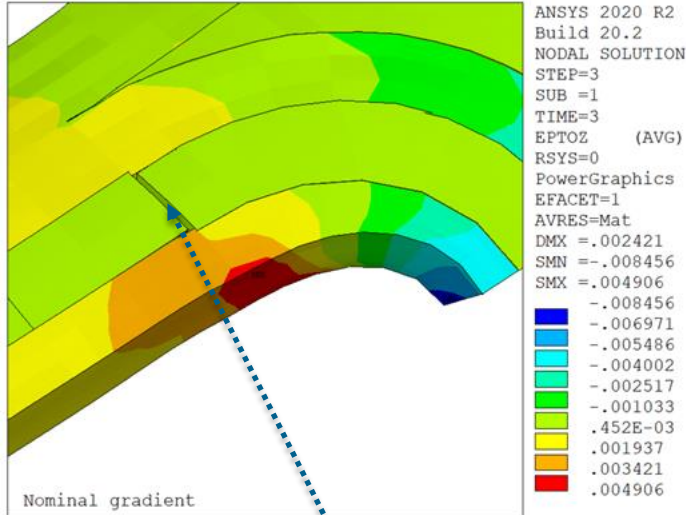
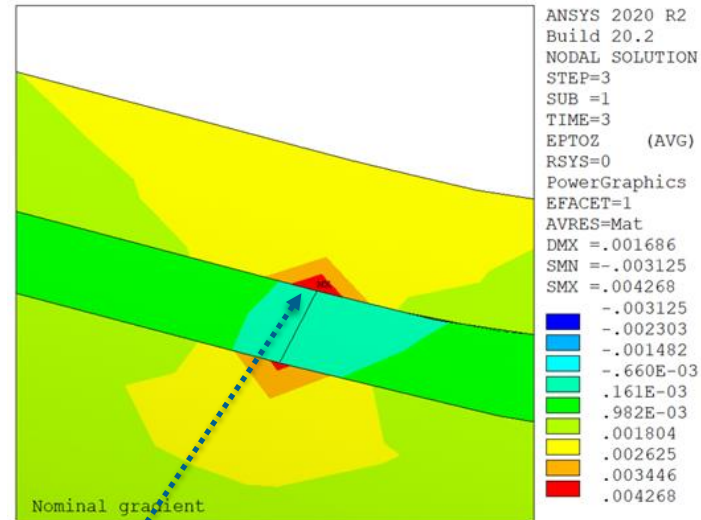
- At cold the coil with less azimuthal preload ends up with **less longitudinal preload**
- At nominal current tension develops between the inner wedge and the end spacer, and a (small) **gap** may open
- This may result in high **longitudinal strain** (up to **0.4%**) in that location
  - This location is consistent with quench data
  - Effect is larger on the pole block, but also visible on the mid plane block

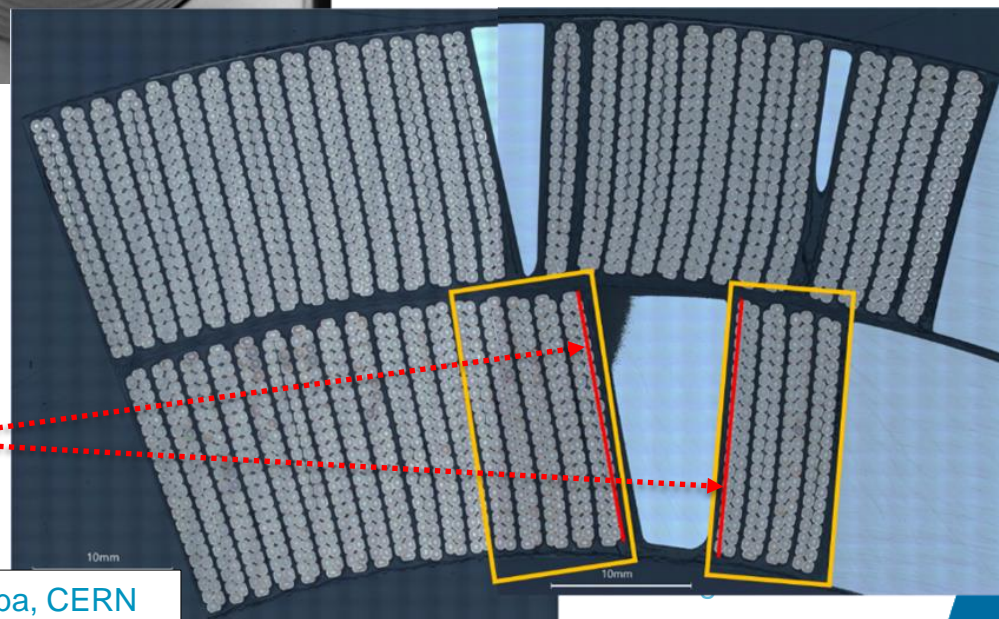
No anomalies found in cross-section #1. Therefore, we did **longitudinal sections**

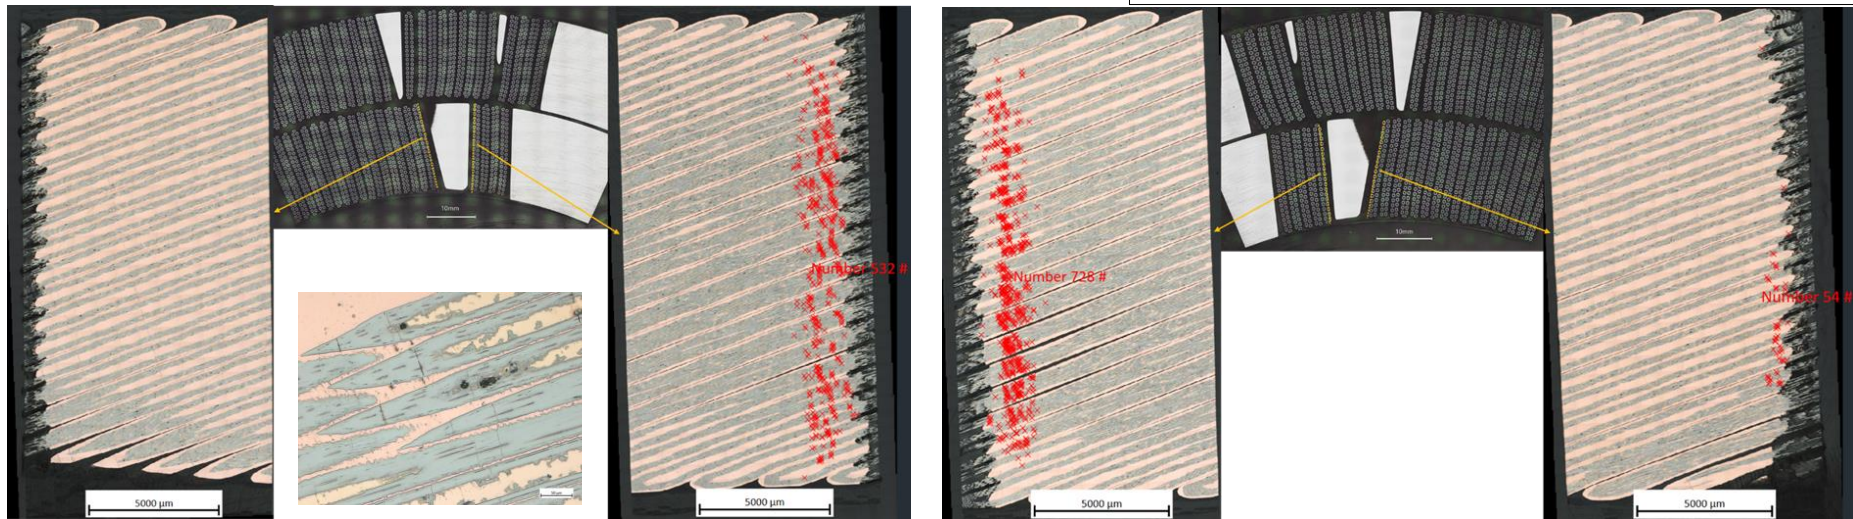
- Longitudinal cuts on cables adjacent to the end-spacer/copper-wedge transition
  - Localized field of **broken filaments (red dots)**, especially at pole block

#	Samples adjacent to W-S transition from coil 214 Lead End	Number of cracked filaments
1	Layer-jump side, cable in midplane block, side adjacent to W-S transition	0
2	Layer-jump side, cable in <b>pole block</b> , side adjacent to W-S transition	<b>532</b>
3	Non-layer-jump side, cable in midplane block, side adjacent to W-S transition	54
4	Non-layer-jump side, cable in <b>pole block</b> , side adjacent to W-S transition	<b>728</b>
5	Same cable of sample 4, side opposite to the W-S transition	0

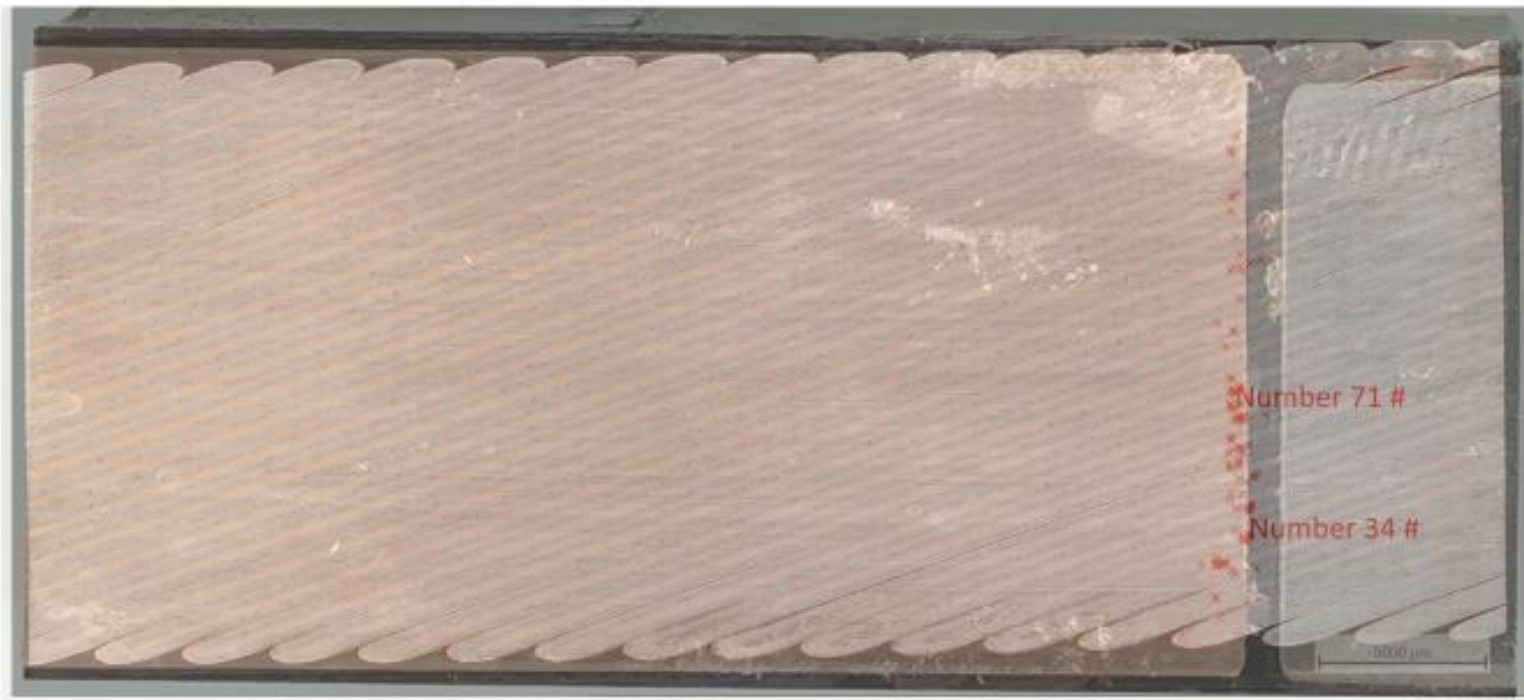
- Same features as in MQXFA07
- Metallographic analysis of lead end shows broken filaments at wedge-spacer interface

Crack field is in correspondence to resin/copper wedge interface

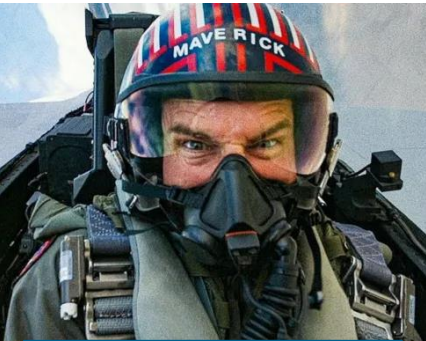
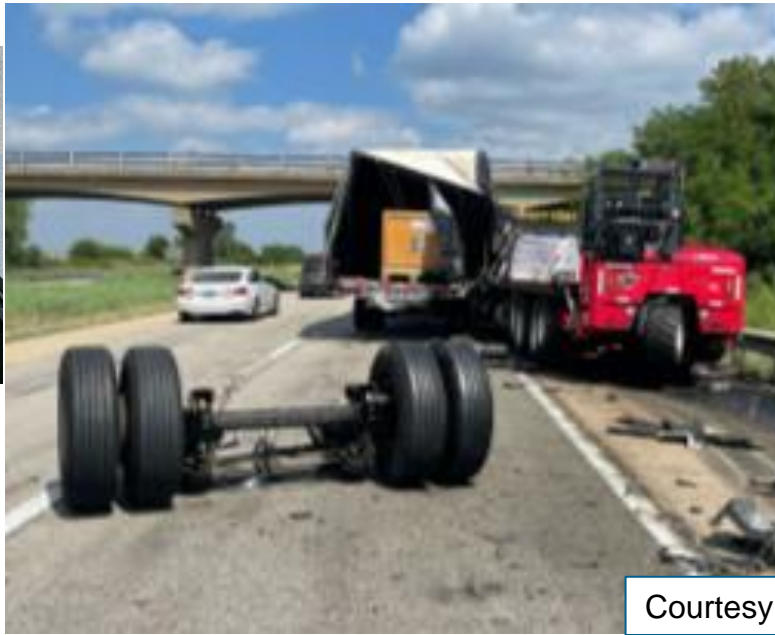
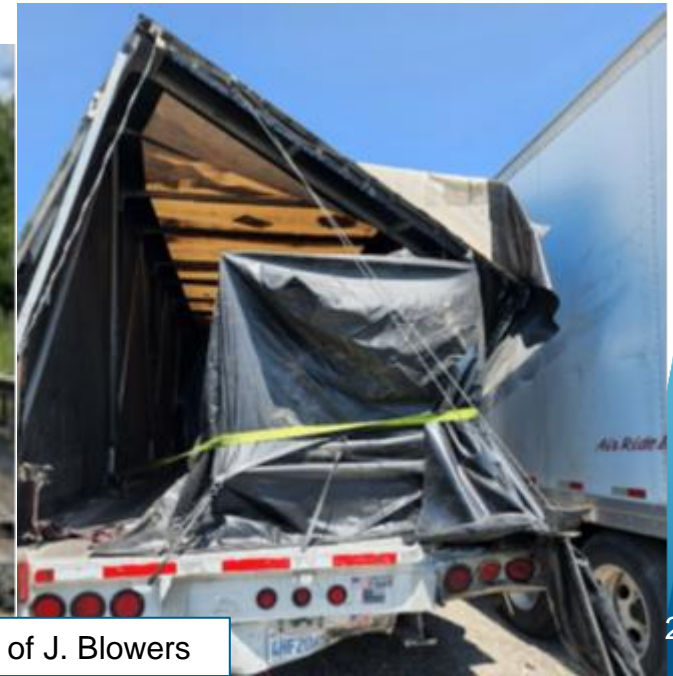
- The truck transporting the MQXFA11 magnet from LBNL to BNL was rear ended by another truck.
- The main hit took place on the right back corner. During the incident the truck rear axle disengaged as displayed below. Nobody was injured.
- The magnet was moved to FNAL. Upon arrival a visual inspection was performed followed by electrical checkout, metrology survey, analysis of the fiber optic sensors and accelerometer data analysis
  - Max shock: 6 or 10 g vertical (depending on the device in the same accelerometer unit)
  - Duration: 5 ms
- All tests and analyses were OK. Magnet was shipped to BNL

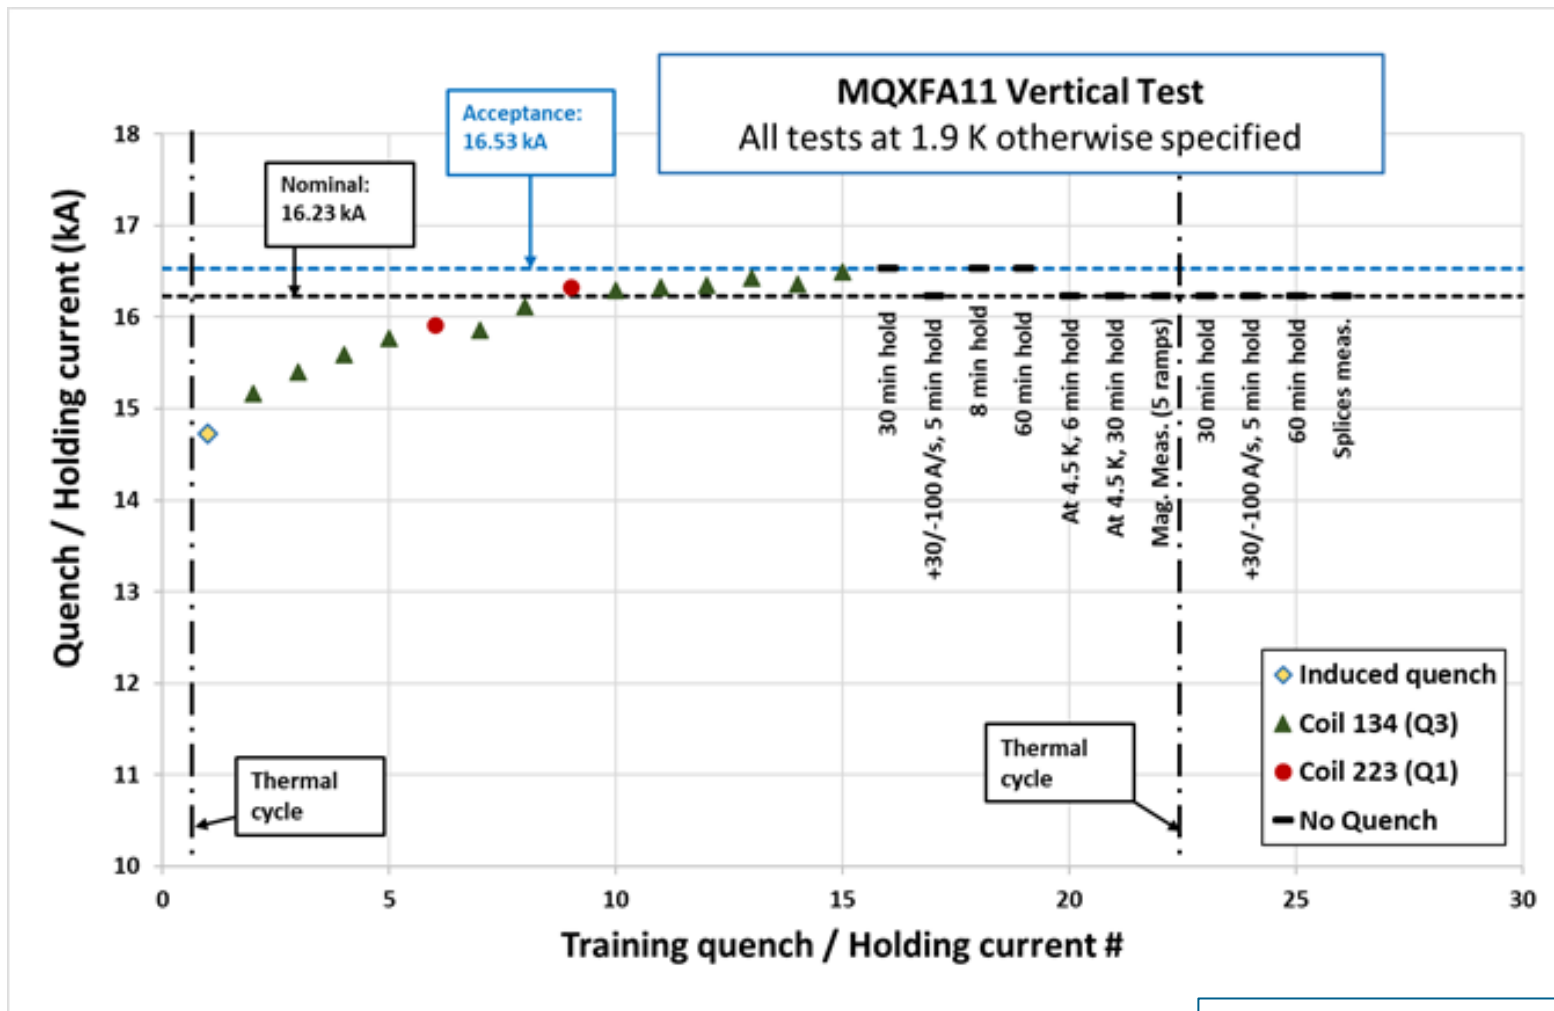
# MQXFA11 “Maverick” Quench History

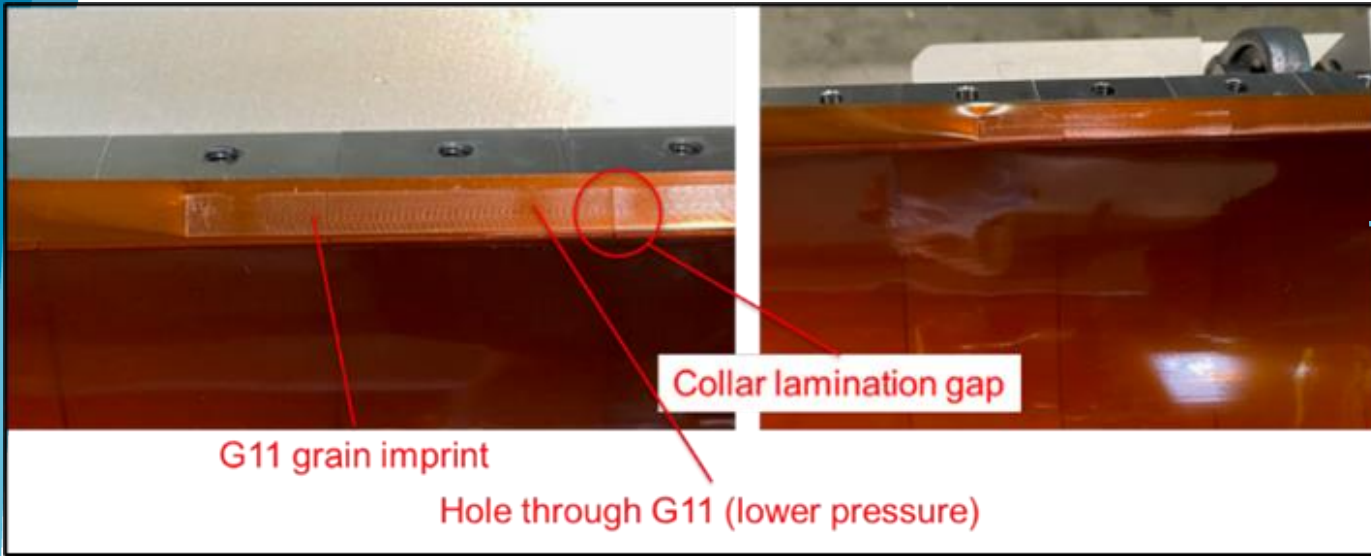
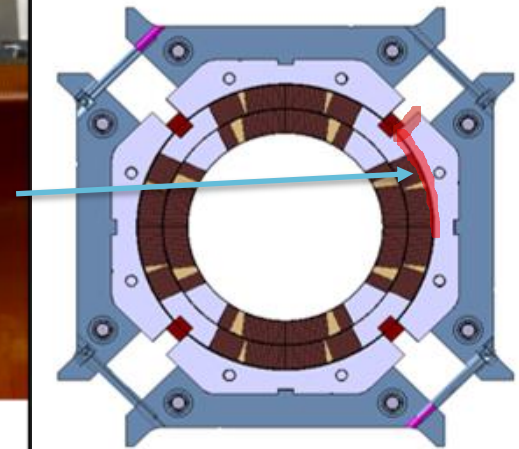
- Pressure imprint in Q3 pole-key gaps
- Unusual marks at wedge-spacer interface in lead end

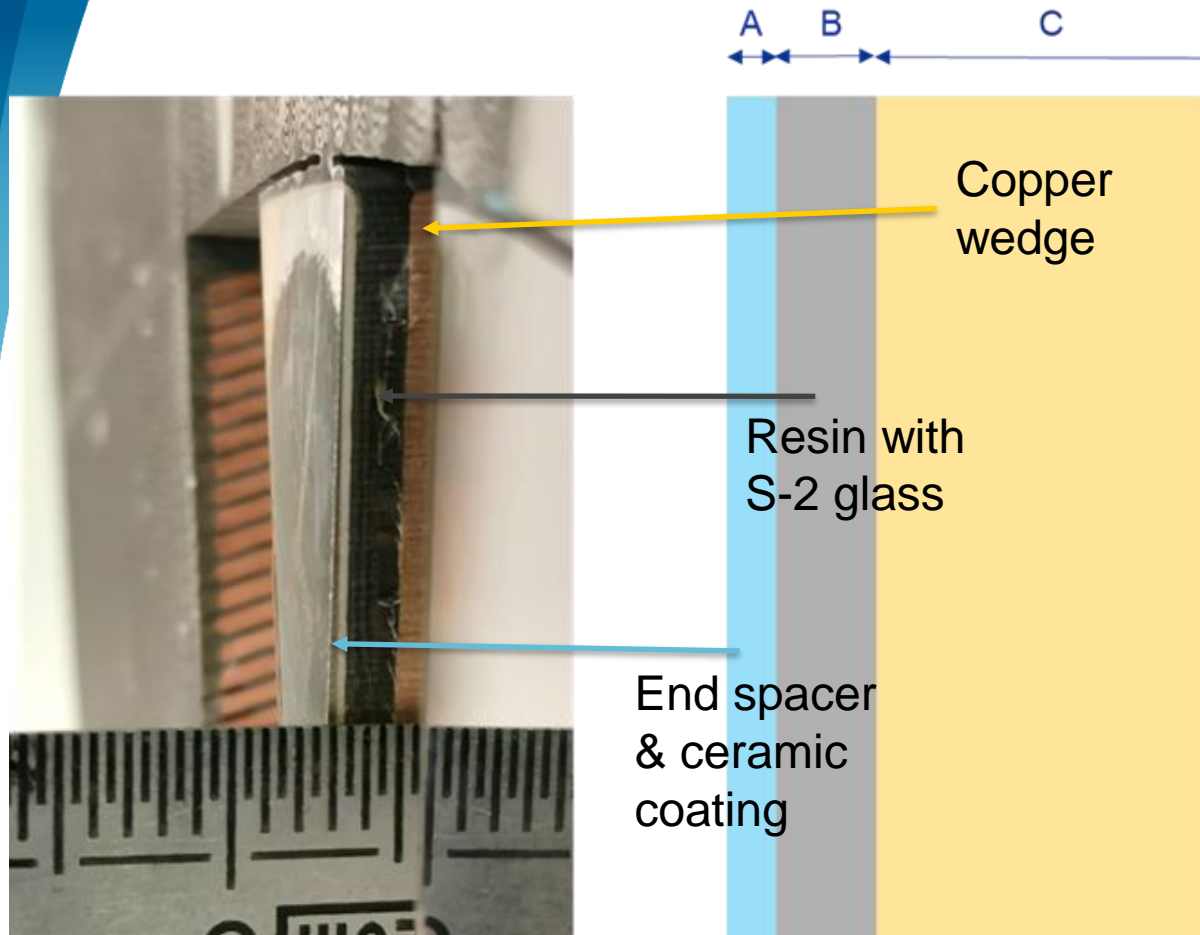
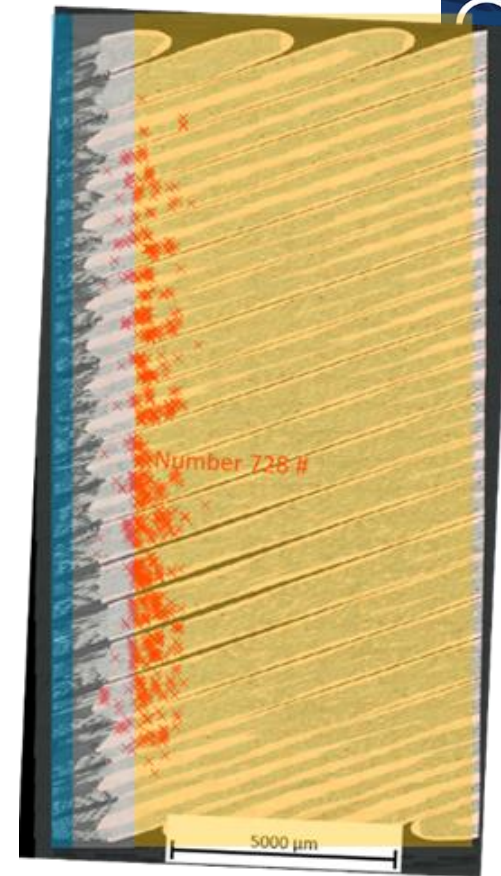
Left: coil section after samples were extracted for metallographic inspection.  
 Center: color scheme used to show the position of filament cracks with respect to the W-S transition in the following figure. A: End spacer + ceramic coating  $\approx 0,5$  mm; B: resin (filled with S-2 glass) between end spacer and wedge  $\approx 1,5$  mm; C: copper wedge.  
 Right: color scheme applied on sample with broken filaments.
