Advanced Examination of Nb₃Sn Coils and Conductors for the LHC luminosity upgrade: Computed Tomography and Materialographic Analyses

S. Sgobba¹, G. Arnau Izquierdo¹, I. Aviles Santillana¹, B. Bulat², M. Celuch¹, M. Crouvizier¹, A. Devred¹, S. Izquierdo Bermudez¹, A. Milanese¹, A. Moros¹, F. Savary¹, E. Todesco¹

¹European Organization for Nuclear Research, Geneva, Switzerland

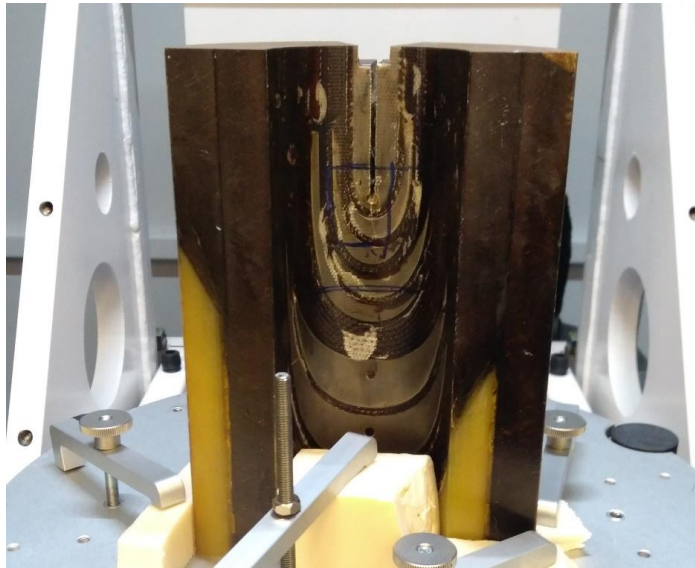
Coil GEC02

Coil head connection side
Likely with damages – Quenches
Received in September 2020

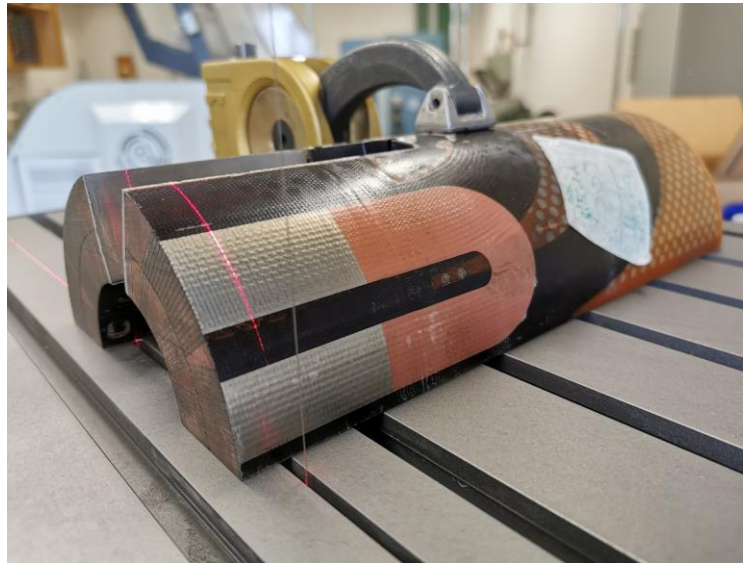
Coil GE02

Coil head non-connection side
Supposedly w/o damages – No quench,
Received in July 2020 for NDT feasibility test

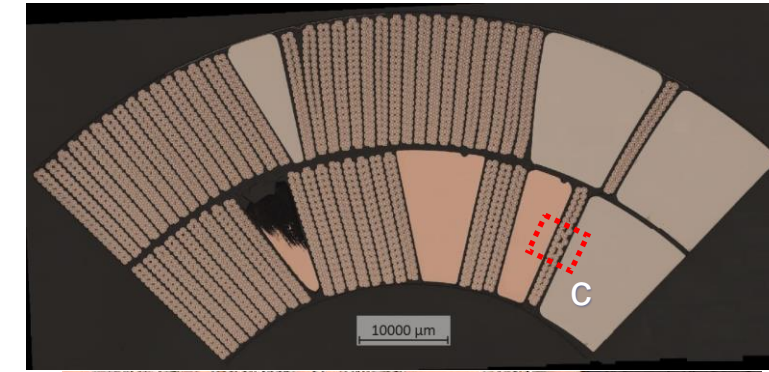
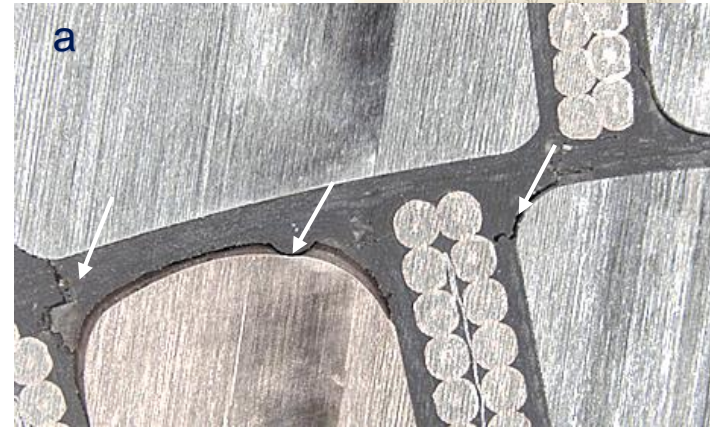
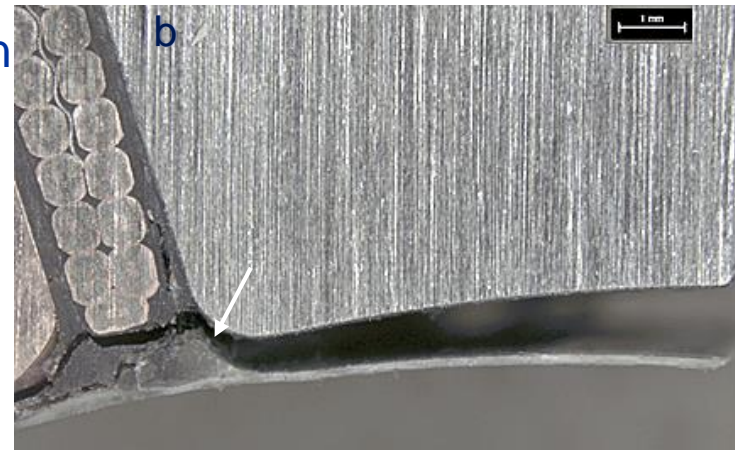
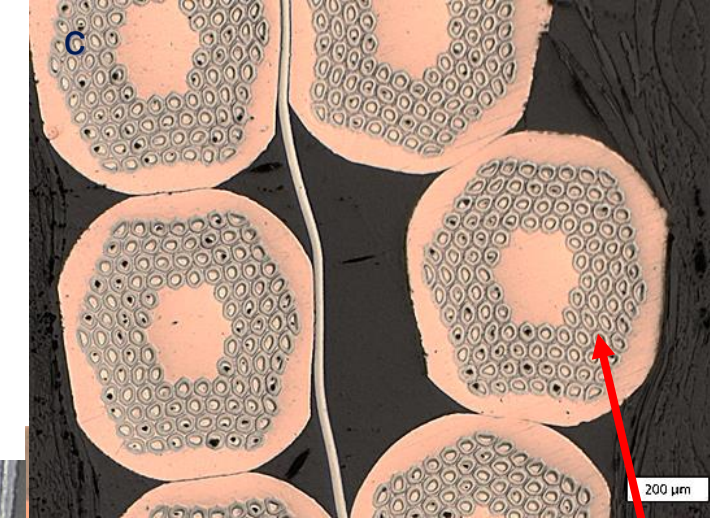
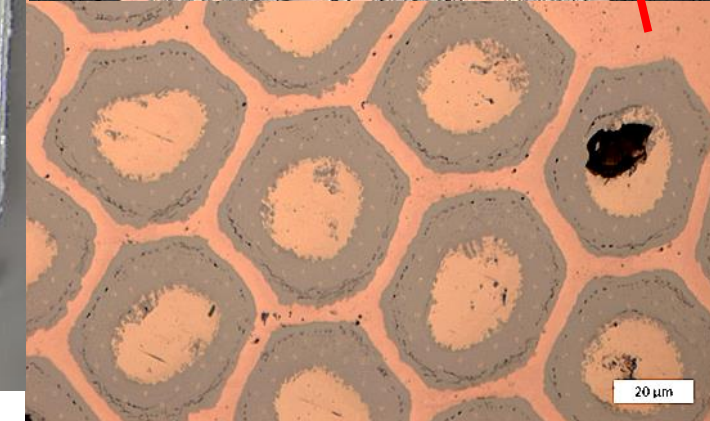
Metallography GEC02 – Event 1

- Lack of bonding between cable of interest, spacers and insulation is highlighted at the mirror cut in correspondence of the detached portion,
- Environment of the cable of interest is preserved on this cut and has been studied

- Pop-out/pop-in strands are embedded in resin
- SC appear free from cracks in this position
- Cracks in insulation and porosities can be observed, especially at the vicinity of spacers
- Copper composing the strands is at annealed state (approx. 55-60 HV0.1)

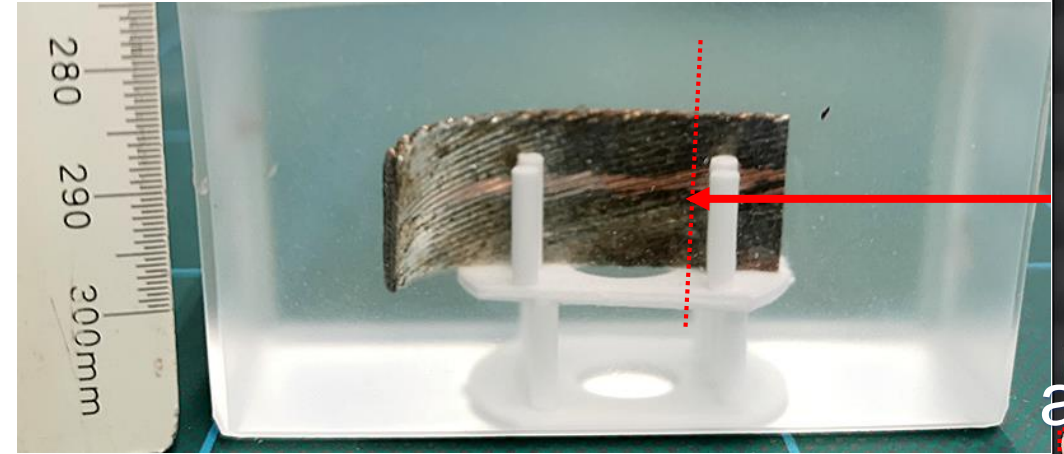
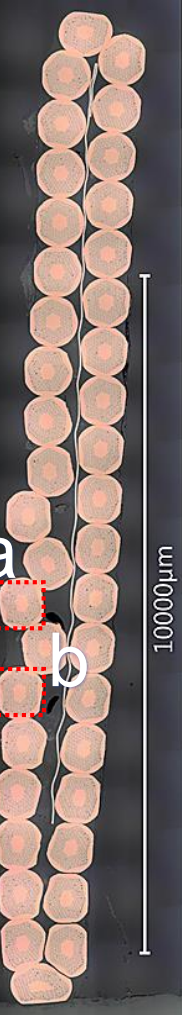
Metallography GEC02 – Event 1

- The presence of angular and radial cracks at indicated plane (few SC impacted from pop-out and other strands of the cable)
- SEM-EDS confirmed that phases in presence in sub-elements composing the SC are the one expected after reaction
- Pop-out/pop-in strands are embedded in resin (some porosities are observed)
- Copper composing the strands is in annealed state (approx. 55-60 HV0.1)

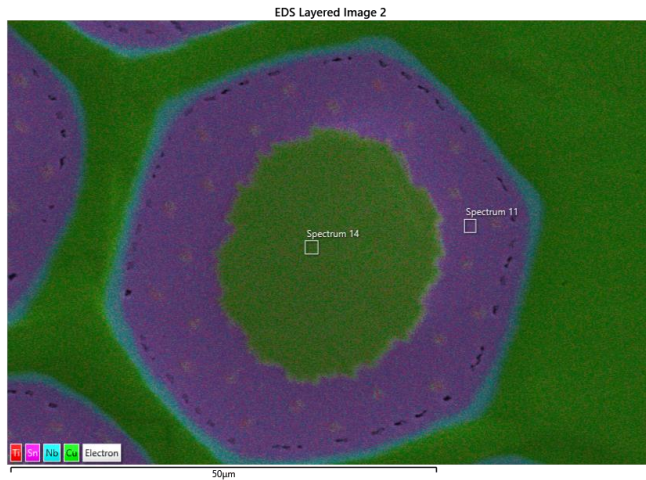
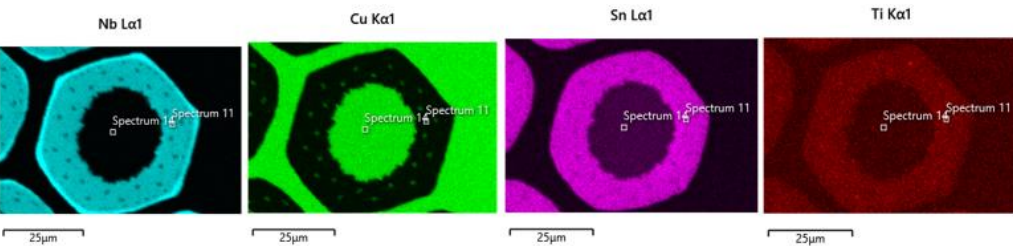
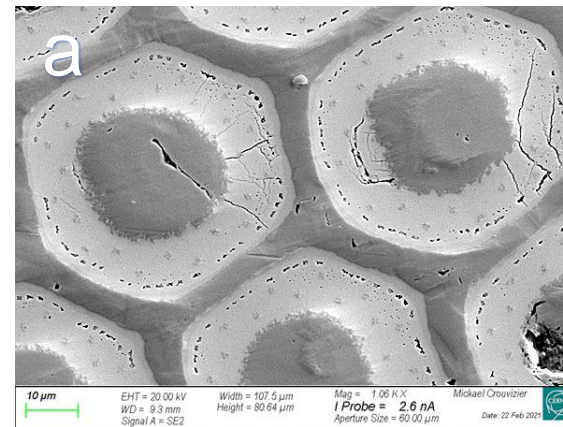
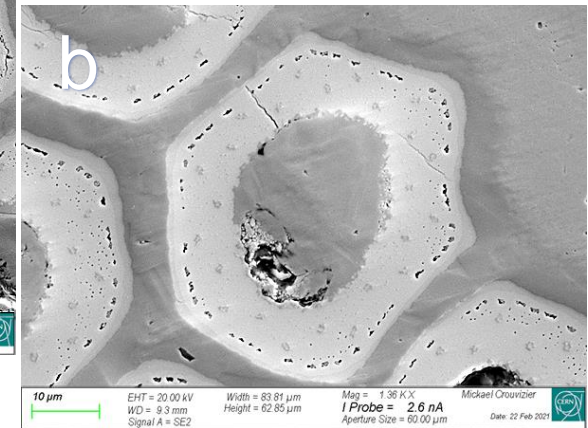
Filaments (belonging to different strands) are affected by cracks in the SC phase

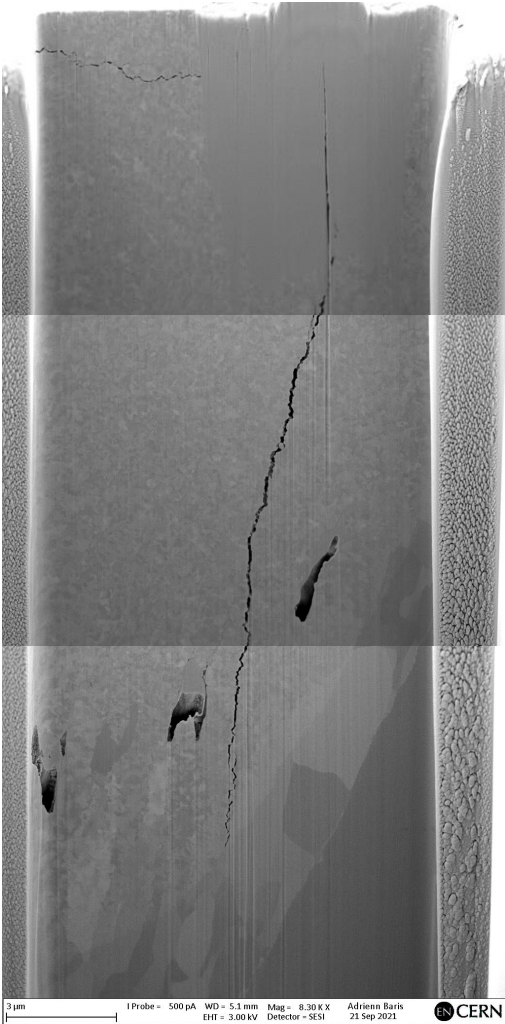
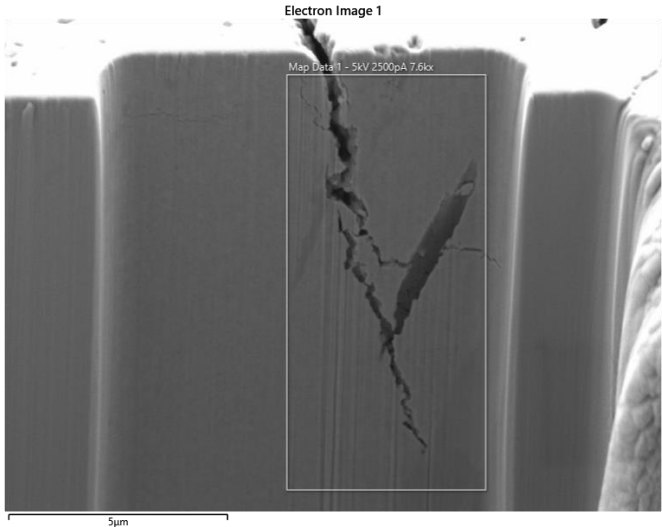
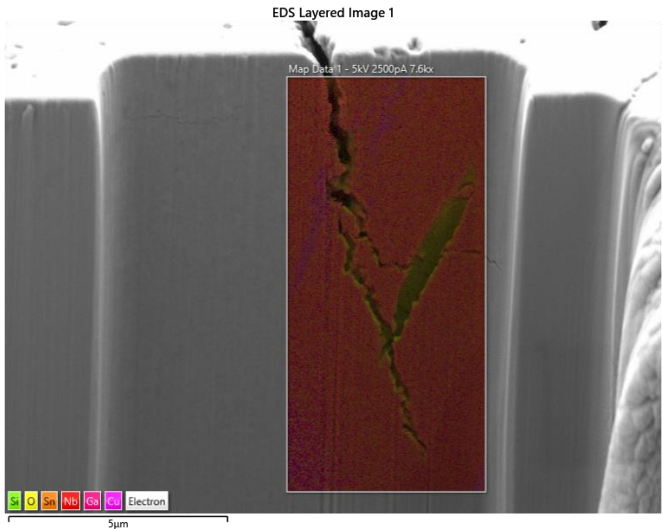
Morphology of crack 1, 22.7 μm deep

Crack 2, phases analysed by EDS, presence of Nb, Sn and traces of Cu

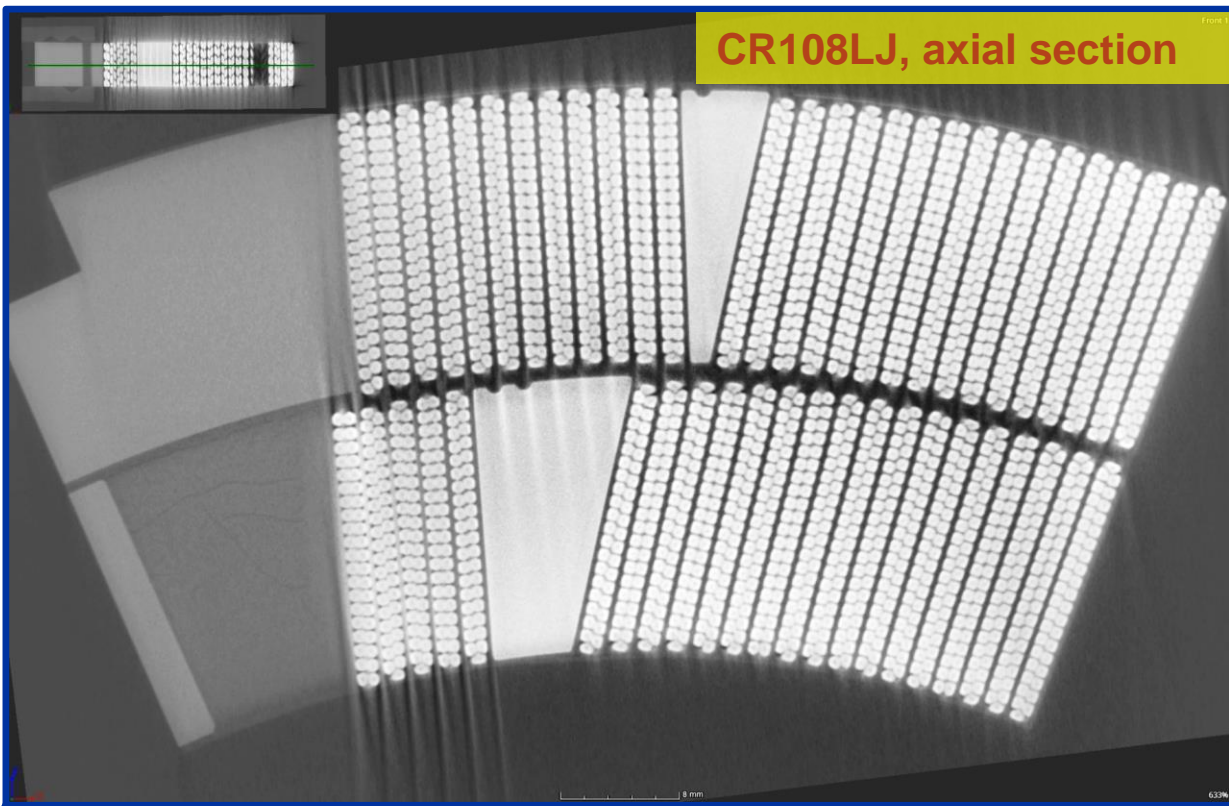
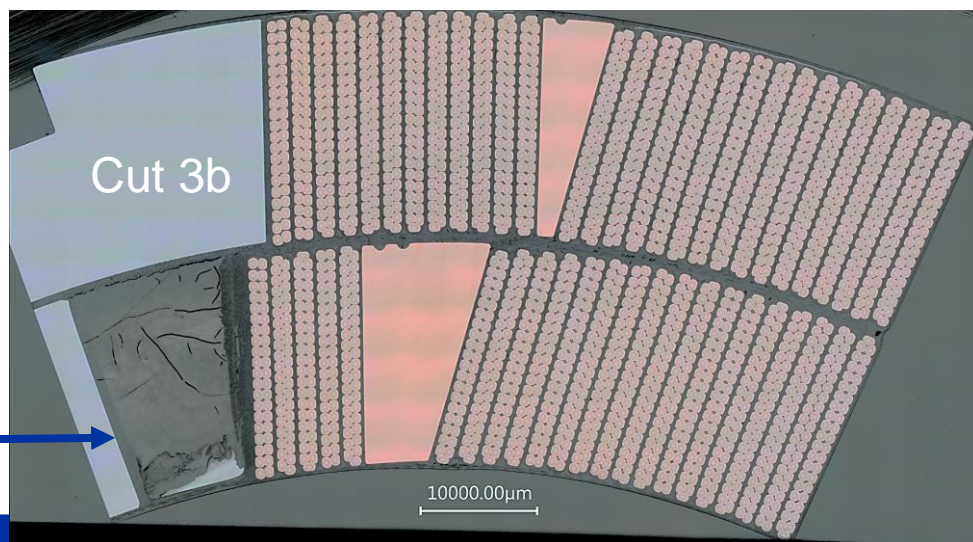
- Absence of bulging and popped in/out strands in straight sections
- Precise dimensional position of references (holes in the Ti-alloy pole) before cut (dimensional metrology tool)
- **For the first time, identification through CT of severe cracking in the resin reach areas of Ti alloy pole shims, eventually confirmed by metallography**

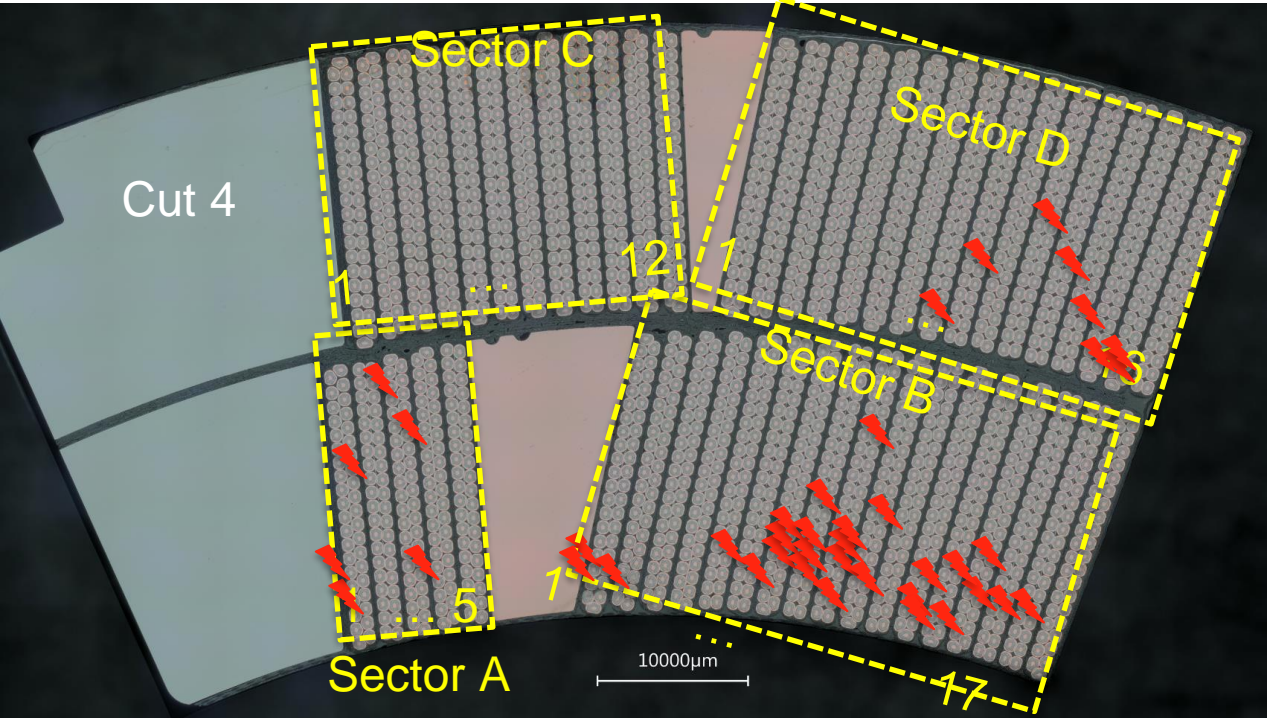
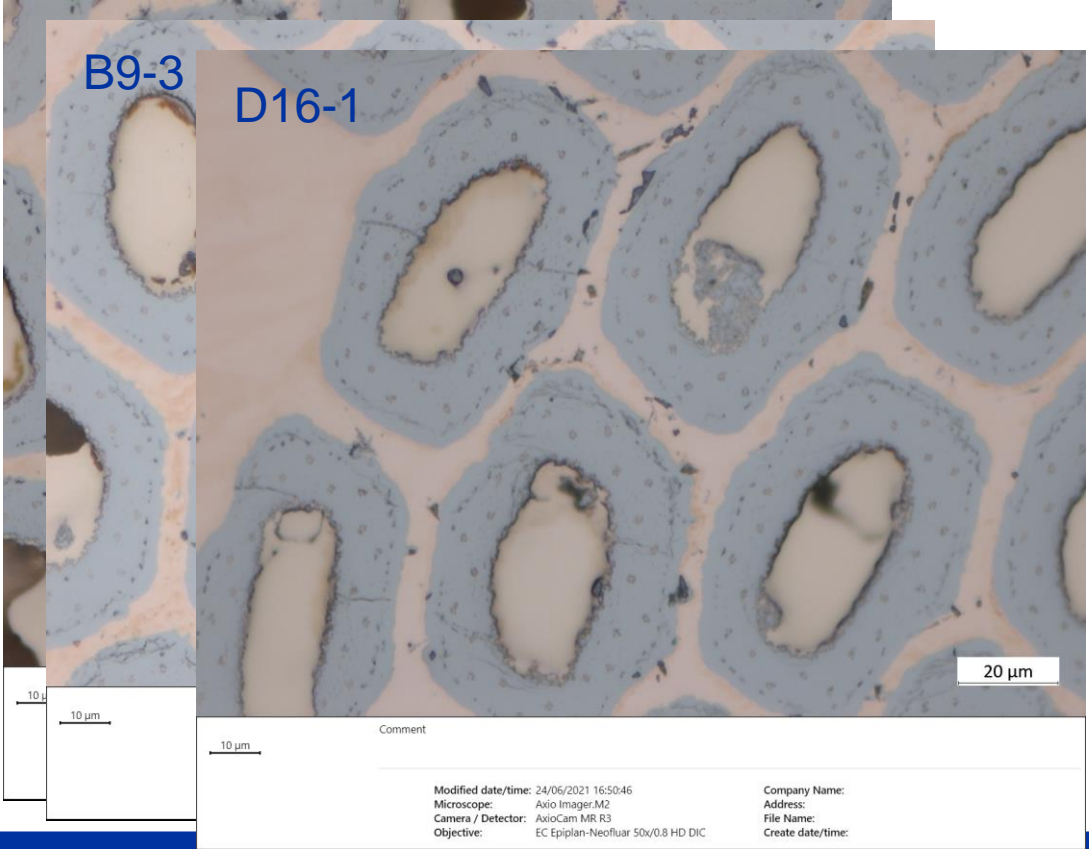
Example of Cut 4: a thorough examination revealed the presence of micro cracks at SC phase (14 sub-elements for sector A, 85 for sector B and 47 for sector D) that seem to be mainly located in a cloud (stress field?). Only few events (<5) with random location have been identified on C.

🔴 Conductor exhibiting micro-cracks (several sub-elements can be impacted for an indicated location)

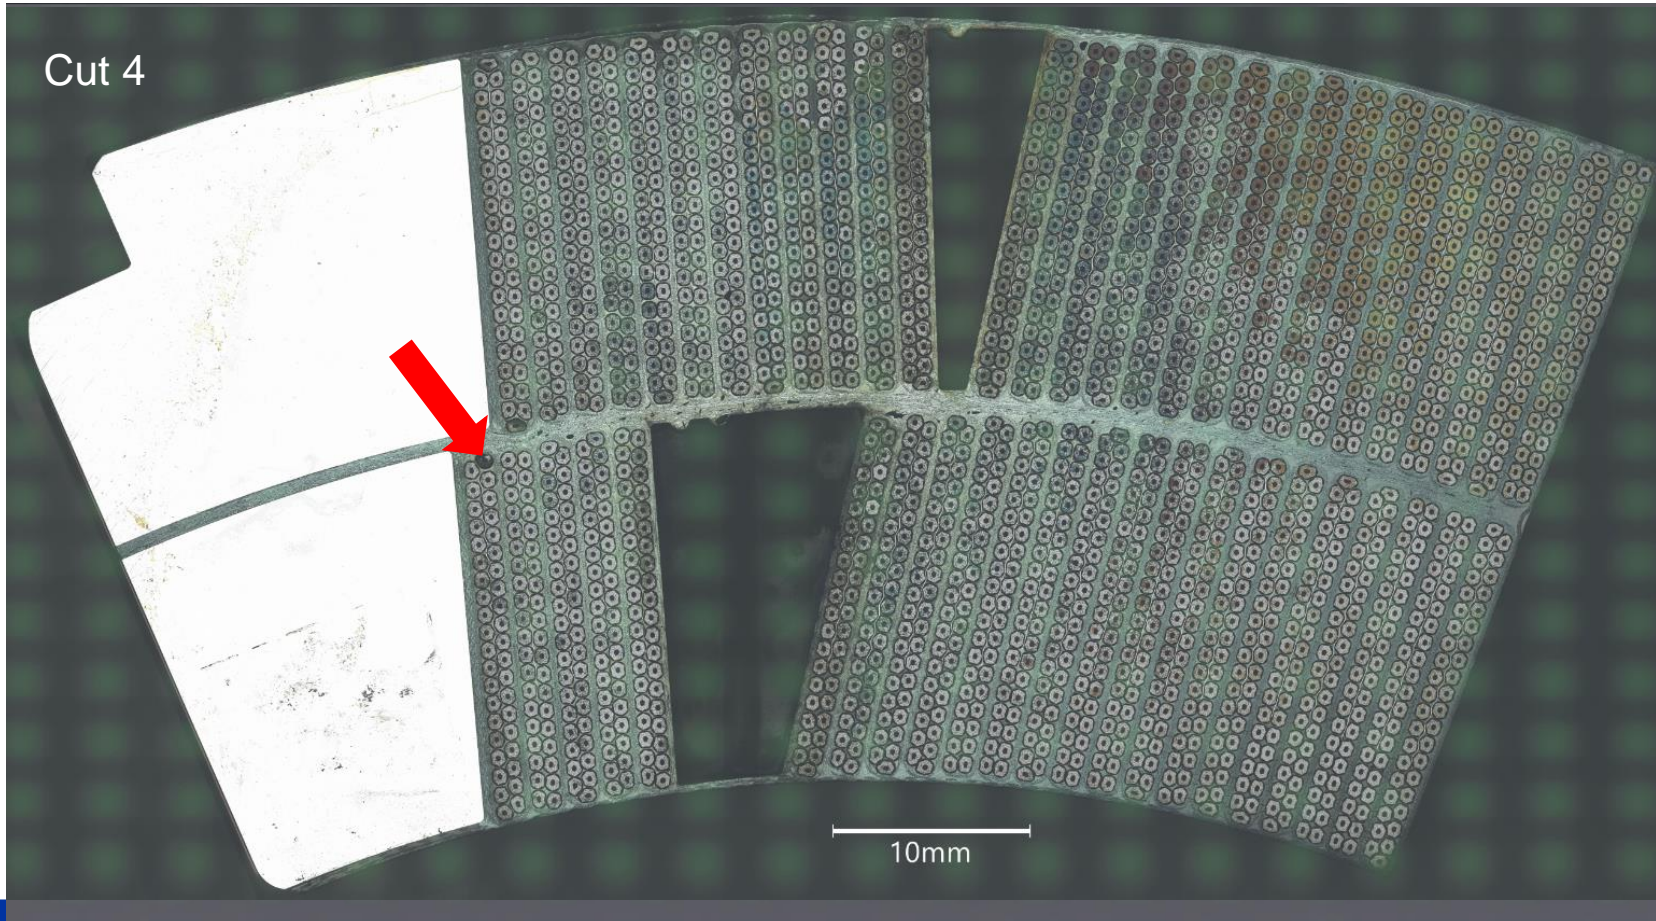
The same and the only one strand at the top edge of the Rutherford cable adjacent to the pole block at inner layer exhibits collapsed SC filaments. The portion of the affected strand where filaments are broken is consistent in the three cuts. Cut 3b does not exhibit broken filaments.

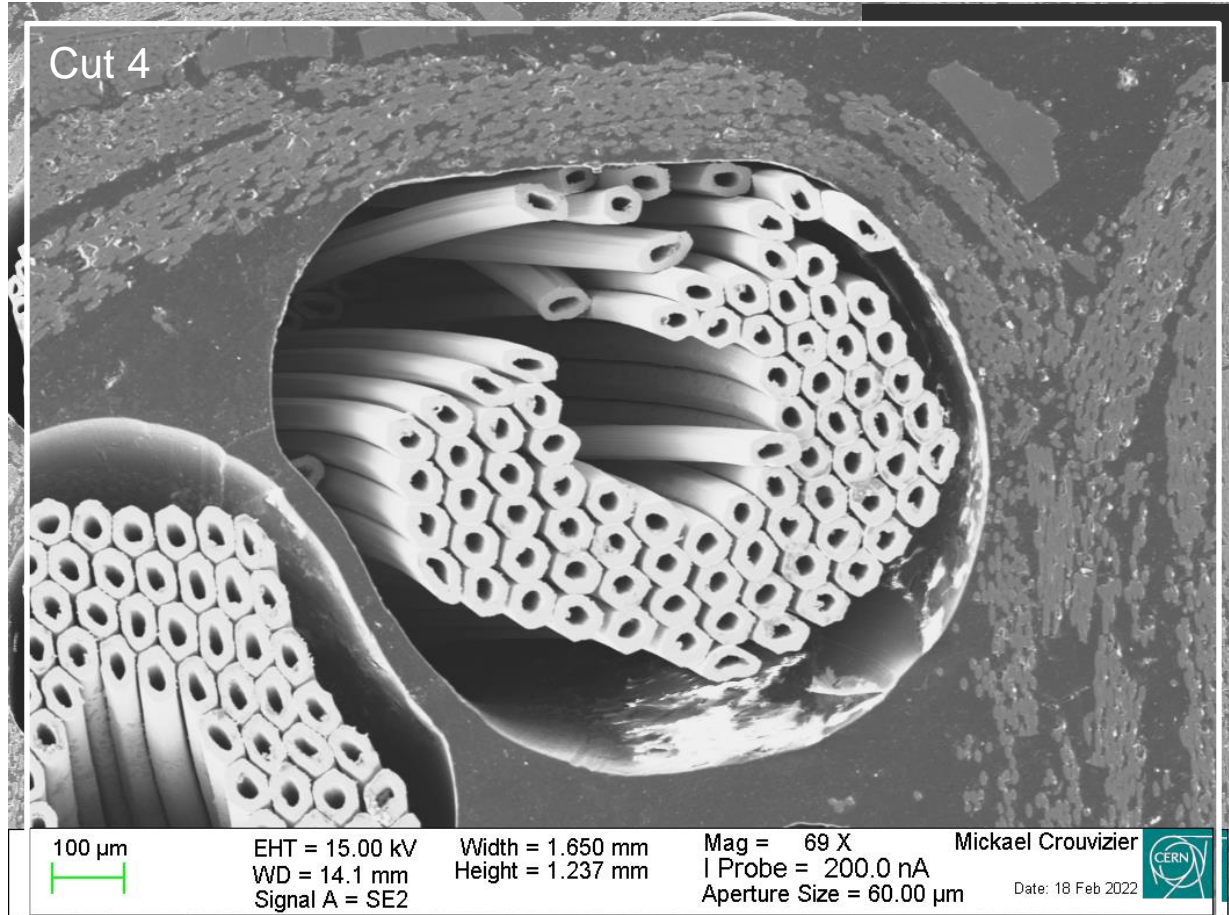
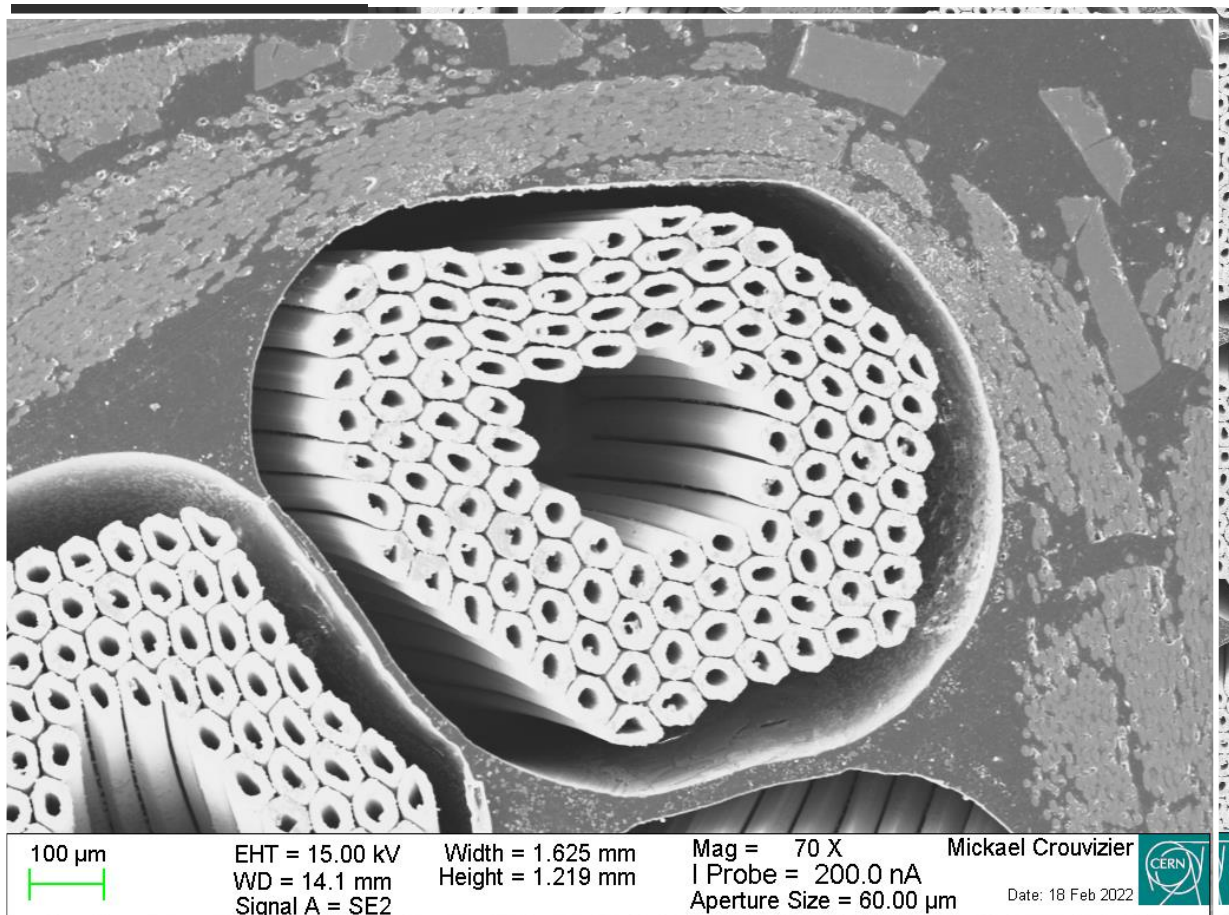
SEM examination allows collapsed filaments and fractured SC sub-elements to be highlighted. Some filaments are missing, they probably withdrew in rinsing water after etching.

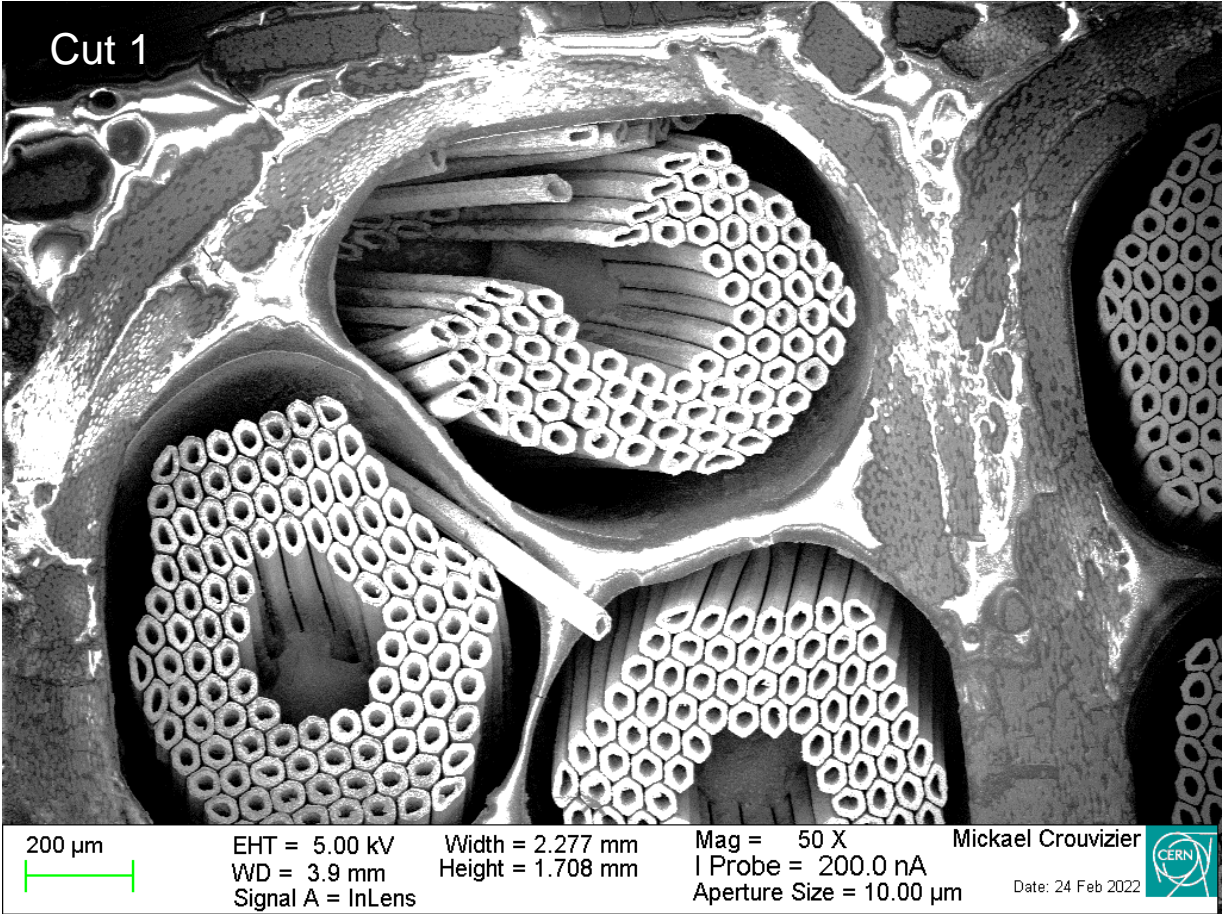
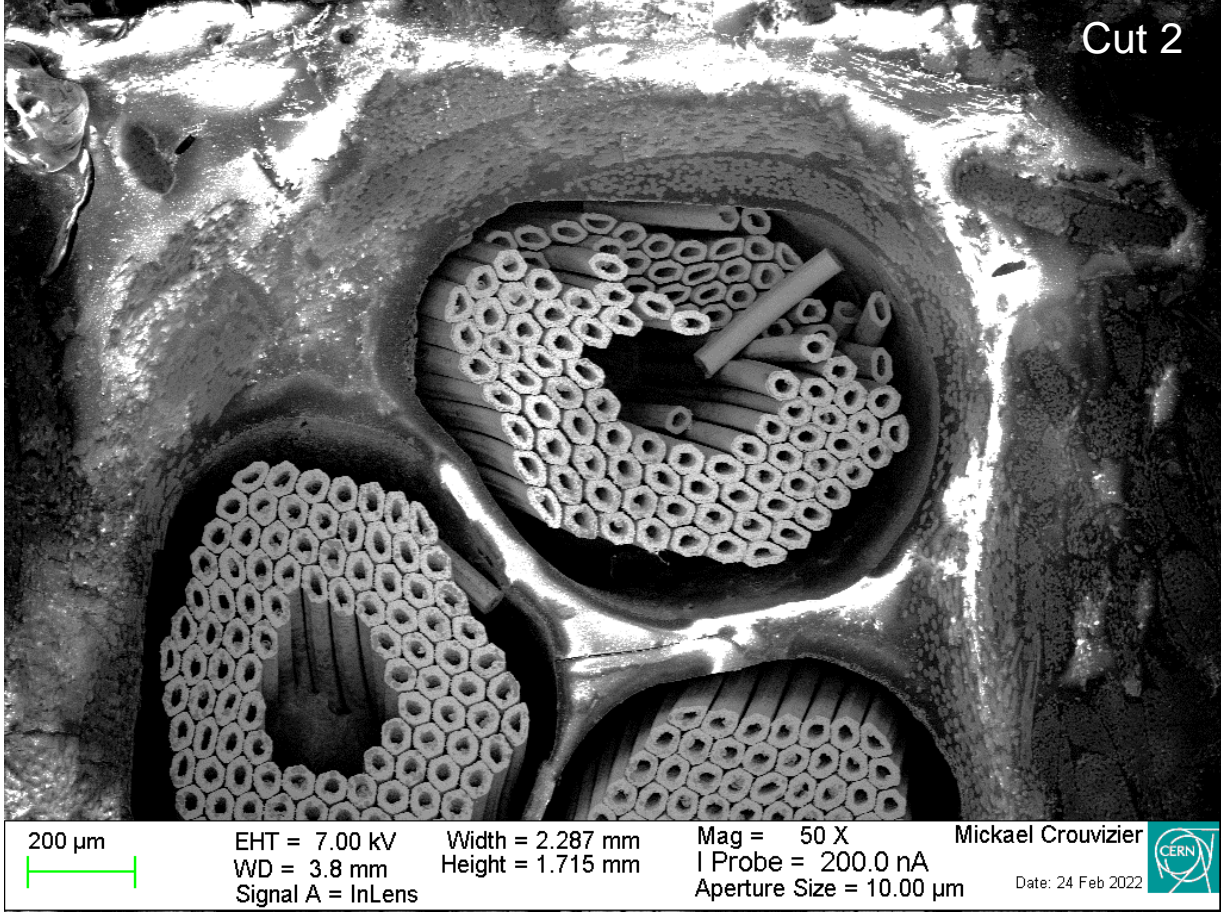
Some filaments are missing (probably withdrew in rinsing water after etching); filaments that seem still intact: 75/108, 76/108, 74/108 for cut 1, 2, 4, respectively.

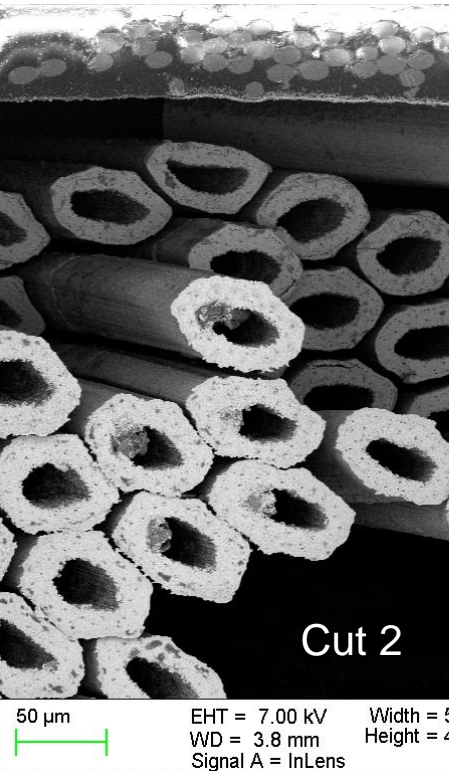
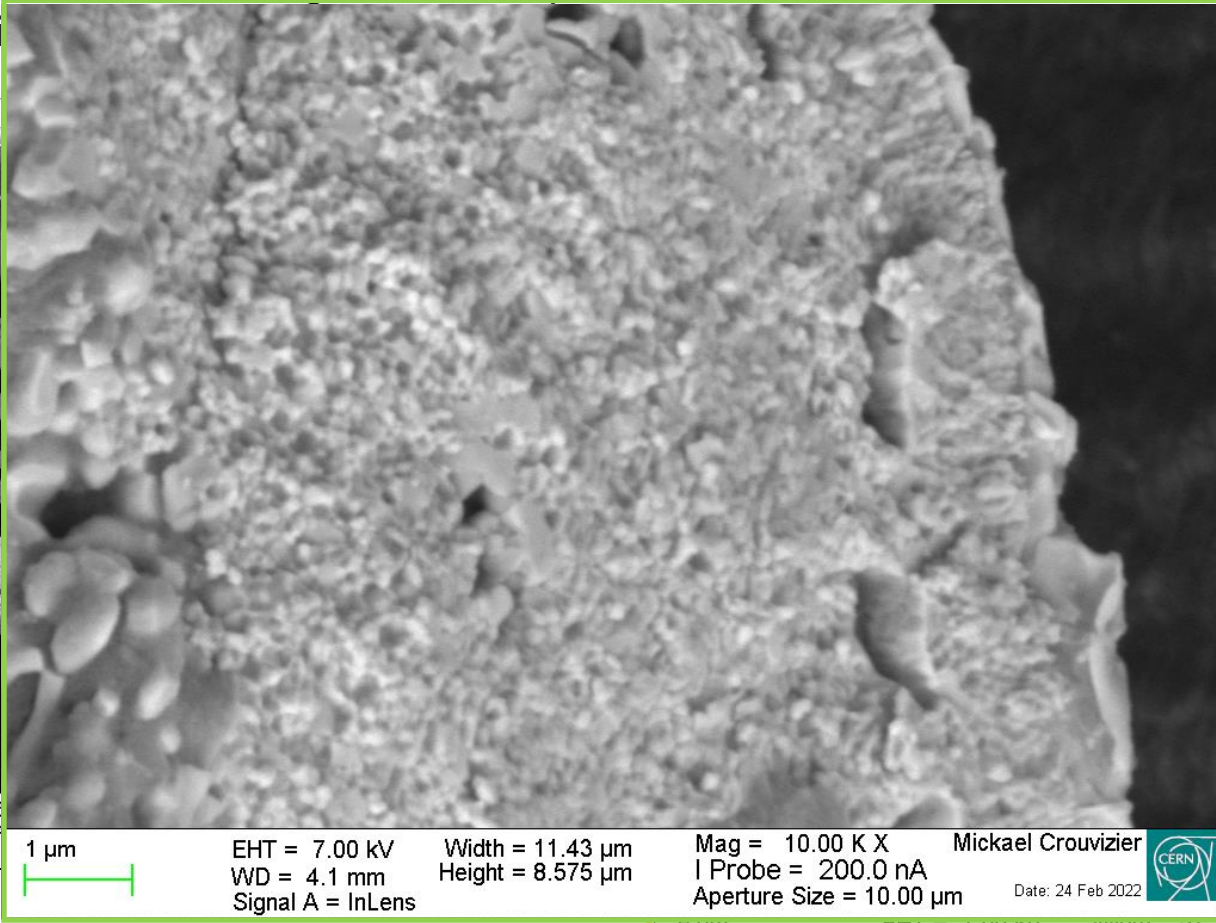
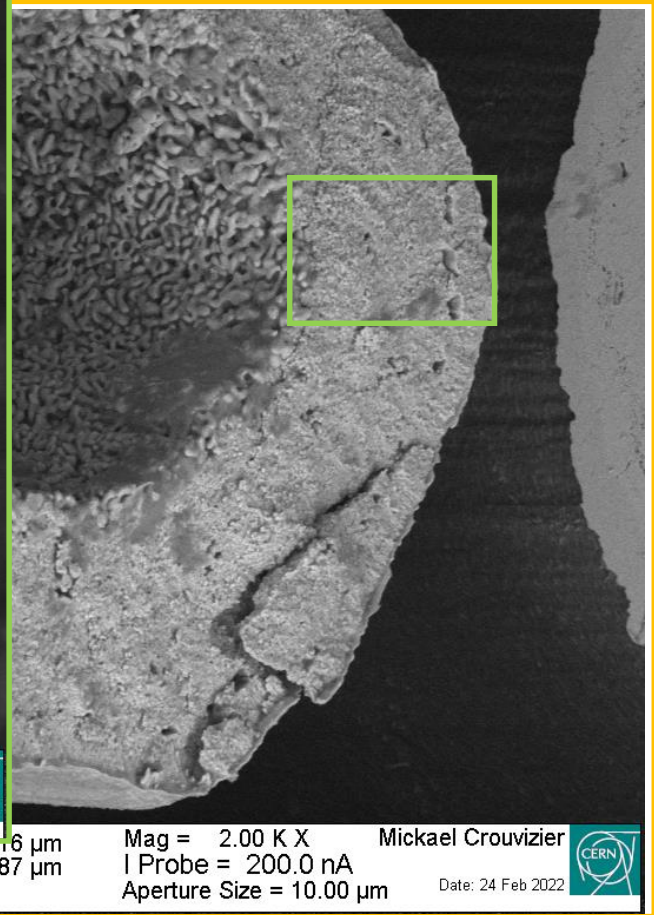
Highlight on fractured filament exhibiting transverse plane fracture: the fractured surface appears perpendicular to filament axis with a typical aspect of a brittle fracture

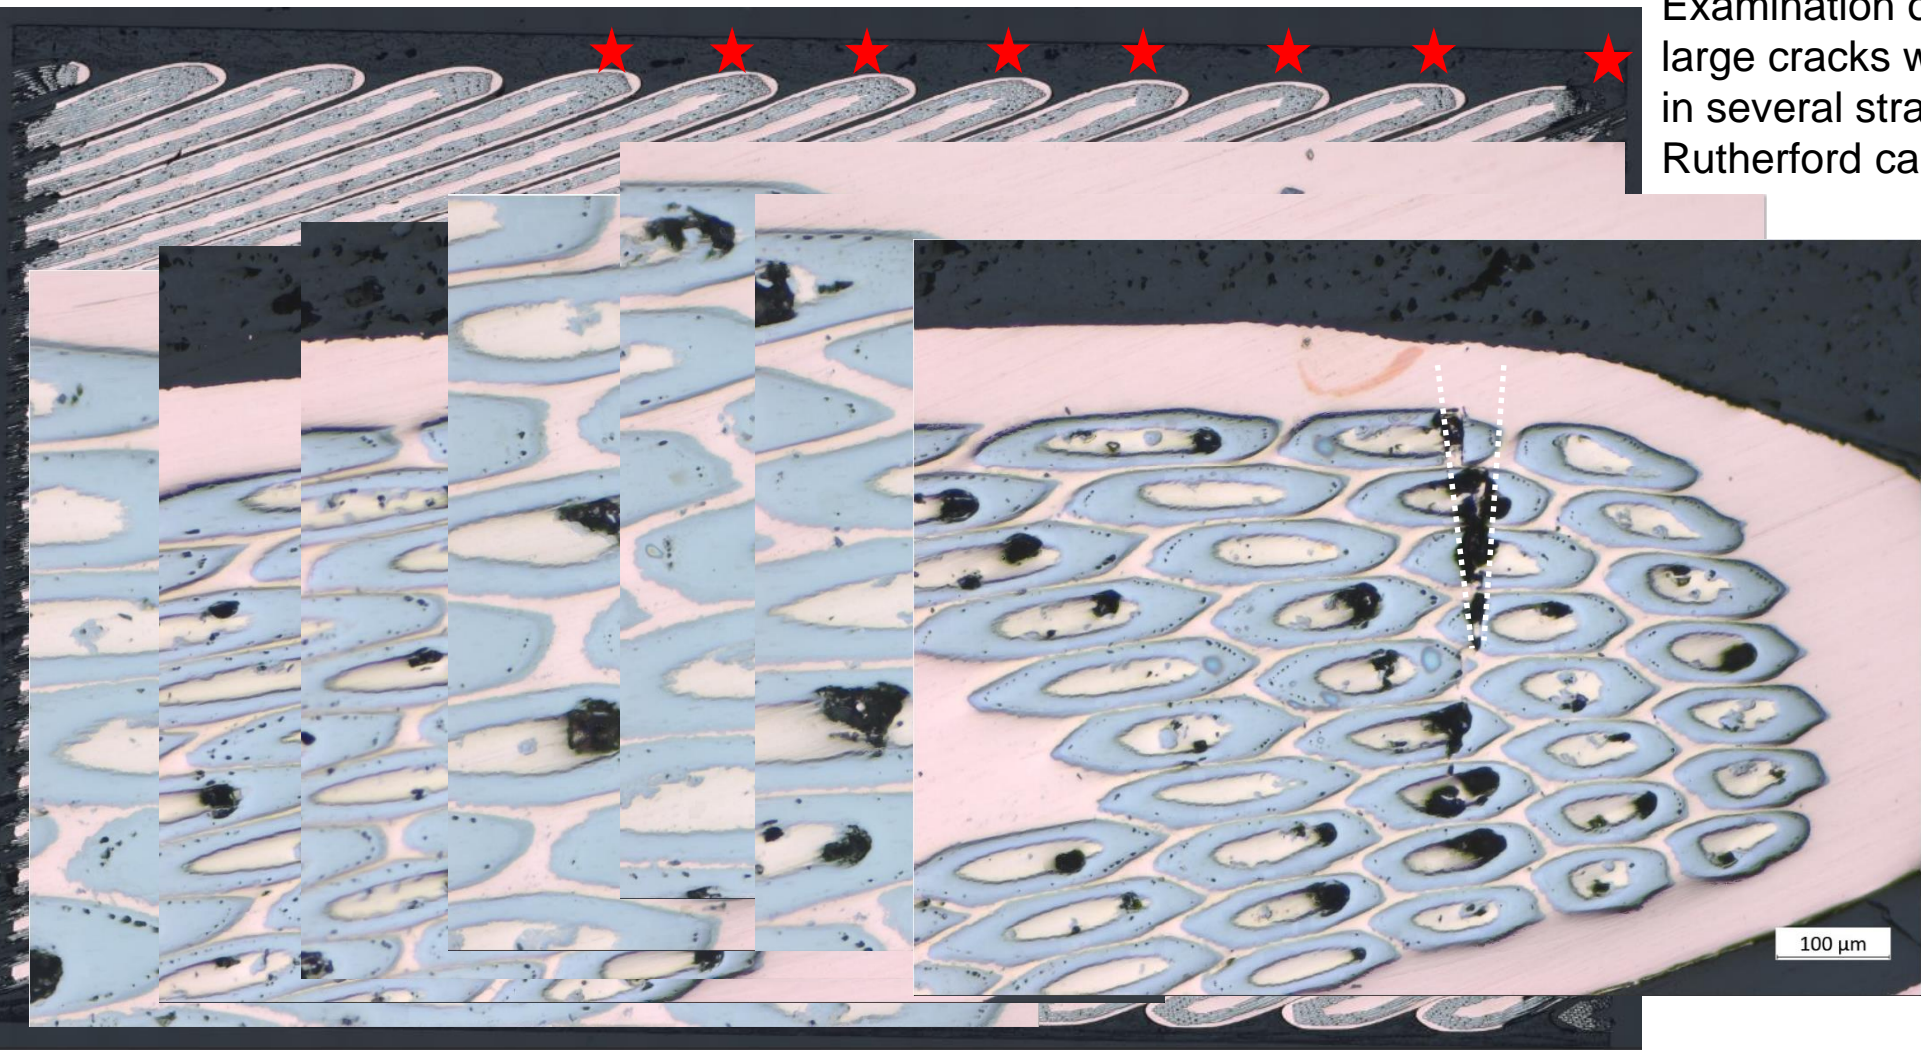
Examination of the whole surface reveals large cracks with clearly cracked filaments in several strands at the top edge of the Rutherford cable close to titanium poles.

Opened and cracked filaments seem to exhibit a V shape which could indicate bending issue.

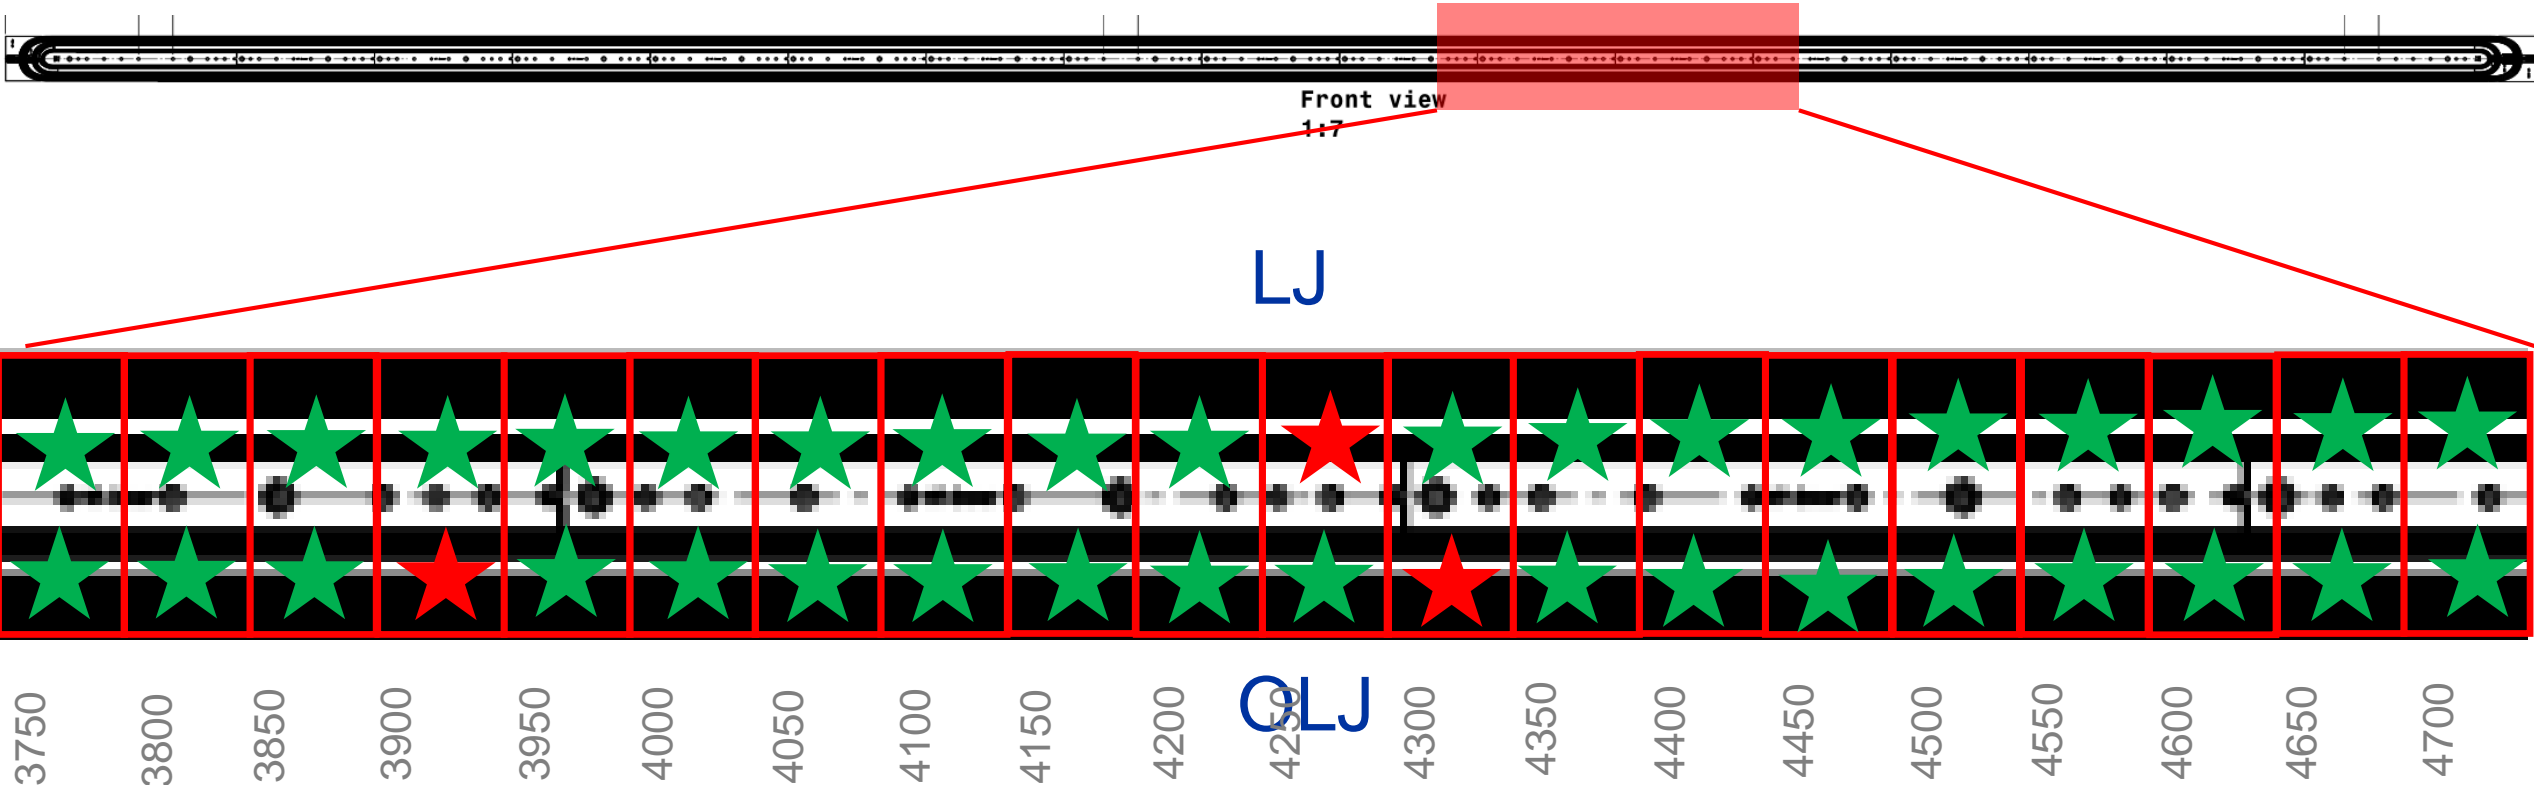
Three positions 300 mm, 650 mm and 700 mm from quench region exhibit damaged strand
