Advanced Examination of Nb₃Sn Coils and Conductors for the LHC luminosity upgrade: Computed Tomography and Materialographic Analyses

S. Sgobba¹, G. Arnau Izquierdo¹, I. Aviles Santillana¹, B. Bulat², M. Celuch¹, M. Crouvizier¹, A. Devred¹, S. Izquierdo Bermudez¹, A. Milanese¹, A. Moros¹, F. Savary¹, E. Todesco¹

¹European Organization for Nuclear Research, Geneva, Switzerland

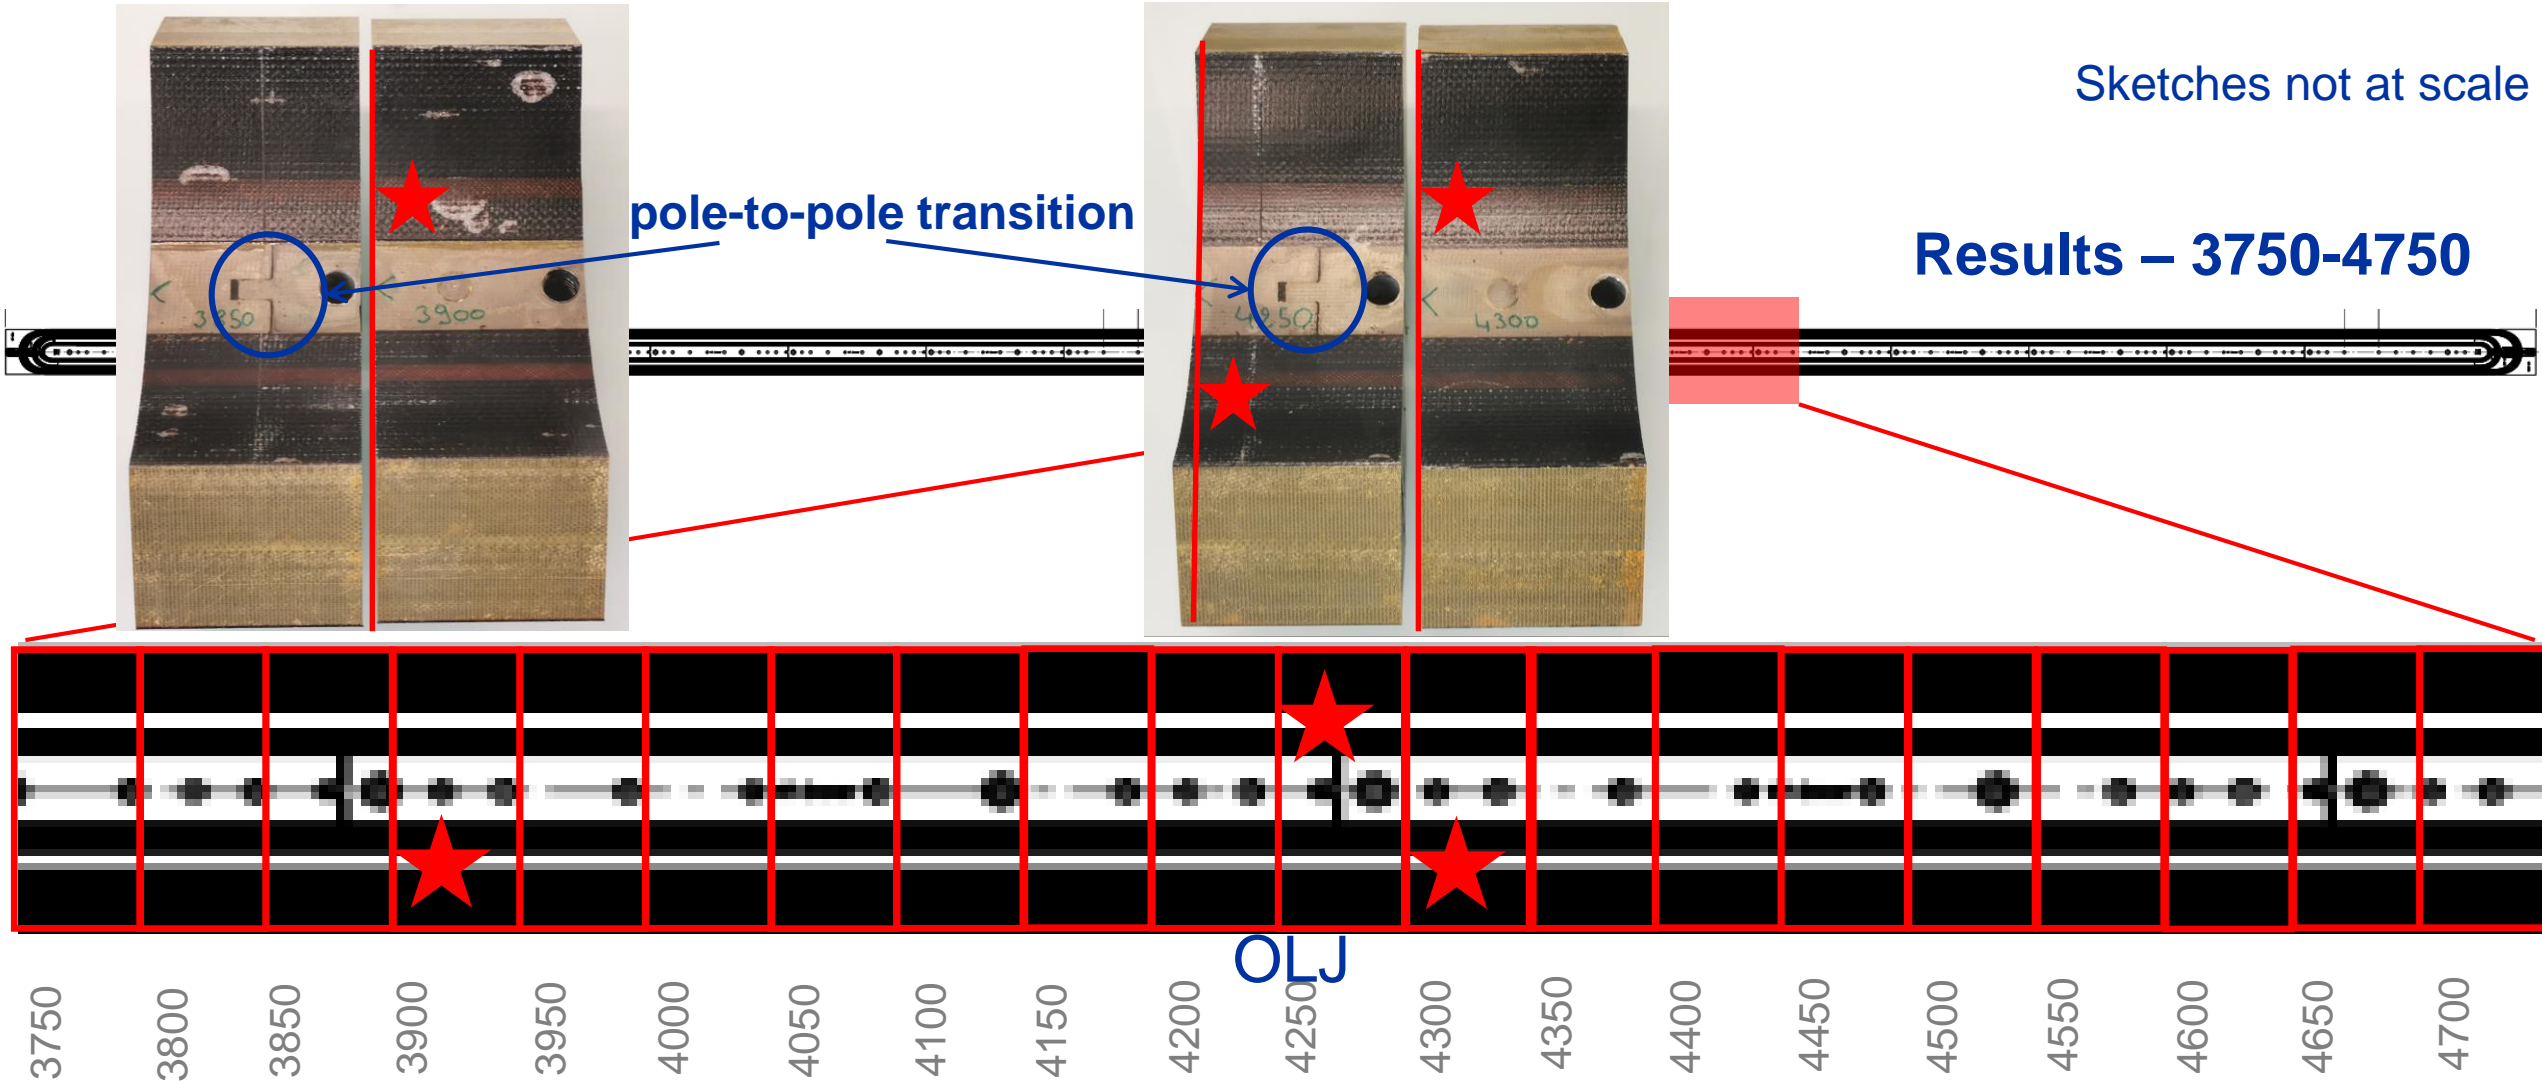
Observed events are in correspondence to titanium pole ends

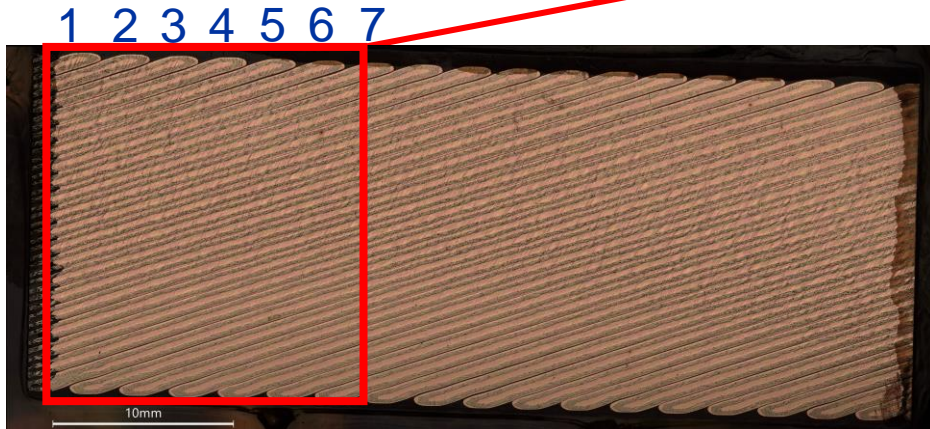
Longitudinal cut 2670 – Cross-section overview

- Longitudinal cuts of the 108 coil-samples 2670 and 3900 (both presenting crack-events as previously shown)
- The longitudinal cut 2670 was found to have approx. 240 crack-events spread over the longitudinal cross-section, especially close to the region where Cu was previously etched away.

The extent of the events is approx. 20 mm.

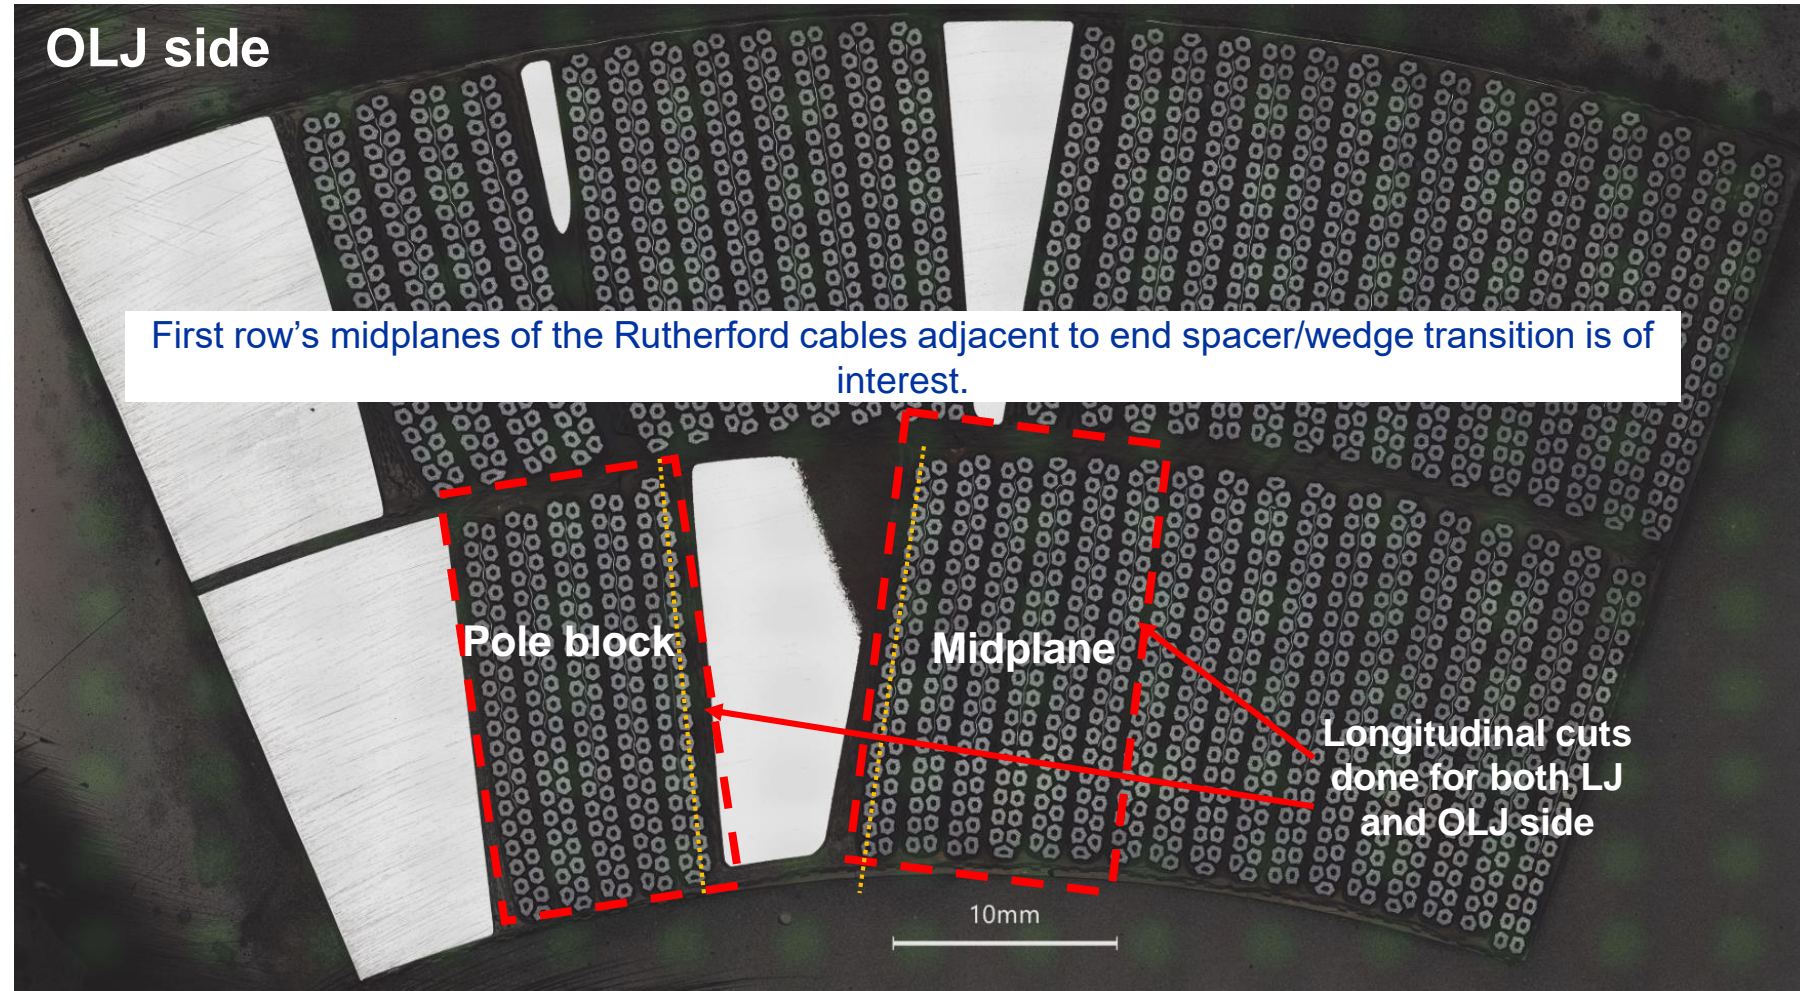
Not a single strand exhibits collapsed filaments.

The same result was found for the OLJ side.

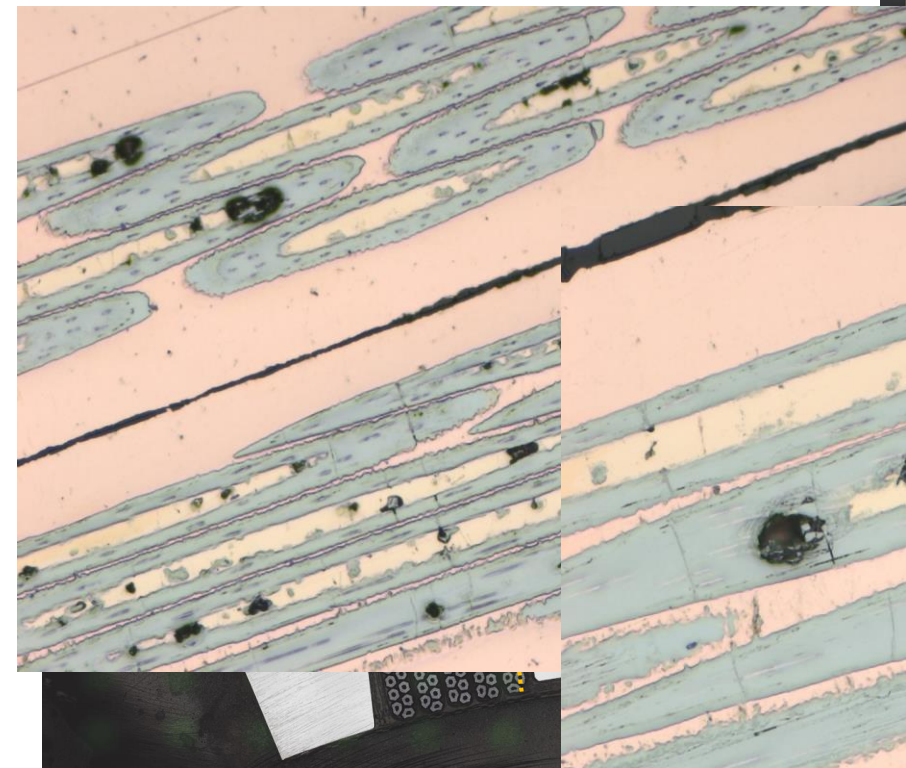
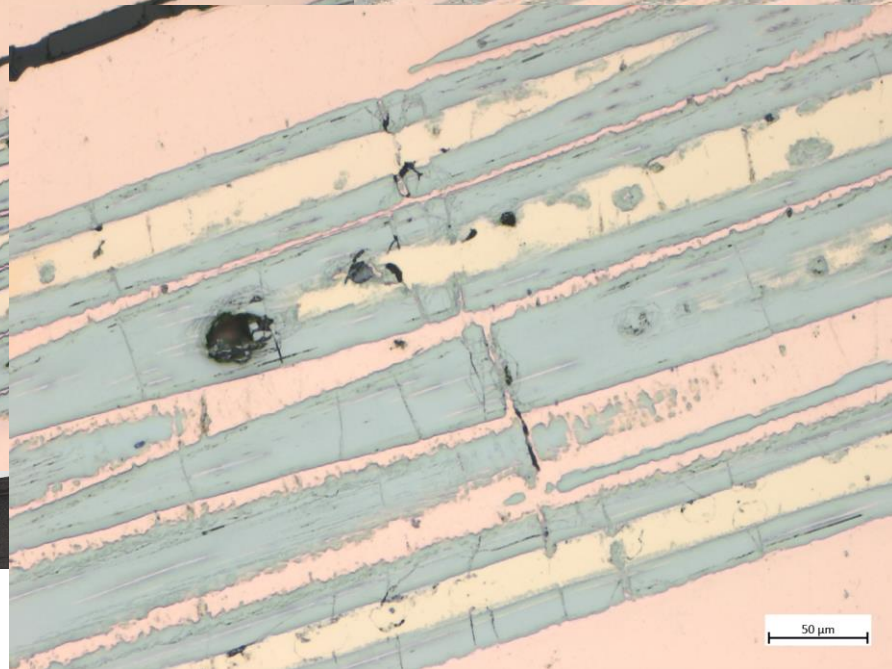
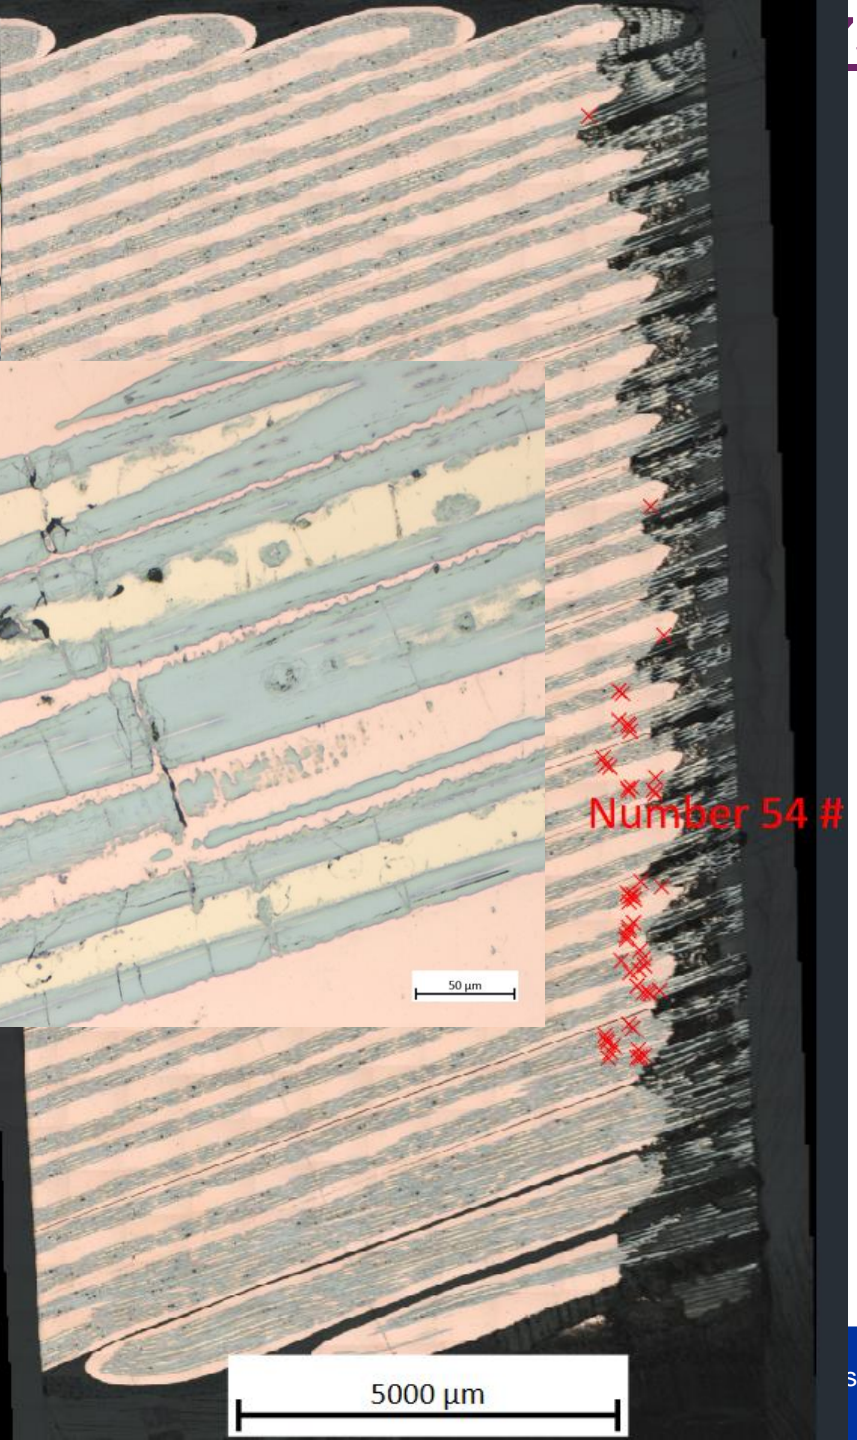
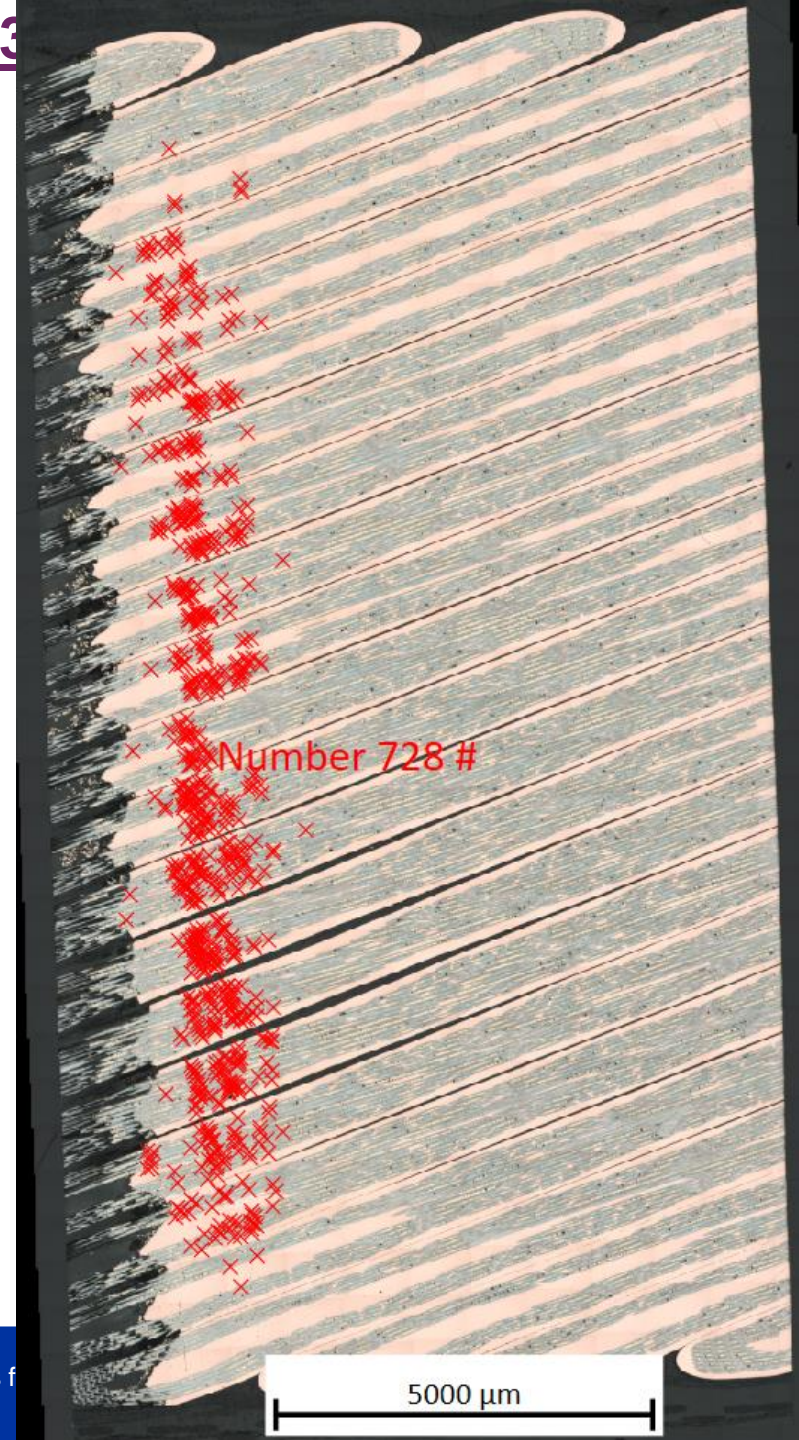
Few cracks at midplane block in a delimited area
A localized field of transverse cracks at SC filaments
is observed at pole block

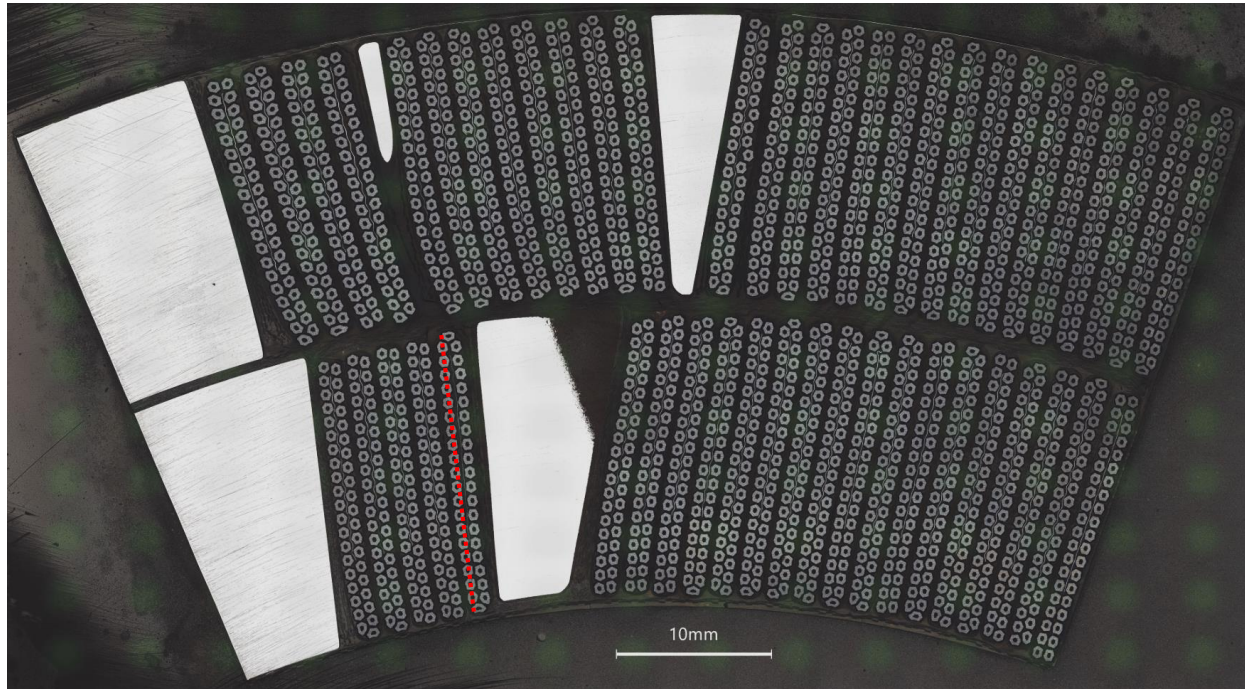
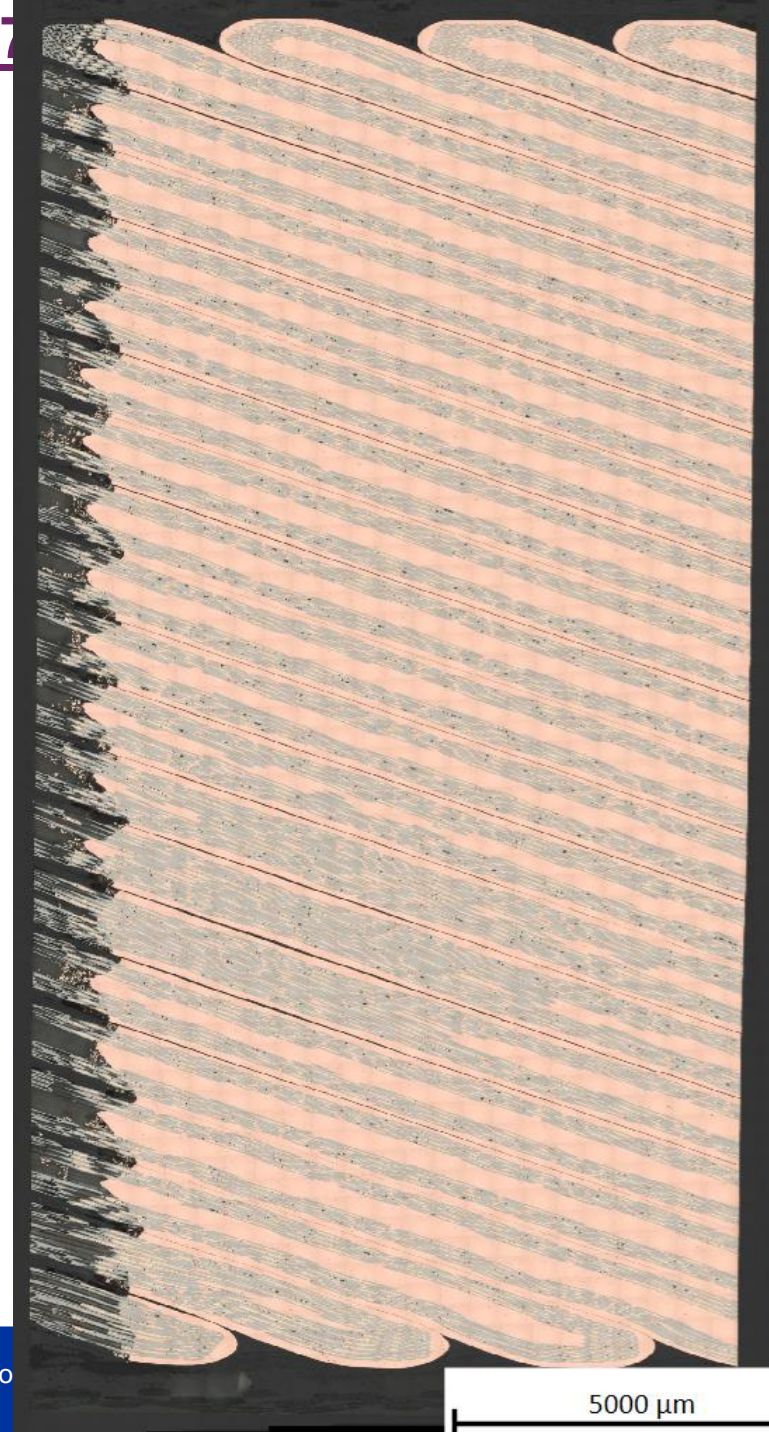
OLJ side – longitudinal cut 2nd row

No transverse cracks at SC filaments are observed at pole block 2nd row of Rutherford cable

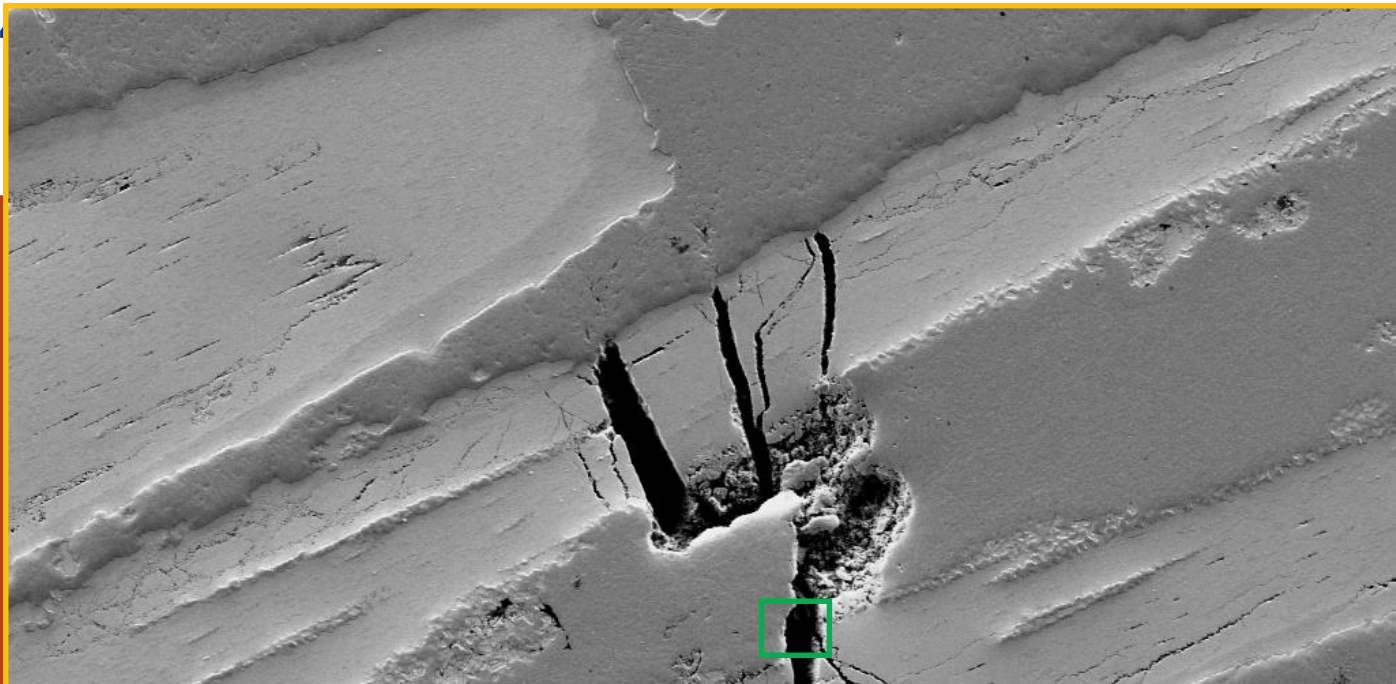
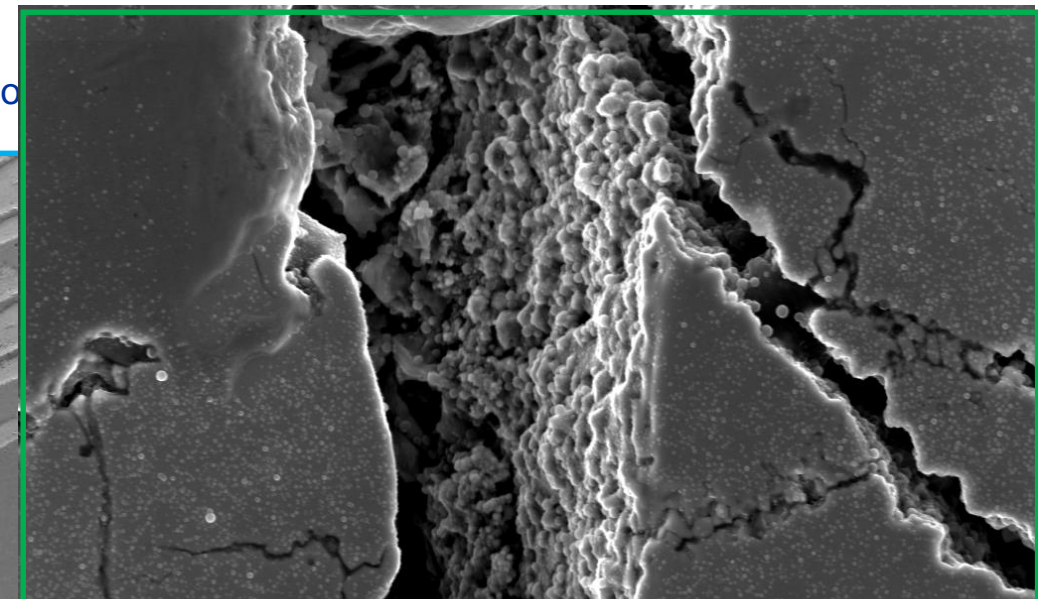
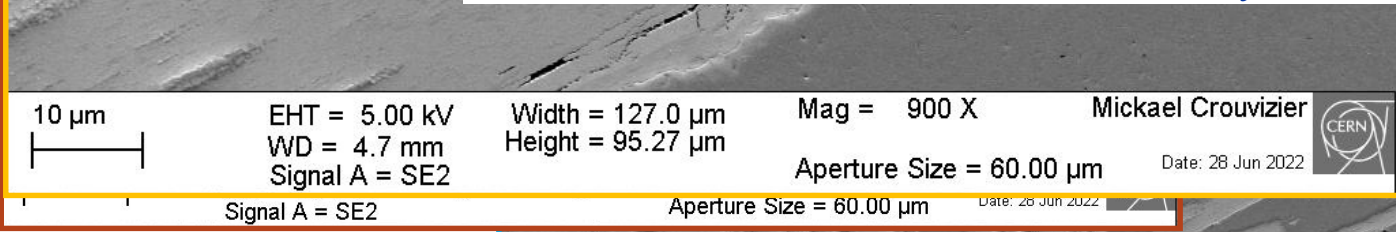
Transverse cracks (with respect to longitudinal axis of the strands) exhibit intergranular fractured aspect.
Networks of secondary cracks are observed

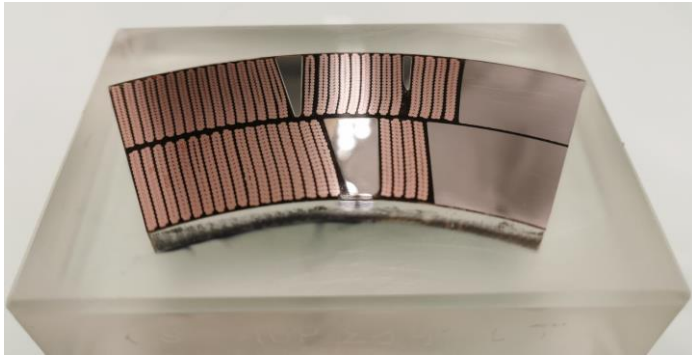
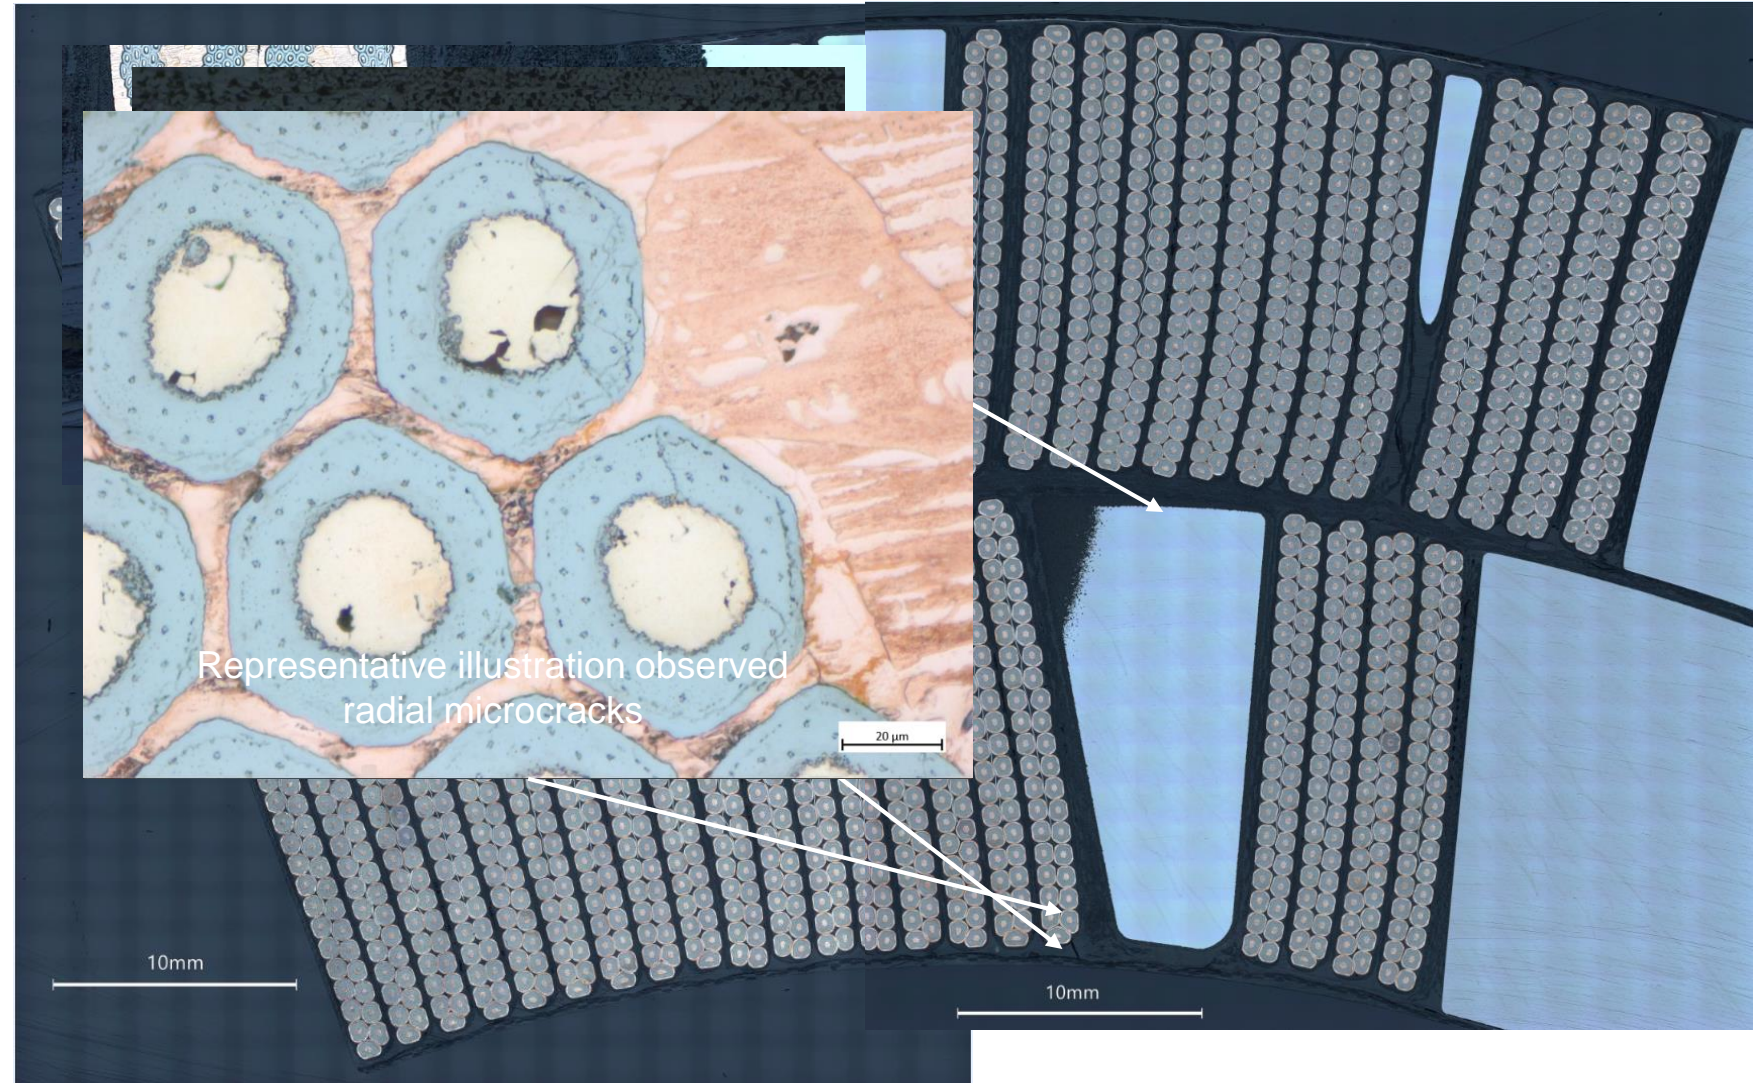
LJ side

Some “usual” shrinkage cavities through glass fibres/resin matrix are identified. Ceramic coating on end spacer ensures good cohesion with resin. Inspection of SC filaments did not reveal any major events. Some radial “closed” microcracks can be observed.

For the OLJ side, very similar results were found (here also some cracks through the glass fibres/resin matrix were identified)

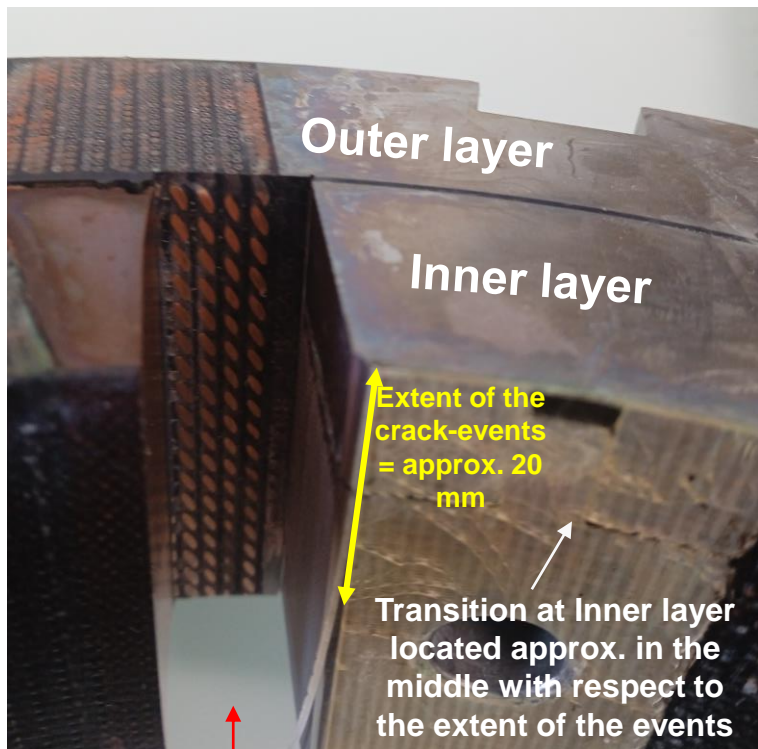
The major events were found at the top part of strand 1 up to strand 7. For strand 3 and 6, the “V” shape was identified.

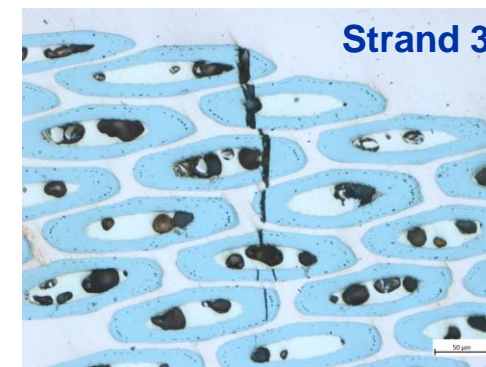
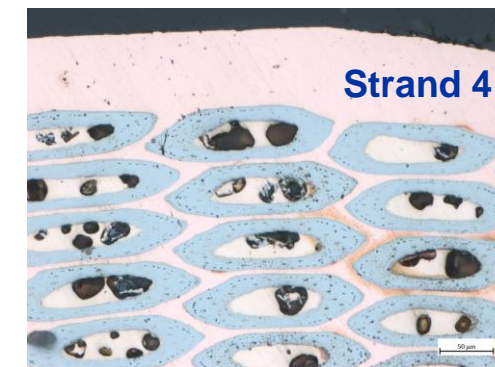
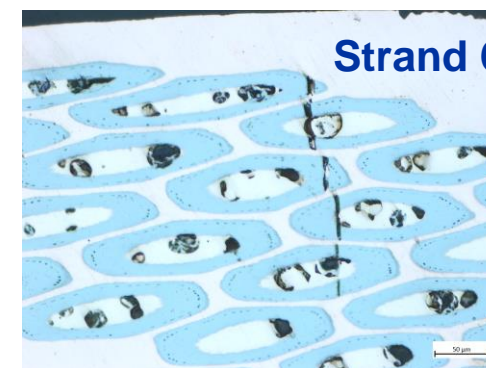
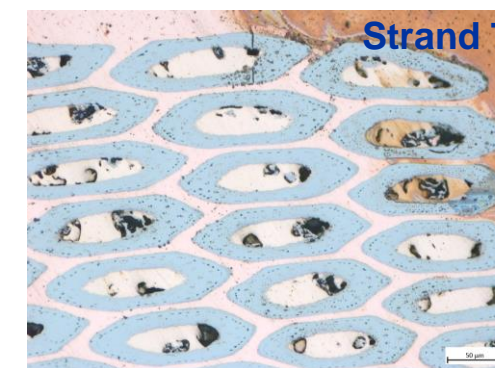
The extent of the events is approx. 20 mm

For the longitudinal cut 3900, an extent of the events of approx. 15 mm was observed at the top part (from strand 1 to strand 6). For this specimen, only few minor events (15-20) were observed over the cross-section, in the region close to the etched side.

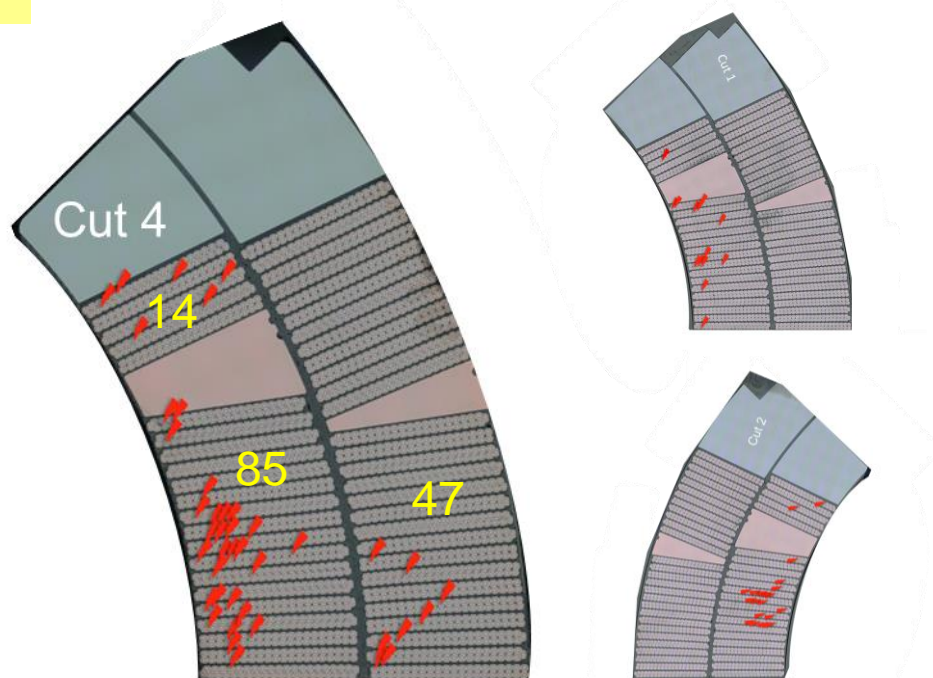
Coil 108, coil straight section

- The higher concentration of micro-cracks in the analyzed sections of coil 108 straight section is in IL the mid- plane block (see talk from S. Sgobba)

Remark: In the case of BP1, with a maximum coil stress of 100 MPa at warm after loading, we expect 135 MPa in the pole block after cool down and a maximum of 110 MPa in the mid-plane at 15 kA
