# ProtoDUNE SC mounting and testing

## Lessons Learned

Antonio Verdugo on behalf of Ciemat Group

November 14<sup>th</sup>, 2022

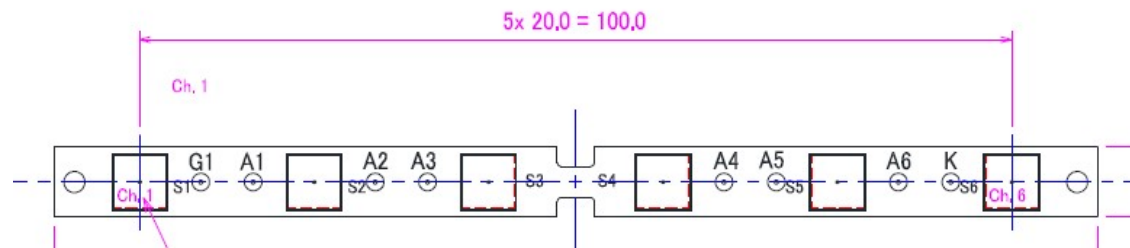
- Symmetric design of the SiPMs PCB allows reverse mounting. An asymmetric placement of the PINs would avoid mounting errors.

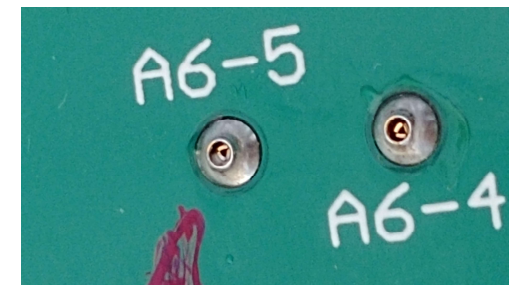
- Length of the PINs too tight and routing board bending when screwed causes PINs miss-connections.
- Some routing boards sockets found with tin inside.

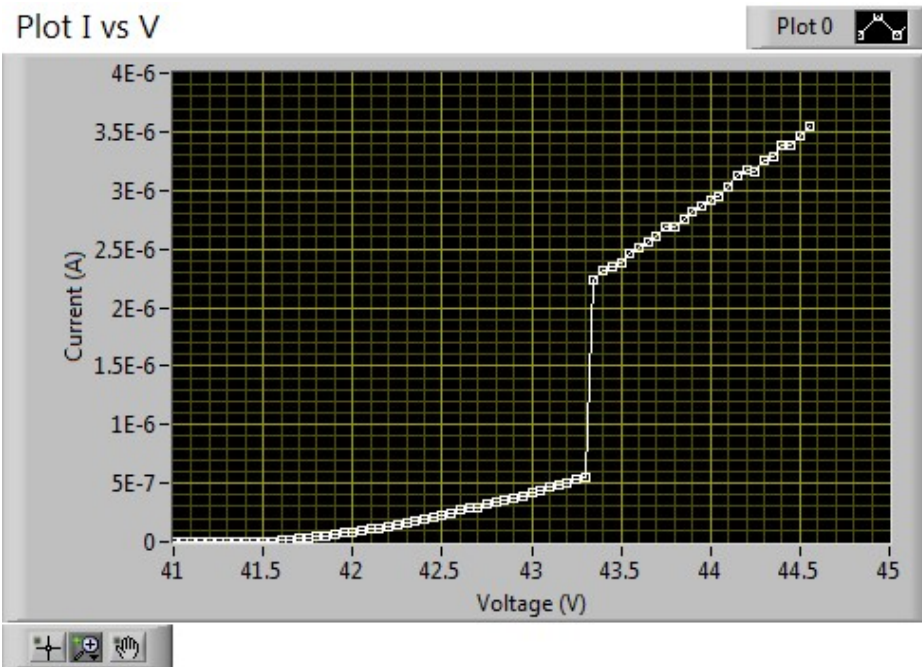
Reverse I-V in LN2  
 $V_{bd} = 41.4V$

- Some (less than 1%) SiPMs showed a high DCR in LN2.
- Checking those SiPMs after the problem was detected, they showed also a jump on the reverse I-V curve at operating voltages. It could not be detected during the previous I-V tests because only values around  $V_{bd}$  were taken.
- To be confirmed if this I-V jump was present before LN2 immersions.
- To try to detect this problem extended I-V curves will be taken during massive testing.

Current jump is more evident in LN2

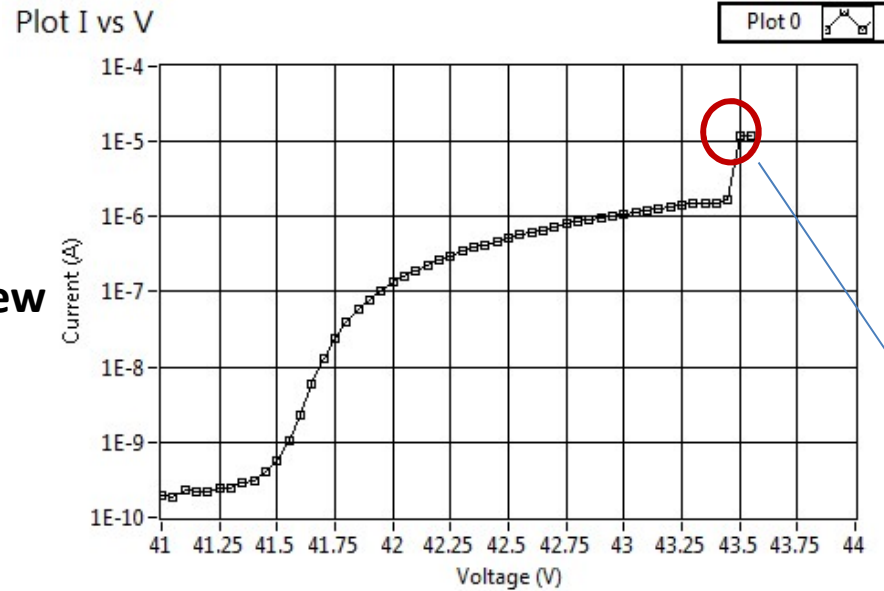
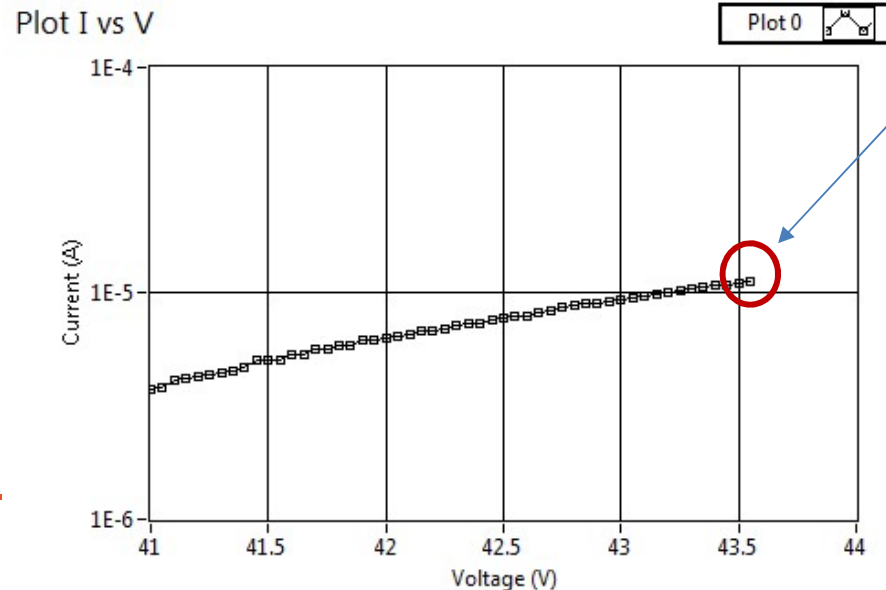
## 75LQR – Faulty SiPM #5 on board 75

# Another noisy SiPM with the same behavior

LN2 after ganging tests

Almost normal response obtained only once after a new immersion
